**MINERALS PROGRAM INSPECTION REPORT**  
**PHONE: (303) 866-3567**

| <b>MINE NAME:</b><br>4406 Alaska, LLC Pit #1 | <b>MINE/PROSPECTING ID#:</b><br>M-2010-036 | <b>MINERAL:</b><br>Clay (general), grave | <b>COUNTY:</b><br>Phillips |
| <b>INSPECTION TYPE:</b><br>Surety-Related Inspection | <b>INSPECTOR(S):</b><br>Brock Bowles | <b>INSP. DATE:</b><br>January 12, 2022 | <b>INSP. TIME:</b><br>13:00 |

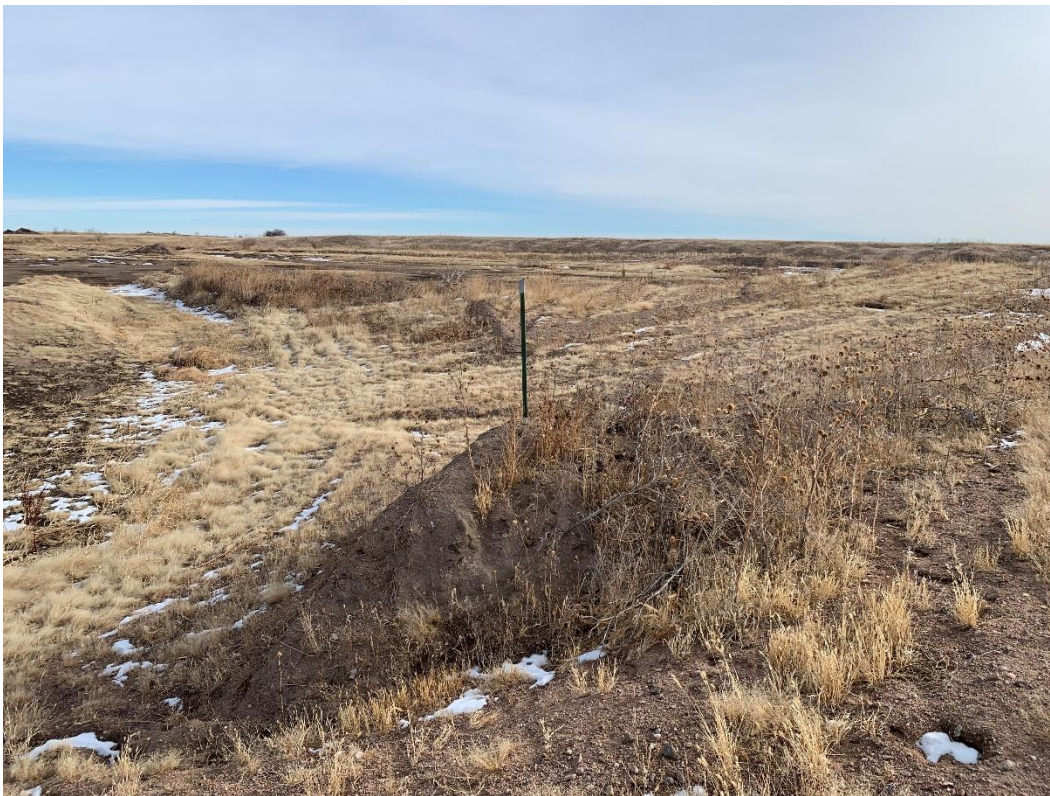
Photo 1 – Western marker of area 2

The northern permit boundary is CR 16. The eastern boundary is 130 feet west of CR 3 and is marked with a t-post. The southern boundary is marked by t-posts along the creek bank and agriculture field. The western boundary is 200 feet east of CR 97 but was not checked as it is more than 3,000 feet from current mining operations. Mining operations are approved to take place in 7 areas as shown on Exhibit C of the CN1 application. Mining is currently only bonded to take place in areas 1 and 2. The western side of area 2 was marked with t-posts (photo 1).

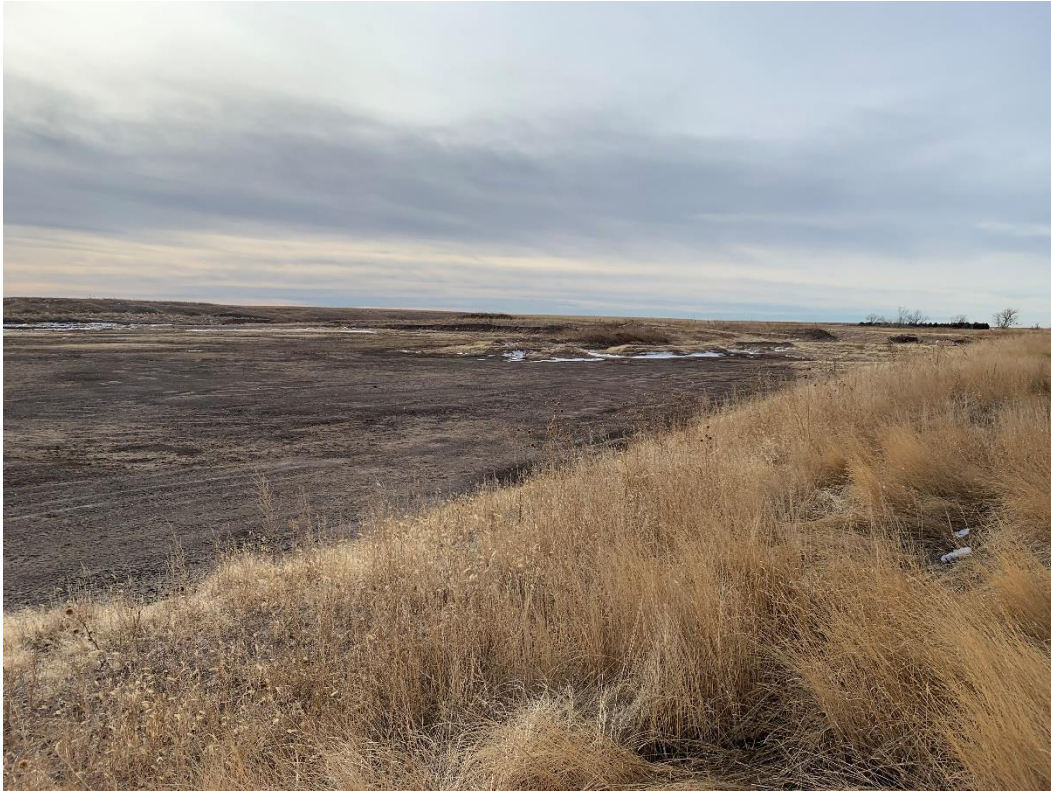
Photo 2 – Pit area 2 facing southeast

Pit area 2 is about 4-6 feet deep (photo 2). No mining was taking place and no equipment was on site. The sides of the pit were sloped to about 1h:1v. The area 2 pit is separated from the creek by a berm that was left in place by the mining operations. No standing water was in the pit, although there are water marks on the pit walls (photo 3) indicating the pit was filled with water, most likely during the heavy rains of the previous summer. The upstream end of the berm was breached during the rain events and water entered the pit area on the western side of the pit. The water was able to exit the pit area on the eastern, downstream side of the pit which is open to the creek.

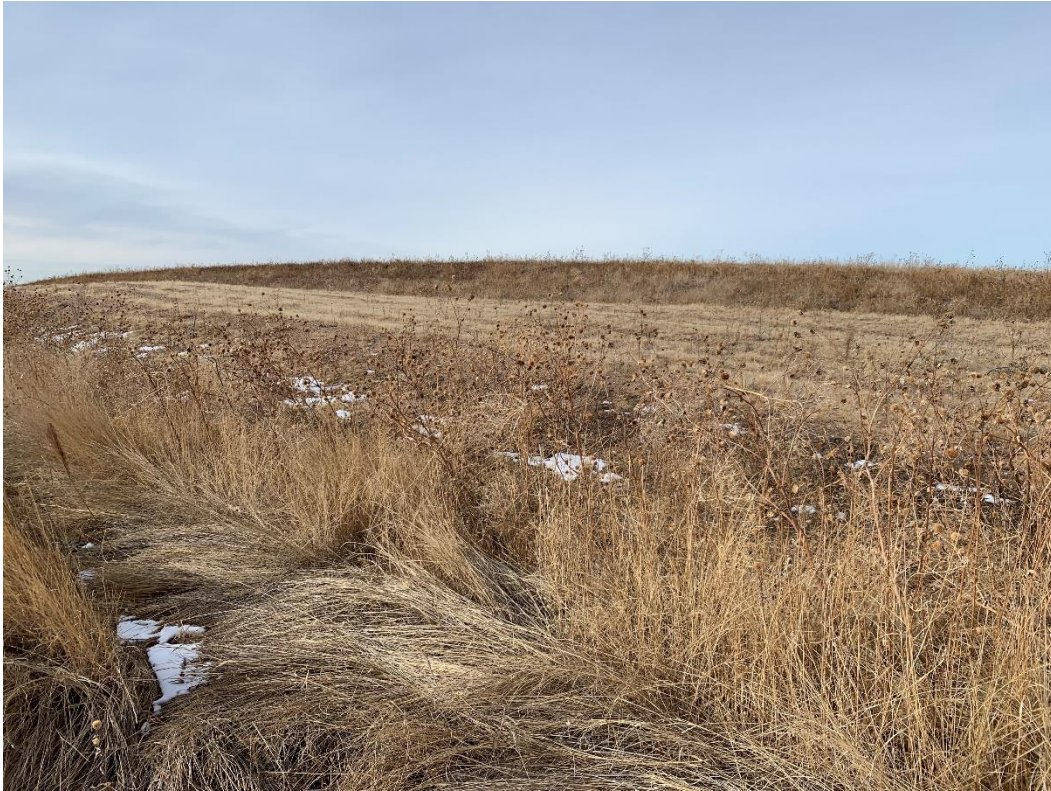
Photo 4 – Topsoil stockpile

The main topsoil stock pile is located north of pit area 2. The pile is well vegetated and appears to be stable (photo 4). A second topsoil stock pile is located on the west side of area 2, is well vegetated and appears stable.

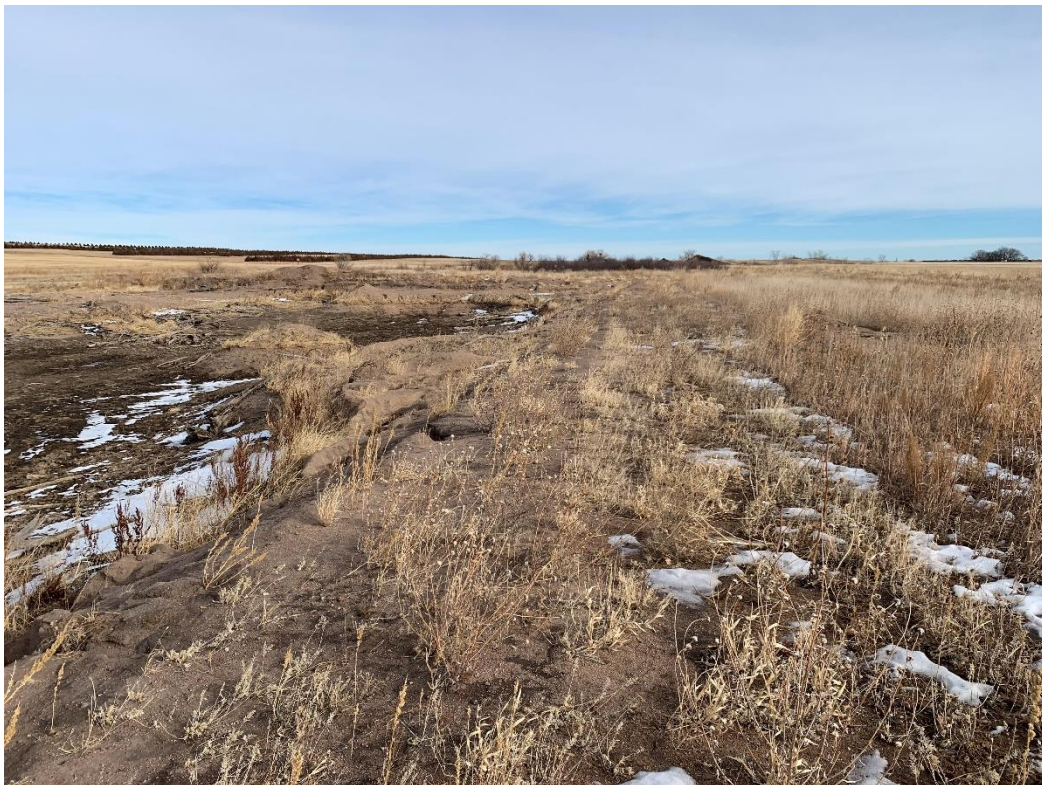
Photo 5 – Area 1 pit

The pit in area 1 is about 1 acre in area, 4-6 feet deep and the pit walls are 1h:1v. There was no standing water in the pit but there was debris from the flood event (photo 5). A small excavation is in the eastern side of area 1. This pit is well vegetated and did not contain water. The topsoil pile for this pit is on the southern edge of the pit and is also well vegetated and stable (photo 6).

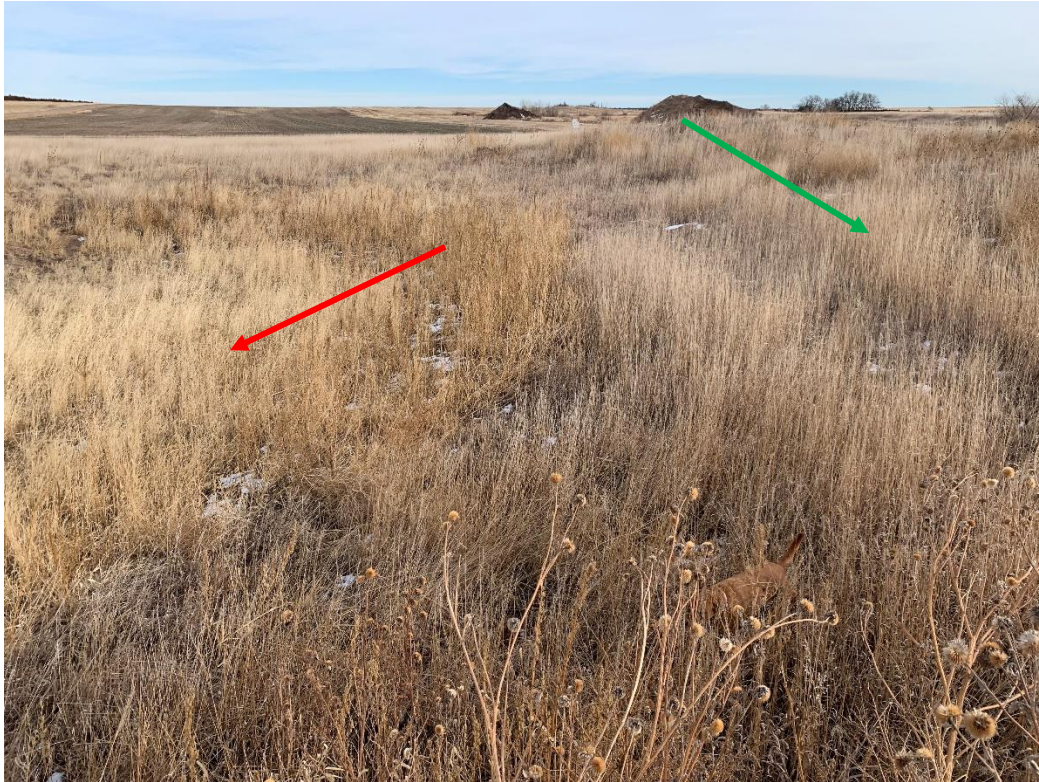
Photo 6 – Small excavation (red), topsoil pile (green)

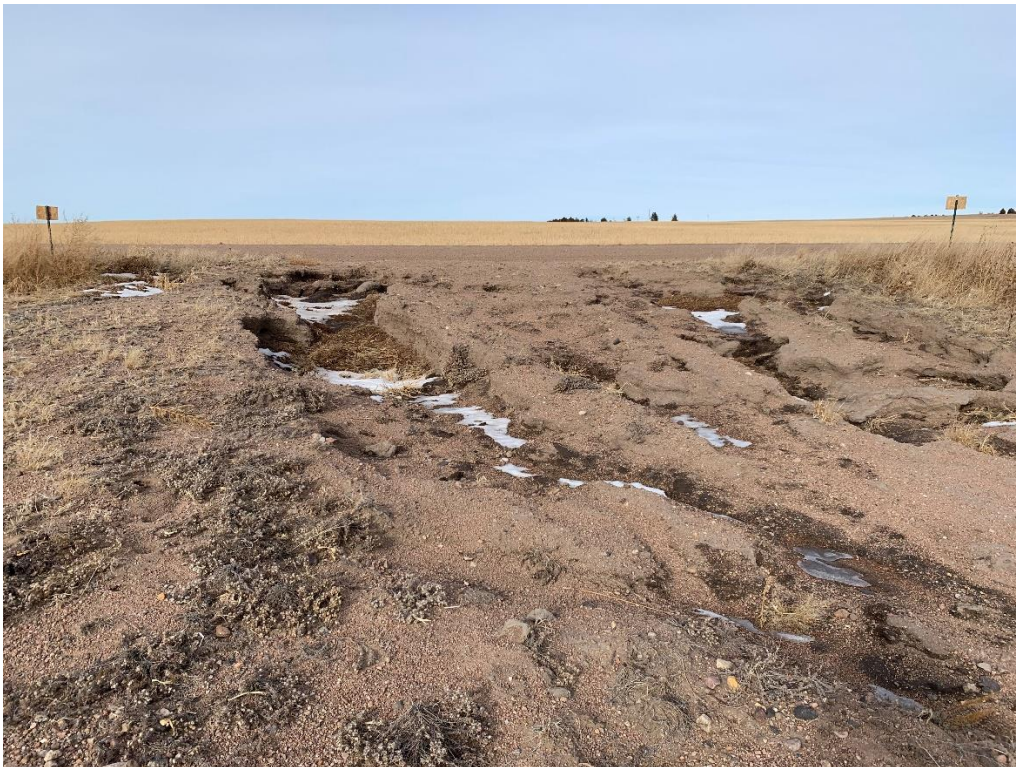
**PROBLEM/POSSIBLE VIOLATION:** Problem: Erosion gullies and ruts were observed on-site. This is a problem at this time for failure to protect the affected land from erosion pursuant to C.R.S. 34-32.5-116 (4) (j).

In the northern part of area 1 there are a couple of gullies about 12" deep that are close to CR 16 (photo 7). These gullies need to be repaired to prevent further erosion within 60 days of this report. See corrective action box above for more information.

Photo 7 – Gullies in area 1

**CORRECTIVE ACTIONS:** The operator shall provide photo documentation to the Division verifying erosion gullies and ruts have been repaired, and that the site has have been reconstructed and stabilized to prevent erosion damage by the corrective action date.

**CORRECTIVE ACTION DUE DATE:** 3/28/22
