**COLORADO DIVISION OF RECLAMATION, MINING AND SAFETY
 MINERALS PROGRAM INSPECTION REPORT
 PHONE: (303) 866-3567**

MINE NAME: Dawson Gold Project	MINE/PROSPECTING ID#: P-2013-002	MINERAL: Gold	COUNTY: Fremont
INSPECTION TYPE: Mineral Prospect Inspection	INSPECTOR(S): Timothy Cazier, P.E.	INSP. DATE: September 15, 2021	INSP. TIME: 10:30
OPERATOR: Zephyr Gold USA Ltd	OPERATOR REPRESENTATIVE: John Kratz & Angela Bellantoni	TYPE OF OPERATION: MP - Mineral Prospecting

P-2013-002 Dawson Gold Project 2021 Post Inspection Map

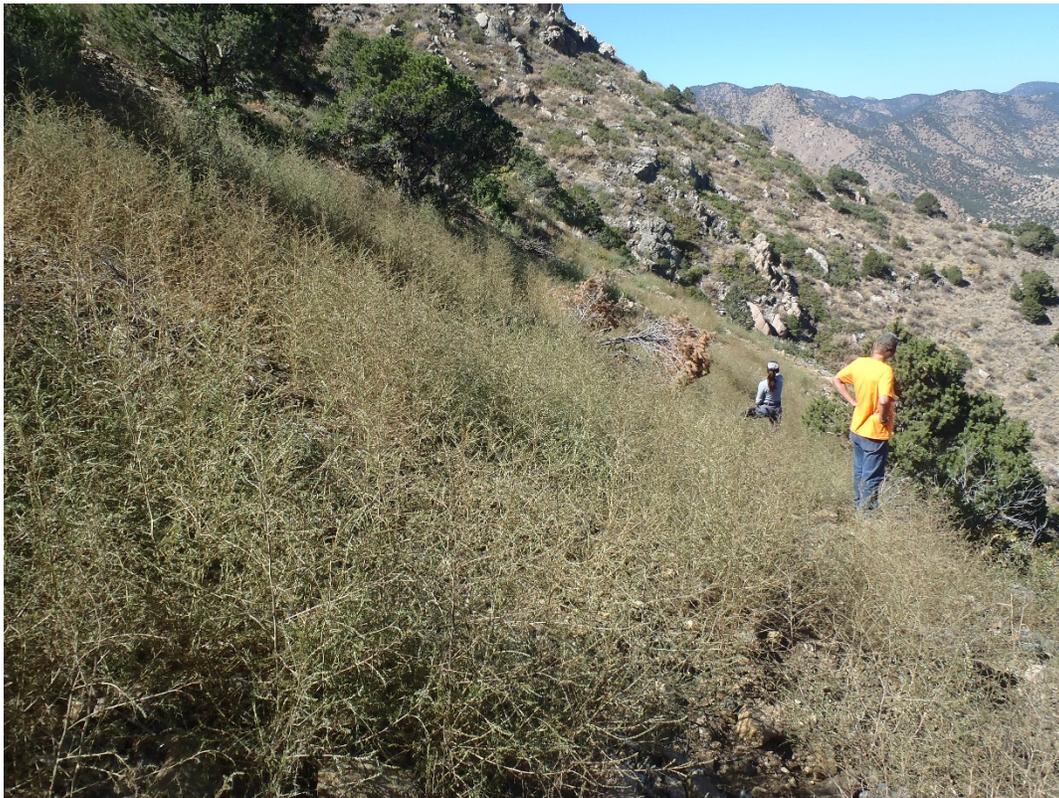
Backfilling and Grading: Trenches 1 (see **Photo 1**), 2 (see **Photo 2**) and 3 (see **Photo 3**) had been backfilled. Additional roads and/or trenches up the hill to the south (see **Photo 4**) were not investigated due to time constraints, but will be visited during a future inspection. The attached **Post Inspection Map** shows the locations of the three trenches.

Photo 1. Trench 1 (looking west, note heavy Russian thistle cover).

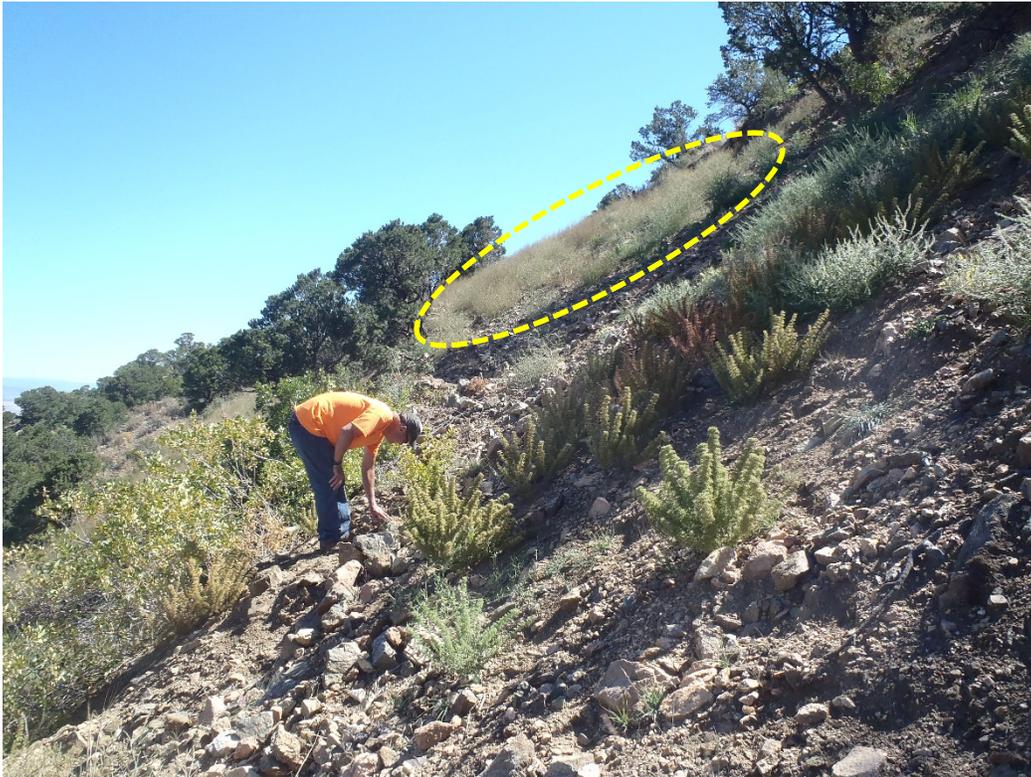
Photo 2. Trench 2 (looking east, note heavy Russian thistle cover beyond).

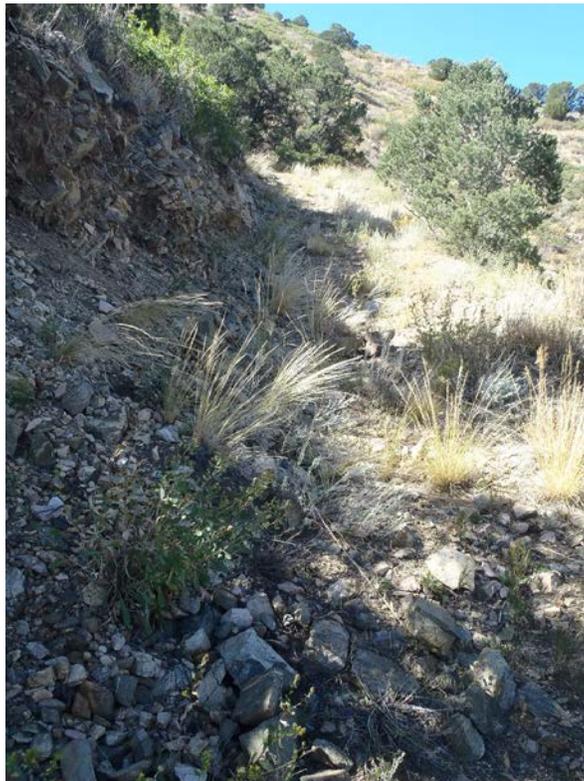
Photo 3. Trench 3 (in access road requiring backfill, looking SW).

Roads: A comparison of historic Google Earth imagery demonstrates which roads in the area inspected are new (magenta lines on the **Post Inspection Map**) and re-disturbed, previously reclaimed access roads (brown lines on the **Post Inspection Map**). All these roads will need to be backfilled per the approved NOI.

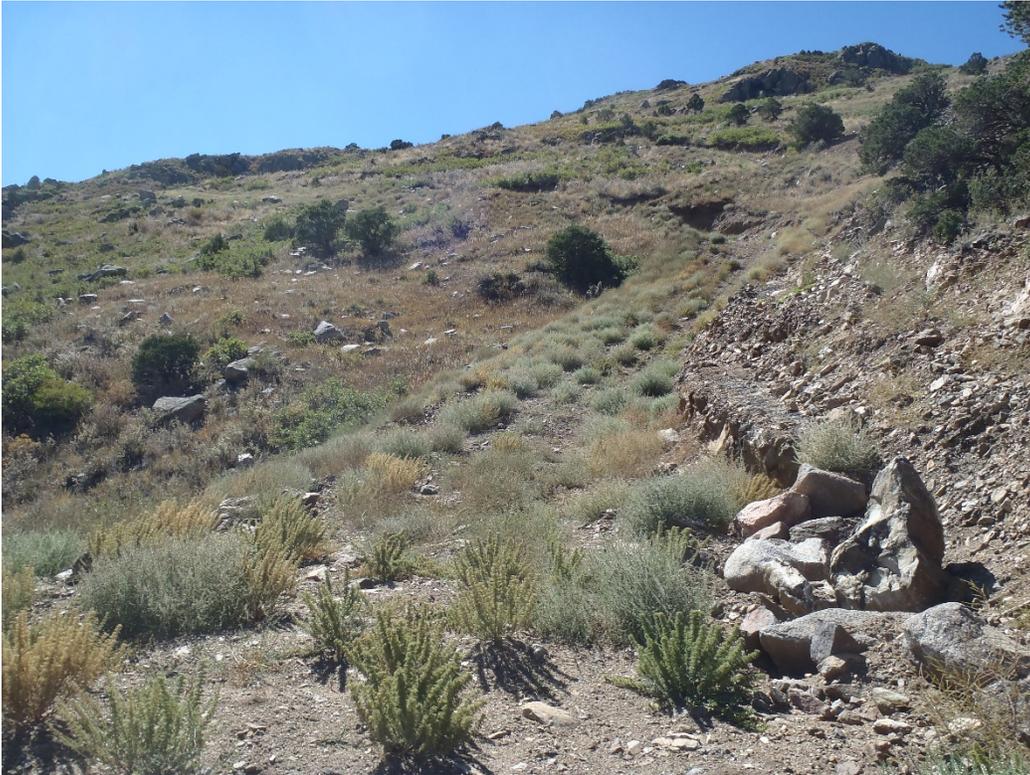
Photo 4. Additional access road to be inspected in the near future (looking south from east of Trench 1).

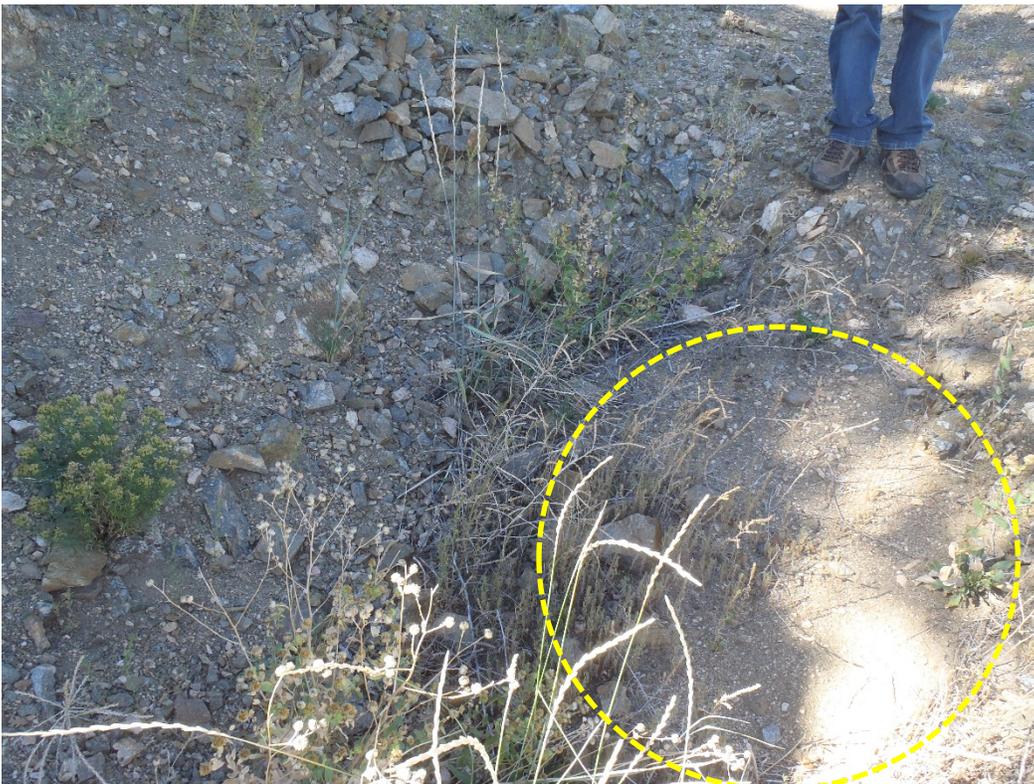
Hydrologic Balance: As part of the file review related to this inspection, the status of borehole abandonment reports was reviewed. DRMS records indicate 43 holes have been drilled under this NOI. A possible 44th hole may have been drilled in Windy Gulch (possible ID WG-13-21). Whether or not WG-13-21 was drilled needs to be clarified. **Attachment A** provides a summary of information provided in previously submitted abandonment reports. Ignoring WG-13-21, only two holes are missing abandonment reports: WG-16-34A (shown on Figure 1 of the abandonment report dated 10/27/2016), and WP-18-18 (found during this inspection near Trench 3, see **Photo 5**, see attached **Post Inspection Map**). All information in red text in **Attachment A** will need to be provided prior to final release. [Abandonment reports for WG-13-21 \(if drilled\), WG-16-34A, and WP-18-18 are past due as they are required to be submitted within one year of drilling/abandonment.](#)

Photo 5. WP-18-18 borehole site (See attached Post Inspection Map for location).

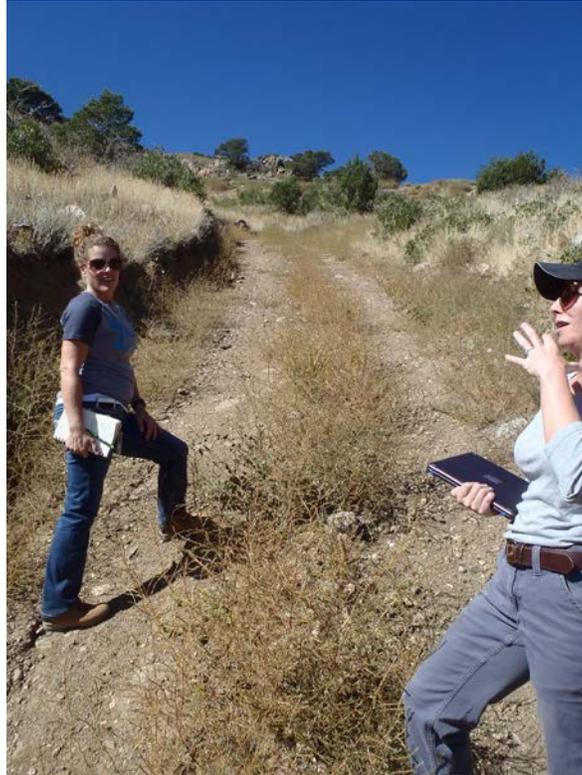
<p>INSPECTION TOPIC: Sediment Control</p> <p>PROBLEM/POSSIBLE VIOLATION: Problem: The steep access road is collecting runoff and directing it off the road causing erosion. This is a problem at this time for failure to protect the affected land from erosion pursuant to C.R.S. 34-32.5-116 (4) (j).</p> <p>CORRECTIVE ACTIONS: The operator shall provide photo documentation to the Division verifying water bars have been installed or commit to backfilling the access road for final reclamation during the 2022 construction season by the corrective action date, such that further erosion is curtailed.</p> <p>CORRECTIVE ACTION DUE DATE: 5/31/22</p>
--

Sediment Control: As part of the aforementioned Google Earth historic imagery review to determine which roads require reclamation, it was noted some erosion off the steep section of the access road (see **Photo 6**) has occurred due to the access road directing runoff along its length to the bend in the road where it is directed off the road and downhill from there. **The erosion on this segment of the access road is cited as a problem on p. 1 of this report.** If this road is not reclaimed during the 2022 construction season, water bars must be constructed to reduce this erosion problem.

Photo 6. Steep section of access road requiring erosion protection (BLM representatives indicate steepness).

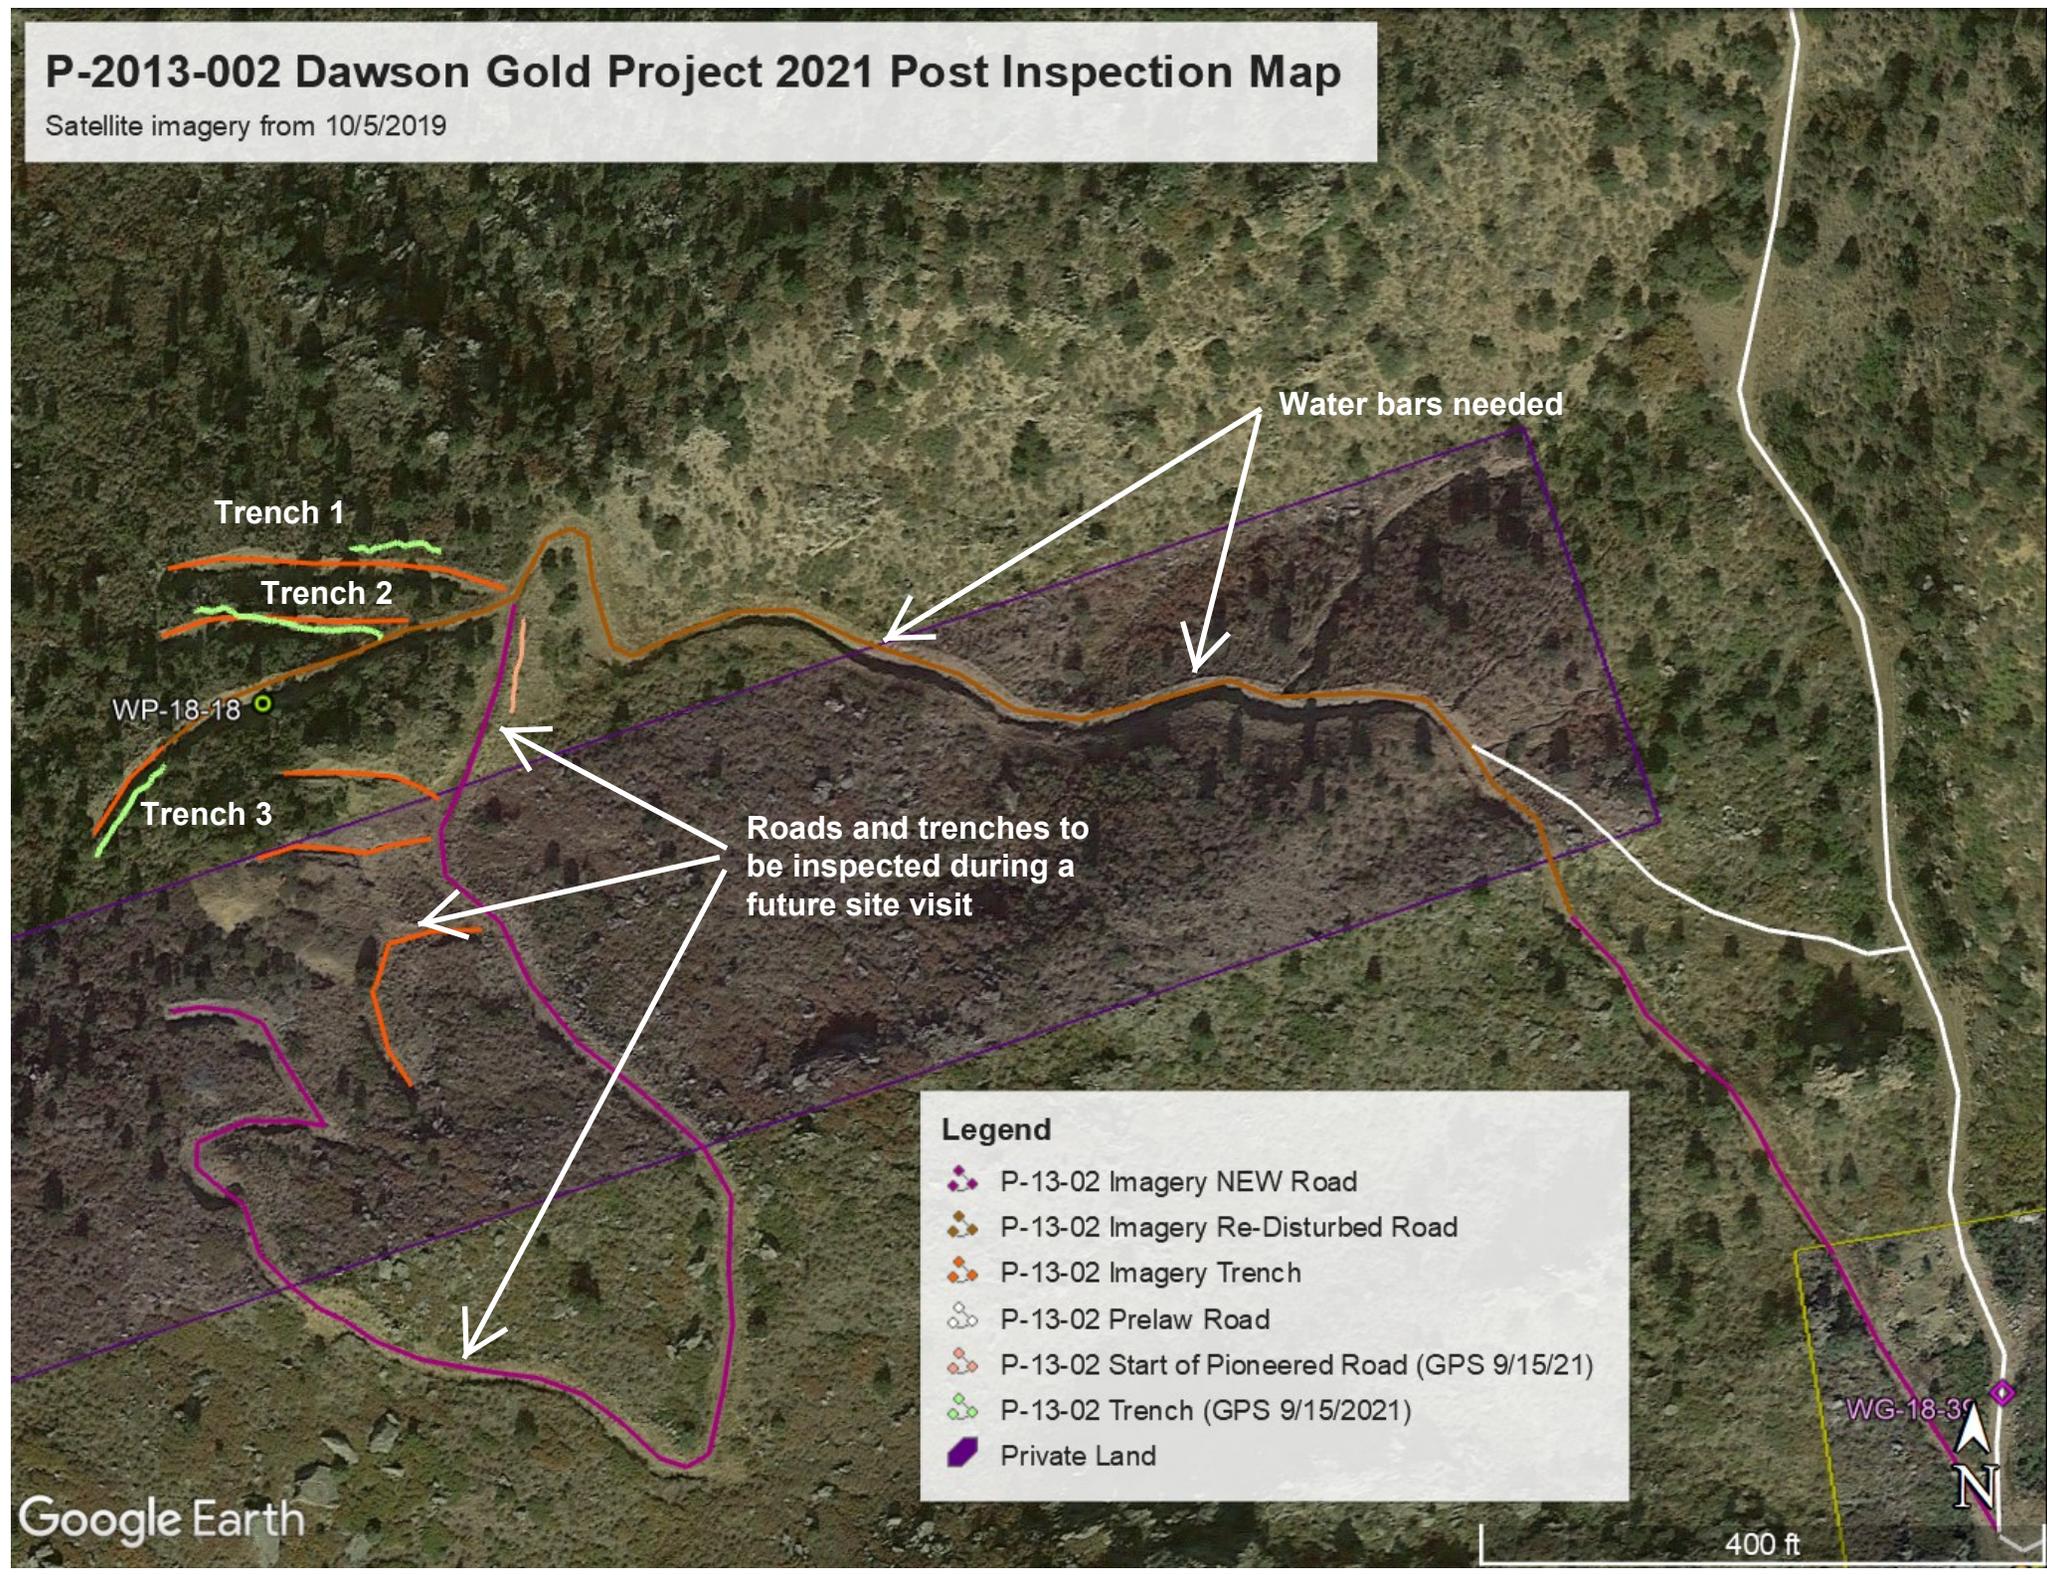
Water bars needed

Roads and trenches to be inspected during a future site visit
