TR-147 Adequacy Response

Class II Cultural Resource Survey Mountain Coal's Future B Seam Short-Term MVBs Pads & Roads, Technical Revision #TR-147 Gunnison County, Colorado

Mountain Coal Company, LLC
West Elk Mine
5174 Highway 133
Somerset, Colorado 81434

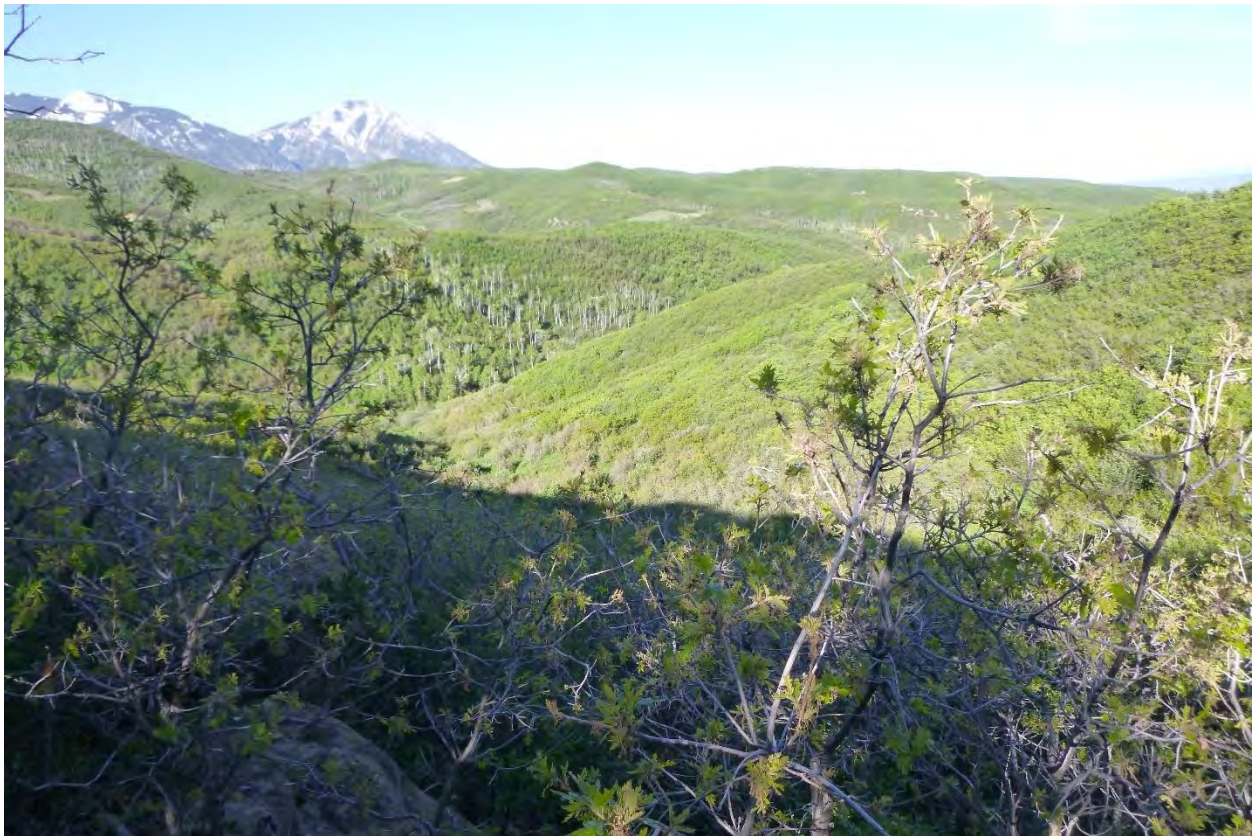
Figure 2. Overview of project area looking into Minnesota Creek. View is to the south.

Contained within the Southern Rocky Mountains geological province, the APE is located along the north and south sides of Minnesota Creek and on the east and west sides of Deep Creek and Poison Gulch. Mount Gunnison lies to the southeast. The area is characterized by steep slopes and deep drainages with thick vegetation (Figure 2). The elevation of the APE ranges from 7,300 to 8,200 feet above sea level (asl). The ground visibility is heavily obscured by thick vegetation and is approximately 10 percent even in the best of locations; the vast majority of the project area afforded no ground visibility. The surface geology consists of the Mesa Verde Formation with major coalbeds (Tweto 1979). Soil data in the APE is based on the Web Soil Survey data compiled by the Natural Resources Conservation Service (NRCS). The soil series represented within the APE are presented in Table 1 in order of dominance (NRCS 2019). The vegetation community in the APE is classified as montane and includes aspen, fir, spruce, Gambel oak, fern, wild rose bush, and other low forbs. Fauna includes coyotes, cottontails, foxes, bobcats, rodents, and various bird species. Mule deer, black bear, and elk are also abundant.

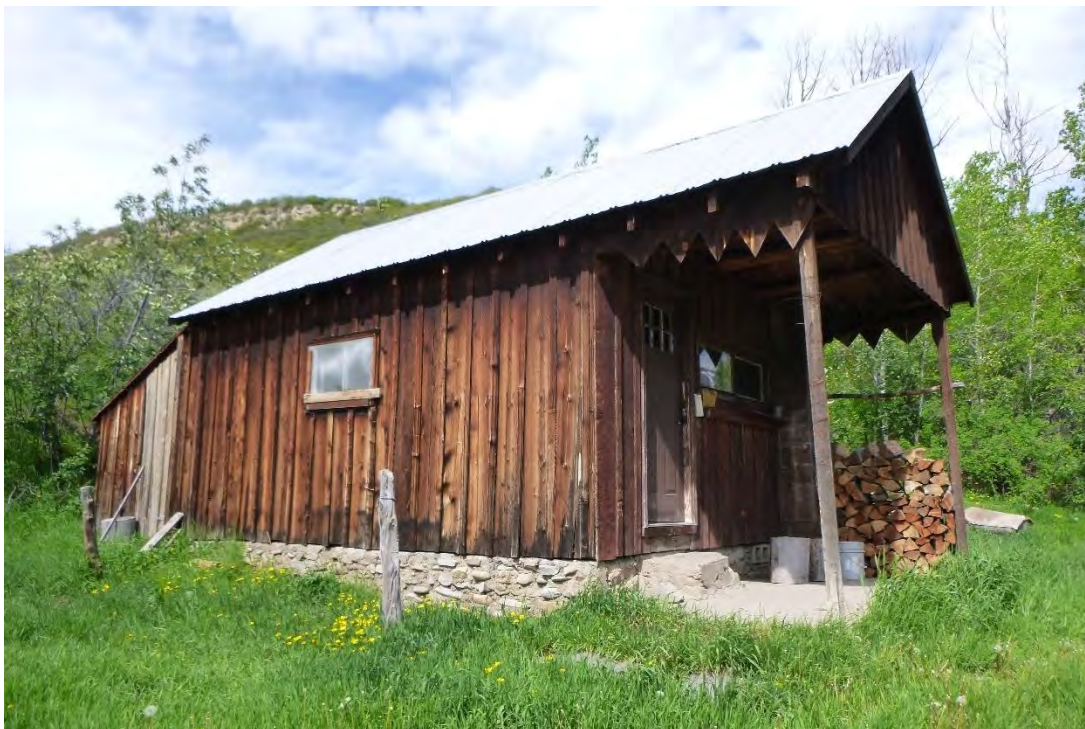
Figure 3. Overview of F1.

The camp is located along County Road 50 (5GN6494.1) and consists of eight features. Feature 1 (F1) is a one-story wood-frame cabin (Figure 3). The rectangular foundation is constructed of concrete and native stone and measures 34.75 by 15.75 feet. Exterior walls are clad with vertical lumber board siding (batten board). The entrance is off center on the south elevation and covered with a paneled metal door with multiple lights in the top half. The door is elevated slightly over a small concrete pad porch that is flush to the ground. The front-gabled roof extends almost 4 feet over the porch, and the roof extension features decorative saw tooth-shaped trim. On the east side of the porch a concrete block chimney is exposed along the exterior of the south elevation and through the slope of the roof extension. The roof is covered with lapped seam steel sheets and features exposed rafter tails. On the rear (north) elevation of the building is a shed addition measuring 8 feet by 16 feet wide; it has a separate entrance covered with a vertical board door on its west side. Window fenestrations include a wood-framed sliding window centered on the south elevation, two aluminum-framed sliding windows on the east elevation, and one aluminum-framed sliding window on the west elevation. The cabin has been continually maintained and is currently in use, and it is, therefore, in good condition. Visible exterior alterations include recent replacement of the front door, most windows, and the roof with modern metal materials.

NRHP Eligibility: ERO recommends 5GN6496 as eligible for listing in the NRHP under Criteria A and D. The site is associated with development of grazing programs on the GMUG. Archival research did not indicate the grazing camp is known to be associated with any historically significant individuals (Criterion B), nor do any constructed features embody a distinctive architectural design or any unique aspects of craftsmanship or engineering (Criterion C). Cultural materials dumped into the privy (F7) have potential to yield information important to interpreting the history of the camp (Criterion D).

Management Recommendations: Avoid and protect. The current design for the placement of MVB pads and roads will not impact this resource.

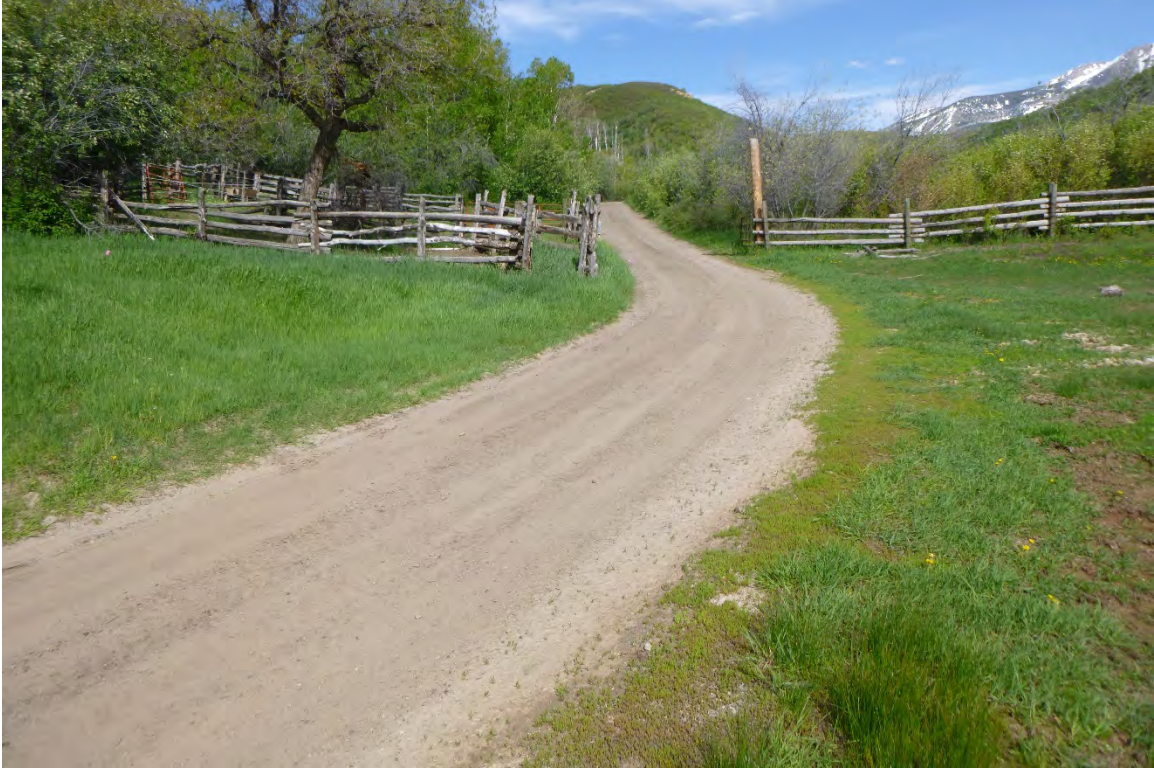
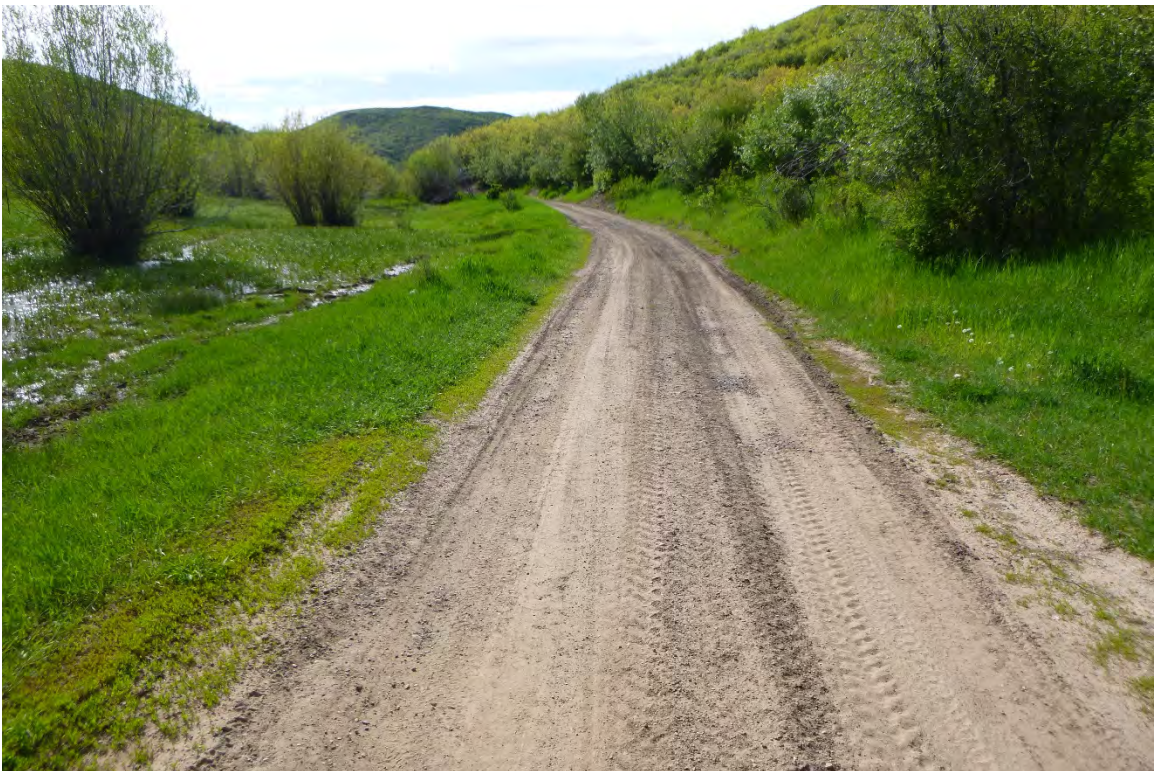
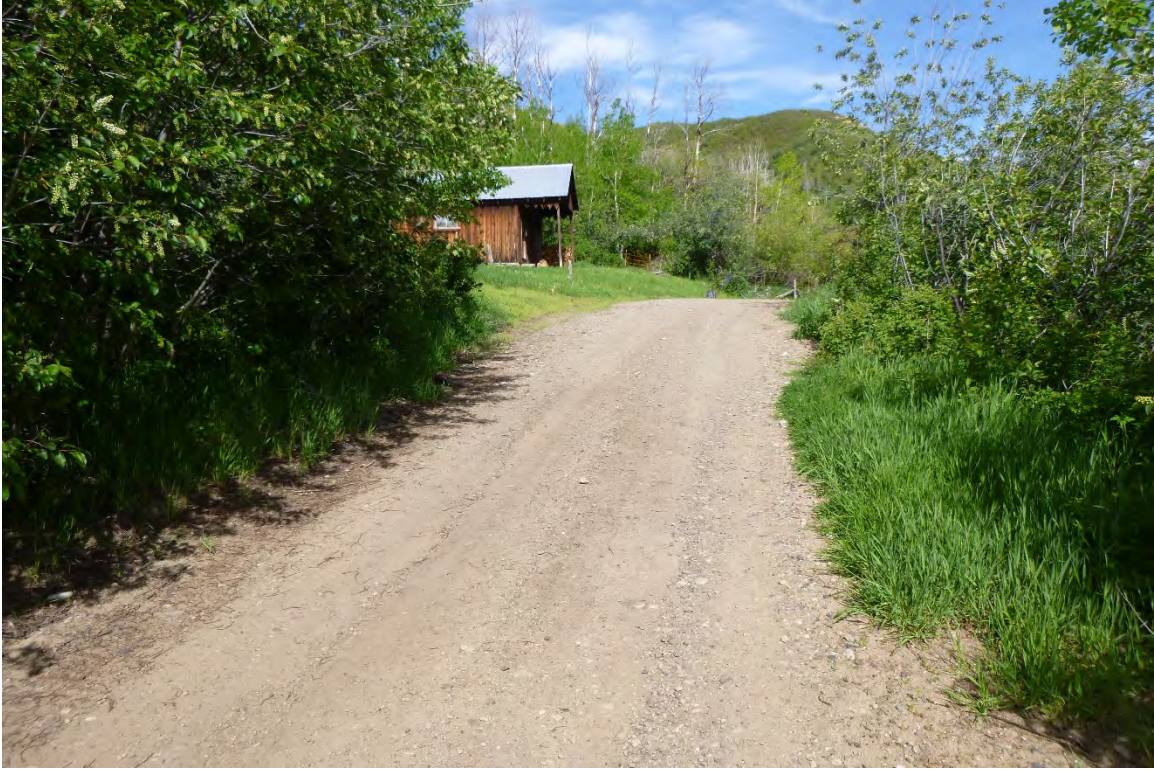
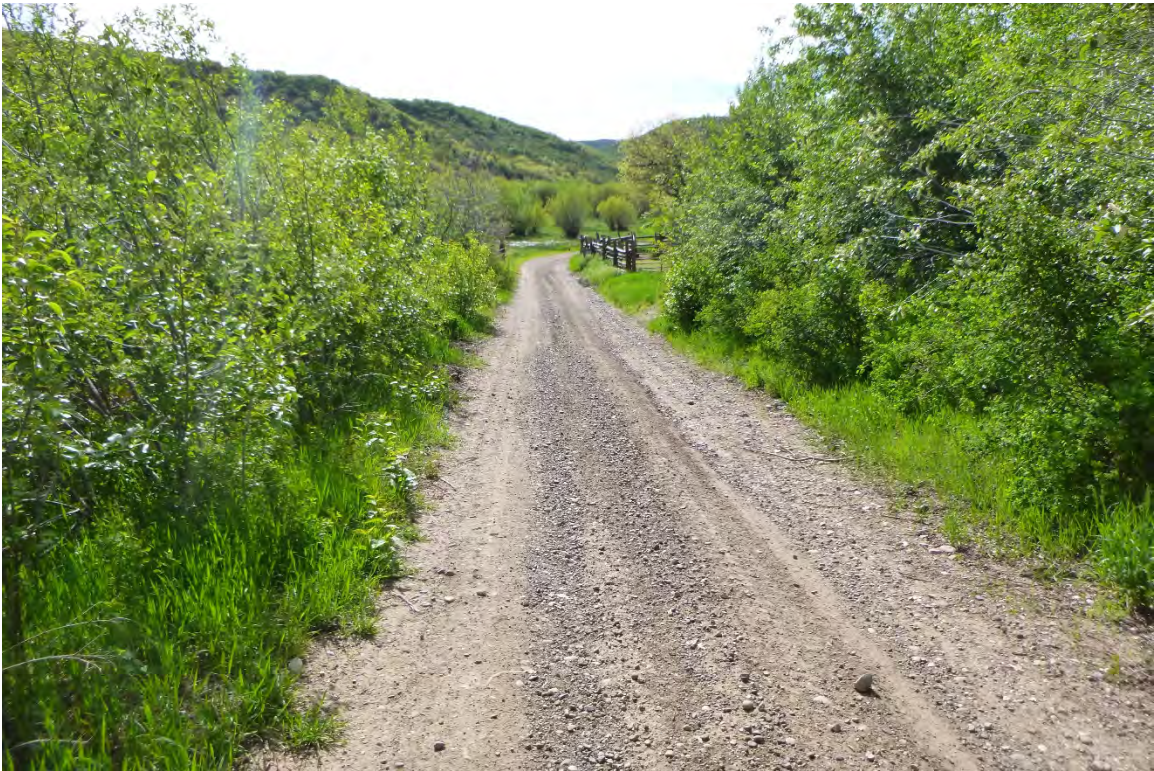
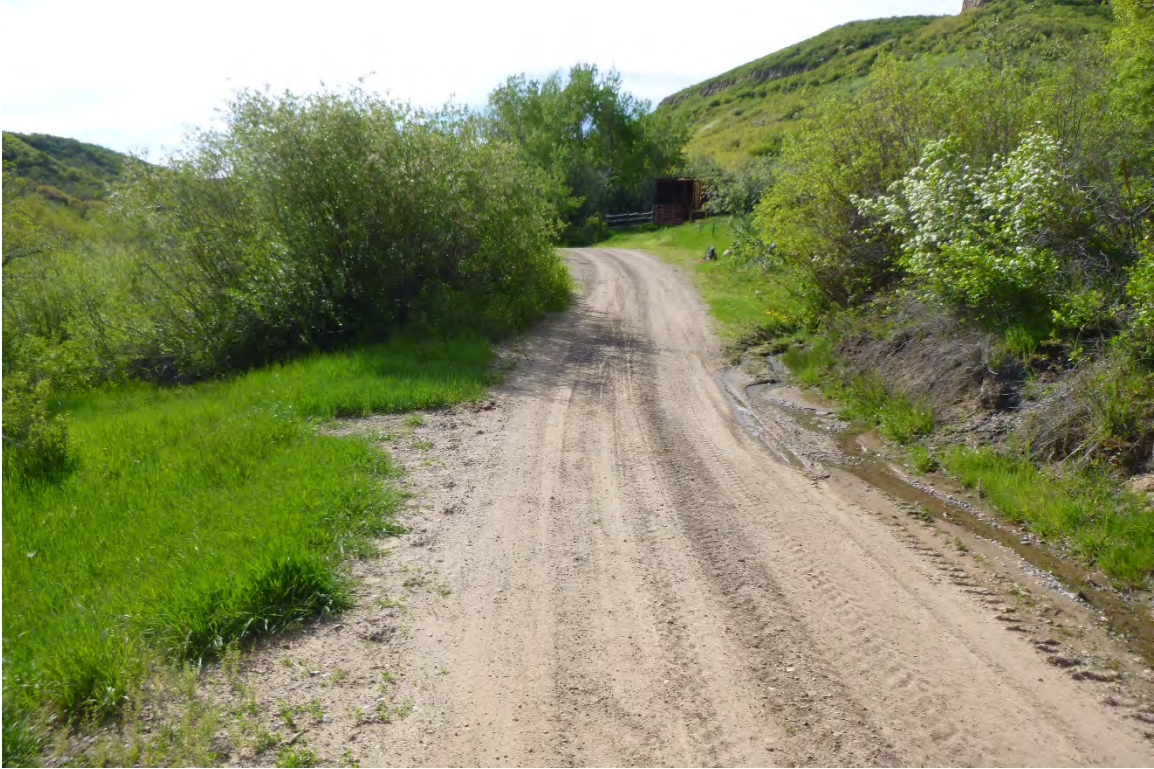
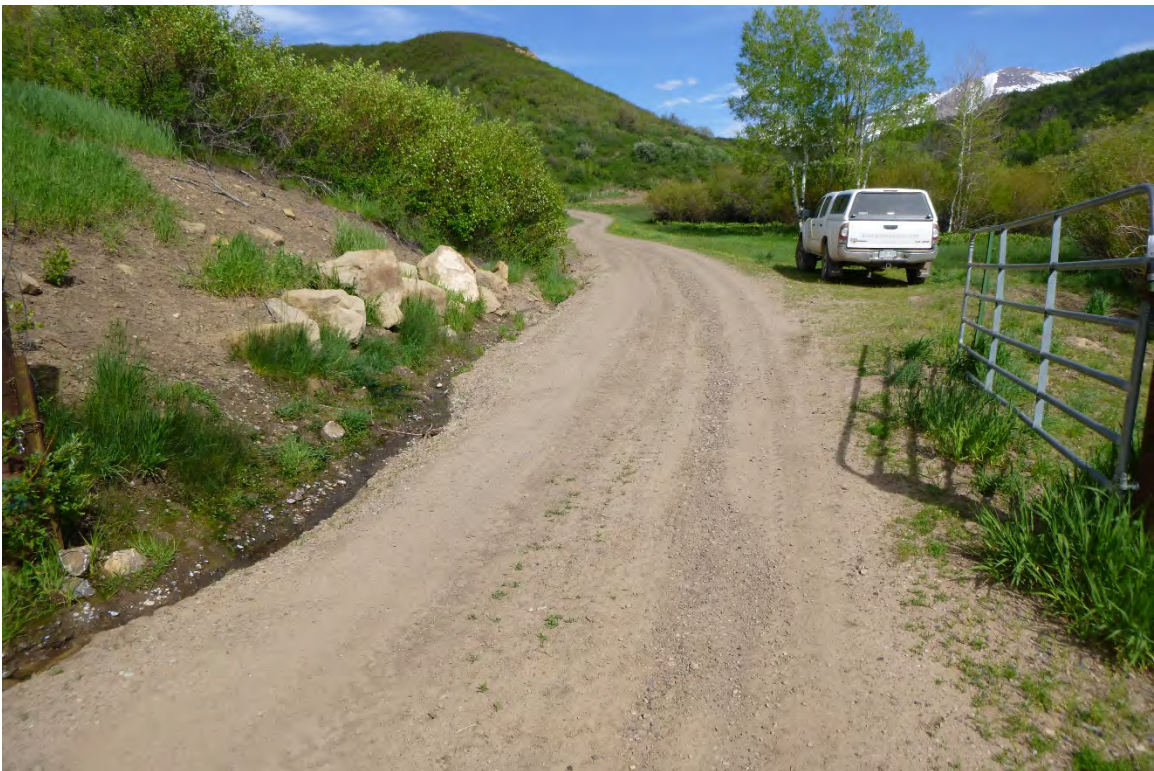
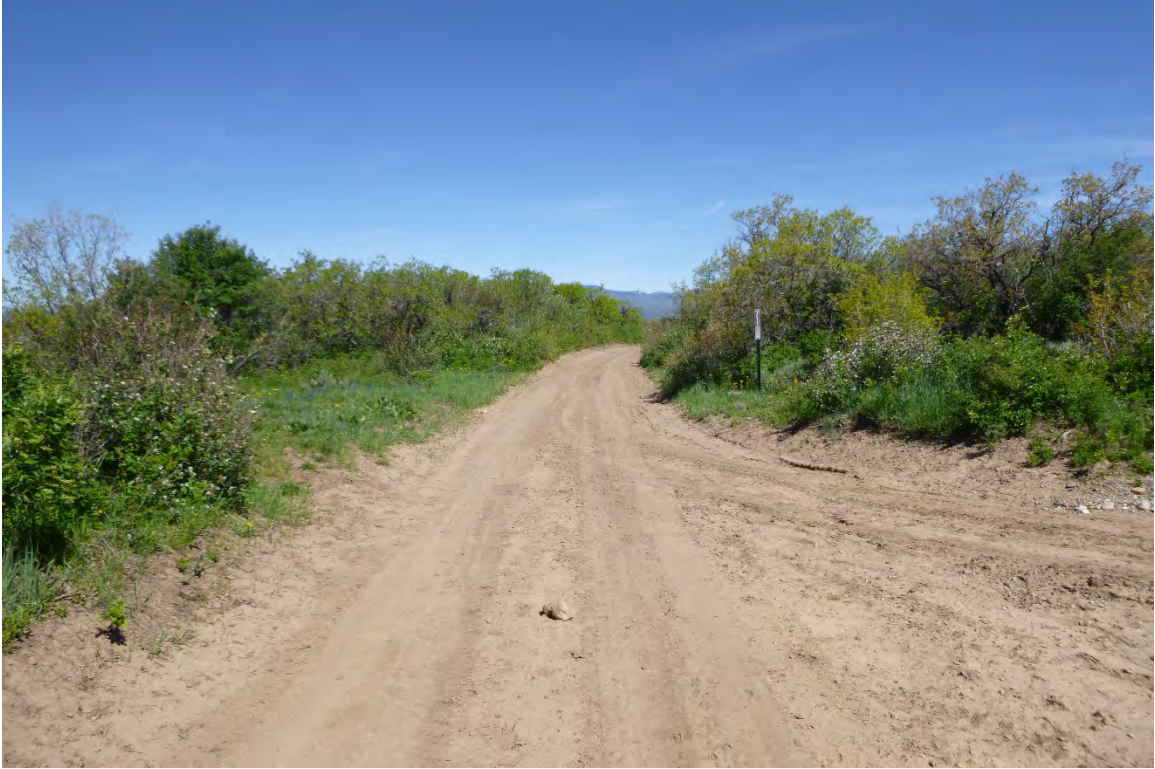
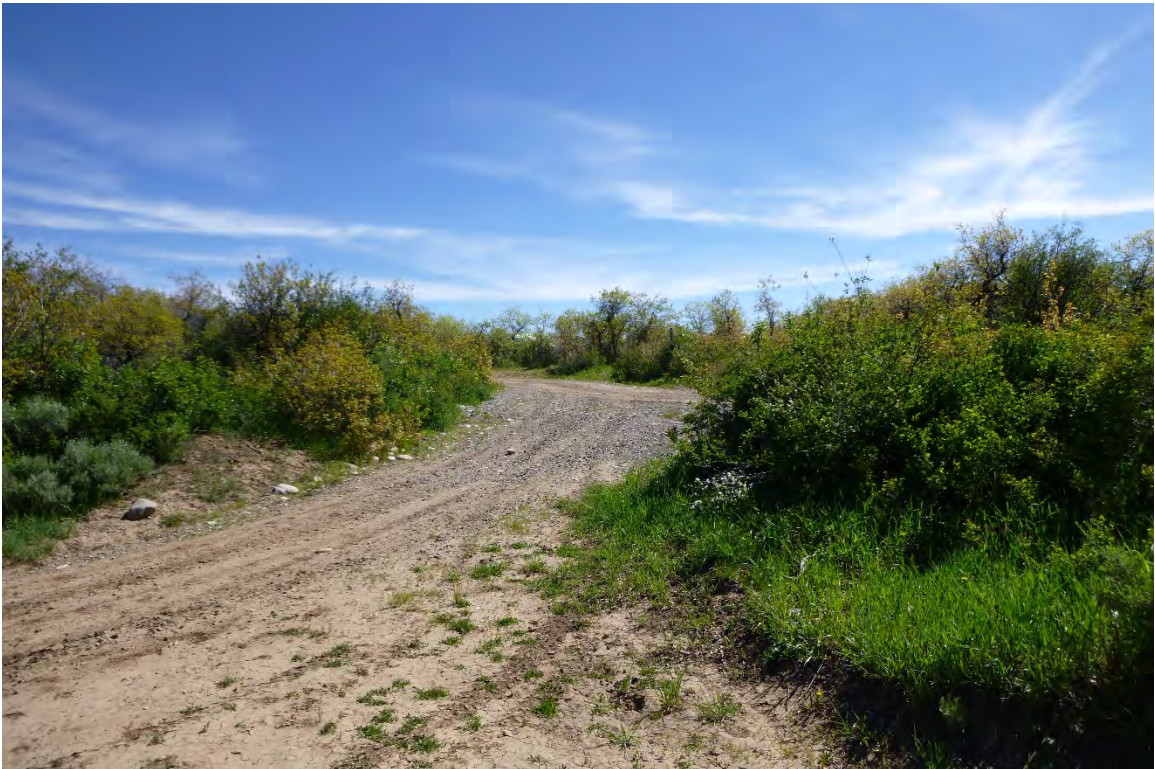
Segment 1 is recommended as non-supporting of the overall eligibility of the entire resource. The road has been converted to crown and ditch and is now graveled for portions of the road. Therefore, maintenance and road improvements have affected the integrity of materials, workmanship, and design. The aspect of location is mostly intact; however, small portions of the original trail alignment have been modified based on the 1885 GLO map. The historical setting, feeling, and association have been compromised by industrial development associated with coal mining.

**5GN6494.1 – Segment overview, Hammond Trail (Minnesota Creek Road/CR50), view to the east.
Photo Number: K.1040001 Date: 6.10.19**

**5GN6494.1 – Segment overview, Hammond Trail (Minnesota Creek Road/CR50), view to the west.
Photo Number: K.1040002 Date: 6.10.19**

**5GN6494.1 – Segment overview, Hammond Trail (Minnesota Creek Road/CR50), view to the east.
Photo Number: K.1040003 Date: 6.10.19**

**5GN6494.1 – Segment overview, Hammond Trail (Minnesota Creek Road/CR50), view to the west.
Photo Number: K.1040004 Date: 6.10.19**

**5GN6494.1 – Segment overview, Hammond Trail (Minnesota Creek Road/CR50), view to the west.
Photo Number: K.1040005 Date: 6.10.19**

**5GN6494.1 – Segment overview, Hammond Trail (Minnesota Creek Road/CR50), view to the east.
Photo Number: K.1040006 Date: 6.10.19**

**5GN6494.1 – Segment overview, Hammond Trail (Minnesota Creek Road/CR50), view to the northwest.
Photo Number: K.1040017 Date: 6.11.19**

**5GN6494.1 – Segment overview, Hammond Trail (Minnesota Creek Road/CR50), view to the southeast.
Photo Number: K.1040019 Date: 6.11.19**

Management and Project Effect Recommendations: No further work upon concurrence with the non-supporting recommendation. Additionally, based on current design for the placement of MVB pads and road, this resource would not be affected by any of the proposed construction. It will be used for access but no upgrades are proposed.

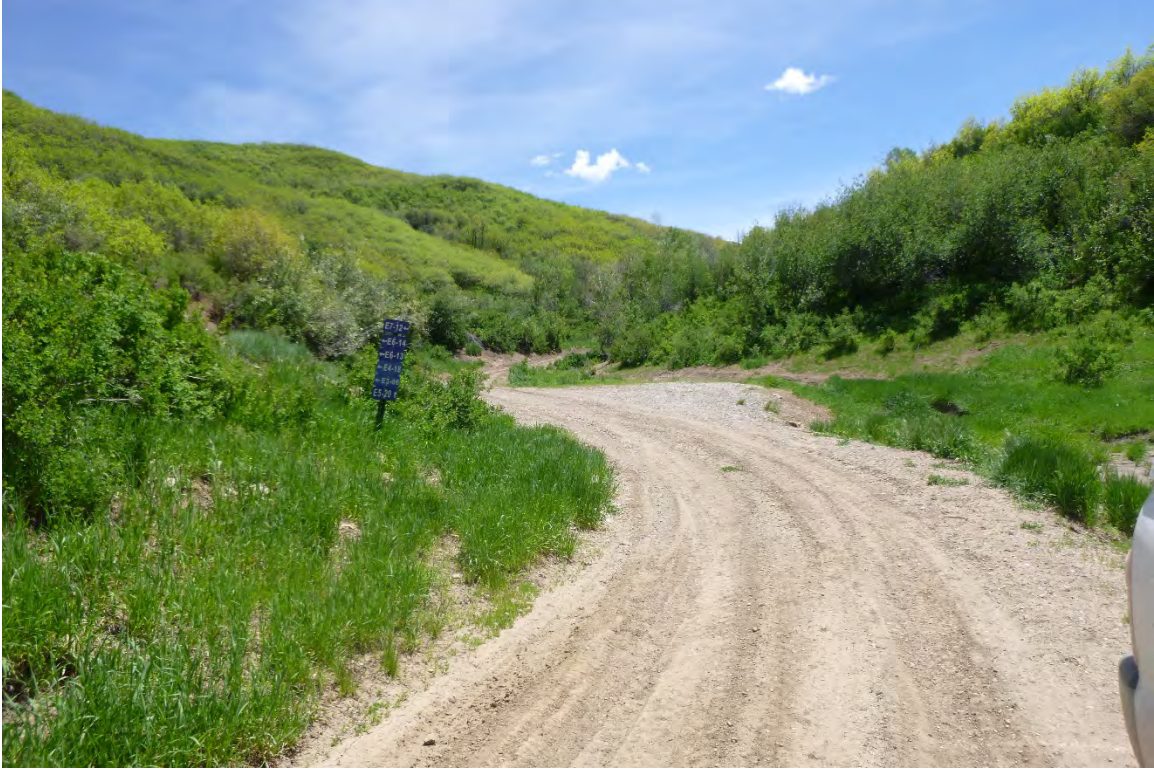
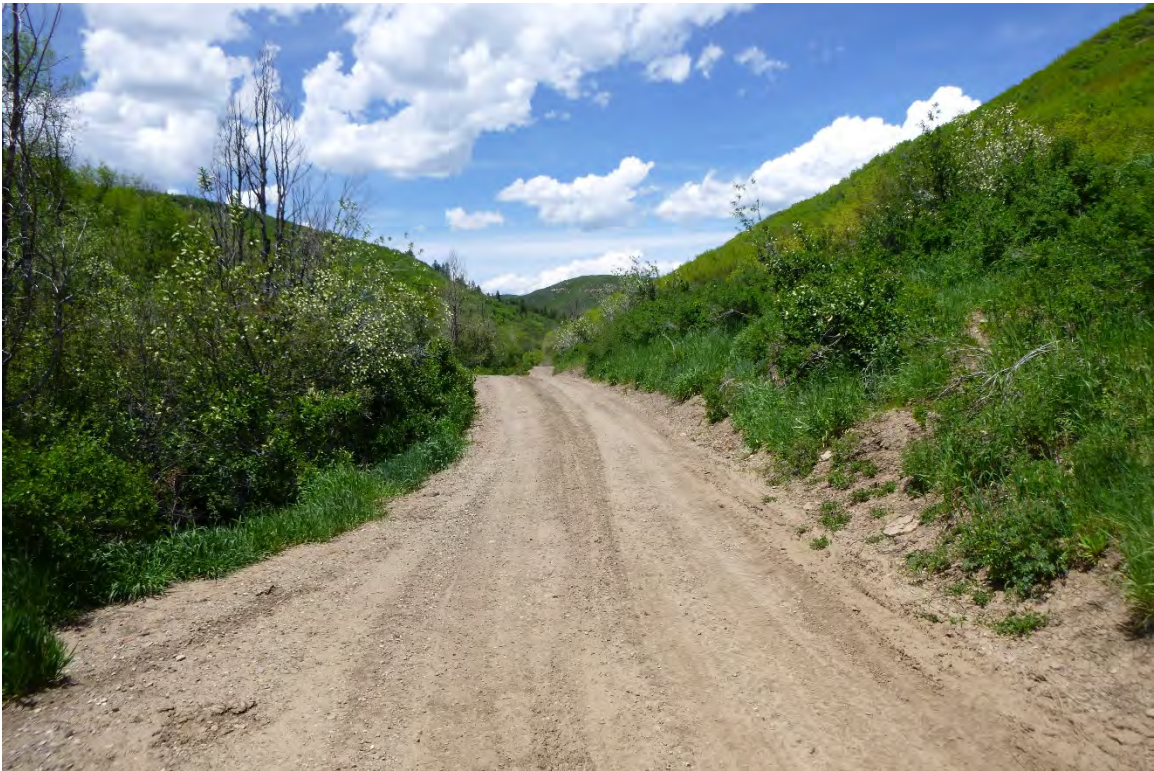
Description: 5GN6495.1 is a segment of Deer Creek road located west of the town of Paonia. Surrounding vegetation consists of dense stands of scrub oak and chokecherry, with dense stands of willow found along the riparian areas. Ground visibility is 30 to 60 percent. Elevation is 2,328 meters (7,640 feet) asl.

NRHP Eligibility: Although ERO did not survey the entire road, aerial overviews and archival sources were used to evaluate eligibility. ERO recommends the entire Deer Creek Road alignment as not eligible for listing in the NRHP. The road first appears on two USGS topographic maps in 1964 (USGS 1964), and the road does not appear to have played an important role in the development of the area. The trail was not historically an important transportation corridor. Segment 5GN6495.1 is not known to be associated with important historical events or persons (Criteria A and B). The road does not have engineering significance (design, materials, and workmanship; Criterion C). No significant information potential remains (Criterion D). Because the entire resource is recommended not eligible, segment evaluation is unnecessary.

**5GN6495.1 – Segment overview, Deer Creek Road, view to the southwest.
Photo Number: K.1040041 Date: 6.13.19**

**5GN6495.1 – Segment overview, Deer Creek Road, view to the northeast.
Photo Number: K.1040042 Date: 6.13.19**

Management and Project Effect Recommendations: No further work upon concurrence with the not eligible recommendation. Additionally, based on current design for the placement of MVB pads and roads, this resource would not be affected by any of the proposed construction.

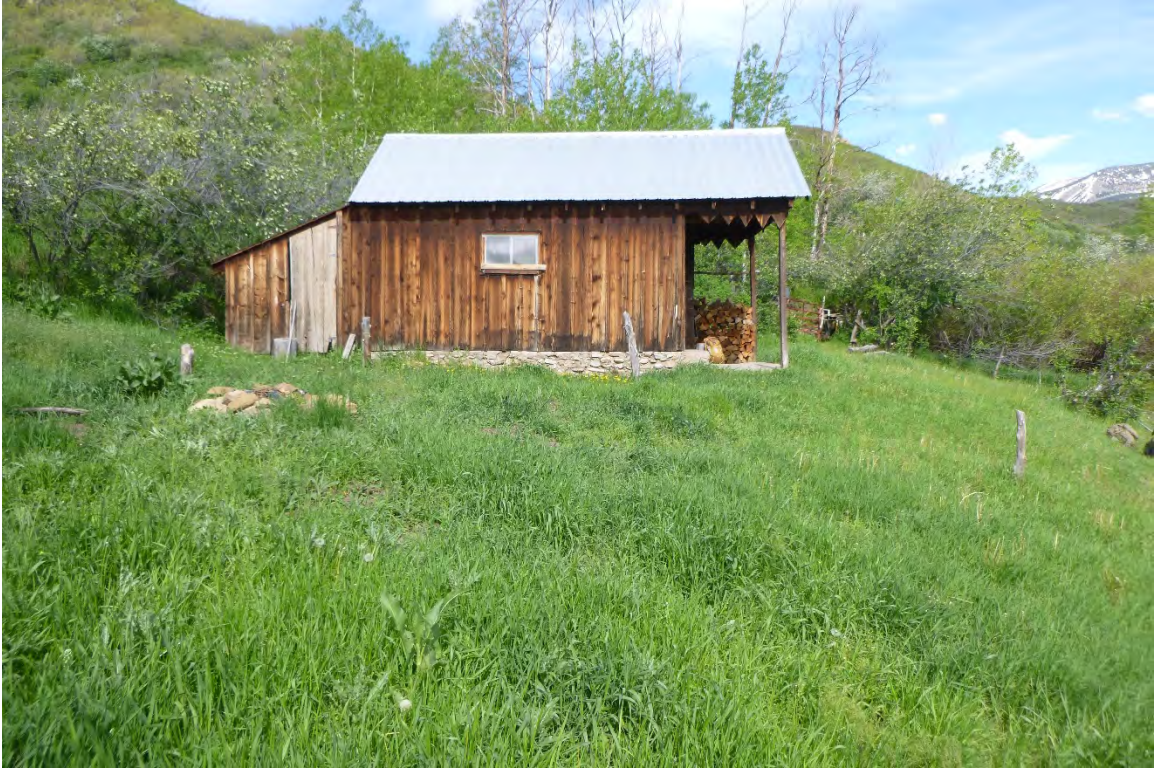
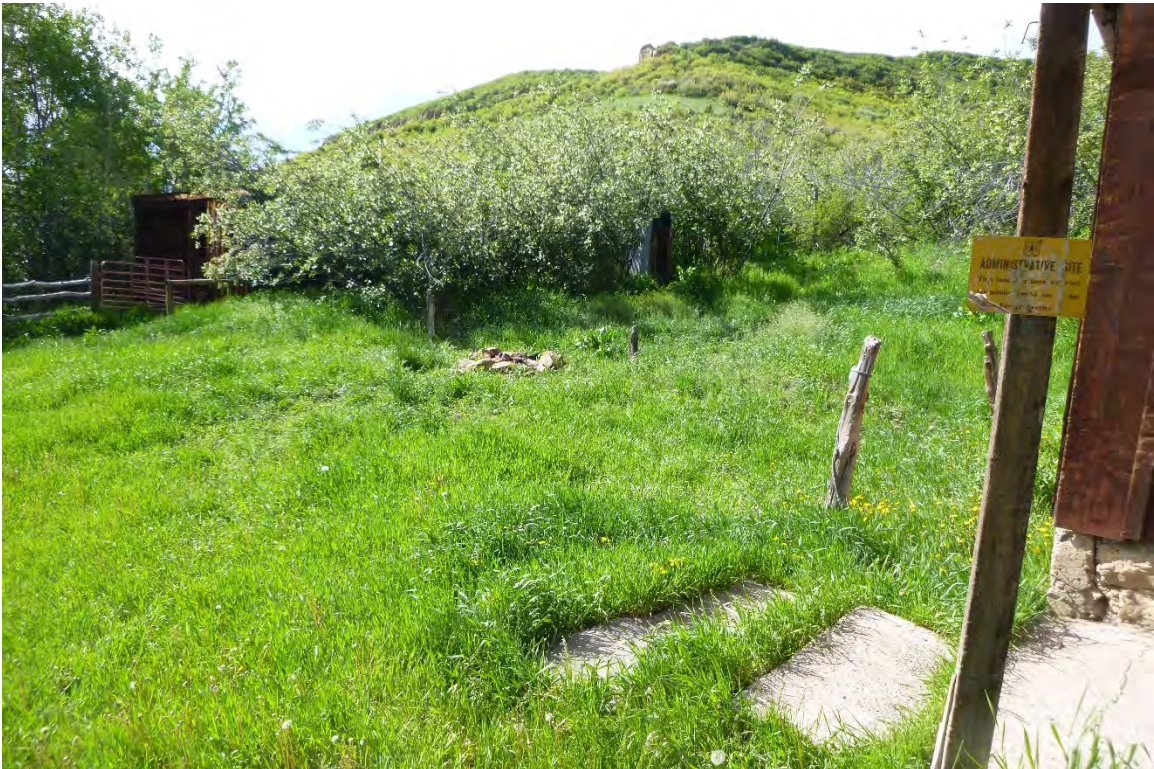
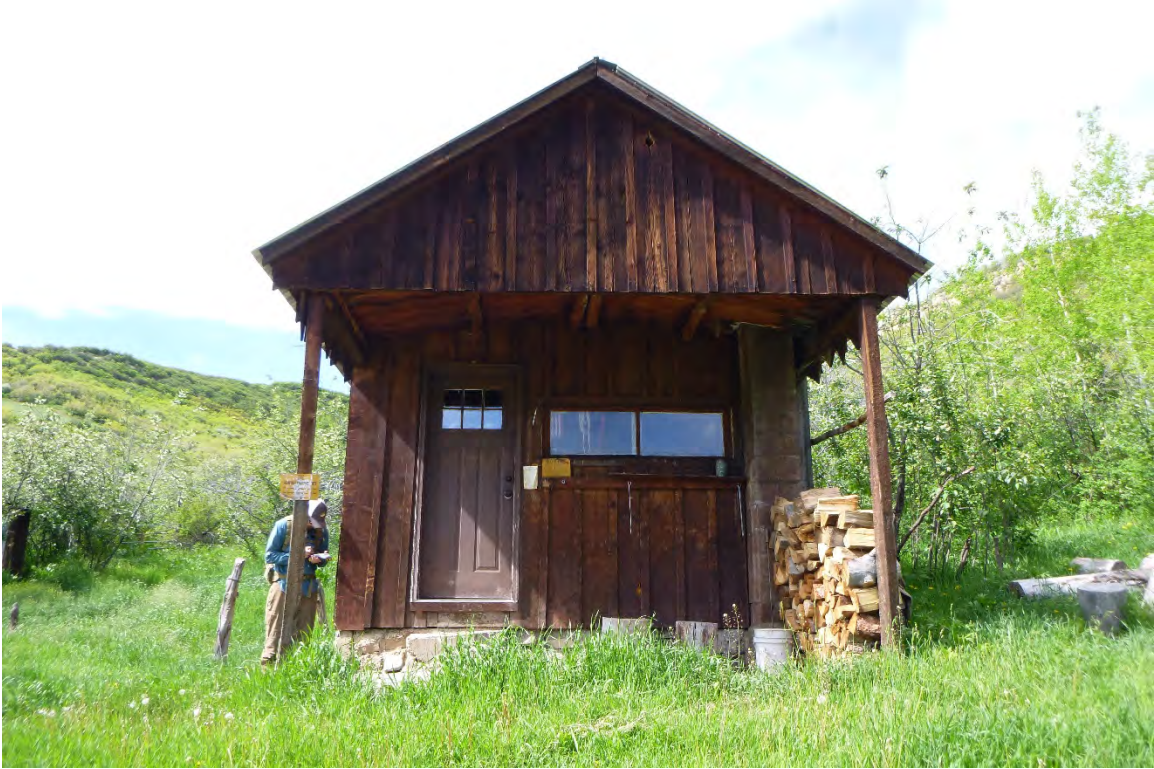
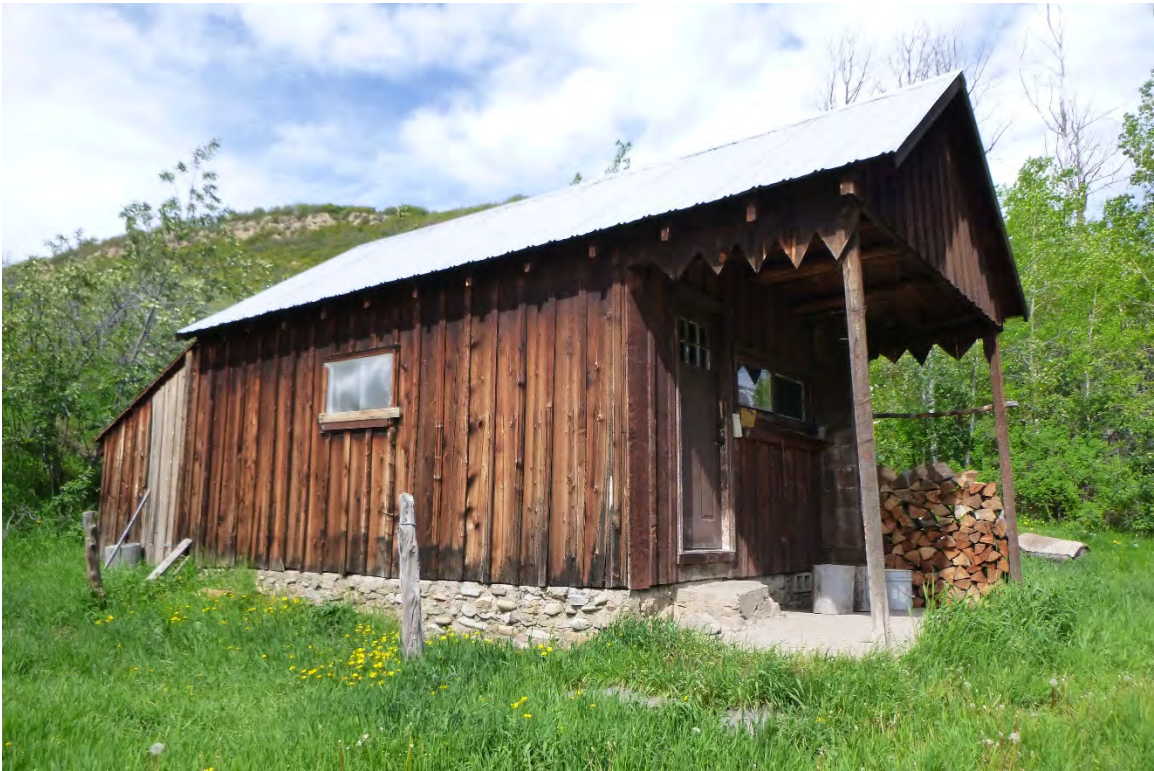
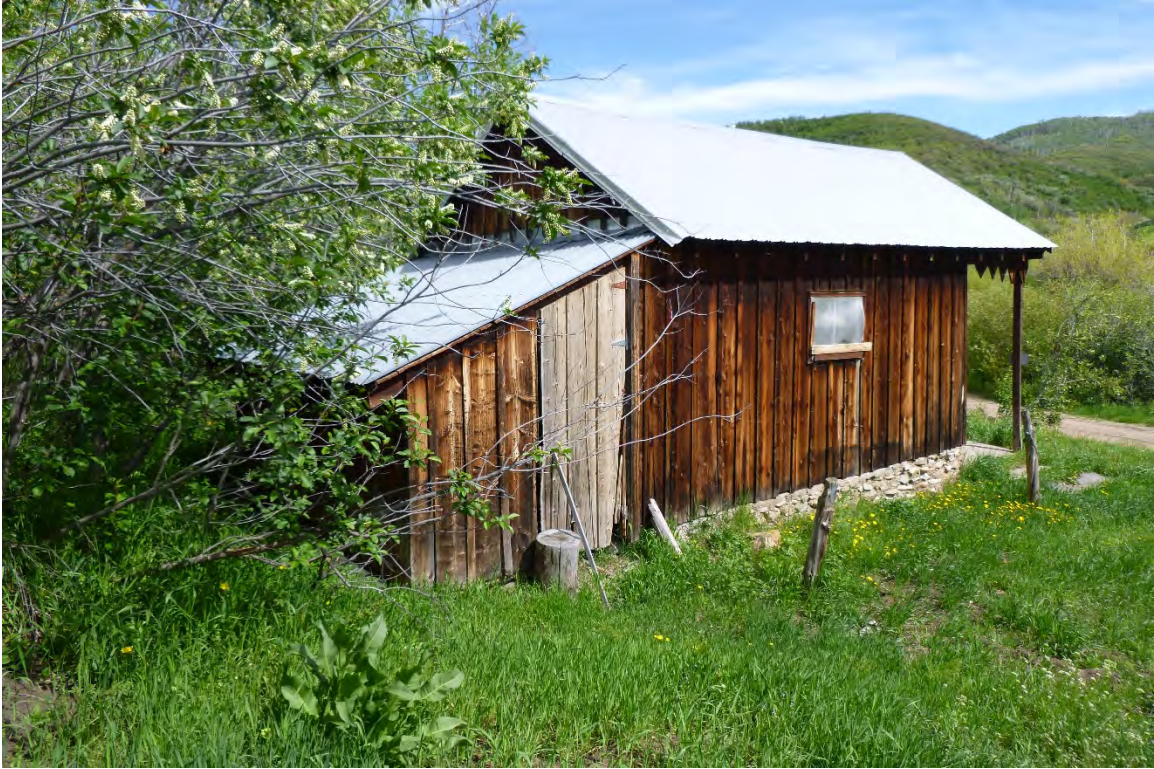
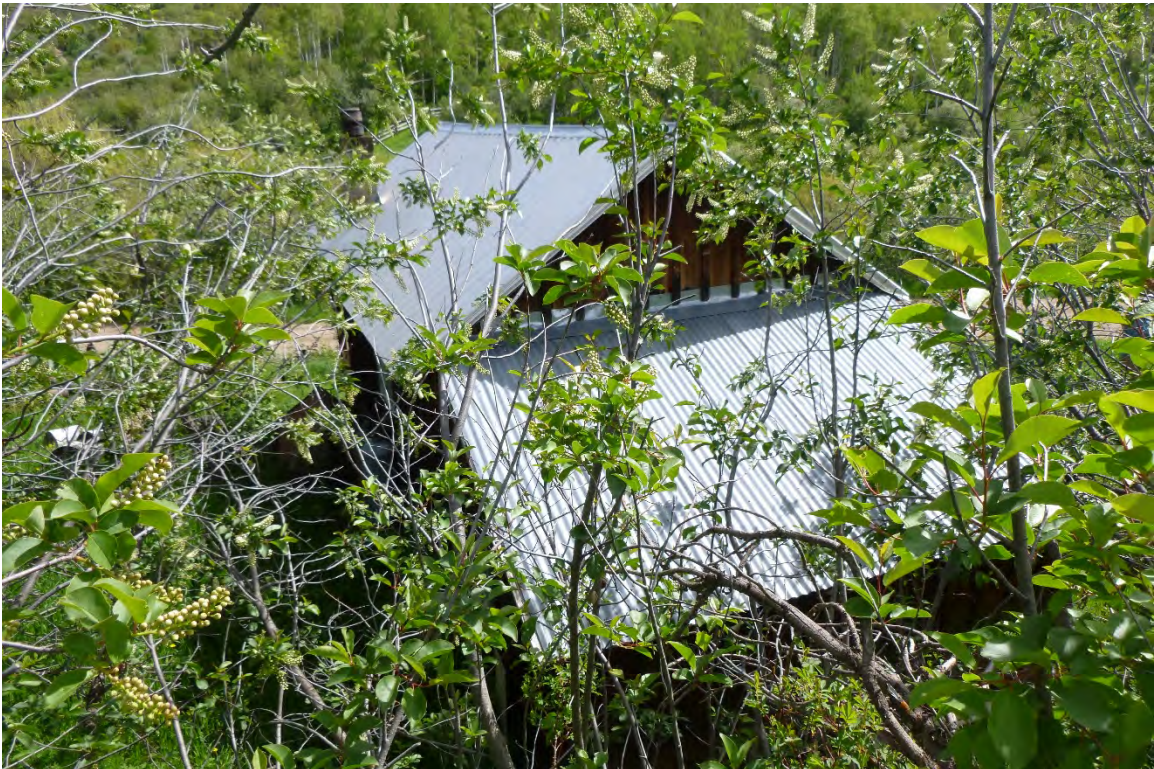
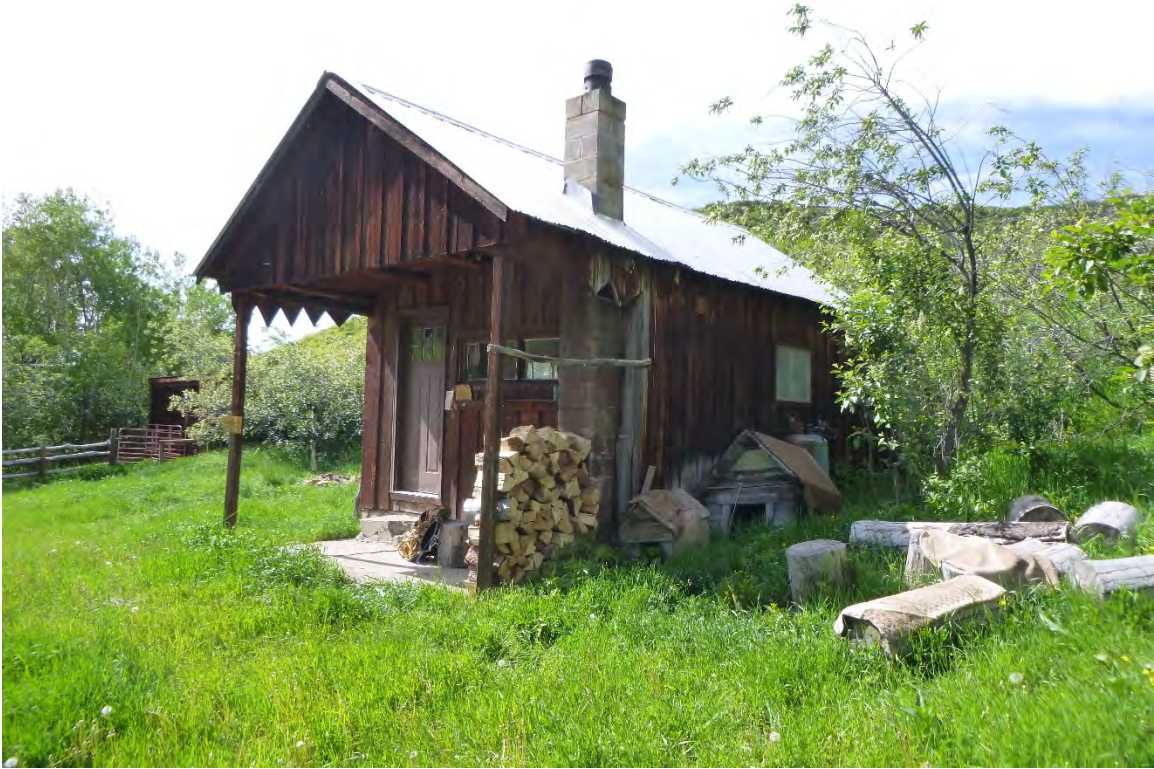
**5GN6496 – Site overview, Hammond (Dry Fork) Cow Camp (F1, F2, and F3 visible), view to the east.
Photo Number: K.1040007 Date: 6.10.19**

**5GN6496 – Site overview, Hammond (Dry Fork) Cow Camp (F1, F3, F4, and F5 visible), view to the northwest.
Photo Number: K.1040008 Date: 6.10.19**

**5GN6496 – F1 overview, main cabin south elevation, view to the north.
Photo Number: K.1030979 Date: 6.10.19**

**5GN6496 – F1 detail, south and west elevation of the main cabin, view to the northeast.
Photo Number: K.1030980 Date: 6.10.19**

**5GN6496 – F1 detail, north and west elevation of the main cabin, view to the southeast.
Photo Number: K.1030981 Date: 6.10.19**

**5GN6496 – F1 detail, north and east elevation of the main cabin, view to the south/southwest.
Photo Number: K.1030982 Date: 6.10.19**

**5GN6496 – F1 detail, south and east elevation of the main cabin, view to the northwest.
Photo Number: K.1030983 Date: 6.10.19**

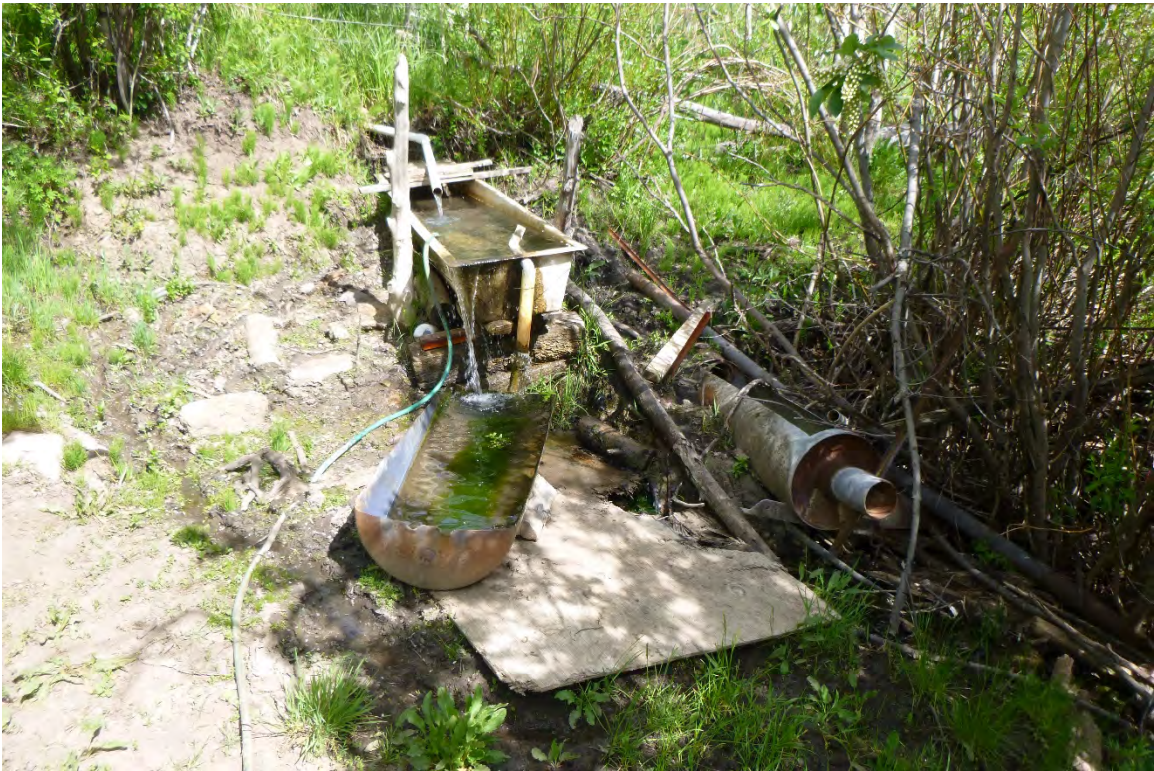
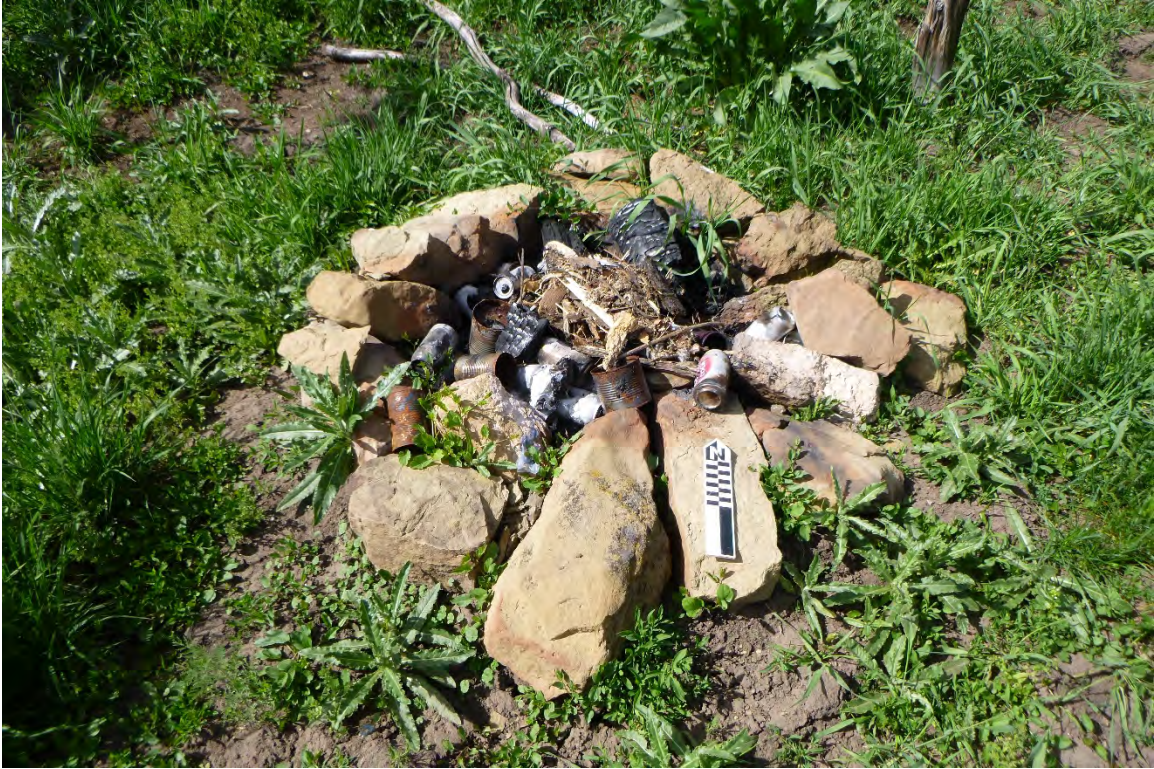
F2 is a water catchment feature to the east of the main cabin on a small drainage that includes an outlet of PVC pipe into two troughs; active and/or abandoned components of the features appear to be made from salvaged and modified materials, including a water softener. F3 is a fire ring made of local stone. The fire ring contains modern trash.

**5GN6496 – F2 overview, water catchment feature, view to the east.
Photo Number: K.1030984 Date: 6.10.19**

**5GN6496 – F3 overview, fire ring constructed of local stone, view to the north.
Photo Number: K.1030985 Date: 6.10.19**

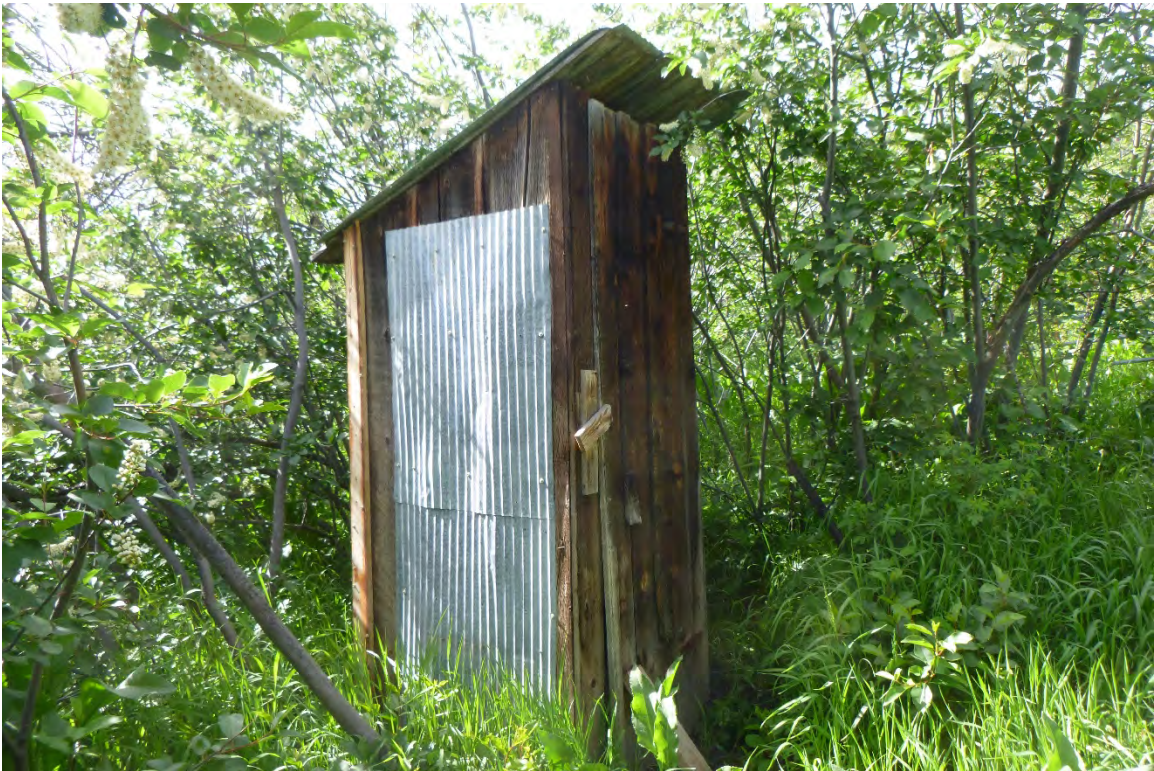
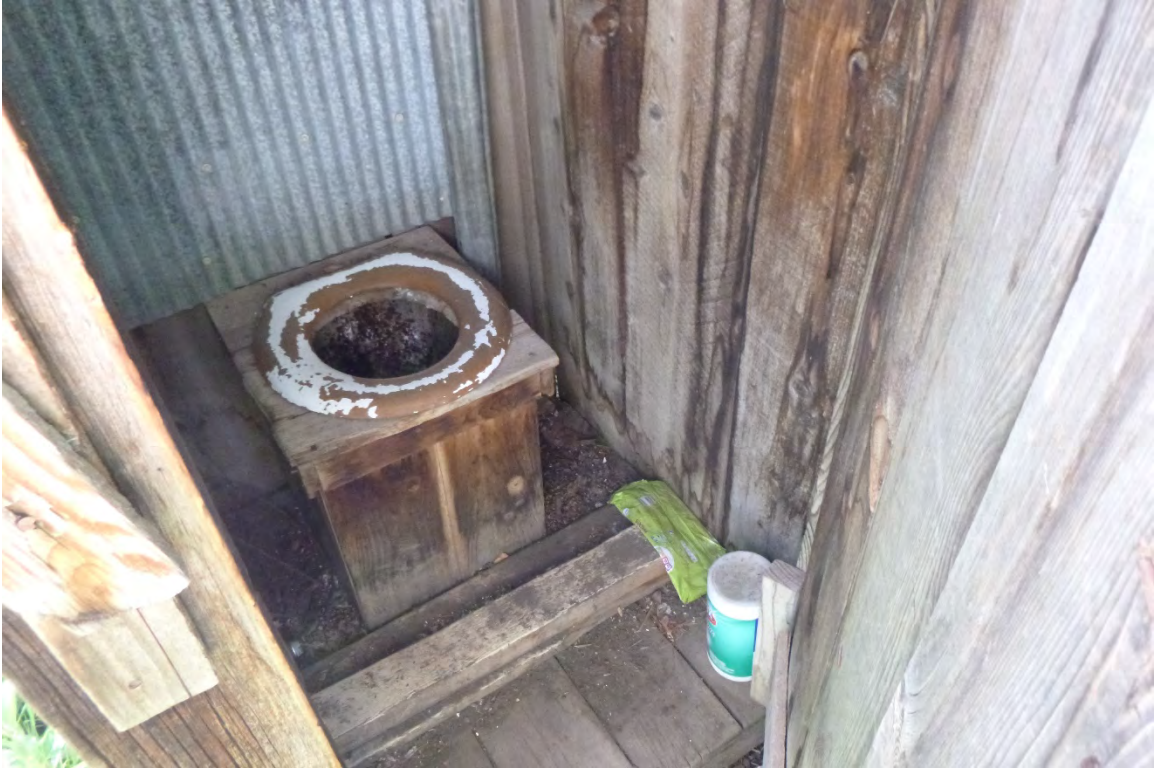
F4 is a wood-framed outhouse measuring 5 feet by 3 feet. The walls are constructed of vertical lumber boards, and the shed roof is covered with asphalt roll. Recent repairs include use of corrugated steel sheets to patch exterior damages.

**5GN6496 – F4 overview, outhouse exterior, view to the northwest.
Photo Number: K.1030986 Date: 6.10.19**

5GN6496 – F4 detail, outhouse interior, plan view.
Photo Number: K.1030987 Date: 6.10.19
