TR-147 Adequacy Response

Class II Cultural Resource Survey Mountain Coal's Future B Seam Short-Term MVBs Pads & Roads, Technical Revision #TR-147 Gunnison County, Colorado

Mountain Coal Company, LLC
West Elk Mine
5174 Highway 133
Somerset, Colorado 81434

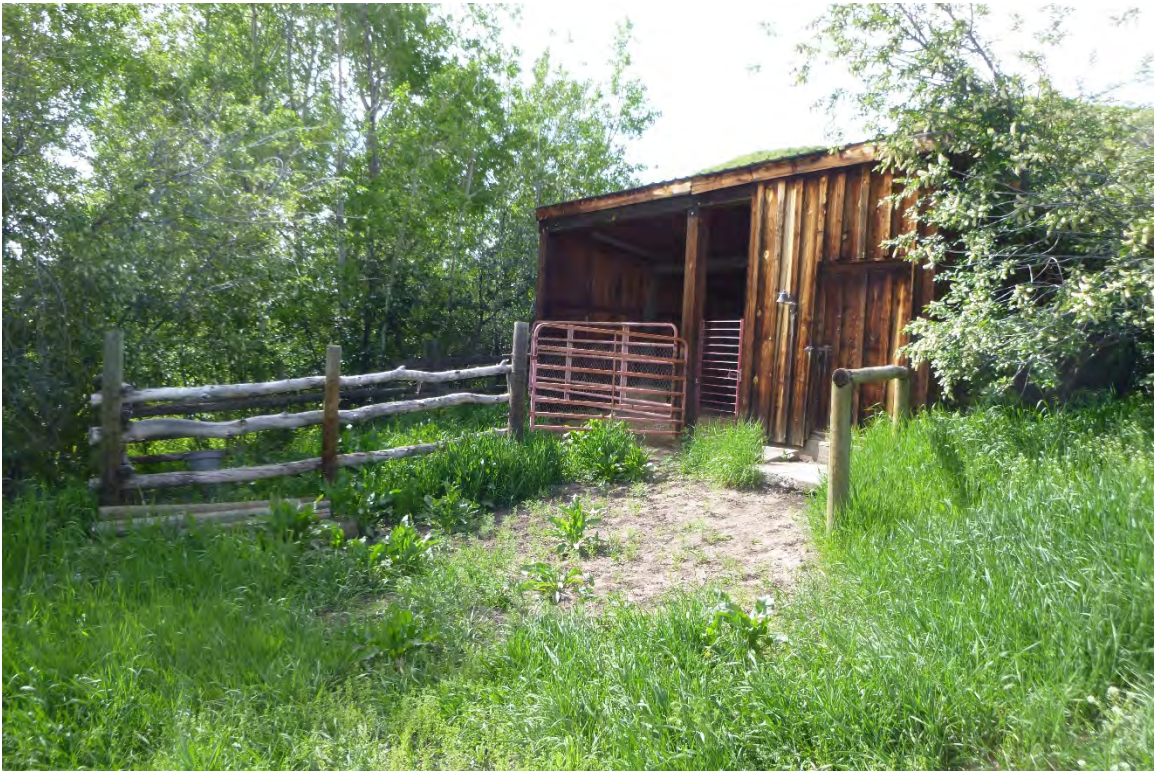
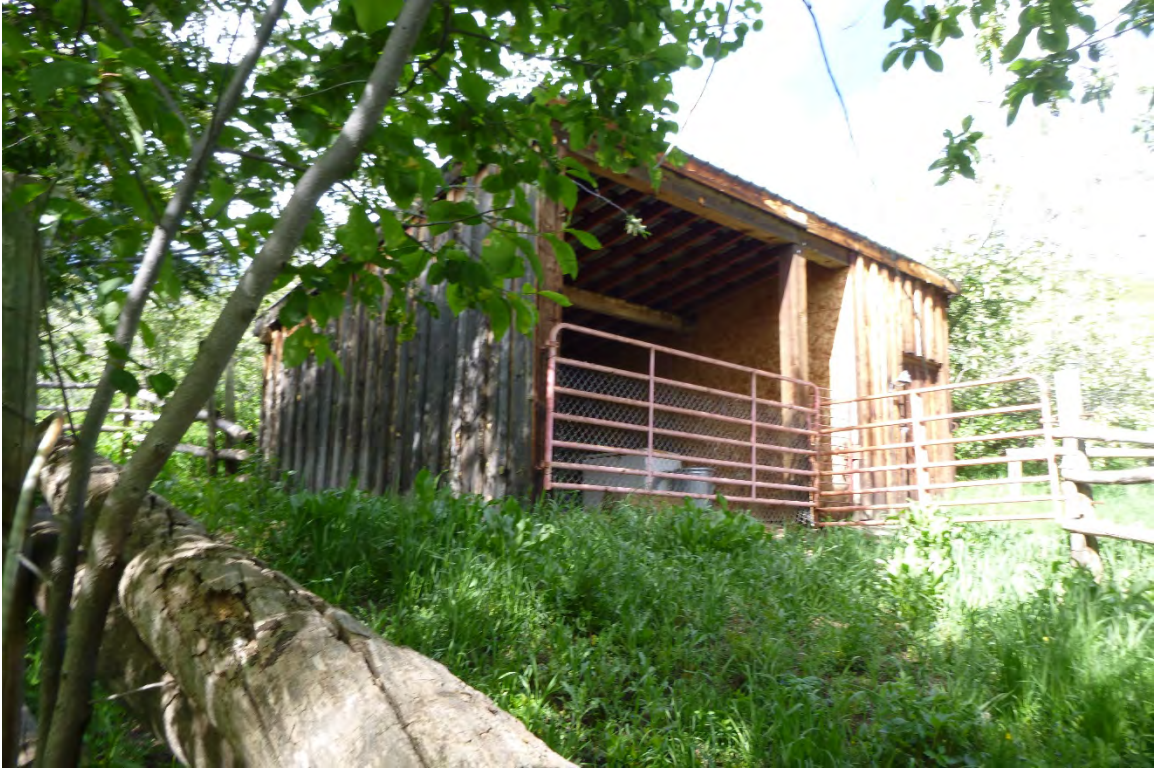
F5 is a loafing shed with an enclosed storage area and a small corral located at the center of the site. Exterior walls are clad with vertical lumber boards (batten board), and plywood is visible in the interior of the open livery. The south wall of the livery portion of the shed is uncovered (about 12 feet by 15 feet), and the east third of the shed is fully enclosed (8 feet by 15 feet). The building has a concrete-footing foundation in a rectangular plan that measures 20 feet by 15 feet. The attached corral is constructed of a variety of materials, including steel tube gates, chain link fence, timbers and unhewn logs, and bailing wire.

5GN6496 – F5 overview, loading shed and small corral, view to the northwest.
Photo Number: K.1030989 Date: 6.10.19

**5GN6496 – F5 overview, shed and small corral with plywood interior visible, view to the northwest.
Photo Number: K.1030991 Date: 6.10.19**

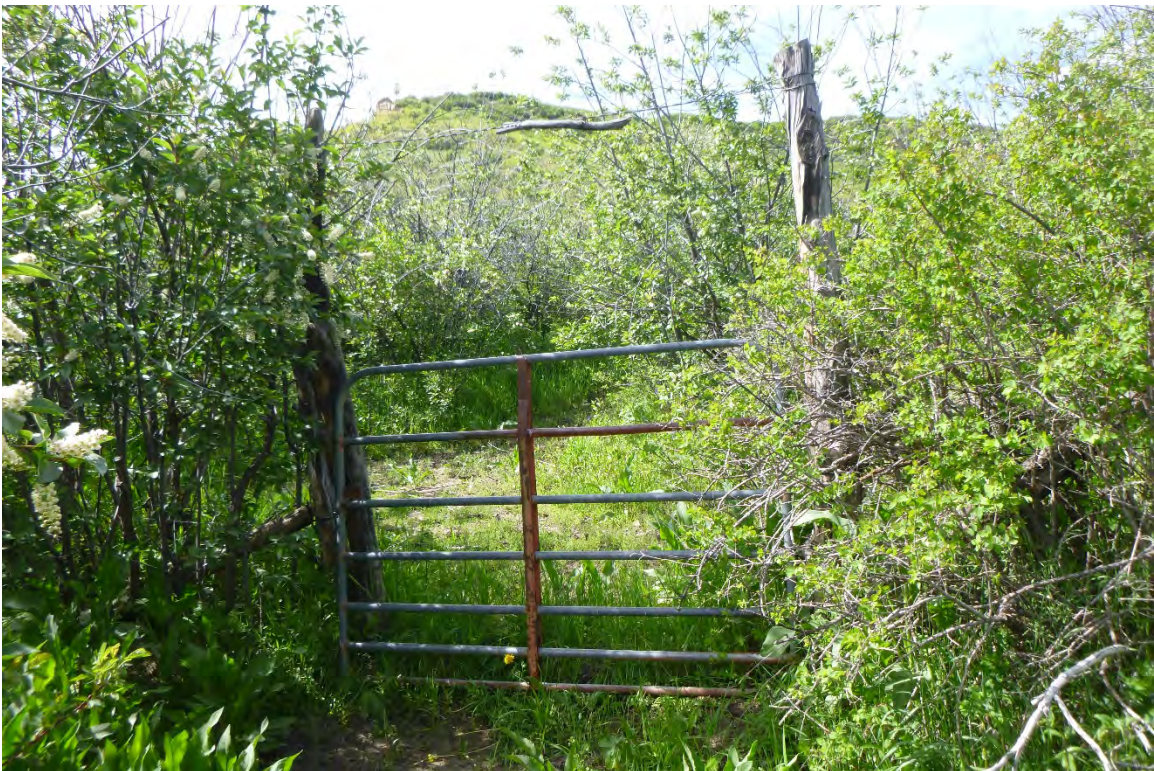
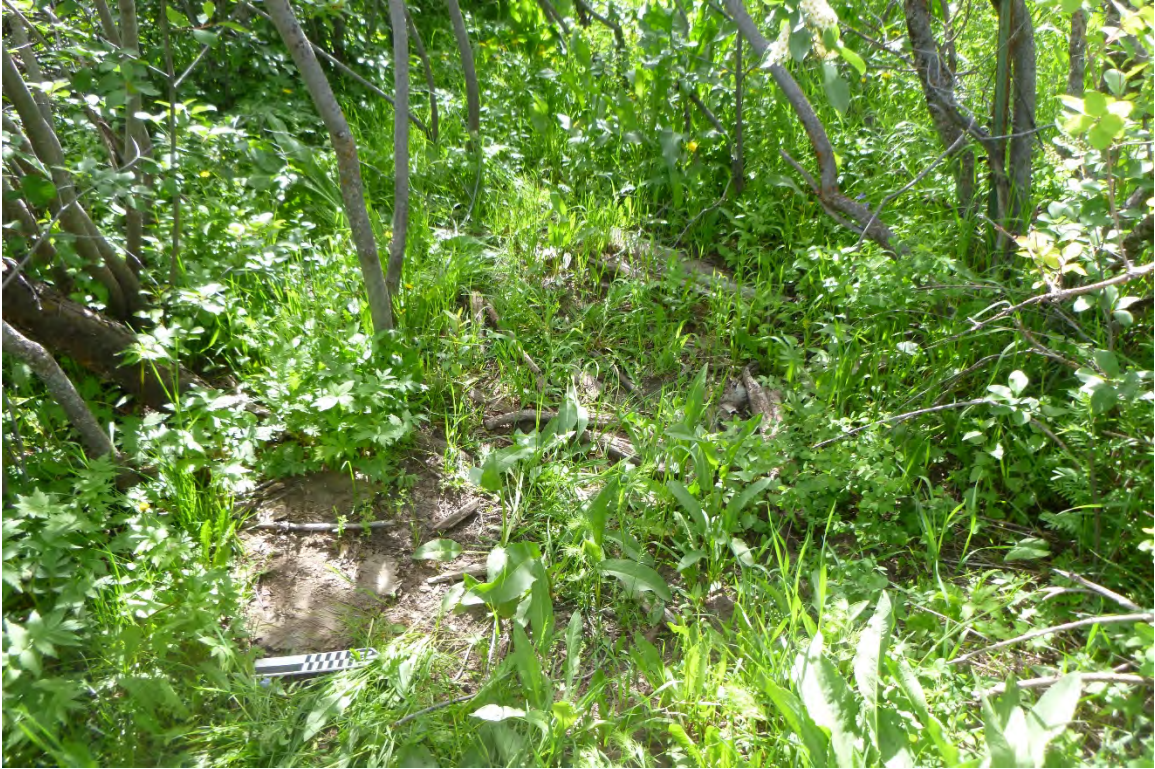
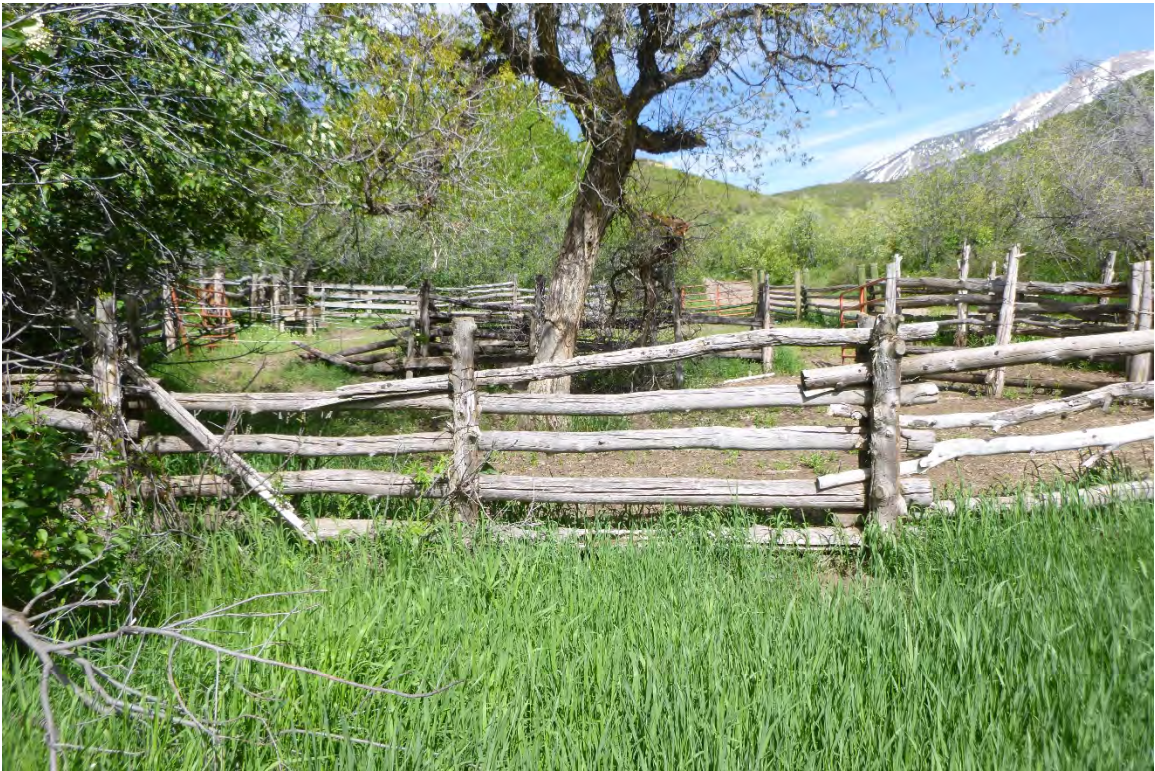
**5GN6496 – F6 overview, fence line with gate, view to the north.
Photo Number: K.1030988 Date: 6.10.19**

5GN6496 – F7 overview, circular depression and possible privy location, view to the west.
Photo Number: K.1030994 Date: 6.10.19

5GN6496 – F8 overview, corral complex, view to the east.
Photo Number: K.1030999 Date: 6.10.19

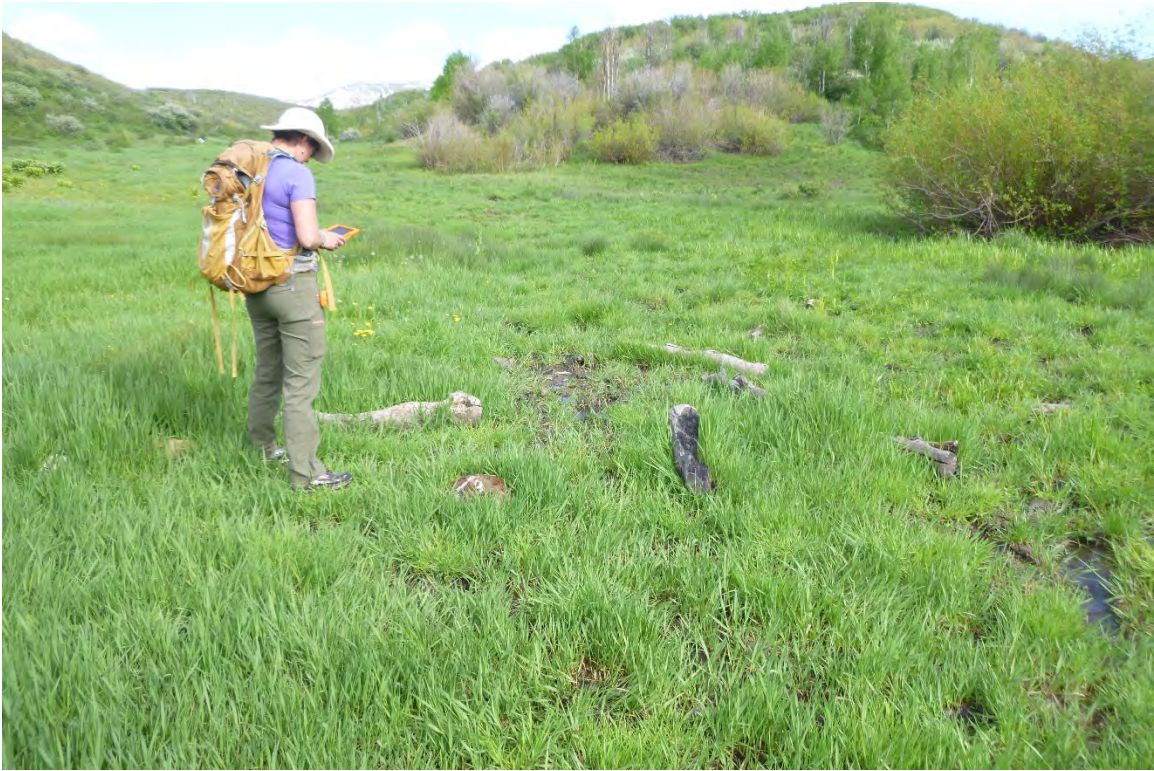
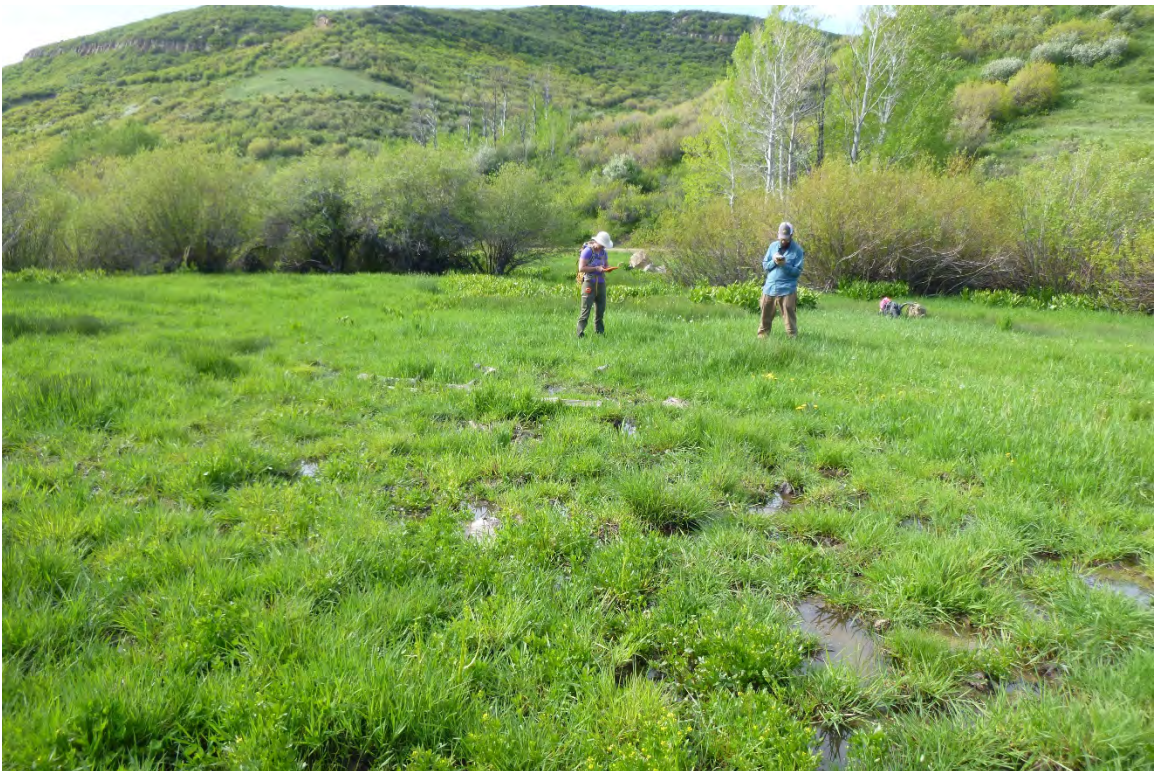
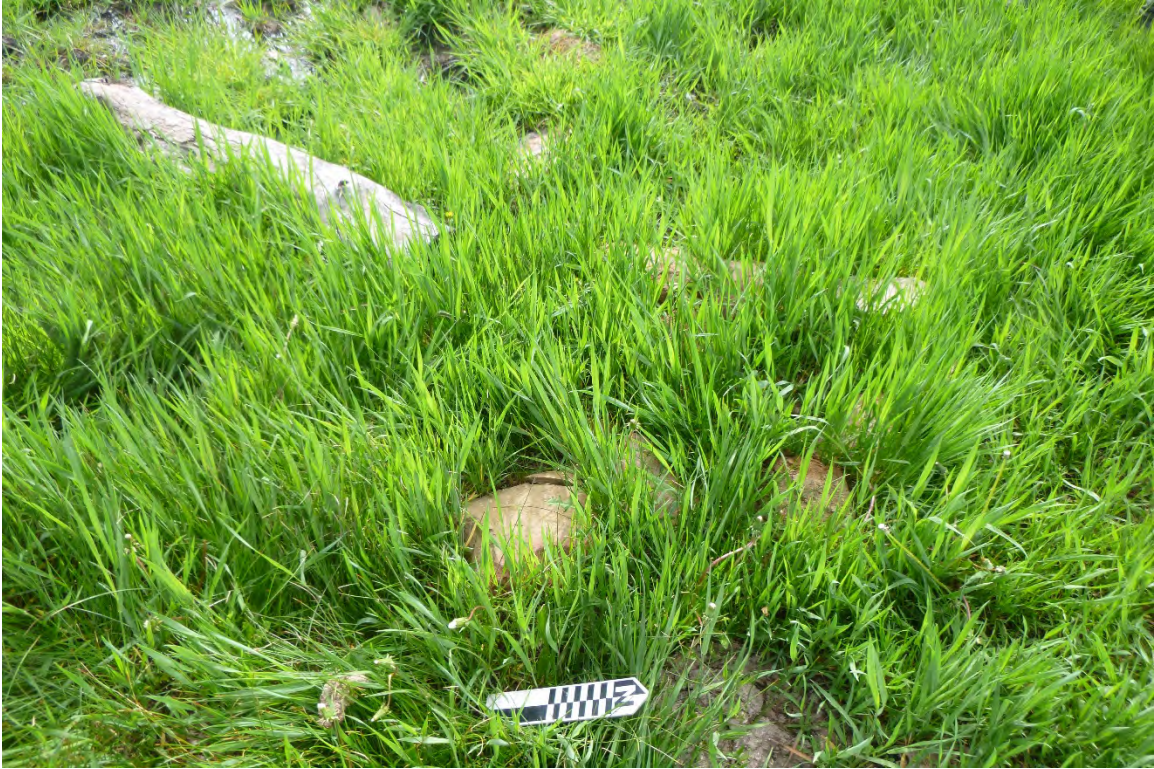
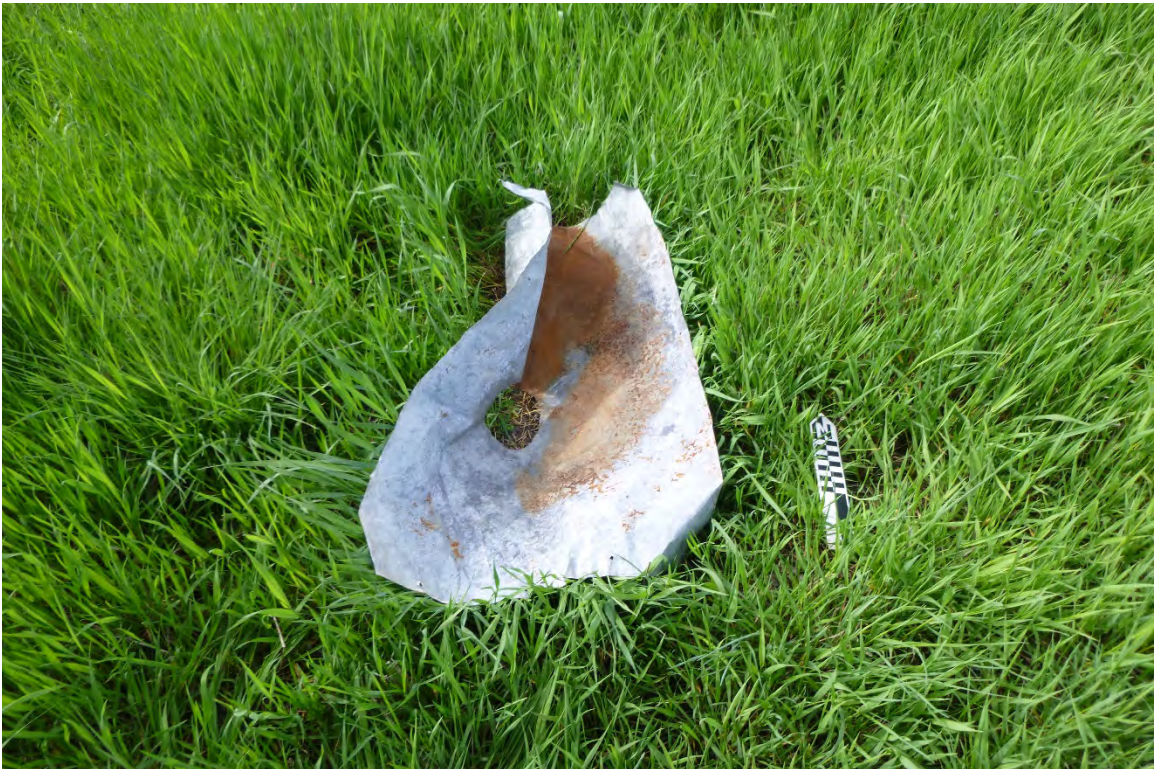
A sparse scatter of structural debris (F1) includes 11 sandstone cobbles and 6 cut log remnants with evidence of burning. A square sheet of galvanized tin with a circular stove pipe hole in the center was located approximately 51 ft northwest of F1. At the time the site was recorded, the area was saturated from flowing water during spring runoff. Additional cultural material may be present but could not be assessed due to saturated ground; however, any cultural material would now be compromised from periodic saturation.

The only intact aspect of integrity is location. Burning and removal of the cabin structure have affected the integrity aspects of materials, workmanship, design, feeling, and association. The historical setting has been compromised by development associated with coal mining as well as alteration of the original trail that led to the cabin (the trail is now a heavily travelled road).

**5GN6497 – Site overview, historic cabin location, view to the southeast.
Photo Number: K.1040011 Date: 6.10.19**

**5GN6497 – Site overview, historic cabin location with Minnesota Creek Road in background,
view to the north. Photo Number: K.1040013 Date: 6.10.19**

5GN6497 – F1 detail, sparse scatter of structural debris, plan view.
Photo Number: K.1040012 Date: 6.10.19

5GN6497 – Detail, galvanized tin with circular stove pipe hole, plan view.
Photo Number: K.1040009 Date: 6.10.19

Management Recommendations: No further work upon concurrence with the not-eligible recommendation. Regardless, based on current design for the placement of MVB pads and roads, this resource would not be affected by proposed project activities.

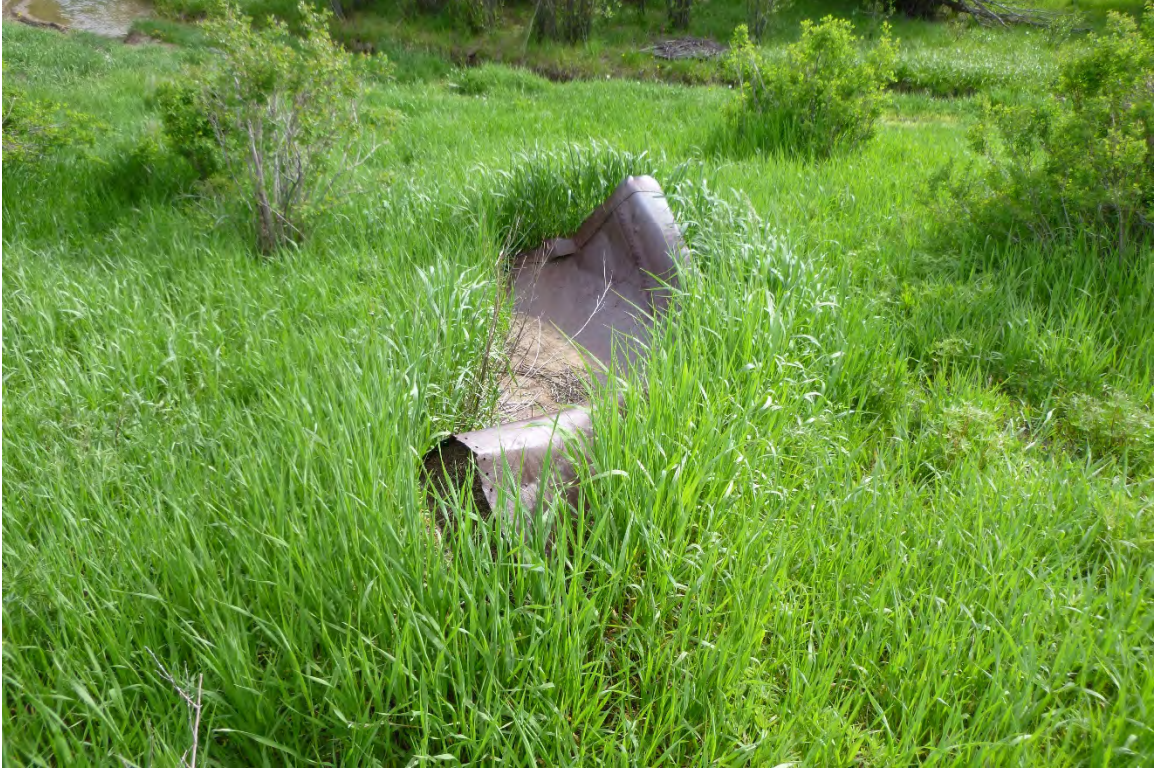
**5GN6498 – Overview of riveted tank, view to the southwest.
Photo Number: K.1040034 Date: 6.12.19**

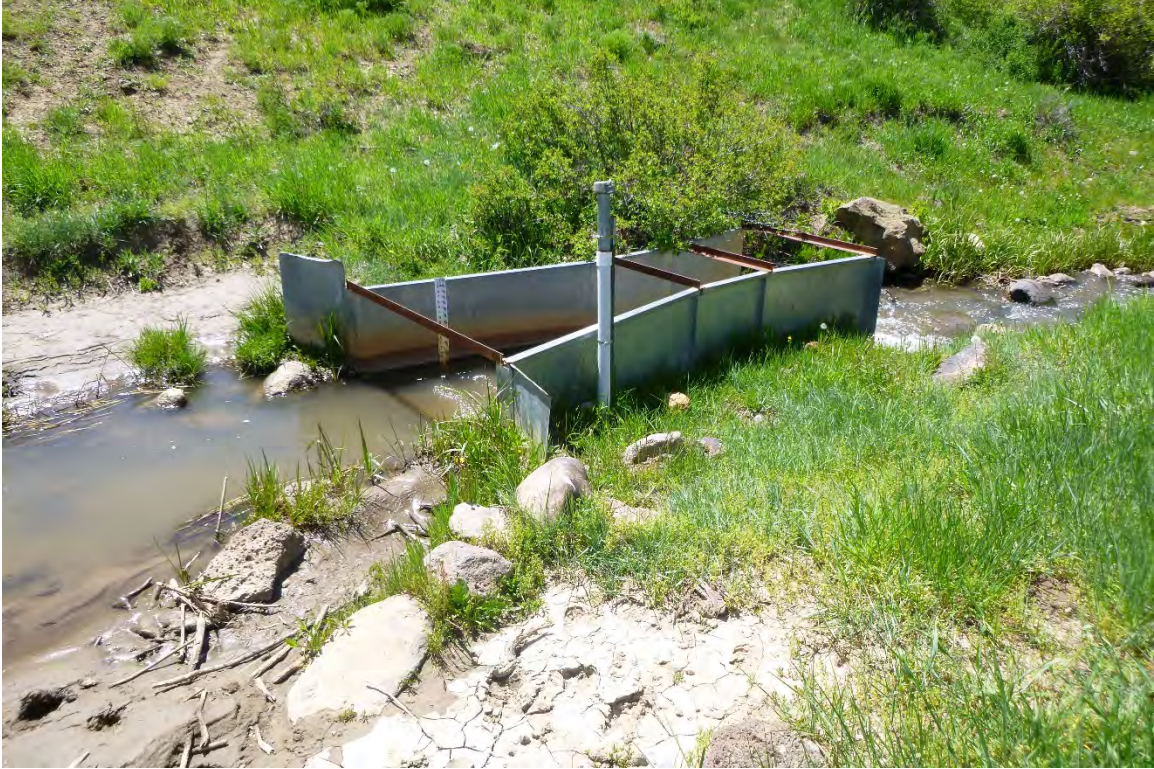
**5GN6500 – Parshall flume installed in Minnesota Creek, view to the south.
Photo Number: K.1040043 Date: 6.13.19**

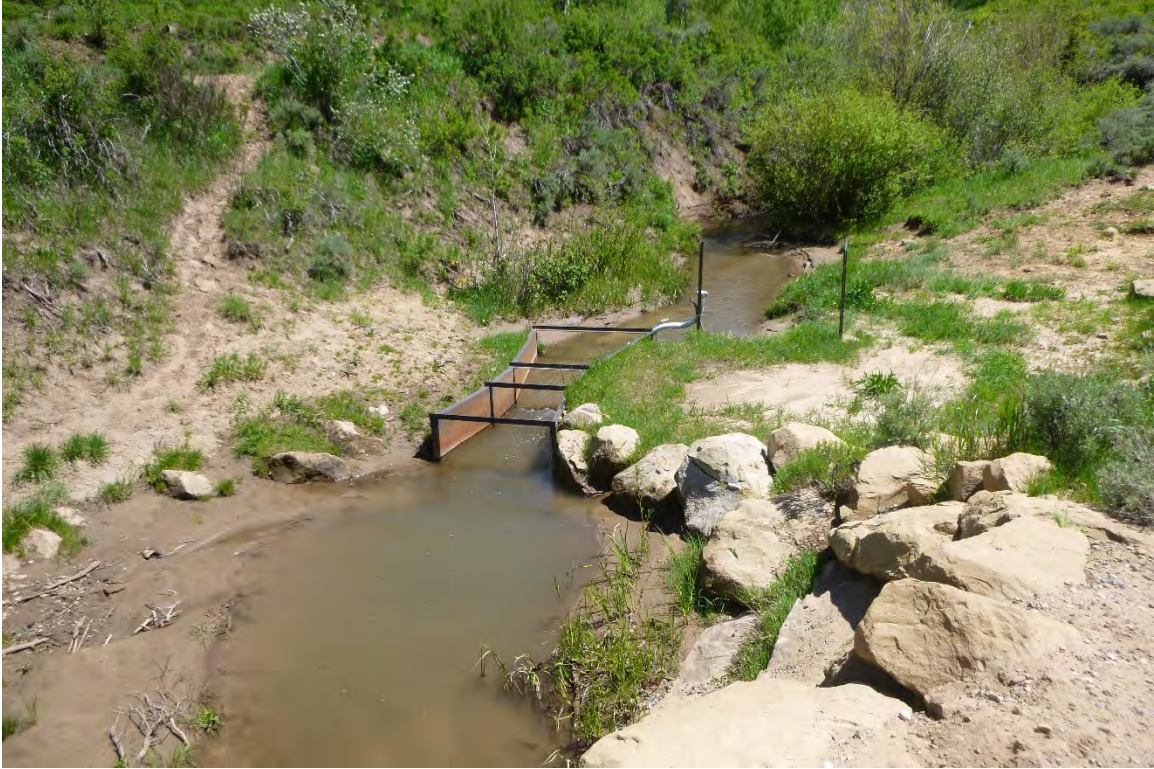
**5GN6501 – Overview of Parshall flume installed near bridge, view to the southeast.
Photo Number: K.1040044 Date: 6.13.19**
