Inspection Report

MINERALS PROGRAM INSPECTION REPORT
PHONE: (303) 866-3567

MINE NAME: B & G Stone	MINE/PROSPECTING ID#: M-1987-092	MINERAL: Sandstone (silica, st quartzite)	COUNTY: Larimer
INSPECTION TYPE: Monitoring	INSPECTOR(S): Robert Zuber, P.E.	INSP. DATE: February 15, 2022	INSP. TIME: 09:00
OPERATOR: Blue Mountain Stone, Inc.	OPERATOR REPRESENTATIVE: Raul Vasquez, Buda Vasquez	TYPE OF OPERATION: 110c - Construction Limited Impact

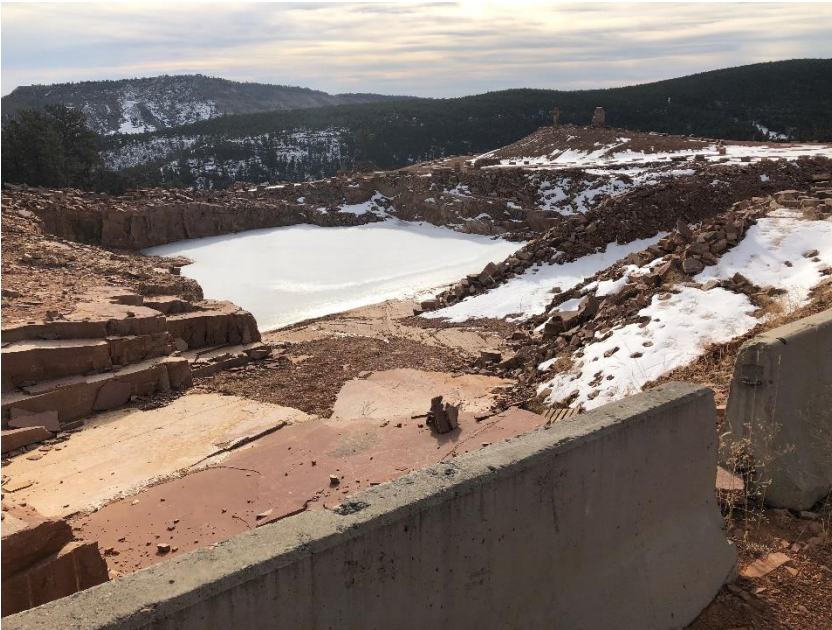
The site includes one pit with approximate dimensions of 200 feet by 100 feet by 15 feet deep. The Division estimates that approximately 7,300 cubic yards of material will have to be moved to fill the pit.

There is impounded surface water or groundwater at the site. Per the regulations of the Division of Water Resources (DWR), this water cannot be impounded for more than 72 hours unless water rights have been approved. Also, if this water is groundwater, a well permit must be obtained. Blue Mountain Stone will need to secure approval from DWR to impound this water, backfill the pit, or regrade to provide positive drainage of the area.

Pit near west end of site

CORRECTIVE ACTIONS: Submit documentation from DWR demonstrating that the impoundment of water in this pit is authorized by that office. If it is exposed groundwater, also demonstrate that a well permit has been obtained.

Alternatively, backfill the pit or remove impediments to proper surface drainage and provide proof to the Division (e.g., photographs) that this has been completed.

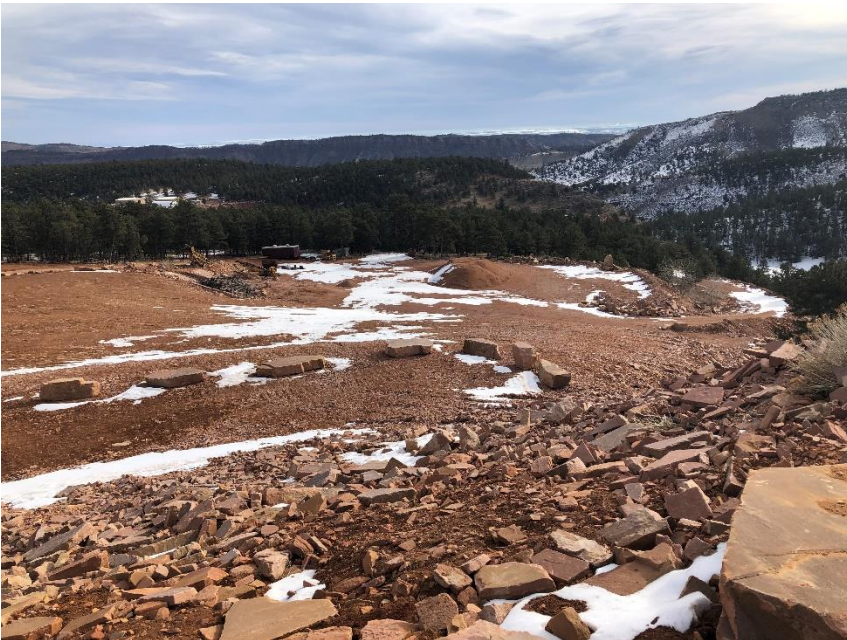
Backfilling has been conducted over a significant portion of the site.

Eastern area that has been backfilled and graded
