Inspection report

Permit Number: C-1981-028 Mine Name: Keenesburg Strip Mine Operator: Coors Energy Company Operator Address: Mr. Ben Moline PO Box 4030 Golden, CO 80402 County: Weld Operation Type: Surface Permit Status: Permanent Cessation Ownership: Private

Inspection Start Date: February 25, 2022 Inspection Start Time: 13:40 Inspection End Date: February 25, 2022 Inspection End Time: 15:15			Inspection Type: Coal Complete Inspection Inspection Reason: Normal I&E Program Weather: Clear	
Joint Inspection Agency:		Joint Inspection Contacts:		
None				
Post Inspection Agency:		Post	Inspection Contacts:	
None				
Inspector(s):	Inspecto	r's Sig	nature:	Signature Date:
Robert Zuber, P.E.	Phot	D.	21-	
				2/28/2022

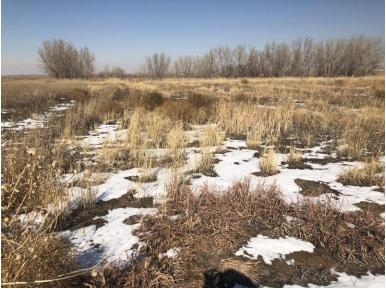
Decent vegetation was seen at the north end of Area 25. Sunflowers and undesirable species (cheat grass, kochia, and Russian thistle) are the predominant species in most of the newly reclaimed areas. These include the reclaimed road adjacent to Sediment Pond 2, Area 42, and the center of the reclaimed Long Term Spoil Area. Grasses were sparse at many newly reclaimed areas.

Northern portion of Area 25

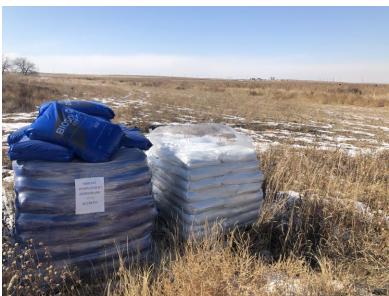
A complete inspection was conducted by Rob Zuber of DRMS on February 25, 2022. No Coors Energy Company (CEC) representative was present at the inspection. The site is in Permanent Cessation. Reclamation activities were completed in the fall of 2020, however, due to poor success in some areas, Coors Energy is preparing to reclaim these areas a second time. In several areas, stockpiles of soil amendments (Biosol fertilizer, phosphate) were seen.

Stockpile of soil amendments at Area 42, with northern boundary in the background

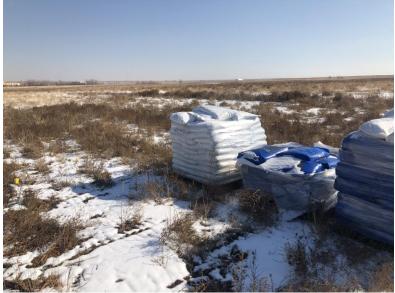
Stockpile of soil amendments in Long Term Spoil Area (reclaimed), Looking southeast from the center of the area

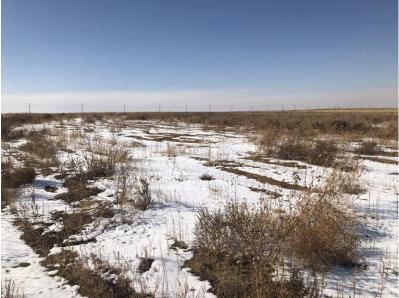
Large bare spots were seen at the east side of the reclaimed B Pit and at the southern portion of the reclaimed Long Term Spoil Area.

Bare spot in B Pit Area (reclaimed), looking northwest from east side

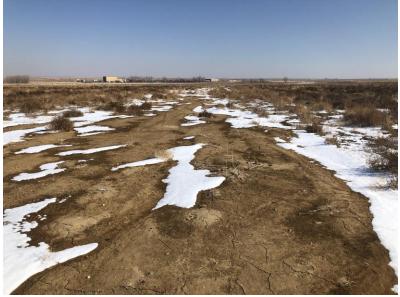
Bare spot near south end of the Long Term Spoil Area (reclaimed)

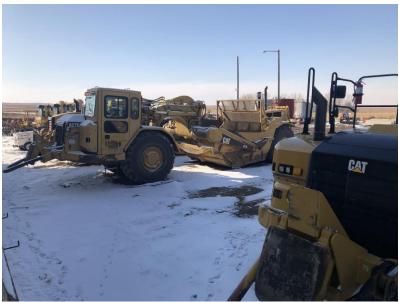
Motor scraper and other reclamation equipment at the facility area
