Keenesburg Mine 2021 Vegetation Monitoring Report

**Keenesburg Mine First Quarter 2021
Pest & Disease Inspection**

**Re: 2021 Annual Groundwater Monitoring Report
Keenesburg Ash Disposal Site
Weld County, Colorado**

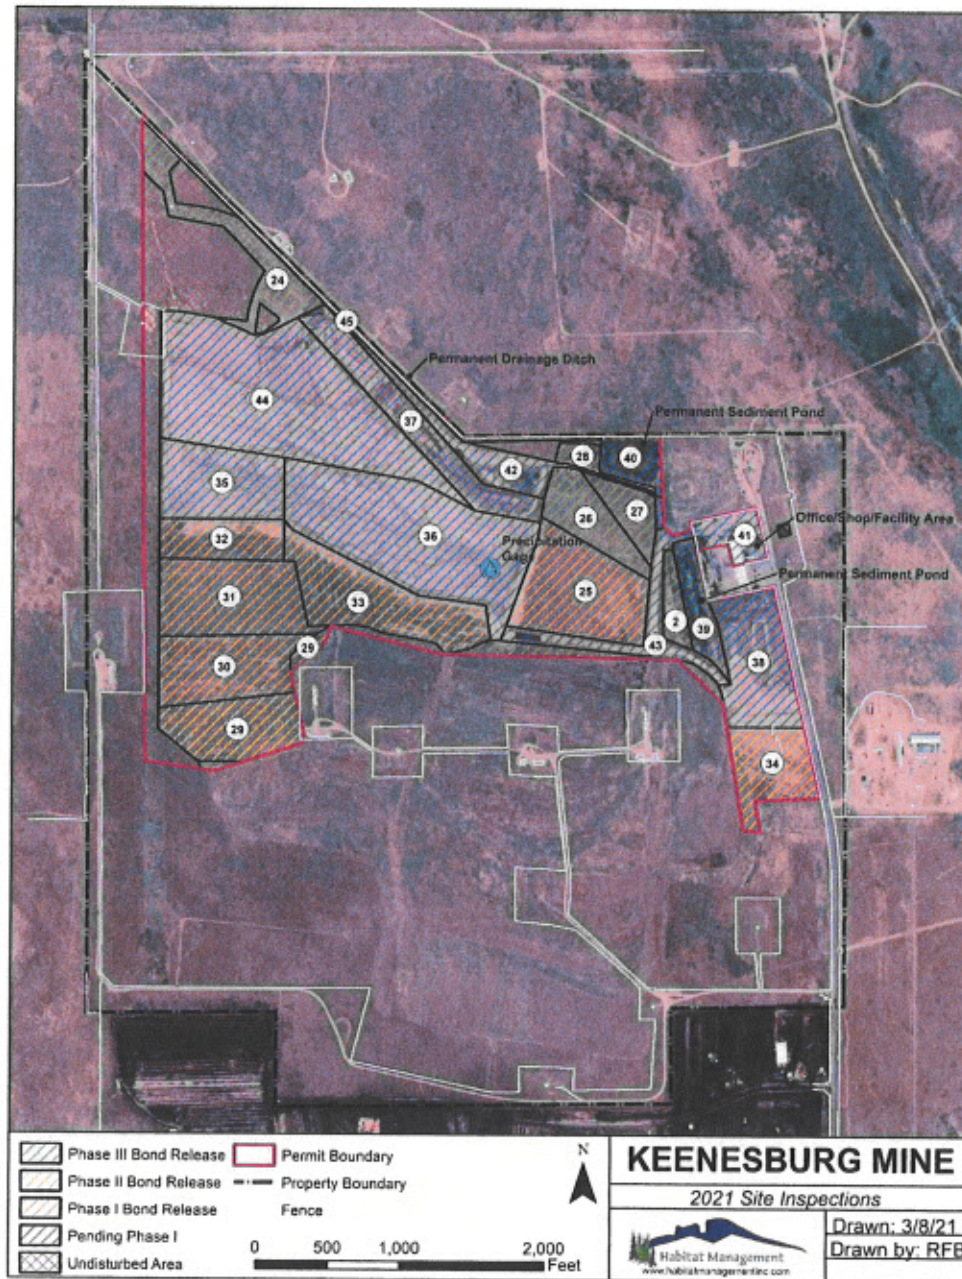
Map 1: Coors Energy Company-Keenesburg Mine

These areas are depicted on Map 1.

Plant pests or diseases were not observed within the areas inspected. The vegetation has not been adversely affected by plant pests. Areas affected by infestation or blight were not identified during this inspection. No areas were observed where noxious weeds, plant pests or plant disease had adversely impacted the normal growth and establishment of vegetation on reclaimed lands.

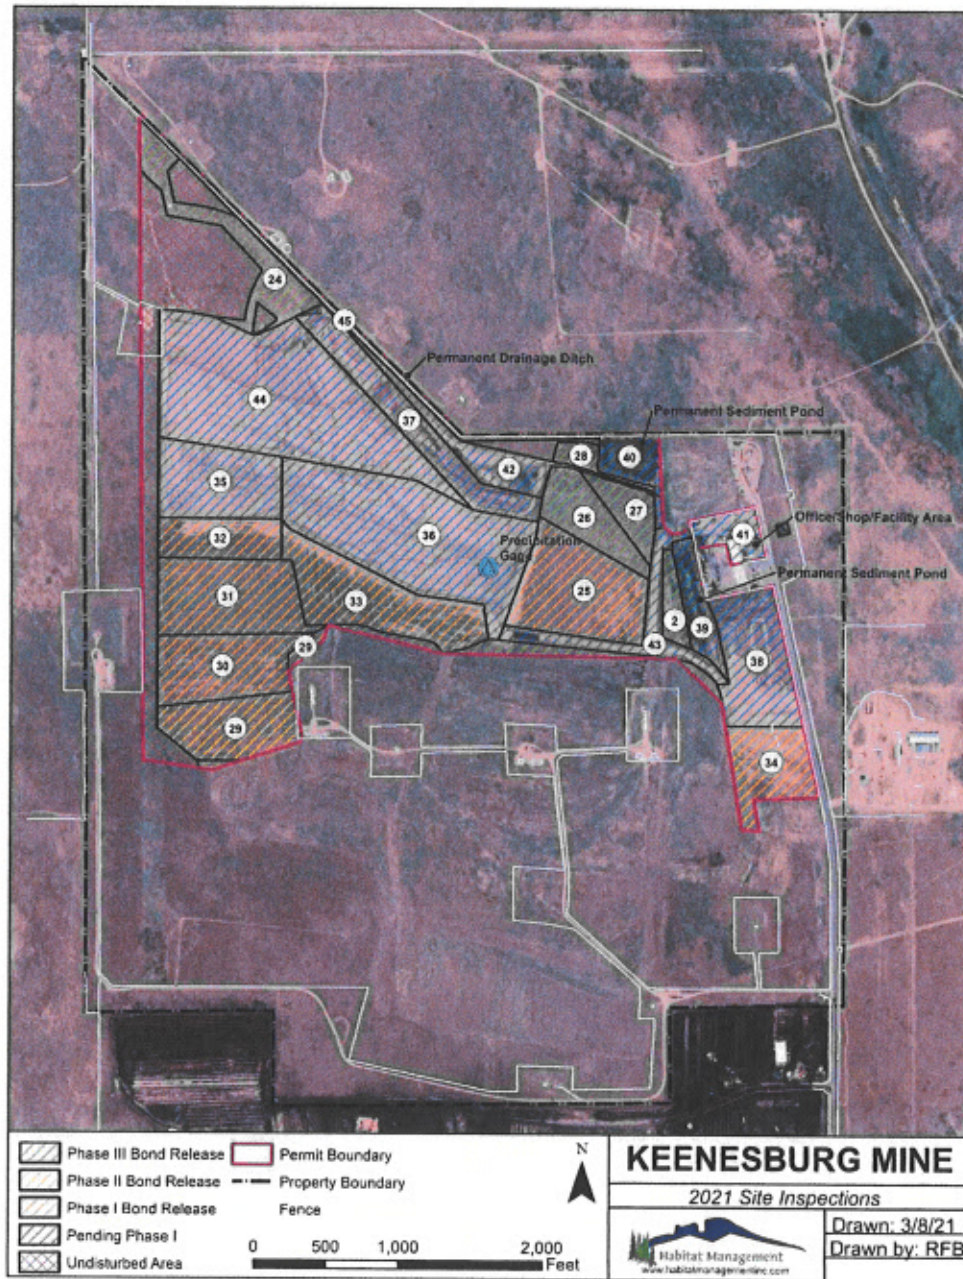
Map 1: Coors Energy Company-Keenesburg Mine

On June 23, 2021 Habitat Management inspected the operational, bonded reclaimed, and shop areas at the Keenesburg Mine for plant pests, plant diseases, and noxious weeds that could or have affected establishment of vegetation on reclaimed lands. The following areas were inspected and are depicted on Map 1:

Plant pests or diseases were not observed within the areas inspected. The vegetation has not been adversely affected by plant pests. Areas affected by infestation or blight were not identified during this inspection. No areas were observed where noxious weed species were impacting normal growth and establishment of vegetation on reclaimed lands.
w/attachment

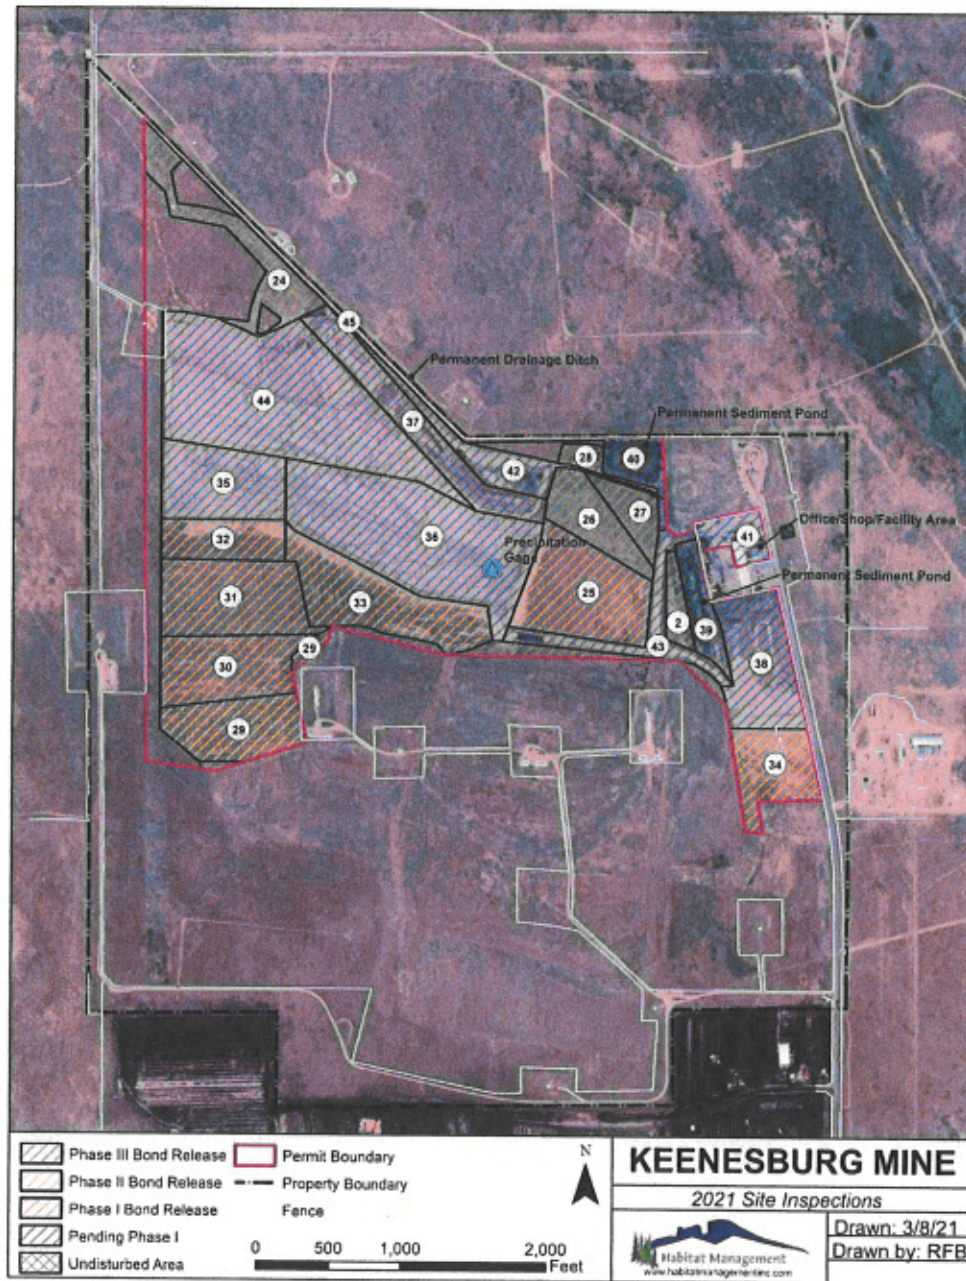
Map 1: Coors Energy Company-Keenesburg Mine

On October 8, 2021 Habitat Management inspected the operational, bonded reclaimed, and shop areas at the Keenesburg Mine for plant pests, plant diseases, and noxious weeds that could or have affected establishment of vegetation on reclaimed lands. The following areas were inspected and are depicted on Map 1:

Plant pests or diseases were not observed within the areas inspected. The vegetation has not been adversely affected by plant pests. Areas affected by infestation or blight were not identified during this inspection. No areas were observed where noxious weed species were impacting normal growth and establishment of vegetation on reclaimed lands.
w/attachment
