Before and After Photo Set 2

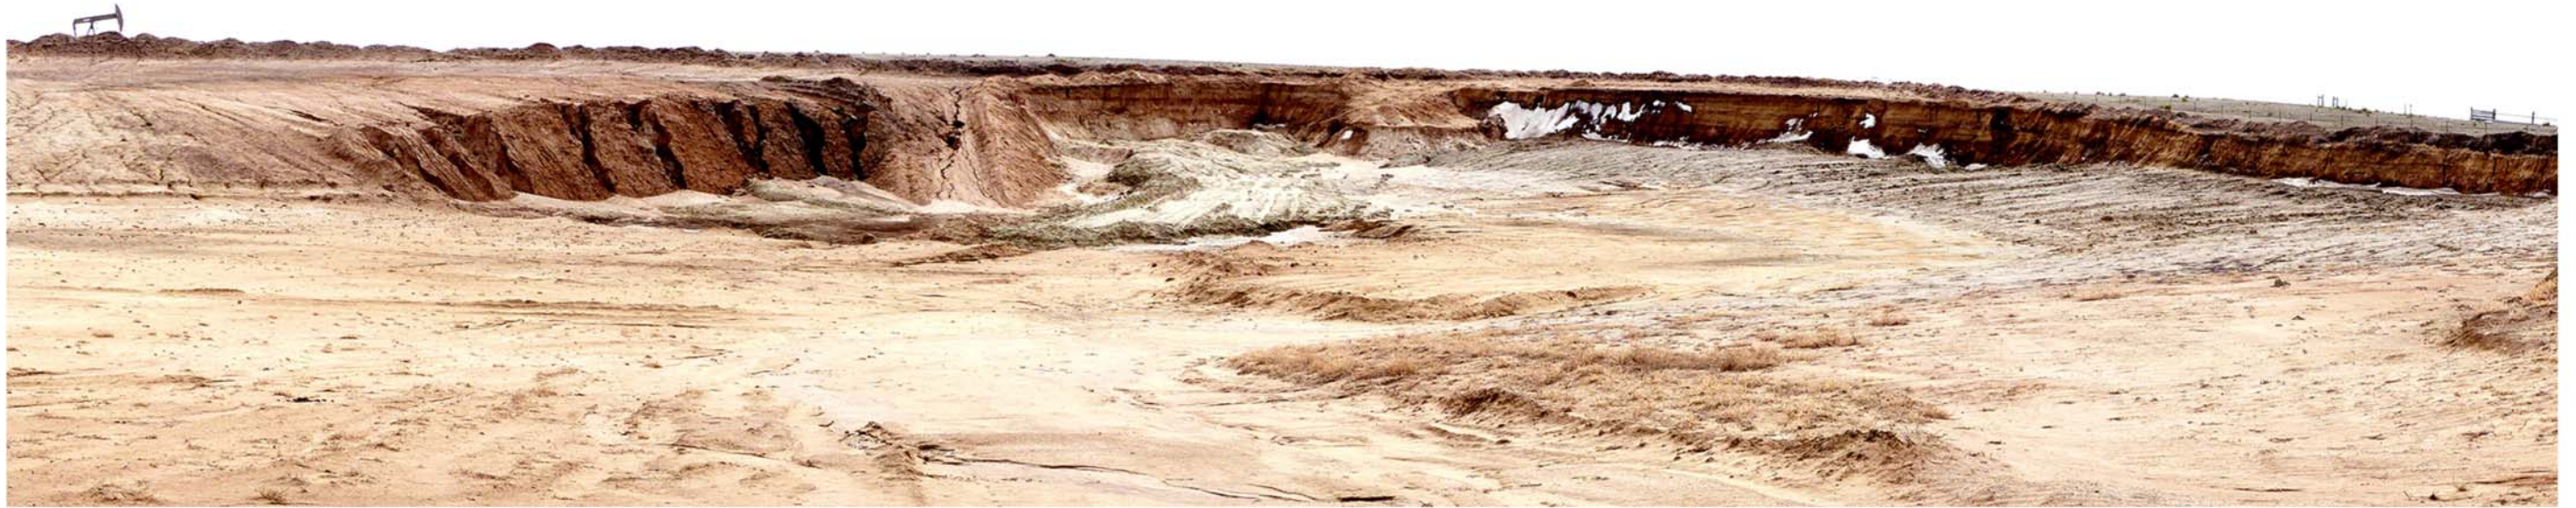
View of Southeastern Corner of the Pit March 13, 2020. Operations at the pit had been concluded. So this is the condition at the end of mining. The distance from side to side is about 900 feet. Total depth of the pit is about 25 feet. Many highwalls are 15 to 20 feet high and at a 1:1 or steeper slope.

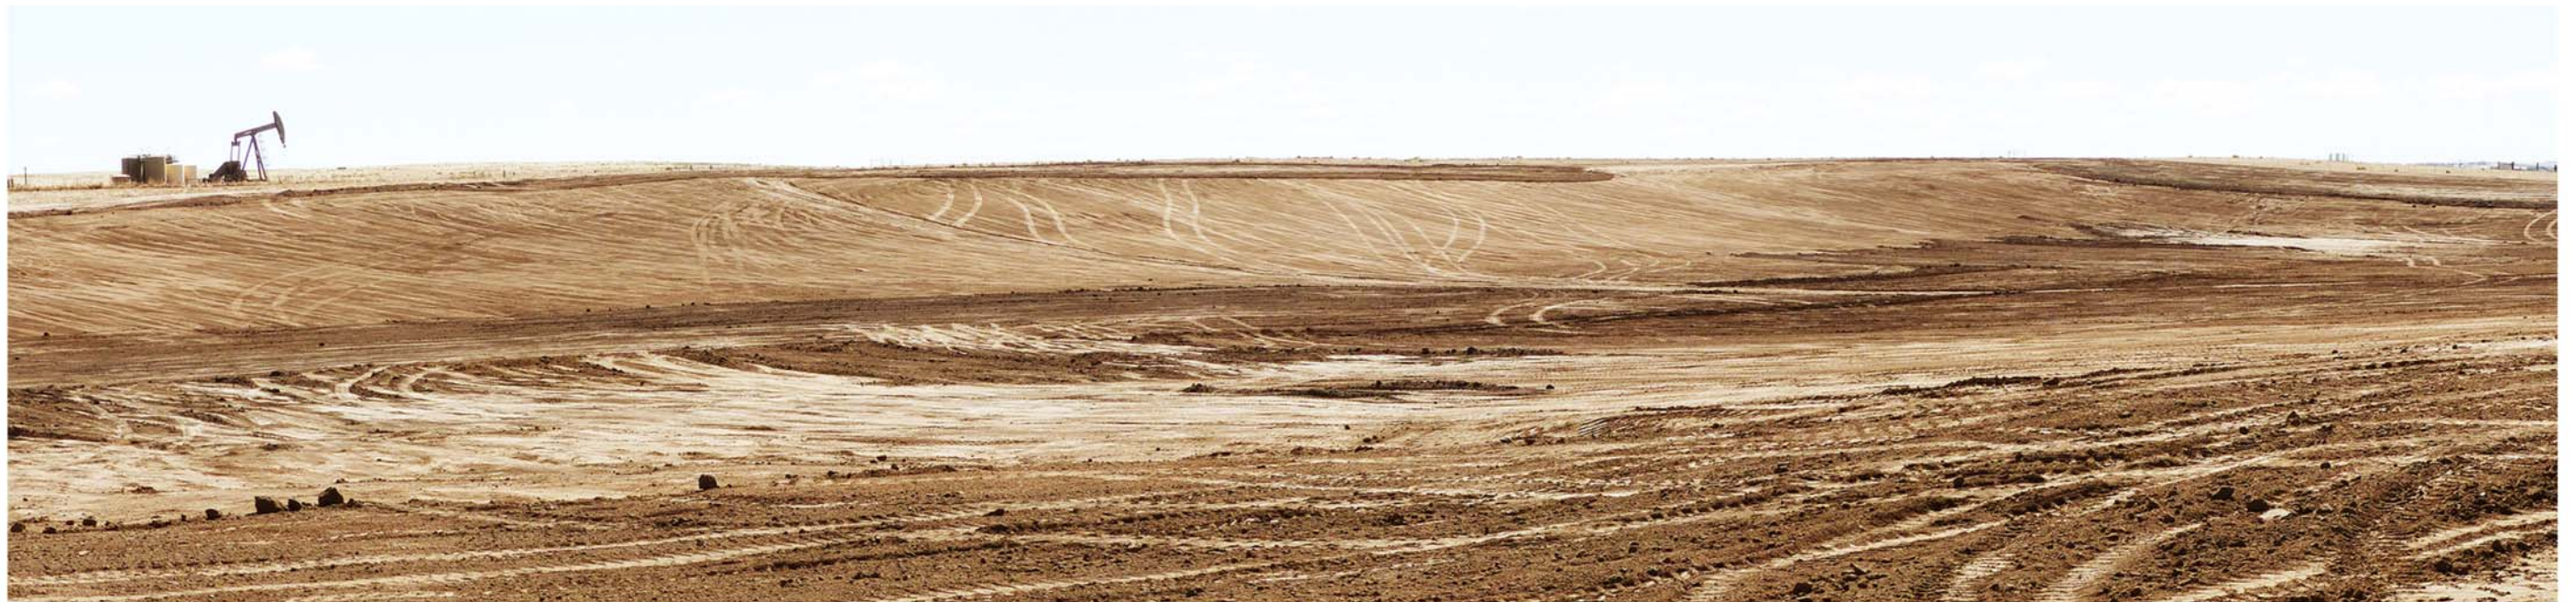
Very similar view to the photo above, but taken on March 14, 2022. Backfilling and grading is very nearly completed. The total depth in the middle of the bottom of the pit along the drainage line is no more than about 2 feet different from the photo taken in 2020. Most of the reclamation was done by cut and fill to create these final slopes which are very near a 5:1 slope as required in the reclamation plan as well as stated in the lease from the Colorado Board of Land Commissioner. (Note: the color balance in the 2022 photo was adjusted to match the color balance of the 2020 photo. The colors in each of the original photos were very different and could introduce a consideration bias.)
