The Division of Reclamation, Mining and Safety has conducted an inspection of the mining operation noted below. This report documents observations concerning compliance with the terms of the permit and applicable rules and regulations of the Mined Land Reclamation Board.

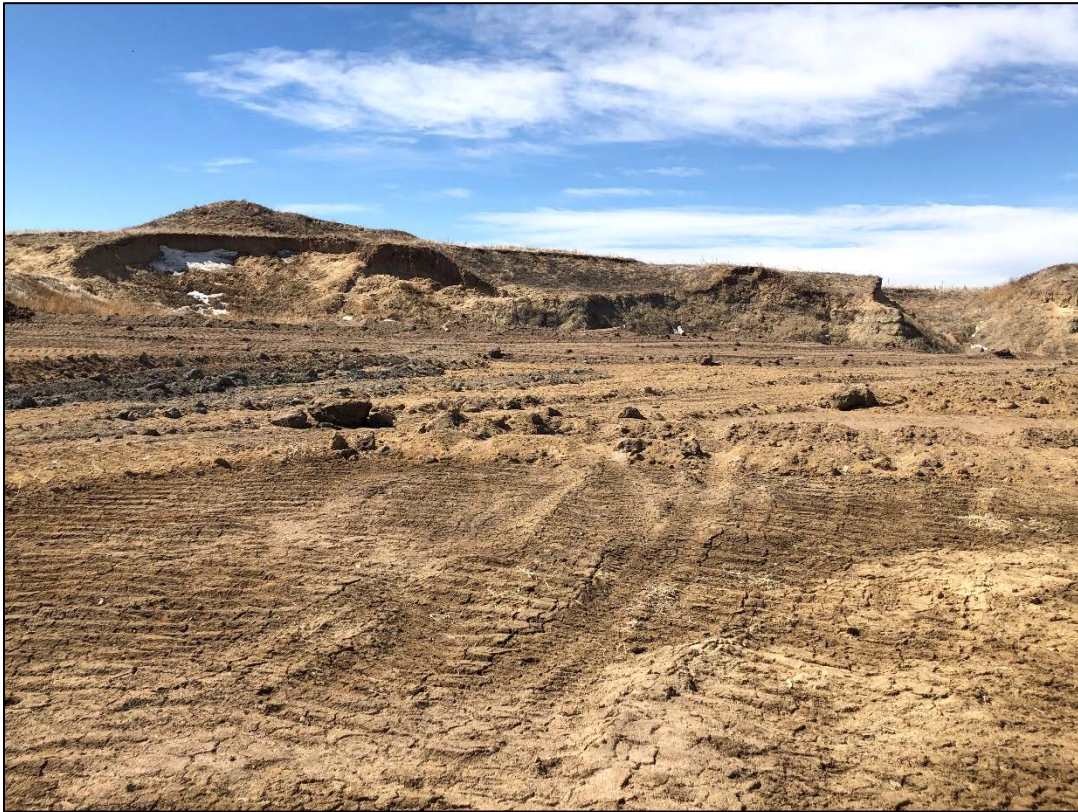
The south pit area includes an excavated pit which opens up to the east, with highwall slope gradients ranging from near vertical to 2H:1V. The southern pit wall is higher (at approximately 15 feet or more) than the rest of the pit walls (at approximately 5-8 feet), and is irregular in shape. A few small topsoil stockpiles are stored along the southern edge of the pit, above the highwall. The Division estimates the pit wall to be approximately 1,855 feet in length. The eastern and southern portions of the pit wall are located very close to the permit boundary, most likely requiring backfilling rather than cut/fill methods to achieve the final slope gradient for reclamation. Due to the irregular shape of the southern pit wall, several knobs along this highwall could be excavated and the material used for backfill. Additional backfill material available on site includes the small stockpile of material stored just north of this pit and the low-lying mounds of material that remain along the western edge of the north pit area. During its last inspection, conducted on February 3, 2021, the Division had observed some imported soil (approximately 20-40 tons) stockpiled at the eastern edge of the pit. This material had been imported to the site to use for reclamation backfill, per the operator's June 28, 2019 notice to the Division. During the current inspection, this material appeared to have been graded out into the eastern portion of the pit. No other changes were observed in this area.

Photo 1. View looking southwest across south pit area, showing southern pit wall in background with slopes of near vertical to approximately 1H:1V.

To complete reclamation of the site in accordance with the approved reclamation plan, the operator would need to grade the pit walls in the south pit area to 3H:1V or flatter, rip approximately 3.6 acres of compacted areas (1.63 acres stockpiling areas + 2 acres pit floor), replace 6 inches of topsoil on all disturbed lands (estimated to cover the entire 9.9 acre permit area), and plant industrial hemp at 5 foot spacing on all disturbed lands.

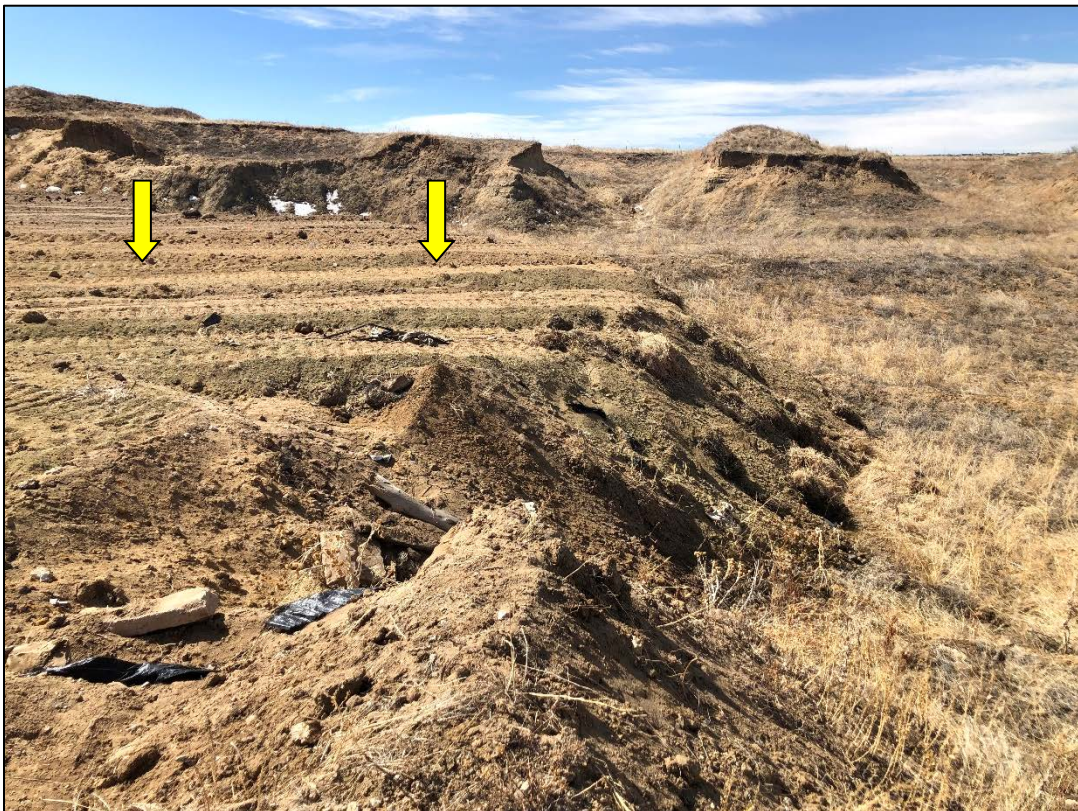
Photo 2. View looking south across eastern edge of south pit area in which imported backfill material (indicated) was pushed into the pit.

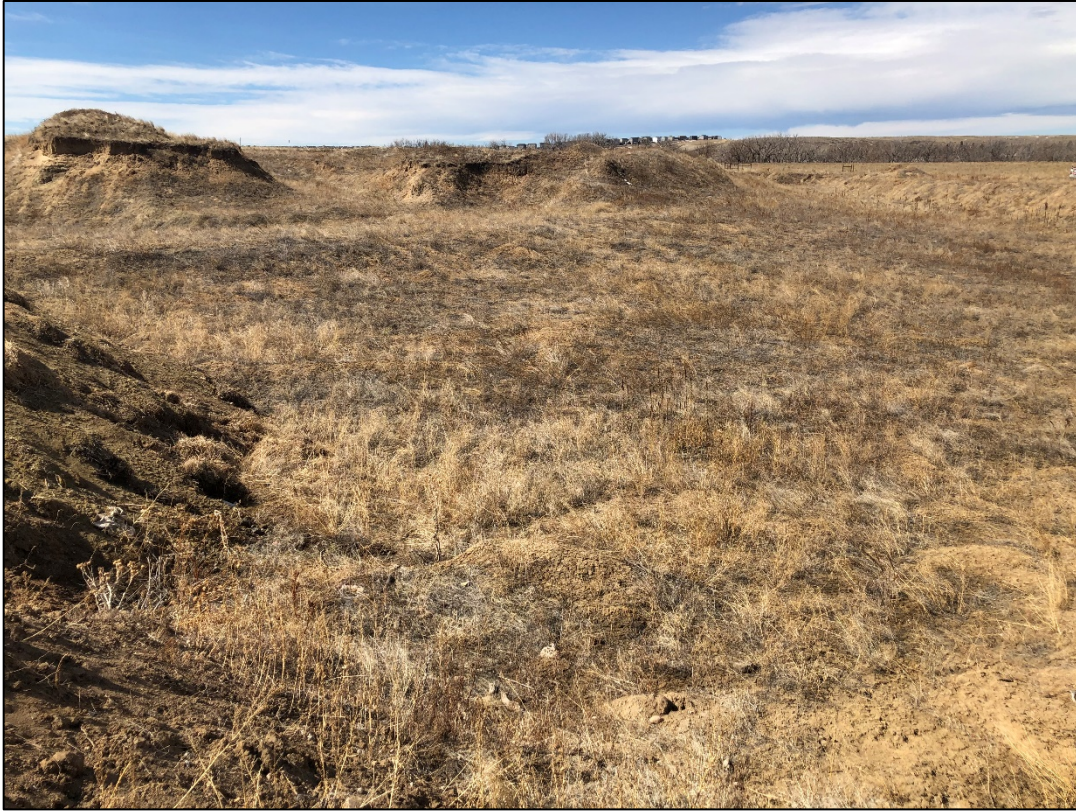
Photo 3. View looking southwest across center of south pit area.

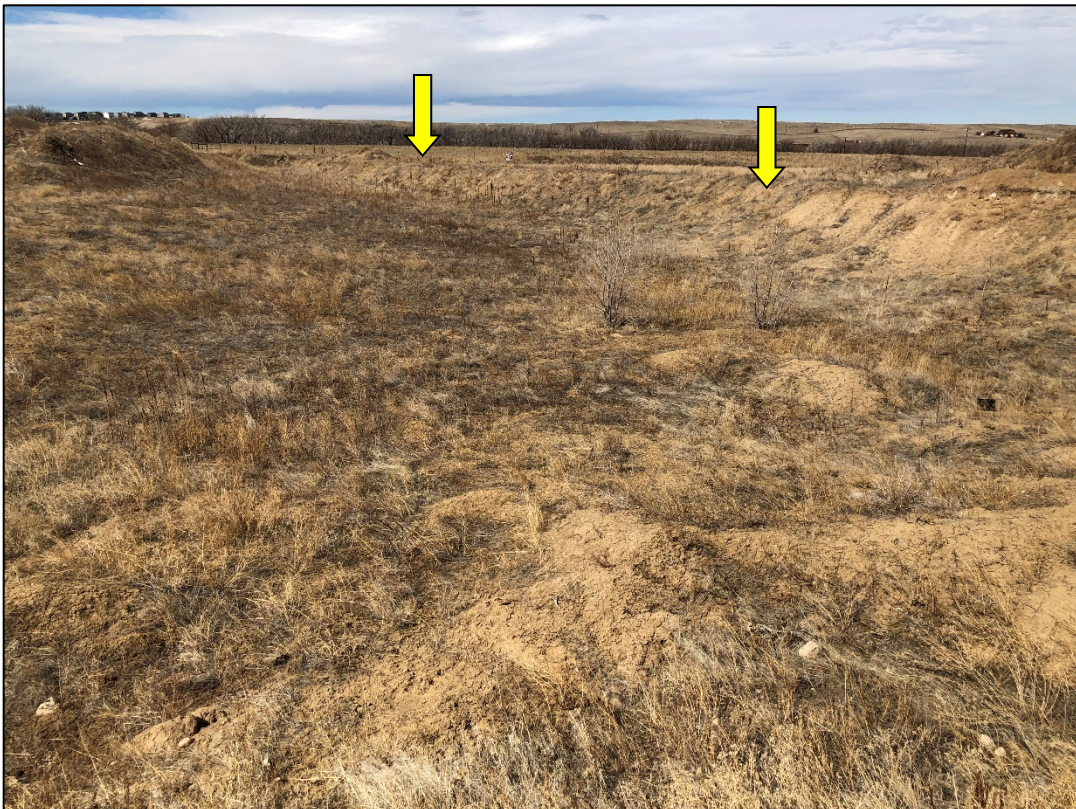
Photo 4. View looking west across south pit area, showing northern pit wall (indicated) in background with slopes of approximately 1H:1V to 2H:1V.

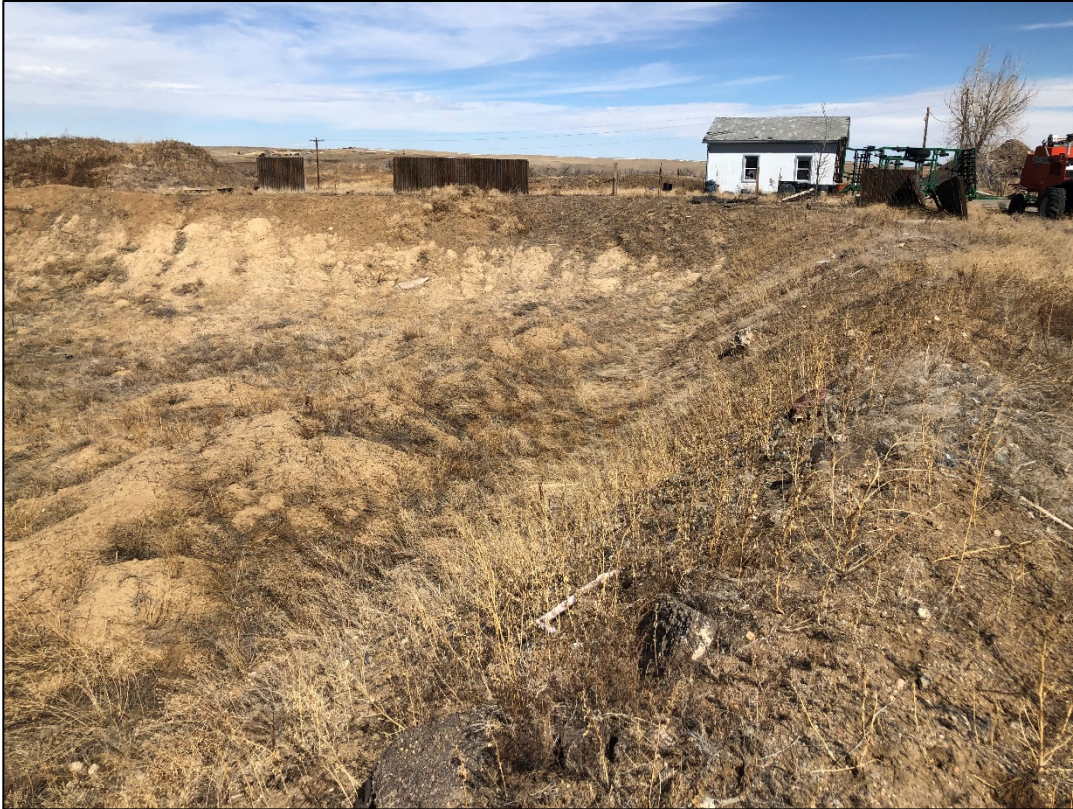
Photo 5. View looking north across northeastern corner of south pit area, showing eastern pit wall in foreground with slopes of approximately 1.5H:1V.

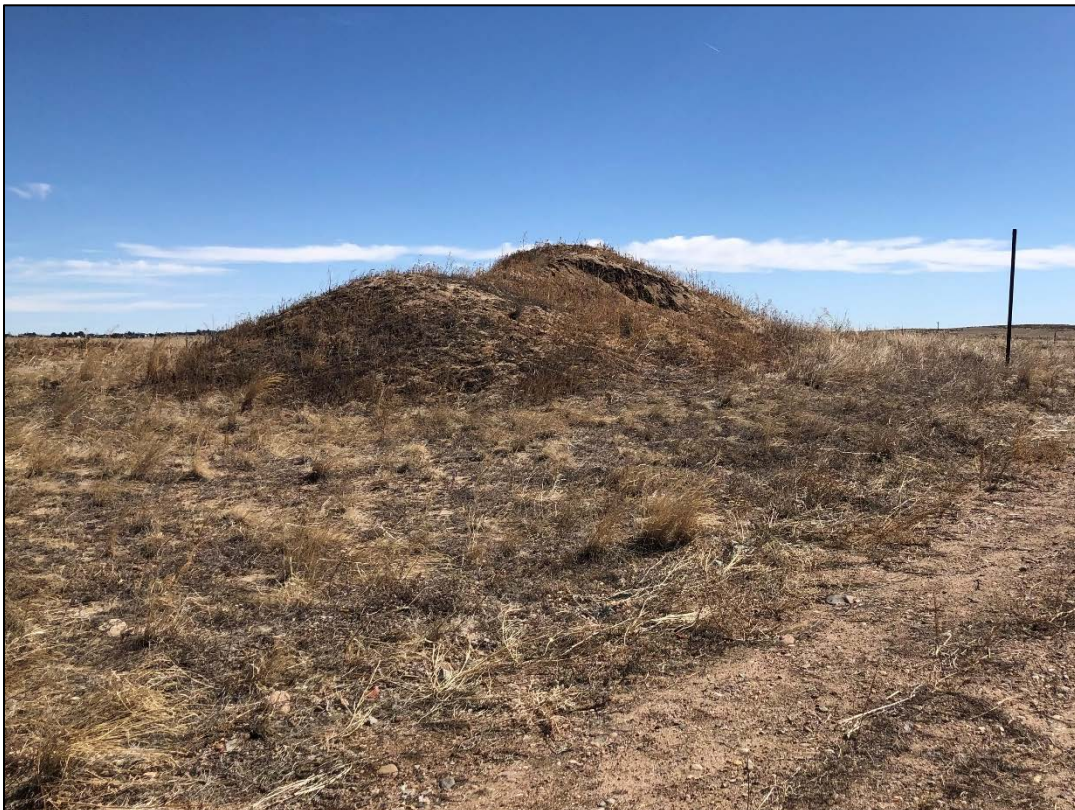
Photo 6. View looking east across southern edge of south pit area, showing small topsoil stockpile stored above pit wall.

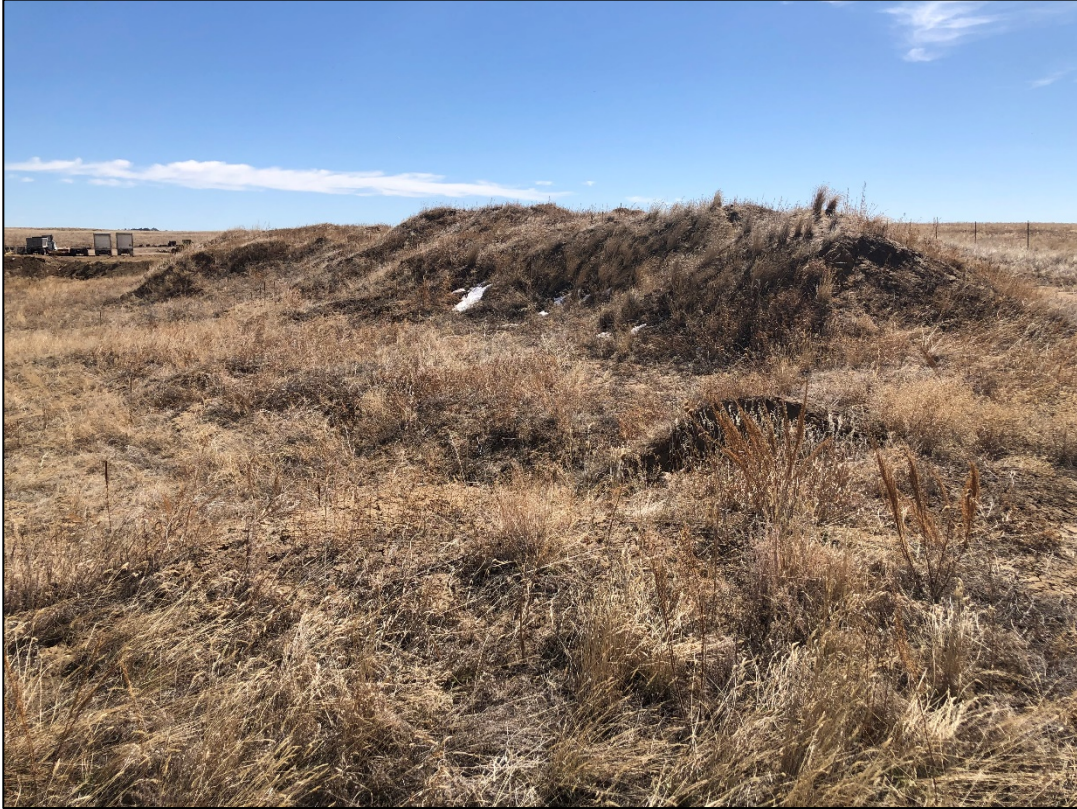
Photo 7. View looking east across southern edge of south pit area, showing additional topsoil stockpile stored above pit wall.

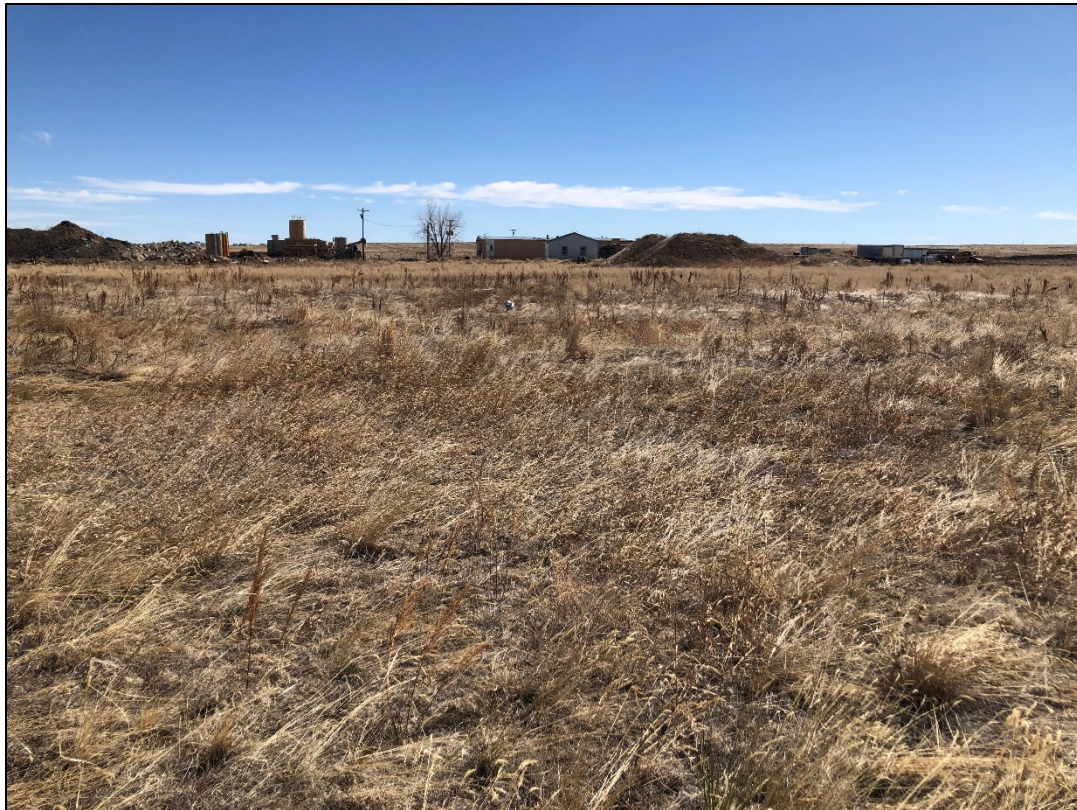
Photo 8. View looking east across backfilled north pit area.

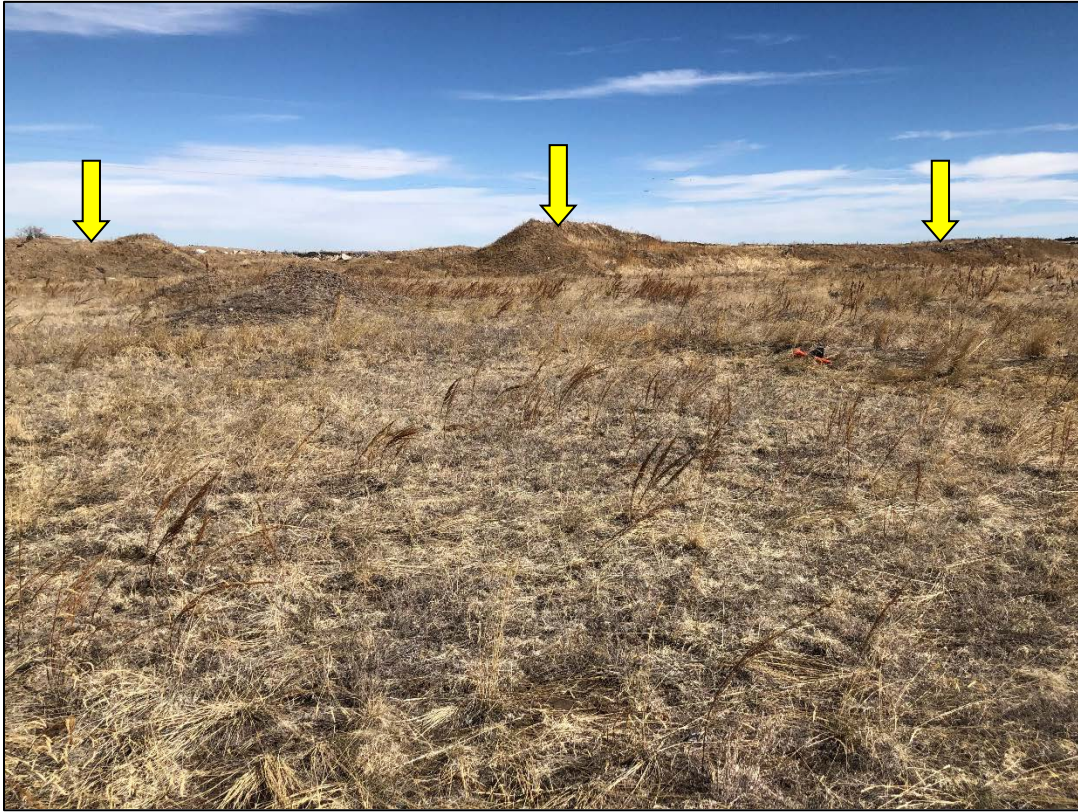
The north pit area includes a large topsoil stockpile stored along the northern permit boundary (estimated to cover 1.35 acres) and a shallow, backfilled excavation area graded nearly flat. A small material stockpile remains at the southern edge of this area (estimated to cover 0.18 acre). Additionally, a few low-lying mounds of material remain along the western edge of this area. According to the permit file, the north pit area was backfilled and graded in 2014. The Division has no evidence the north pit area was ever retopsoiled or seeded. In fact, the large topsoil stockpile left in this area indicates it was not retopsoiled. Grasses and annual weeds have volunteered across this area. No changes were observed in this area since the Division's last inspection conducted on February 3, 2021.

Photo 9. View looking north across backfilled north pit area, showing large topsoil stockpile (indicated) stored along northern permit boundary.

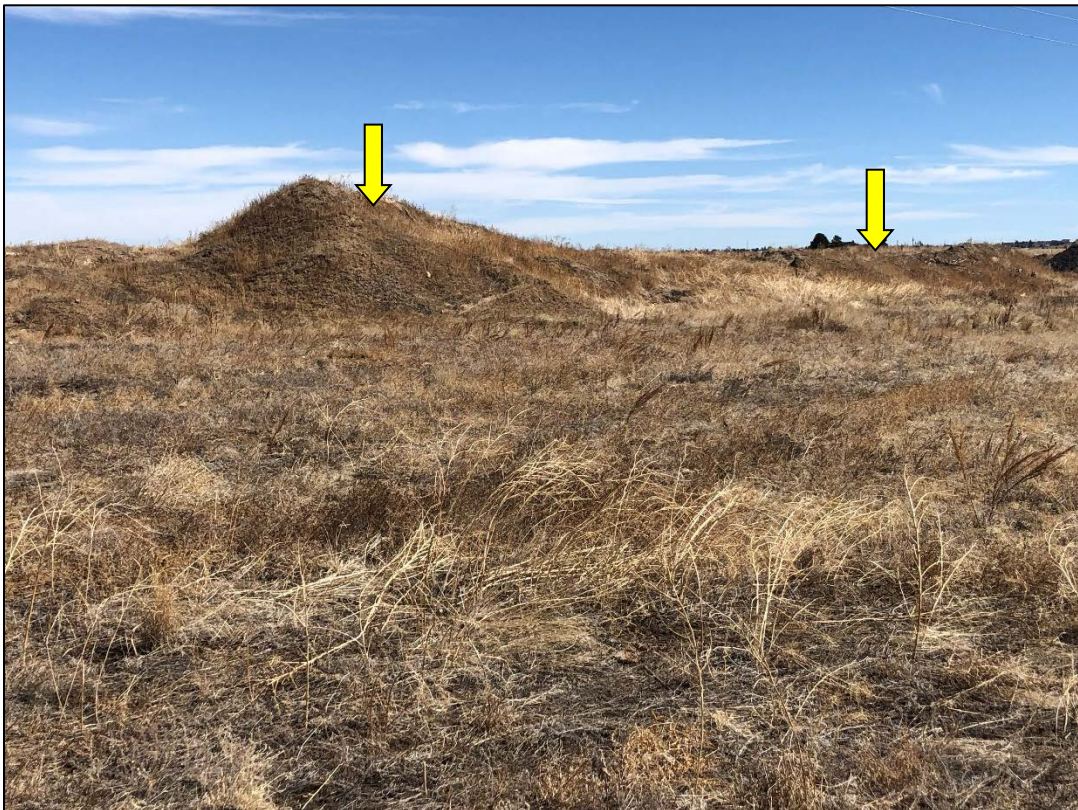
Photo 10. View looking north across backfilled north pit area, showing closer view of large topsoil stockpile (indicated) stored along northern permit boundary.

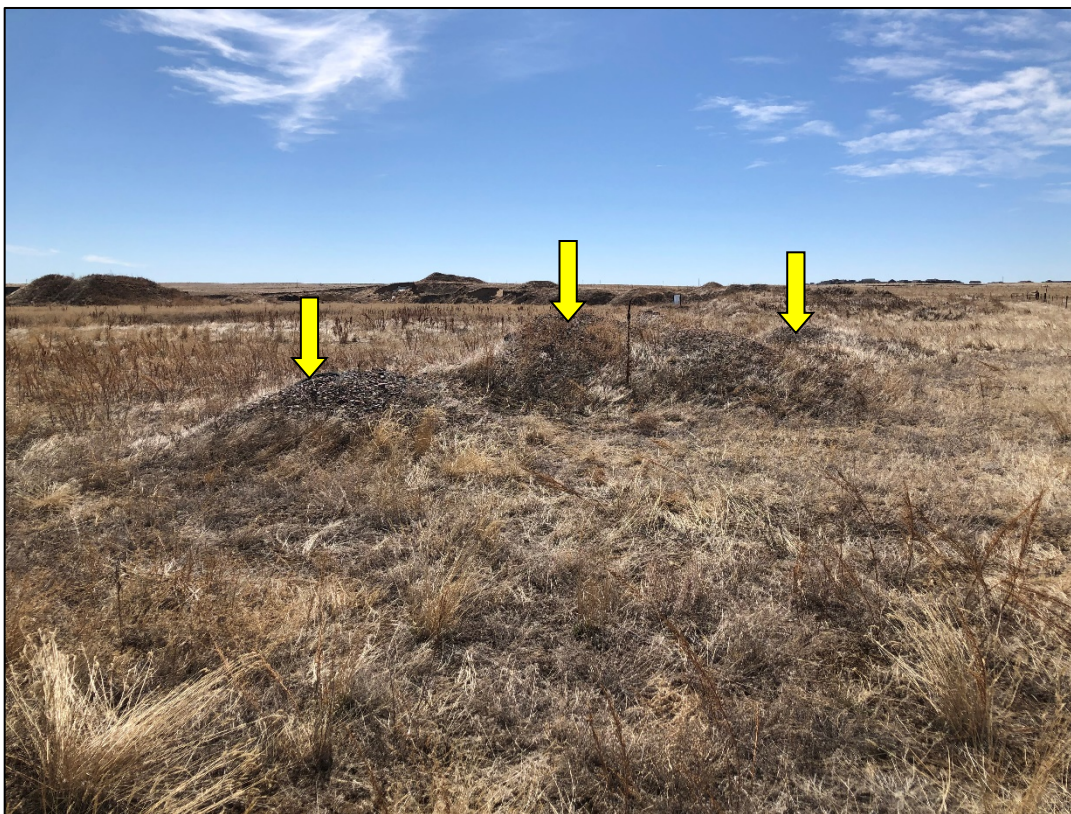
Photo 11. View looking south across western edge of backfilled north pit area, showing low-lying mounds of material (indicated) that remain in this area.

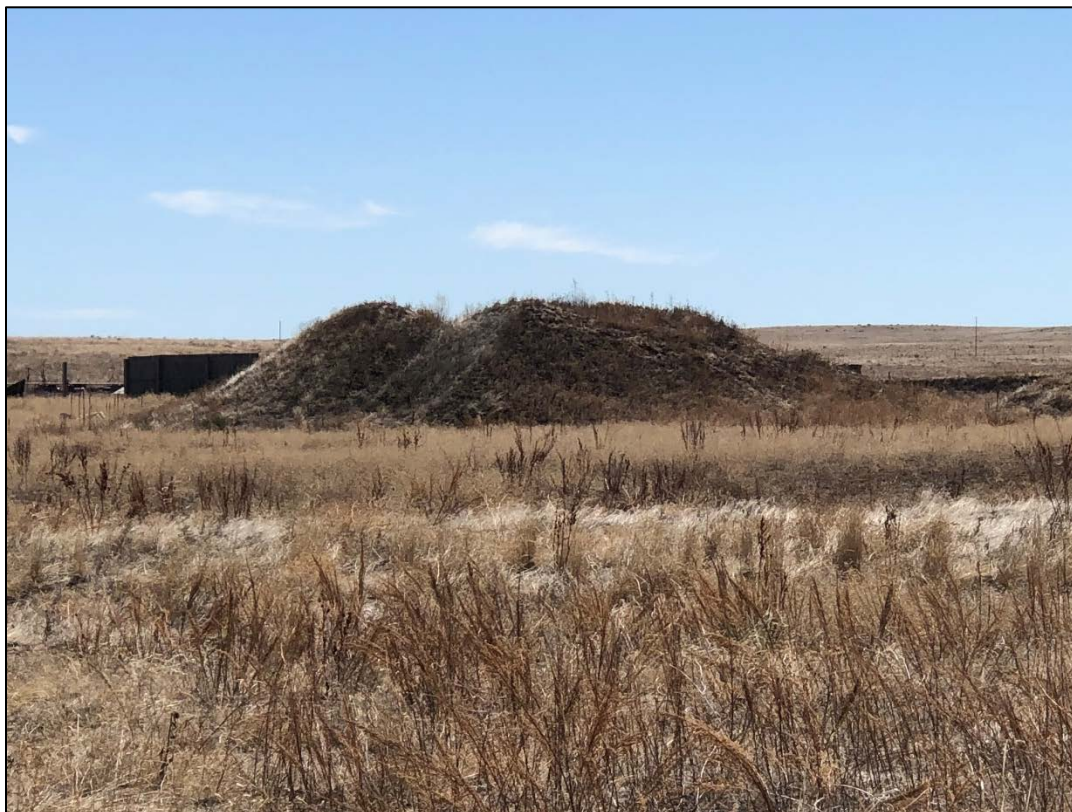
Photo 12. View looking east across backfilled north pit area, showing small material stockpile that remains at the southeastern edge of this area (adjacent to the south pit).

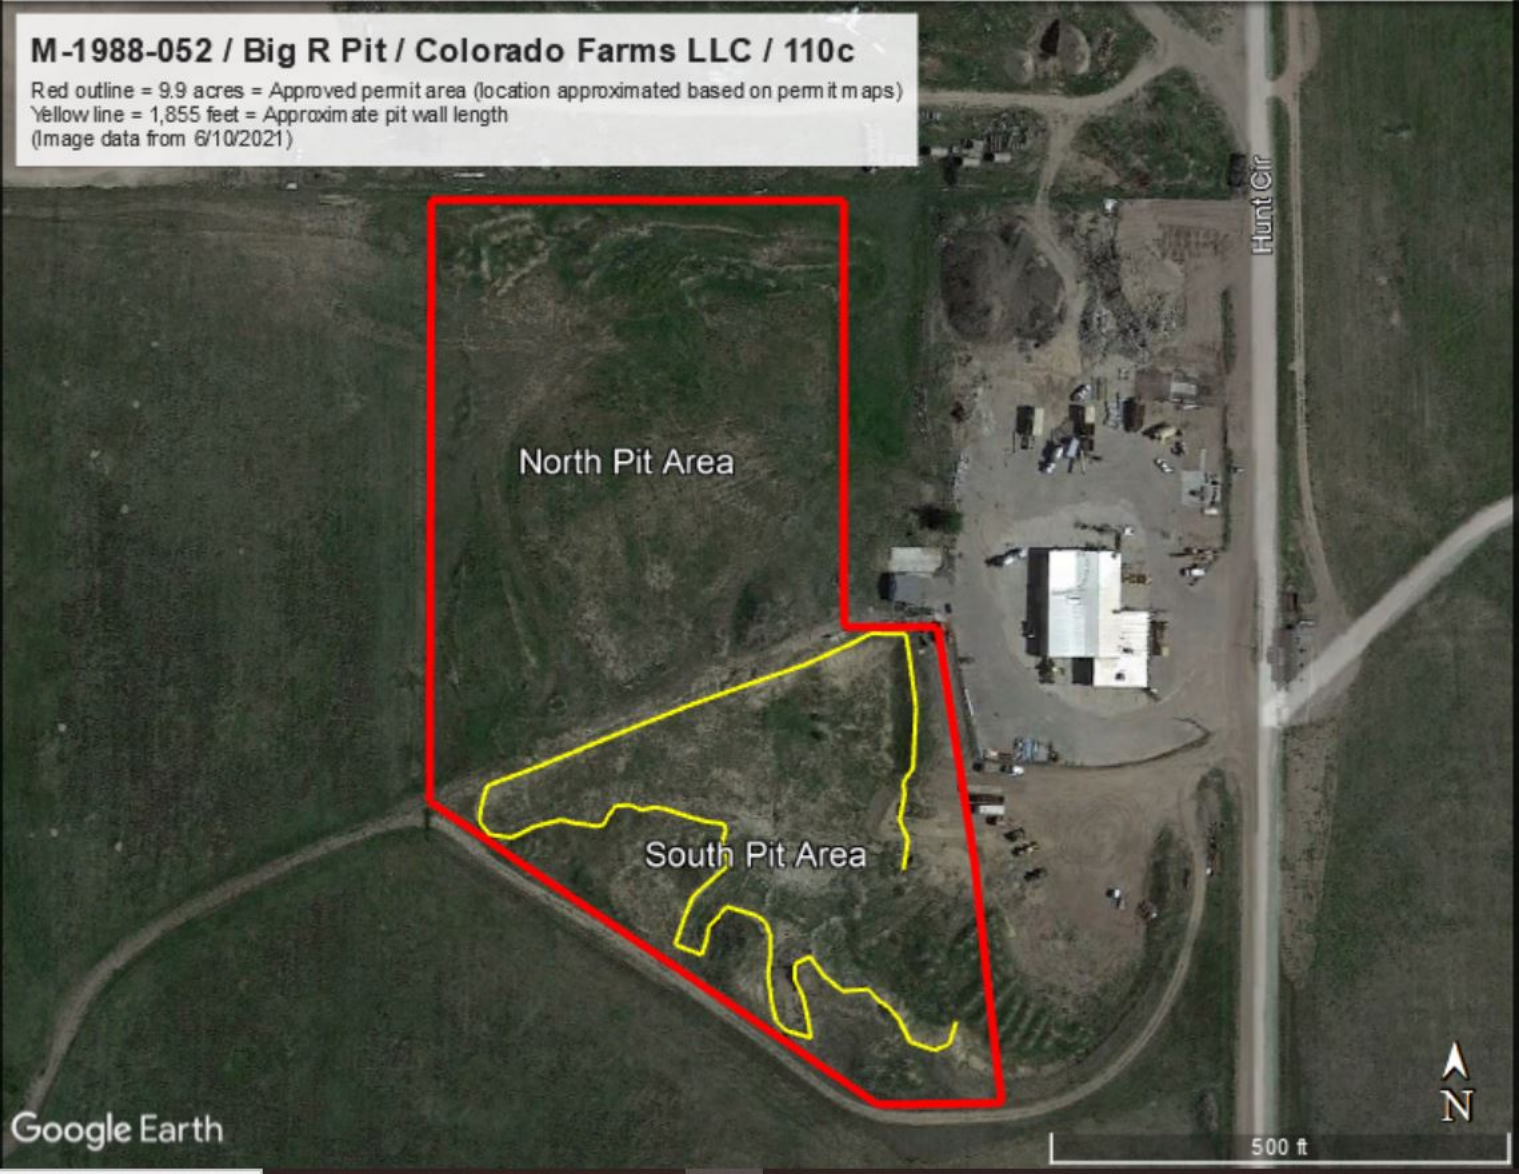
M-1988-052 / Big R Pit / Colorado Farms LLC / 110c

Red outline = 9.9 acres = Approved permit area (location approximated based on permit maps)

Yellow line = 1,855 feet = Approximate pit wall length
