MINERALS PROGRAM INSPECTION REPORT
PHONE: (303) 866-3567

MINE NAME: Kirtright Pit	MINE/PROSPECTING ID#: M-1986-123	MINERAL: Sand and gravel	COUNTY: Larimer
INSPECTION TYPE: Monitoring	INSPECTOR(S): Brock Bowles	INSP. DATE: February 15, 2022	INSP. TIME: 10:30
OPERATOR: Coulson Excavating Company, Inc.	OPERATOR REPRESENTATIVE: Ken Coulson	TYPE OF OPERATION: 112c - Construction Regular Operation	
REASON FOR INSPECTION: Normal I&E Program		BOND CALCULATION TYPE: None	
DATE OF COMPLAINT: NA		BOND AMOUNT: \$58,400.00	
POST INSP. CONTACTS: None		JOINT INSP. AGENCY: None	
WEATHER: Cloudy	INSPECTOR'S SIGNATURE:

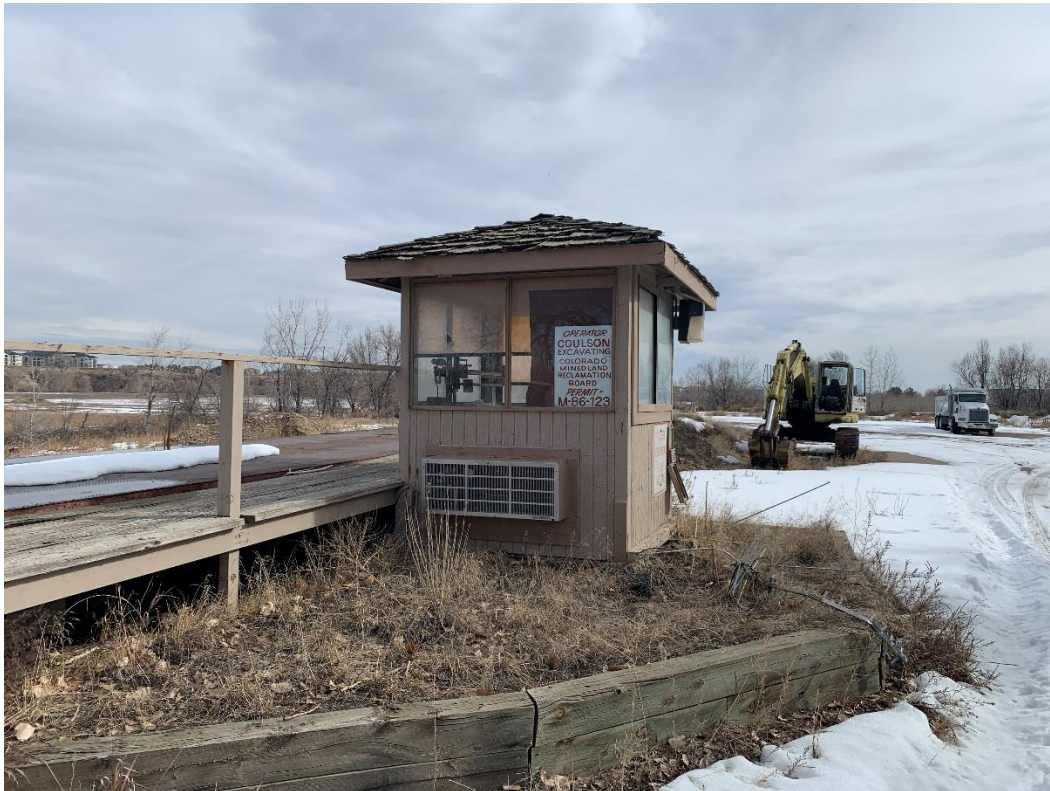
The mine entrance sign was in place on the scale house at the entrance of the mine (photo 1). The site was mostly reclaimed and vegetated with the exception of the scale house and some older equipment near the entrance (photo 1). No mining was taking place, or has taken place for a while. This is evident by the amount and condition of the vegetation on the site (photos 2 & 3). No product stockpiles were remaining.

Photo 1 – Mine entrance sign, scale house and some equipment

According to the 2021 Annual Report, no mining activity has taken place since Dec 2008. The 2010, 2014 and the 2018 inspection reports also state that mining has been completed. As per Rule 3.1.3, all reclamation shall be carried to completion within 5 years from the date the operator has ceased mining. The reclamation of the ponds need to wait until the Augmentation Plan scheduled for water court in 2024 is complete. All other reclamation items, such as removing the scale and scale house, should be completed before the court date.

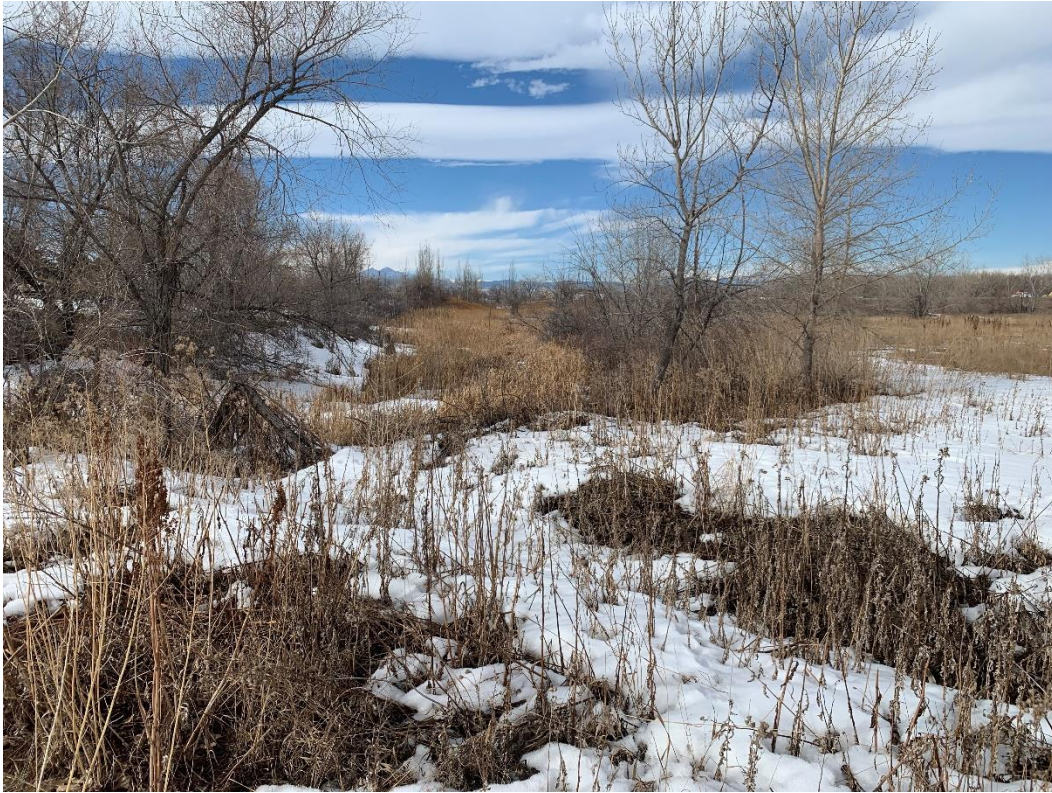
Photo 2 – From the center of the pit area, looking west towards pond 1

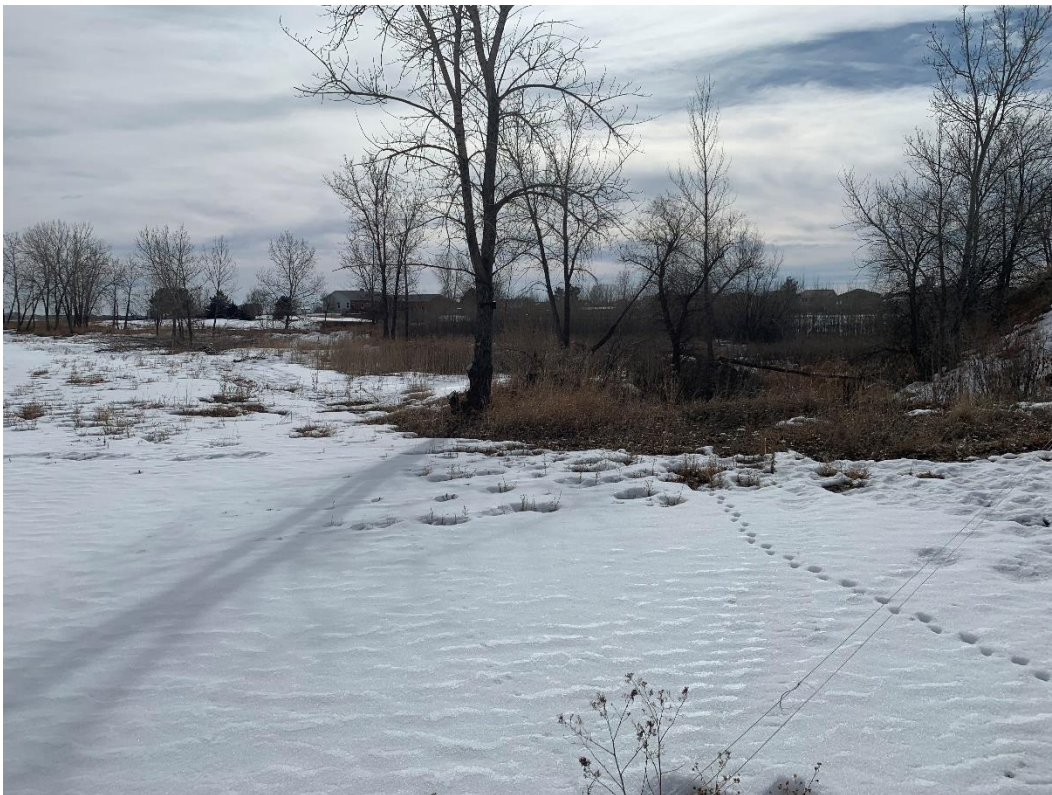
Photo 3 – From the center of the pit area, looking east towards ponds 2 and 3

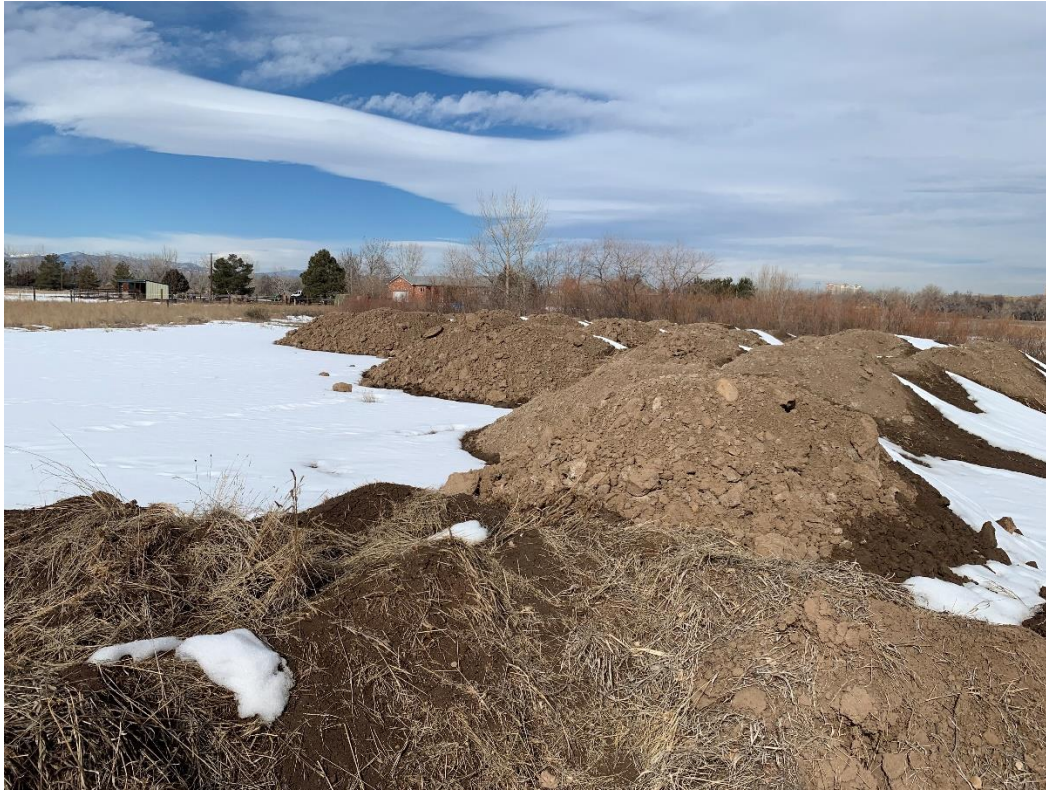
On the southwest corner of the east pond, approximately 25 dump truck loads (piles) of soil have been deposited (photo 4). The soil appears to be topsoil by the amount of grassy vegetation in the soil. The fence and fence posts along Lacy Lane were cut and were placed off to the side giving access to this part of the permit. It is not clear who placed the soil or where it came from. No other disturbances were seen on the site, but it should be noted that the ground was mostly snow covered. The topsoil piles are not consistent with the reclamation plan and need to be addressed. The operator needs to incorporate the soil into the surrounding landscape and revegetate it or remove the piles altogether.

Photo 4 – Soil piles on the southwest corner of the southeast pond
