**MINERALS PROGRAM INSPECTION REPORT**  
**PHONE: (303) 866-3567**

<b>MINE NAME:</b> Gray Pit #2	<b>MINE/PROSPECTING ID#:</b> M-2005-012	<b>MINERAL:</b> Sand and gravel	<b>COUNTY:</b> Montrose
<b>INSPECTION TYPE:</b> Monitoring	<b>INSPECTOR(S):</b> Dustin Czapla	<b>INSP. DATE:</b> April 20, 2022	<b>INSP. TIME:</b> 12:00
<b>OPERATOR:</b> Nick H. Gray	<b>OPERATOR REPRESENTATIVE:</b> Aaron Brock	<b>TYPE OF OPERATION:</b> 112c - Construction Regular Operation	
<b>REASON FOR INSPECTION:</b> Normal I&E Program	<b>BOND CALCULATION TYPE:</b> Complete Bond	<b>BOND AMOUNT:</b> \$16,500.00	
<b>DATE OF COMPLAINT:</b> NA	<b>POST INSP. CONTACTS:</b> None	<b>JOINT INSP. AGENCY:</b> None	
<b>WEATHER:</b> Clear	<b>INSPECTOR'S SIGNATURE:</b>

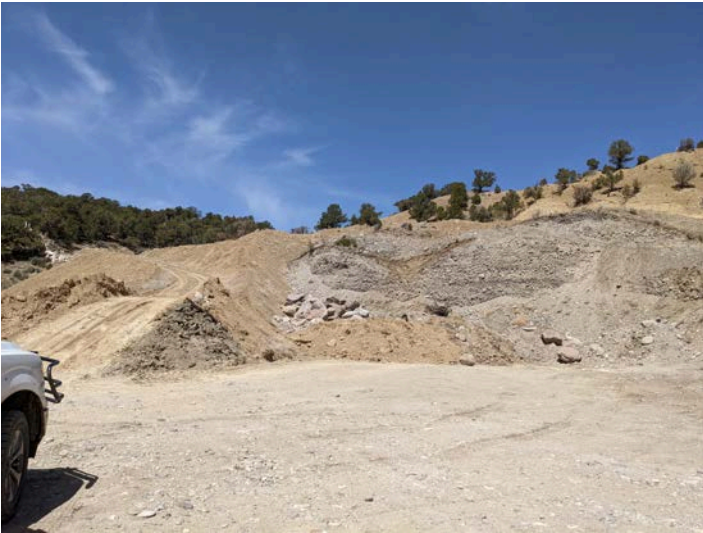
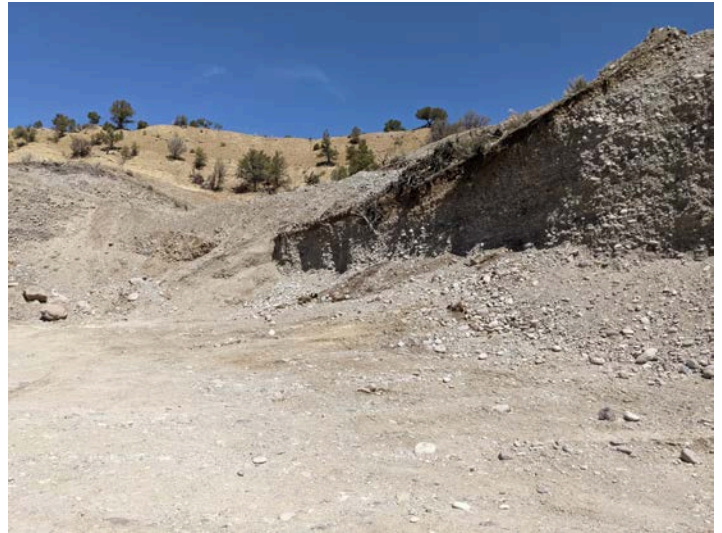
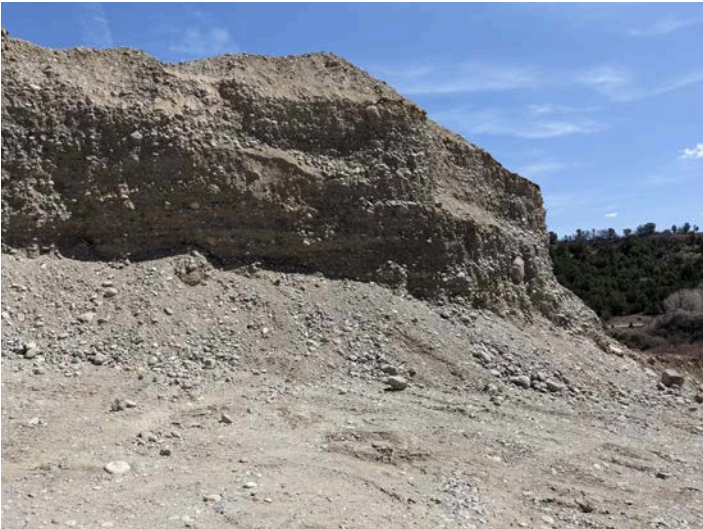
Mining has commenced at the site. Approximately two acres are currently disturbed. A near vertical highwall approximately 20 feet high and spanning approximately 200 feet has been created. Limited overburden and topsoil has been pushed to the south side above the current mining area.

A mine identification sign was not posted at the entrance to the site. Pursuant to Rule 3.1.12, a sign stating (a) the name of the Operator (Lewis Energy Lands, LLC), (b) that a reclamation permit for the operation has been issued by the Colorado Mined Land Reclamation Board, and (c) the permit # (M-2005-012) must be posted and maintained at the entrance to the site by the Successor Operator.
