MINERALS PROGRAM INSPECTION REPORT
PHONE: (303) 866-3567

MINE NAME: Wells Pit	MINE/PROSPECTING ID#: M-2006-027	MINERAL: Sand and gravel	COUNTY: Delta
INSPECTION TYPE: Monitoring	INSPECTOR(S): Robert Zuber, P.E.	INSP. DATE: April 20, 2022	INSP. TIME: 07:45
OPERATOR: Dirt Merchant, Inc.	OPERATOR REPRESENTATIVE: Troy Wells	TYPE OF OPERATION: 110c - Construction Limited Impact	
REASON FOR INSPECTION: Normal I&E Program	BOND CALCULATION TYPE: None	BOND AMOUNT: \$14,289.17	
DATE OF COMPLAINT: NA	POST INSP. CONTACTS: None	JOINT INSP. AGENCY: None	
WEATHER: Clear	INSPECTOR'S SIGNATURE:

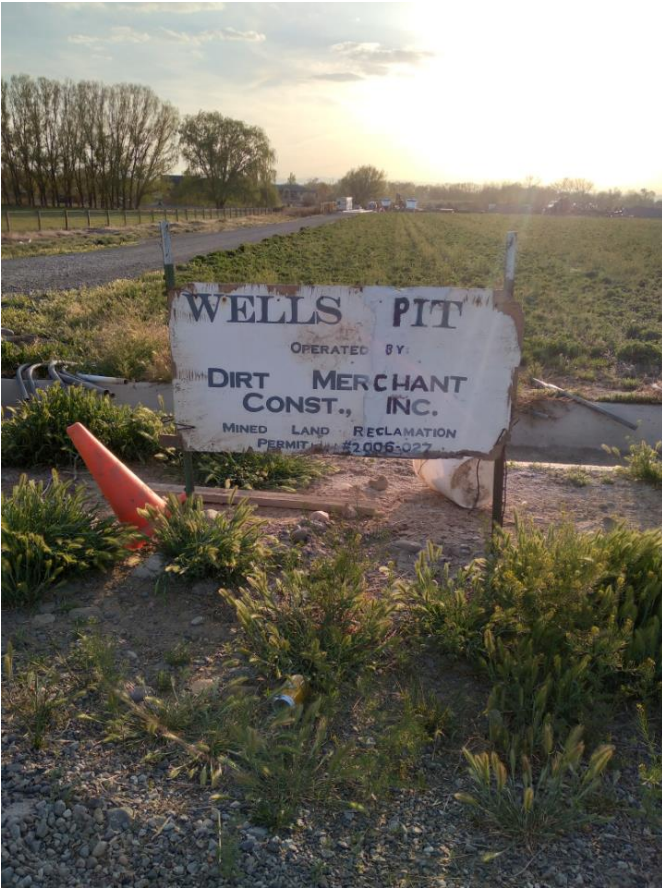
The entrance sign was not in place during the inspection. Troy Wells indicated that it had been taken down for ditch maintenance. Brian Wells (Troy's brother and official permittee) sent a photograph of the sign on April 28, 2022. The photograph shows that the sign has been re-hung at the entrance. The information on the sign meets the requirements of Rule 3.1.12.

Entrance sign

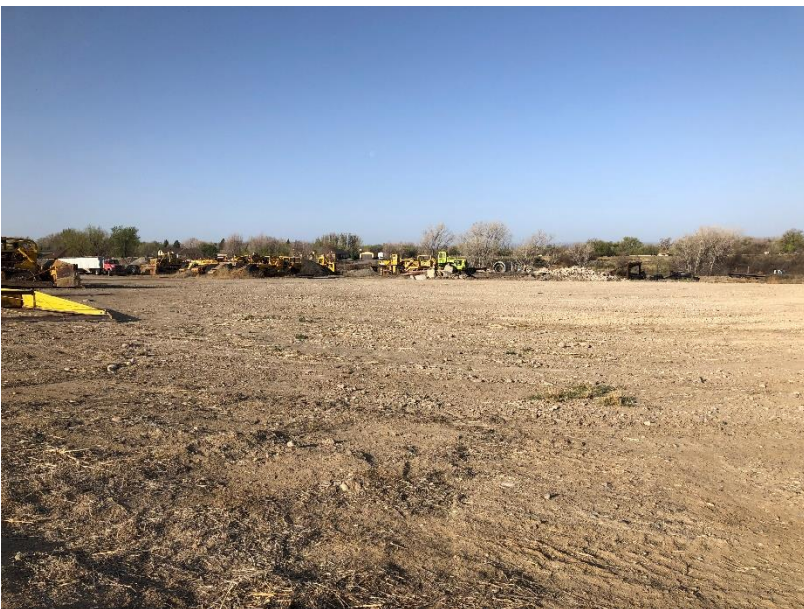
Boundary markers were not seen at some locations during the inspection, namely at the northeast corner and the northwest corner. On April 28, 2022, Brian Wells sent photographs to the Division showing that the missing markers have been placed at the site.

Center of site, looking southwest from northeast corner

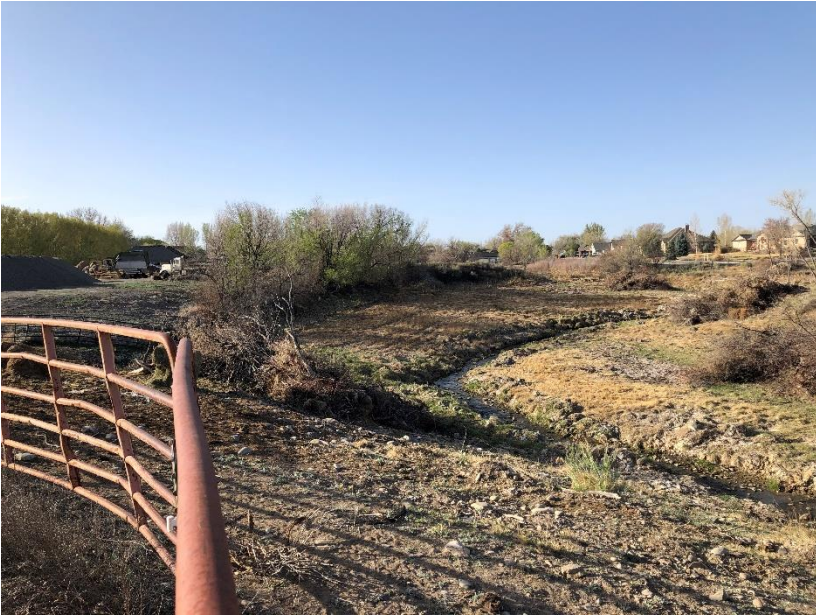
There were no signs that stormwater runoff or snowmelt runoff from the site are causing pollutant loading to the adjacent land, including the creek to the west. The Division recommends that this status be maintained by constructing a berm to prevent erosion from the low area near the west permit boundary.

West side of site and adjacent creek

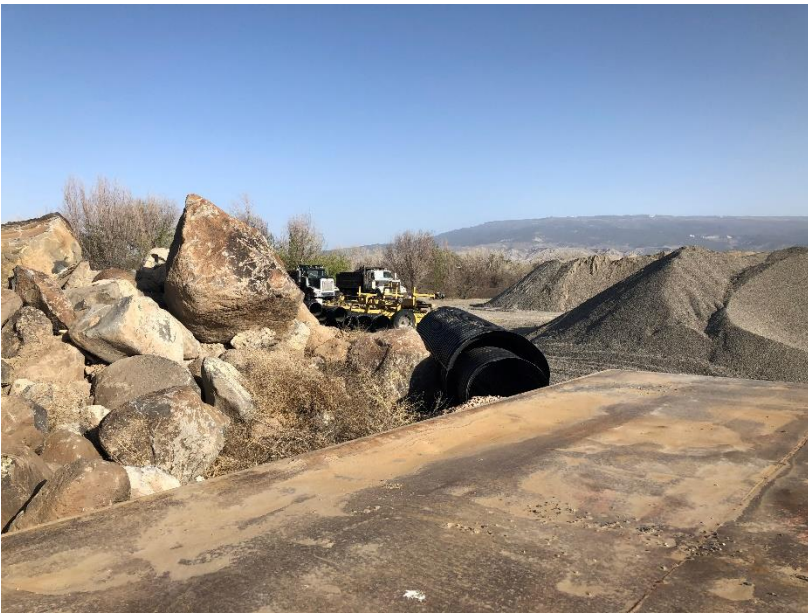
A scale is present near the entrance to the site. Heavy equipment is stored on site, but no fuel tanks were seen. Piles of large rocks and gravel were stored at the south end of the yard, and all of the material appeared to be commercially viable.

Stockpile of materials to be sold
