## M-1980-244 TR-129 Points of Compliance - Numeric Protection Levels Second Adequacy Response

**RE: Permit No. M-1980-244; Cripple Creek & Victor Gold Mining Company; Cresson Project;** Second Adequacy Review Response; Technical Revision 129 (TR-129) Proposed Numeric Protection Levels and Site Point of Compliance Well Identification, Permit No. M-1980-244

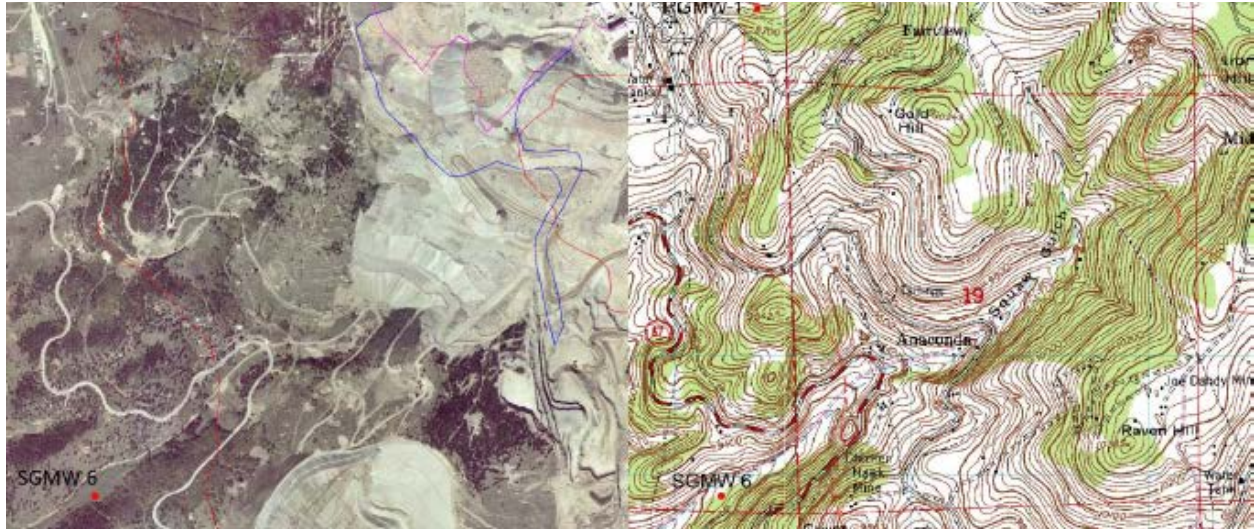
**Figure 2: 2006 aerial image (L) showing the location of Rosebud Gulch monitoring well SGMW-6; the footprint of the waste rock in 1997 is shown in blue, yellow shows the extent in 1991. Right side is the same area on the 1951 USGS 1:24000 topography. The red line in both images is the Precambrian-diatreme contact.**

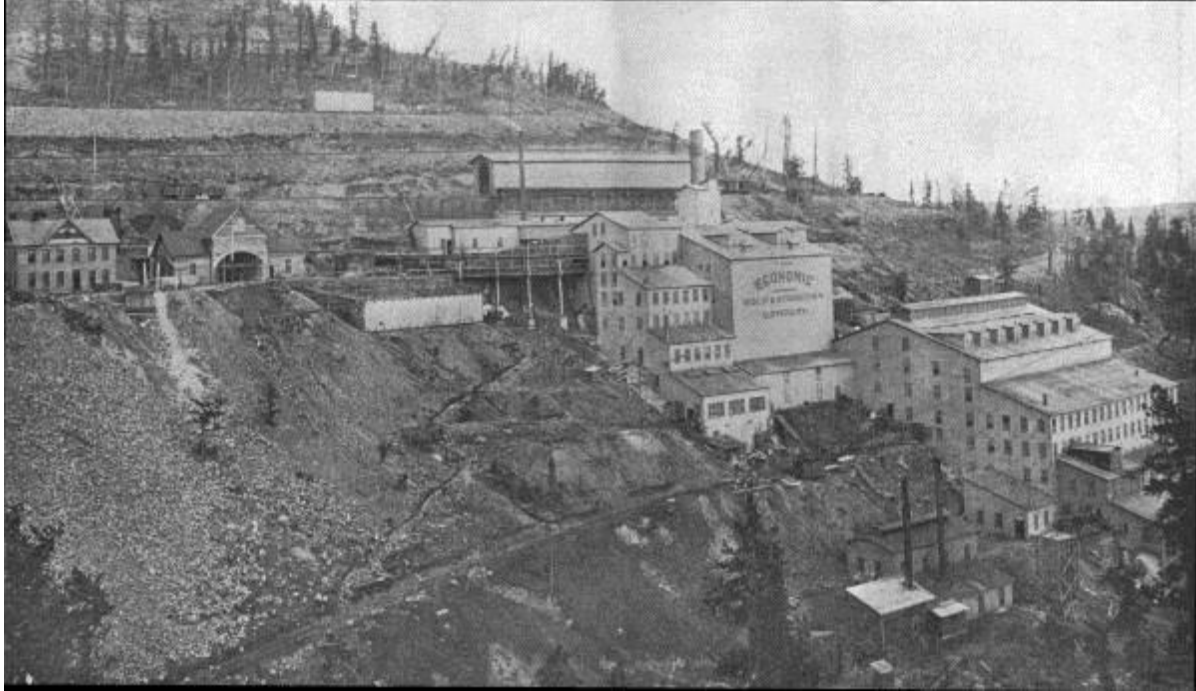
The Economic mill was built in 1899 (Levine, 1982) and utilized roasting and chlorination with hydrogen sulfide precipitation for gold recovery (Lakes, 1901). The Economic mill was a modestly-sized mill (300 tons per day), and operated until it was destroyed by fire in 1907 (Lindgren and Ransome, 1906; Henderson, 1926). Figure 6 is a photograph of the Economic Mill.

**Figure 6: Photograph of the Economic mill (Woods, 1901).**

No information regarding how these two mills disposed of tailings is available, but given the time period it is likely that the mill tailings were discharged directly to the Arequa Gulch drainage. Inefficiencies in metallurgical processing in the early 1900s would have resulted in incompletely oxidized sulfide minerals being contained within the tailings. After deposition of the tailings, the remaining sulfide minerals would gradually oxidize, resulting in soluble mineral species. These oxidation products, and soluble species that resulted from the beneficiation processes, including metal-cyanide complexes in the case of the Arequa mill tailings, could then be mobilized during precipitation events. A portion of these dissolved species would report to groundwater as a result of recharge following precipitation.

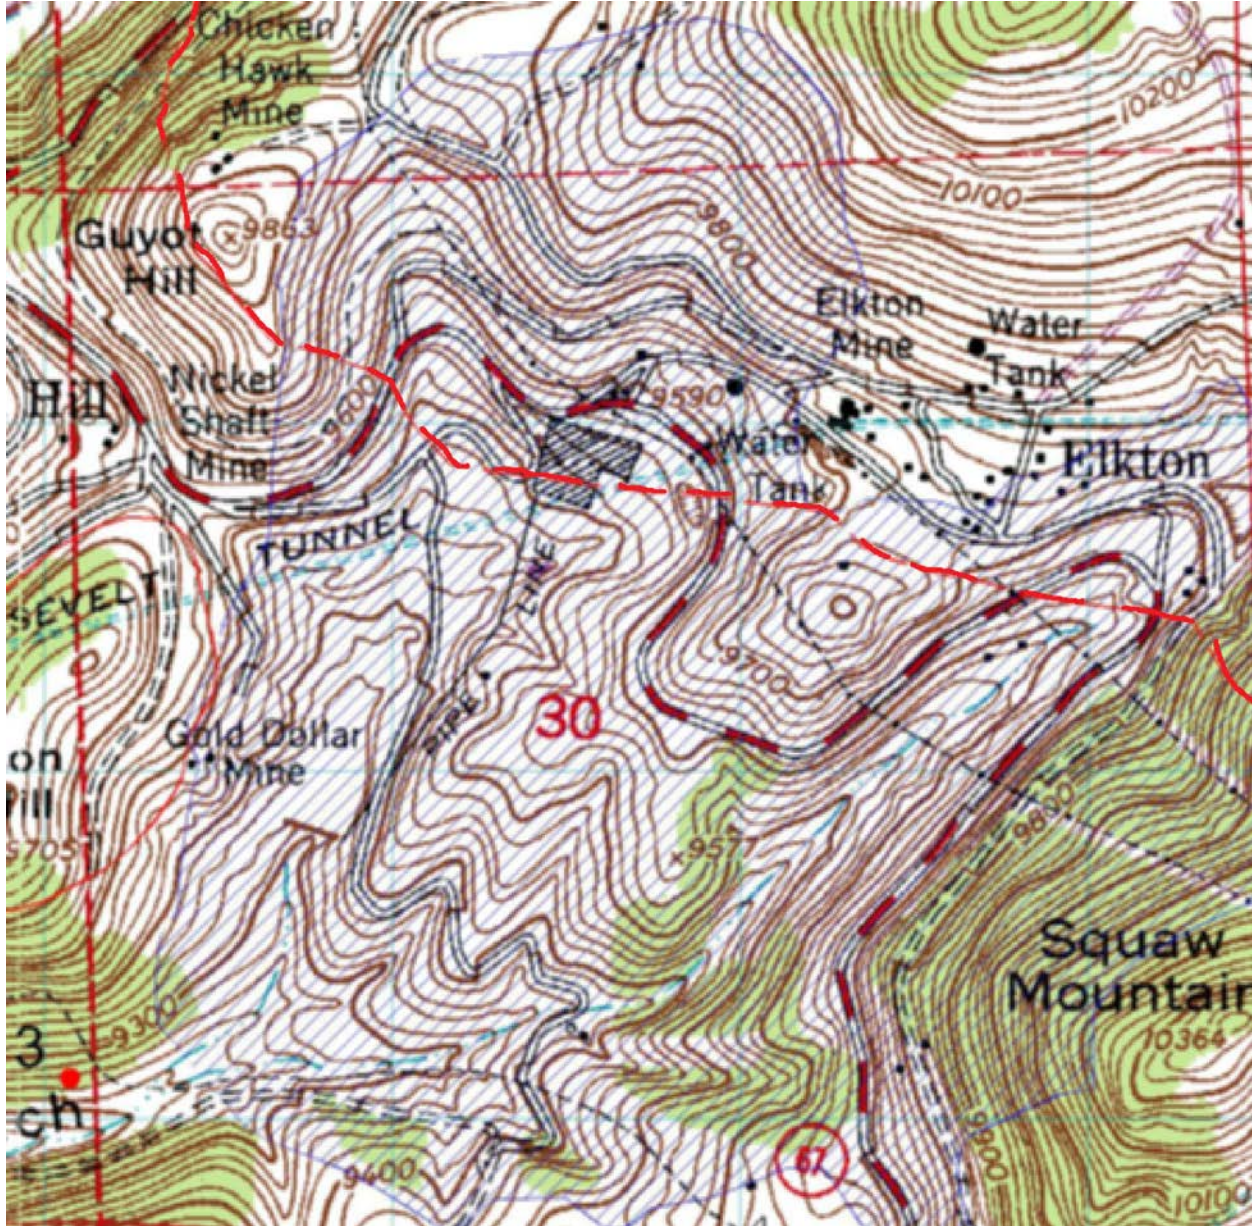
**Figure 8: Footprint of VLF1 (blue hatched area), Arequa Gulch monitoring wells (red dot, lower left), and the Precambrian-diatreme contact (red dashed line) on 1951 USGS 1:24000 topography.**

The Arequa Gulch monitoring wells are constructed in the bottom of the Arequa Gulch drainage, below the Arequa Gulch Valley Leach Facility (VLF1). Prior to construction of VLF1, tailings from the now-dismantled Carlton mill, which operated from 1951 into 1962 (Feitz, 1978) were deposited in an un-lined tailings facility which was located at the confluence of the north and east forks of Arequa Gulch, above the site of the Arequa mill (Grimstad and Drake, 1983). Figure 7 shows the Carlton mill, lower tailings facility, and two lined heap leach pads in a 1991 aerial view. The larger heap leach pad in Figure 7 was built on top of the upper Carlton Mill tailings pile (EPA, 1992). The Carlton mill tailings were relocated prior to construction of VLF1 (Henry et al., 1996). Tailings were also removed from the active stream channel of Arequa Gulch as part of VLF1 construction (Henry et al., 1996). Figure 8 shows the footprint of VLF1, the Arequa Gulch monitoring wells, and the Precambrian-diatreme contact on the 1951 USGS 1:24000 topography

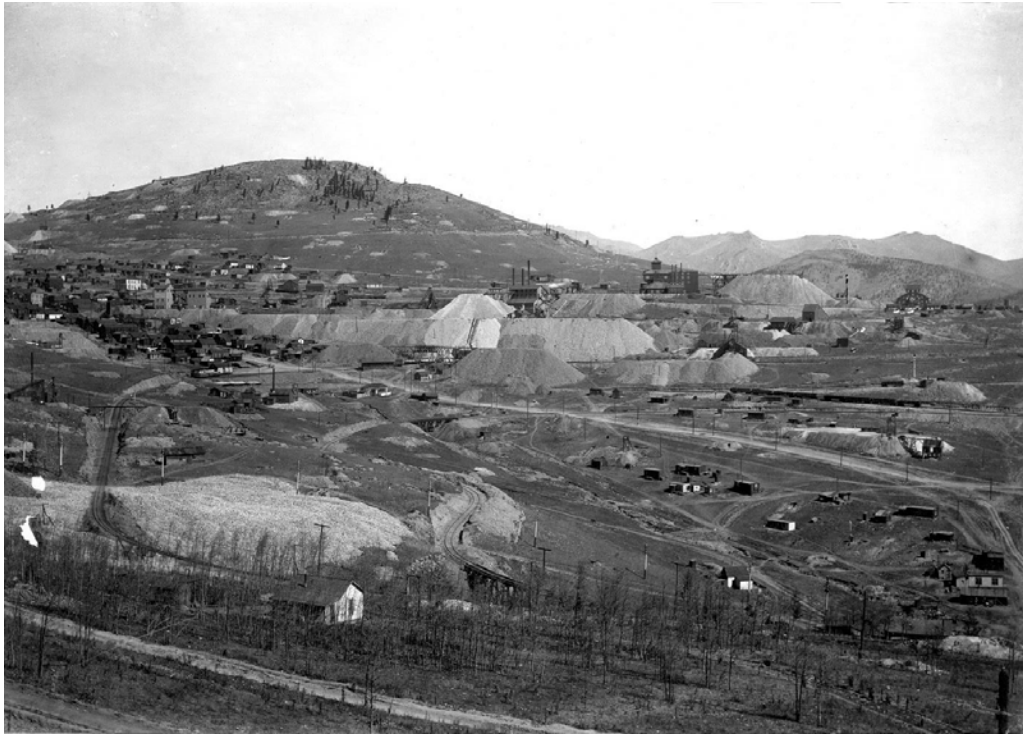
Figure 11 shows the Vindicator Valley in 1903. In 1915, a flotation mill was constructed at the Vindicator mine to process low grade material from waste dumps (Henderson, 1926). No information regarding the disposal of tailings from the Vindicator mill is available, but it is likely that they were deposited in Vindicator Valley. The mill closed 30 July 1918, and at that time there were still two million tons of low grade ore on the dumps (Henderson, 1926).

**Figure 11: Vindicator Valley in 1903, including the town of Independence and the Vindicator (upper center and upper left) and Lillie (upper right) mines (US Geological Survey public domain photograph taken by F.L. Ransome, 1903). The Golden Cycle mine and the Vindicator Valley compliance monitoring wells are just off the lower right portion of the image.**

These two monitoring wells are located within an area that contained a substantial amount of mine waste, as described in Section 2 and shown in Figures 11 and 12. At the time groundwater monitoring commenced at VIN 2A and VIN 2B in 2004, the Altman pit was nearing the end of its operational life. Backfilling of this pit with waste rock from surficial stockpiles commenced in 2007 or 2008, thus reducing the amount of waste material exposed on the ground surface in the basin. As shown by the data presented in the figures in this section, groundwater quality has been reasonably consistent over the last 18 years of monitoring.

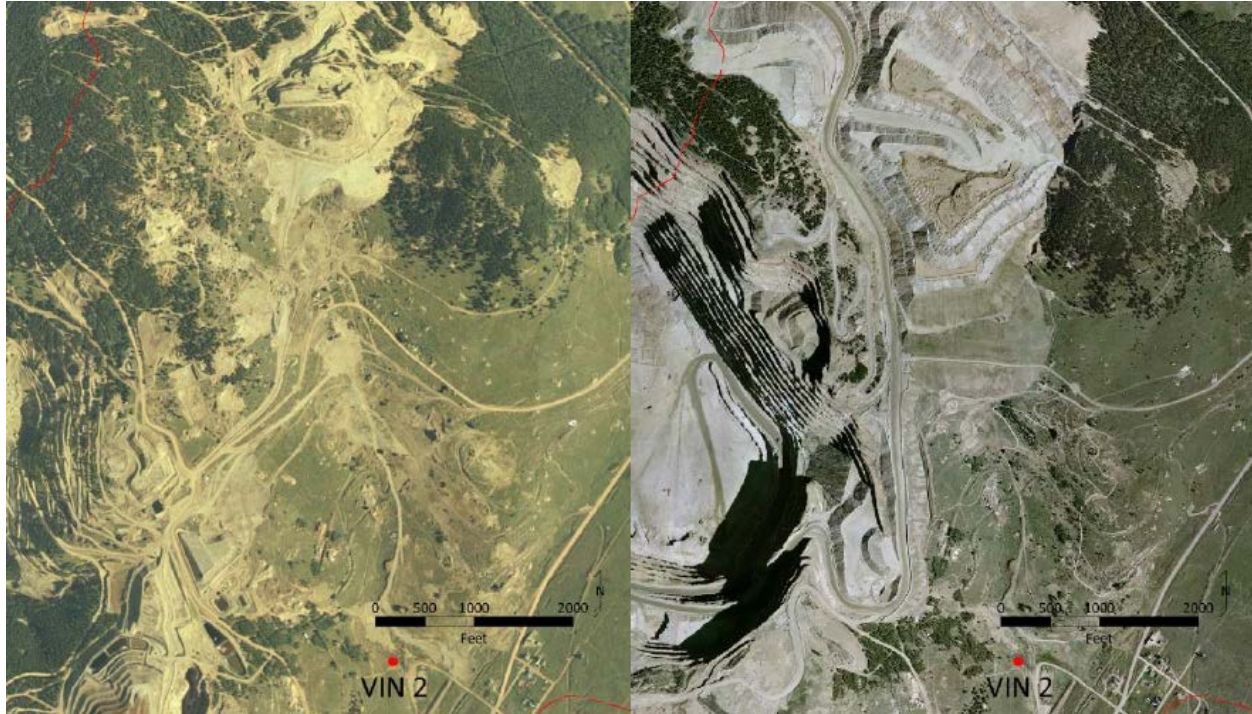
**Figure 13: Aerial images of Vindicator Valley in 1991 (left) and 2013 (right), with the compliance monitoring point shown with a red dot labeled VIN 2. The Precambrian-diatreme contact is the red dashed line in the lower right portion of both images.**

Prior to 31 January 1994, there were fairly large waste rock dumps and a relatively small open pit at the head of Vindicator Valley. In 1999 the Altman pit was mined, ultimately consuming the earlier open pit. Mining of the Altman pit concluded in 2007, and the pit was back-filled over several years starting in 2008. Figure 13 shows Vindicator Valley in 1991 and in 2013. The location of the Vindicator Valley compliance monitoring point and the Precambrian-diatreme contact are also shown.

The recharge area in Vindicator Valley is substantially reduced after mining of the two pits visible in Figure 13 (Altman is the pit that has been backfilled), because the exposed pit walls and backfill offer ready infiltration into the diatreme. Therefore, the impacted groundwater is likely to have the current concentrations of dissolved constituents for some time. While this area has a significant legacy of mining and mine waste disposal, it appears that a combination of factors, including the backfilling of waste rock

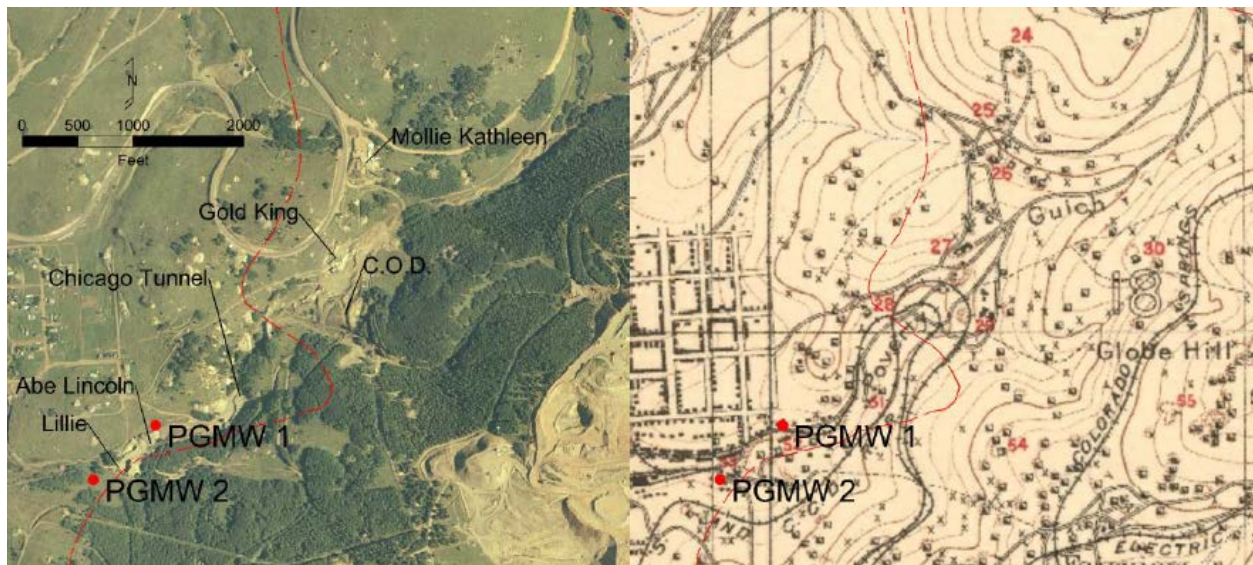
**Figure 14: Poverty Gulch in a 1991 aerial image (left) and on a portion of Plate 1 from Lindgren and Ransome (1906). The current compliance monitoring wells are shown with a red dot and the label PGMW 1. The Precambrian-diatreme contact is shown by the red dashed line.**

Figure 14 shows the location of the Poverty Gulch monitoring wells on a 1991 aerial image and on a portion of Plate 1 from Lindgren and Ransome (1906). It is evident that the monitoring wells are down-gradient and in close proximity to the historic mines. The modern open pit and heap leaching operation shown in the lower right of the aerial image began in 1978.

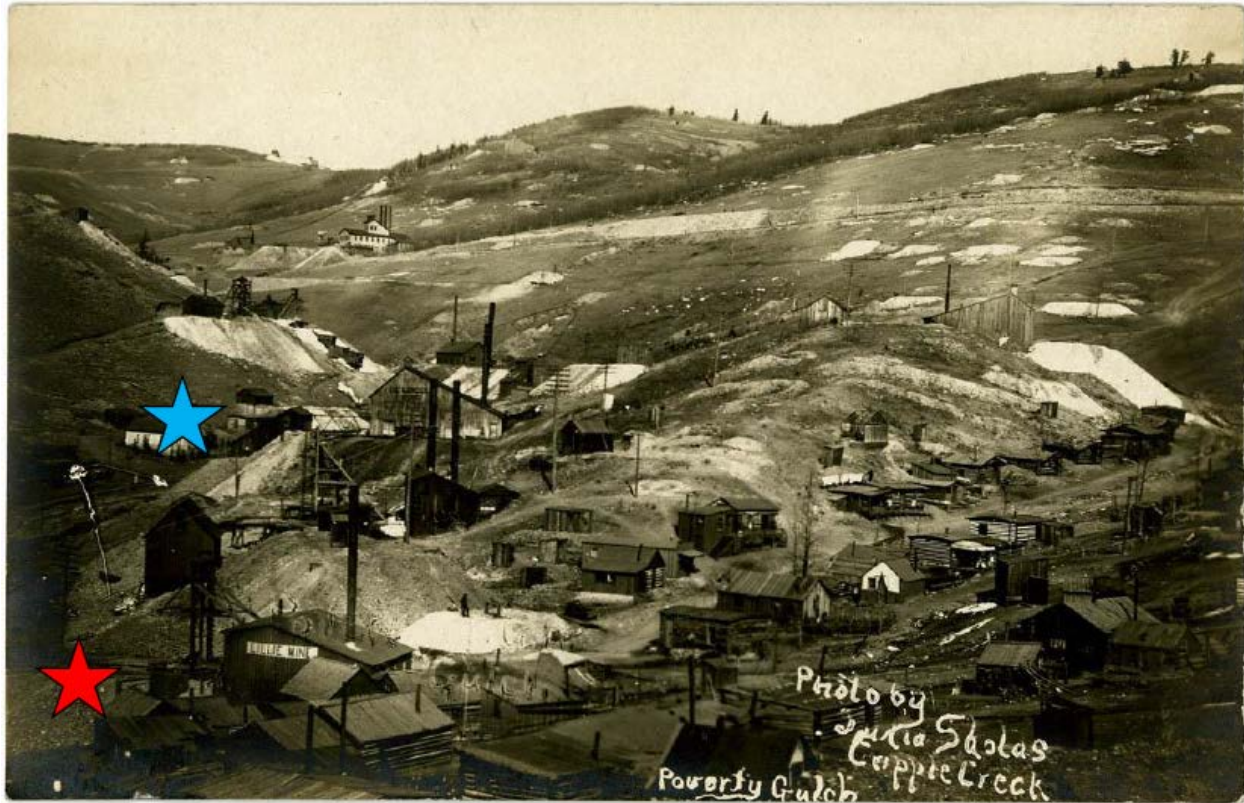
Figure 15 is a photograph looking up Poverty Gulch from a point just south of the Lillie (spelled Lily in Lindgren and Ransome, 1906) showing the mines in the period 1907-1915 (www.mtgothictimes.com). The Lillie is closest, followed by the Abe Lincoln, Chicago Tunnel, and C.O.D. The Gold King was located off the upper left of the image. Stars have been placed at the approximate locations of the current and abandoned Poverty Gulch monitoring wells, using features in the photograph as well as Plate 1 from Lindgren and Ransome (1906), 1951 USGS 1:24000 topography, and a 1991 aerial image.

**Figure 15: Photograph of Poverty Gulch from south of the Lillie mine, taken by Julia Skolas sometime between 1907 and 1915 ([www.mtgothictimes.com](http://www.mtgothictimes.com)). The Lillie mine is in the foreground, followed by the Abe Lincoln, Chicago Tunnel, and C.O.D. mines. The approximate location of the PGMW 1 monitoring wells is indicated with a blue star, and PGMW 2 with a red star.**

It is hypothesized that the elevated constituents in water sampled from the Poverty Gulch monitoring wells result from long term geochemical processes leaching of soluble species from the waste rock that was dumped in Poverty Gulch during historic mining.
