**MINERALS PROGRAM INSPECTION REPORT**  
**PHONE: (303) 866-3567**

<b>MINE NAME:</b> DeHaan Calf	<b>MINE/PROSPECTING ID#:</b> M2022-023	<b>MINERAL:</b> Topsoil	<b>COUNTY:</b> Weld
<b>INSPECTION TYPE:</b> Investigation - Unpermitted Operation	<b>INSPECTOR(S):</b> Eric Scott	<b>INSP. DATE:</b> May 3, 2022	<b>INSP. TIME:</b> 10:00
<b>OPERATOR:</b> ABCD Landco LLC	<b>OPERATOR REPRESENTATIVE:</b> David DeHaan	<b>TYPE OF OPERATION:</b> Unpermitted

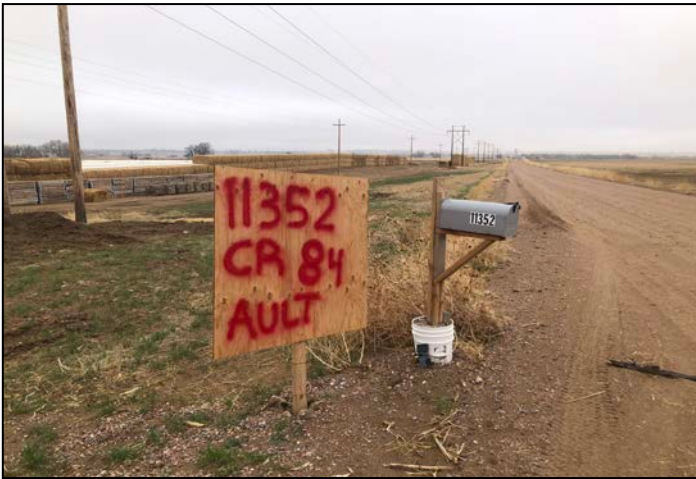
**Photo 1 – looking west along WCR 84 at entrance to DeHaan Calf site.**

This was an inspection of an unpermitted site located at the southeast corner of the intersection of Weld County Roads 84 and 23. This inspection was conducted by Eric Scott of DRMS, who met with site landowner representative David DeHaan, and project engineer Travis Hertnecky, at a building located near the site entrance at approximately 10:00. The site entrance is located on the south side of WCR 84 approximately midway between WCR 23 and WCR 25, and the address is 11352 WCR 84 (Photo 1).

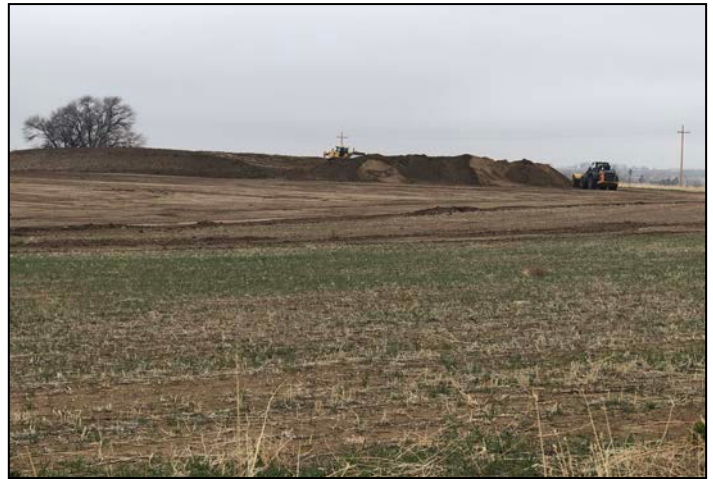
**Photo 2 – looking southwest at excess topsoil stockpile located at SE corner of WRC 23 and WCR 84.**

On April 25, DRMS received notice from Weld County that they had received complaints of excessive dust related to truck traffic hauling topsoil from the intersection of WCR 23 and 84. Weld County had observed the activity and confirmed that topsoil sales were taking place at that location from a large stockpile of material located at the SE corner of WCR 23 and 84 (Photo 2). Weld County inquired if DRMS had issued a mining permit for that location. DRMS has not issued a permit for this location, however, dust and traffic issues are not within DRMS permitting jurisdiction.

During the initial phone conversation with DRMS, Mr. Hertnecky stated that the topsoil being sold was excess material generated from the surface stripping/grading of a composting area, which was part of the construction of a 320 acre calf operation that was currently under development, and that a grading permit had been obtained from Weld County for the work associated with this development. He also stated that the excess topsoil material had been sold from the site for approximately the last 1.5 months.

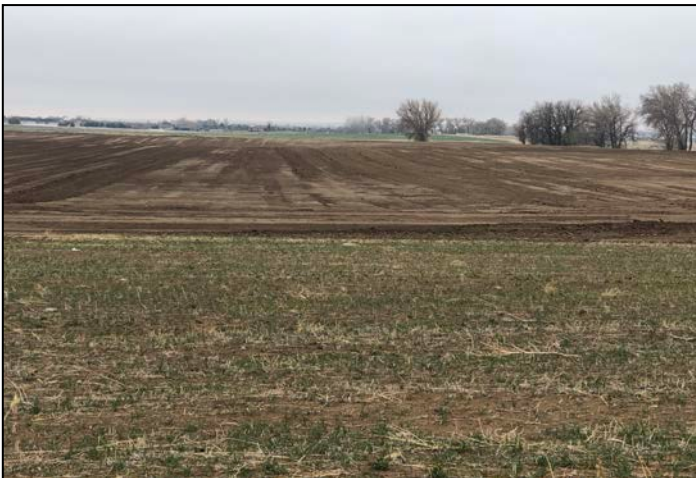
**Photo 3 – looking south across the graded composting area located at the SE corner of WRC 23 and WCR 84.**

During the inspection, Mr. Hertnecky and Mr. DeHaan, a managing partner of ABCD LandCo, stated that they were not aware that a reclamation permit was required from DRMS prior to selling the excess topsoil material generated by their development for use off-site. They stated that the composting area was approximately 20 acres in size, and that approximately 0.8 feet of topsoil had been removed from that area and stockpiled for sale off-site (Photos 3-4). They estimated that the total volume of topsoil removed and stockpiled was approximately 26k cubic yards and that approximately 13k cubic yards had been sold to-date, with approximately 13k cubic yards remaining to be removed. Loading and trucking of the material was underway during the DRMS inspection (Photo 2) as was documented by Weld County. They also stated that the lot grading/stripping activity was completed and that no additional excess material would be generated during this phase of the site development beyond what was currently stockpiled. They also informed DRMS that they had directed that the trucks removing the material from the site modify their haul route to avoid passing any residences in order to minimize any dust issues.

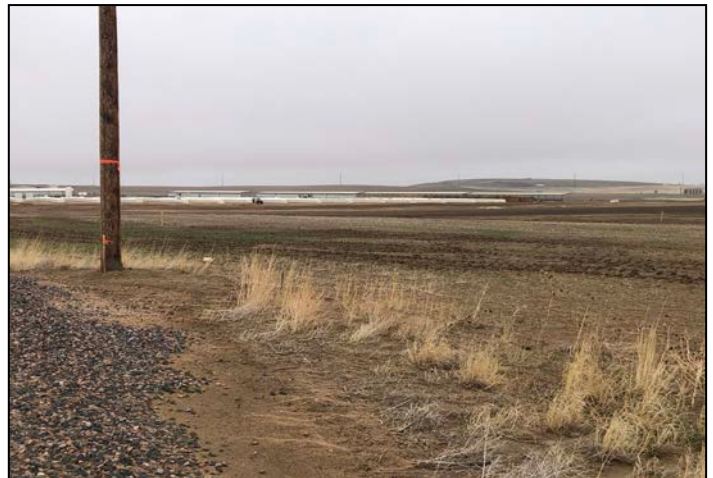
**Photo 4 – looking southeast from the SE corner of WRC 23 and WCR 84 across the graded composting area and toward the DeHaan Calf site.**
