MINERALS PROGRAM INSPECTION REPORT
PHONE: (303) 866-3567

MINE NAME: Henderson Mine	MINE/PROSPECTING ID#: M-1977-342	MINERAL: Molybdenum	COUNTY: Clear Creek, Grand
INSPECTION TYPE: Monitoring	INSPECTOR(S): Peter Hays	INSP. DATE: March 31, 2022	INSP. TIME: 10:00
OPERATOR: Climax Molybdenum Company	OPERATOR REPRESENTATIVE: Geoff Niggeler	TYPE OF OPERATION: 112d-3 - Designated Mining Operation	
REASON FOR INSPECTION: Normal I&E Program	BOND CALCULATION TYPE: None	BOND AMOUNT: \$135,204,778.00	
DATE OF COMPLAINT: NA	POST INSP. CONTACTS: None	JOINT INSP. AGENCY: None	
WEATHER: Clear	INSPECTOR'S SIGNATURE:

Designated Chemical Storage:

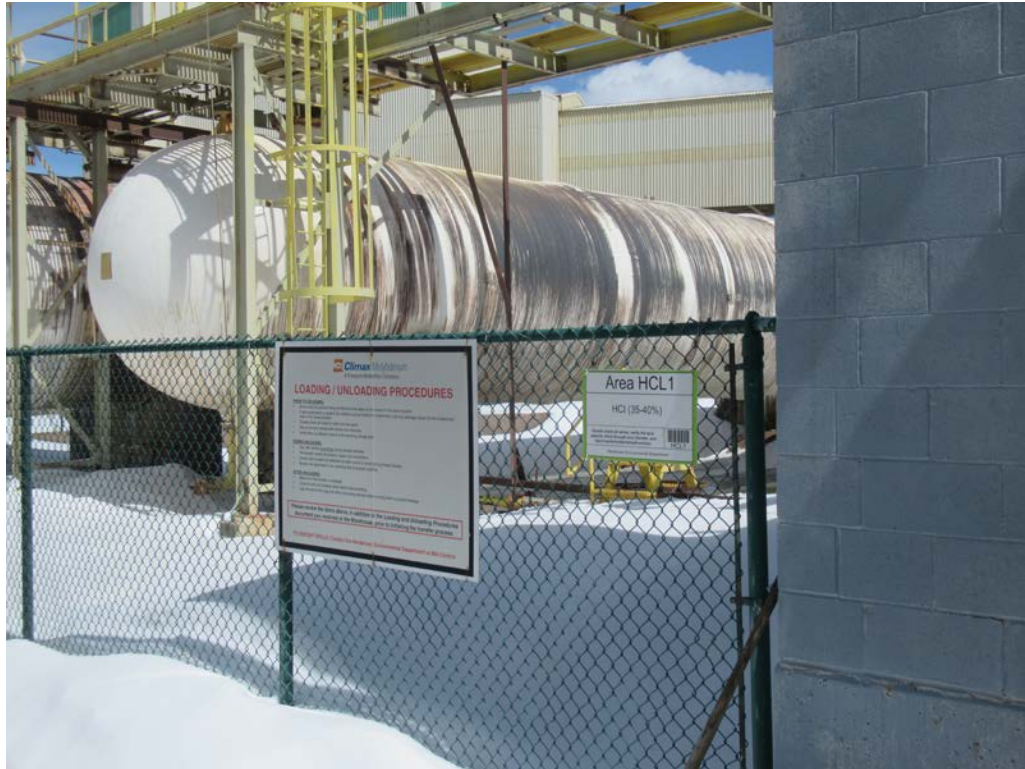
- The Hydrochloric Acid Storage tank sign does not include the capacity of the tank(s). The capacity of the tank(s) on the sign is not a requirement of the EPP, however all other observed tank signs indicate the capacity. The Operator stated they would investigate the issue.

Hydrochloric Acid Storage Tank (1 of 2) and Sign
