**MINERALS PROGRAM INSPECTION REPORT**  
**PHONE: (303) 866-3567**

| <b>MINE NAME:</b><br>North Delta Pit | <b>MINE/PROSPECTING ID#:</b><br>M-1979-002 | <b>MINERAL:</b><br>Sand and gravel | <b>COUNTY:</b><br>Delta |

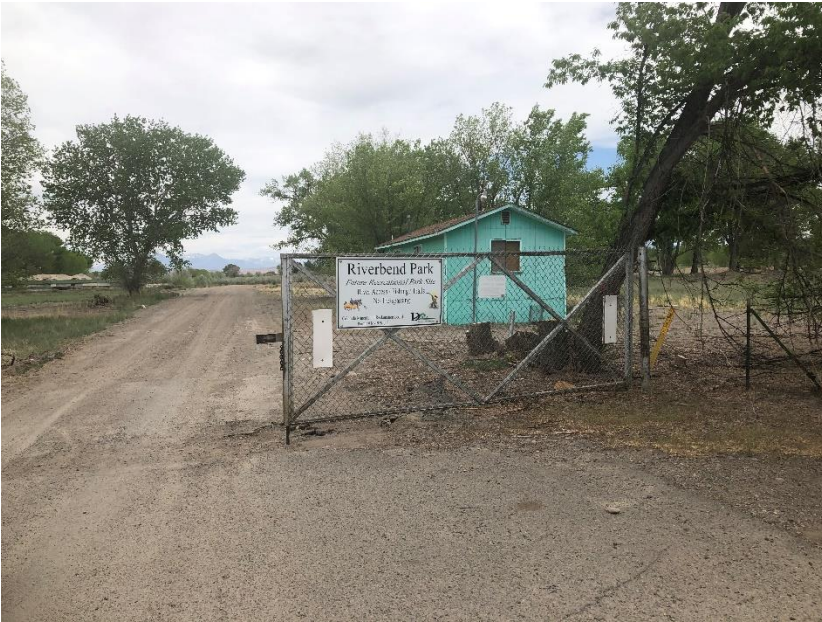
The entrance sign was in place during the inspection, and it contained the necessary information.

A scale house is present near the entrance to the site, as are large beams from a bridge. No heavy equipment or fuel tanks were seen on site. Piles of soil were stored north of the pond. This material originated off site, and Mr. Barnard indicated that much of this material will likely be used at other sites.

Entrance gate with sign and scale house

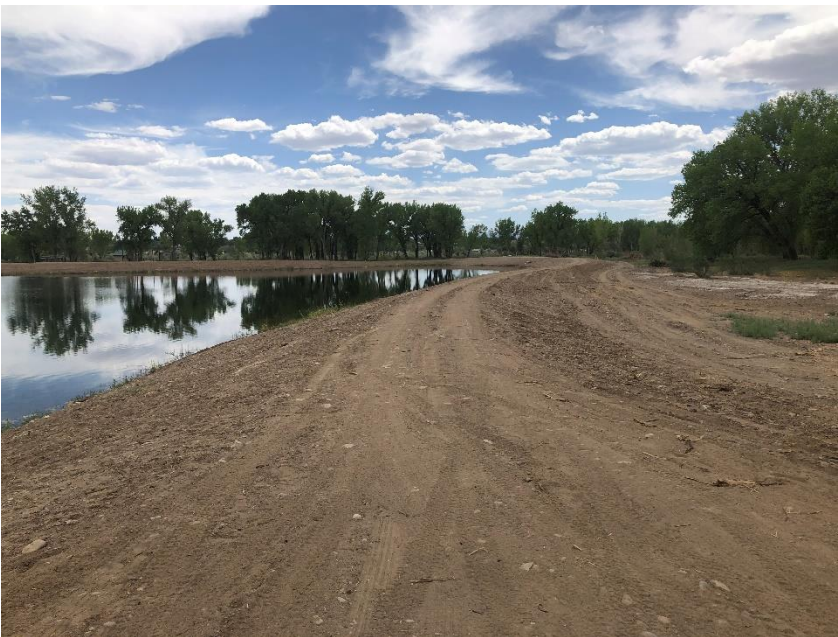
The pond onsite covers approximately 13 acres. The slopes all around the pond have been recently graded well and are flatter than 3H:1V.

West side of pond

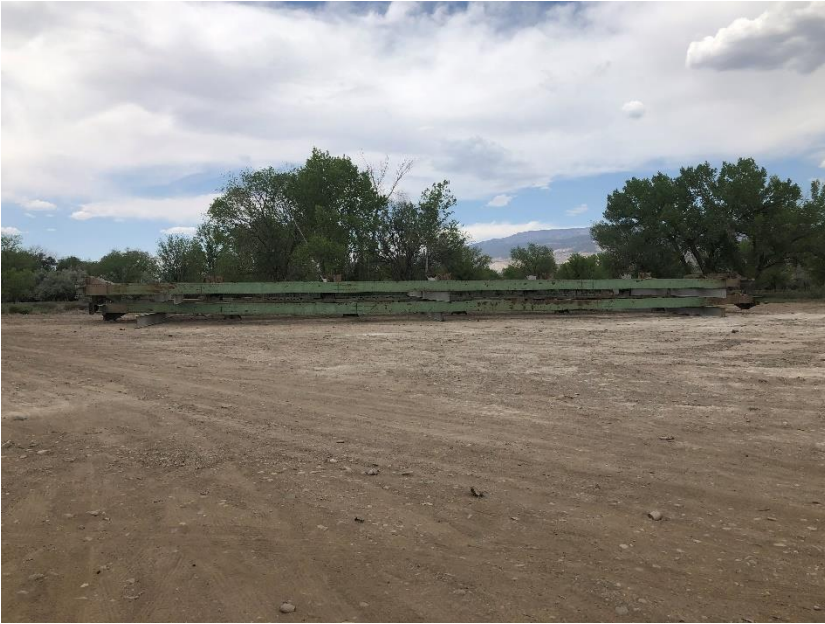
**Beams stored on site**

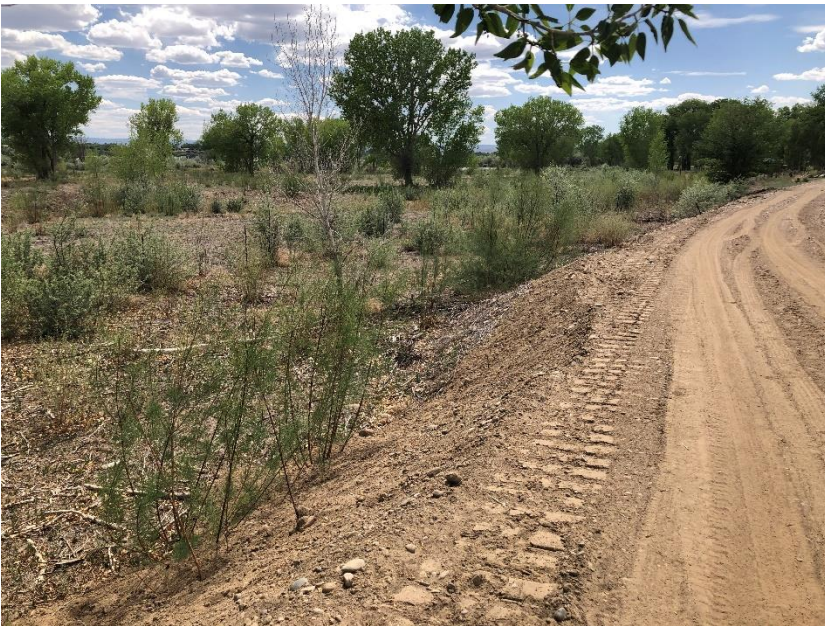
**PROBLEM/POSSIBLE VIOLATION:** Problem: Russian olive trees are present within or have volunteered into the permit area and are becoming established. Also, tamarisk, knapweed, and white top were found at locations around the site. This is a problem for failure to employ weed control methods for a state listed noxious weed species within the permitted area, and to reduce the spread of weeds to nearby areas as required by Section 3.1.10 (6) of the rule.

Many weeds were seen around the site. These include knapweed and white top, but the biggest problem is the trees. Russian olive and tamarisk were seen in many locations, and many of the Russian olive trees are very large.

**Tamarisk near southeast corner of pond**

**CORRECTIVE ACTIONS:** The operator shall implement the existing weed control plan.
