**PERMIT INFORMATION**

<b>Permit Number:</b> C-1981-028 <b>Mine Name:</b> Keenesburg Strip Mine <b>Operator:</b> Coors Energy Company <b>Operator Address:</b> Mr. Ben Moline PO Box 4030 Golden, CO 80402	<b>County:</b> Weld <b>Operation Type:</b> Surface <b>Permit Status:</b> Permanent Cessation <b>Ownership:</b> Private
	<b>Operator Representative Present:</b>  None
<b>Operator Representative Signature: (Field Issuance Only)</b>

**INSPECTION INFORMATION**

<b>Inspection Start Date:</b> May 27, 2022 <b>Inspection Start Time:</b> 09:00 <b>Inspection End Date:</b> May 27, 2022 <b>Inspection End Time:</b> 09:45		<b>Inspection Type:</b> Coal Partial Inspection <b>Inspection Reason:</b> Normal I&E Program <b>Weather:</b> Clear	
<b>Joint Inspection Agency:</b>  None		<b>Joint Inspection Contacts:</b>	
<b>Post Inspection Agency:</b>  None		<b>Post Inspection Contacts:</b>	
<b>Inspector(s):</b>  Robert Zuber, P.E.	<b>Inspector's Signature:</b>

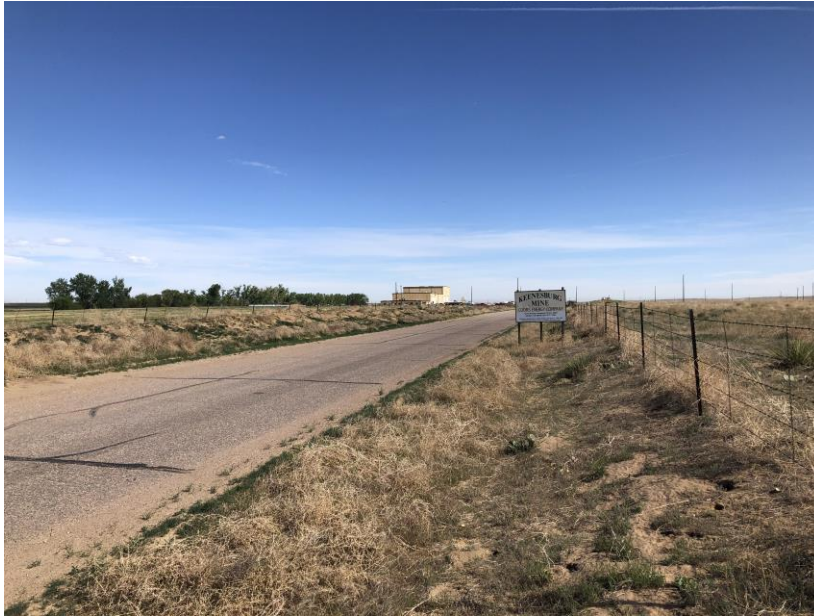
The entrance sign was in place and contained all necessary information.

**Entrance sign**

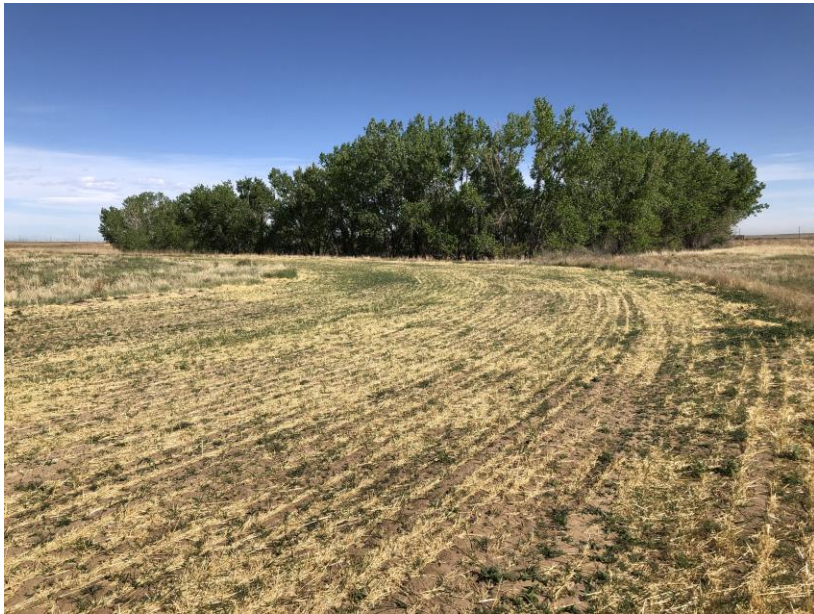
Green grass was seen emerging at several recently reclaimed locations, including (but not limited to) the reclaimed road near Sediment Pond 2. Area 25 has good vegetation cover and appears to be recovering well after mowing for cheat grass in 2021.

**Reclaimed road by Sediment Pond 2**

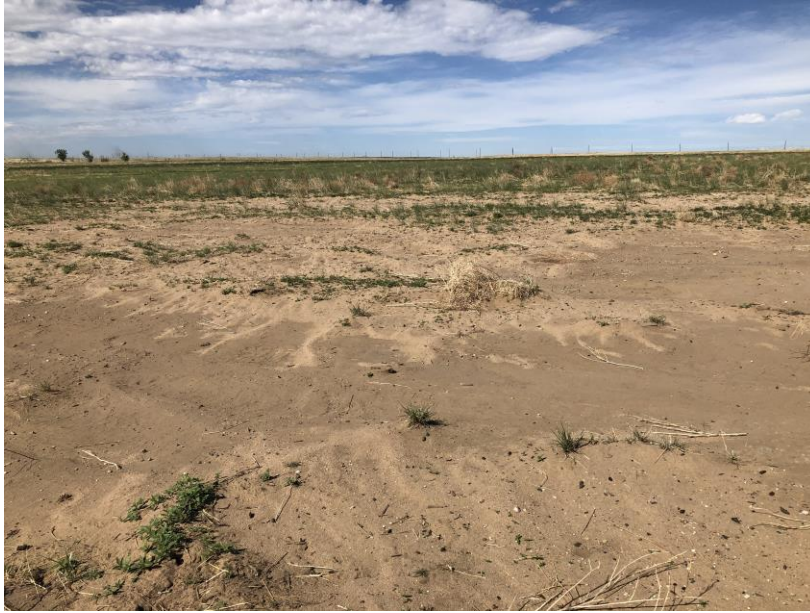
No erosion problems were seen onsite. The inspected areas include Areas 25, 34, 36 (reclaimed Long Term Spoil Area), 37 and 38 (reclaimed topsand storage areas), 42, and 43 (roads). A significant bare area was seen in the eastern portion of the Long Term Spoil Area; this area may need re-seeding in the future.

**Bare area in reclaimed Long Term Spoil Area**

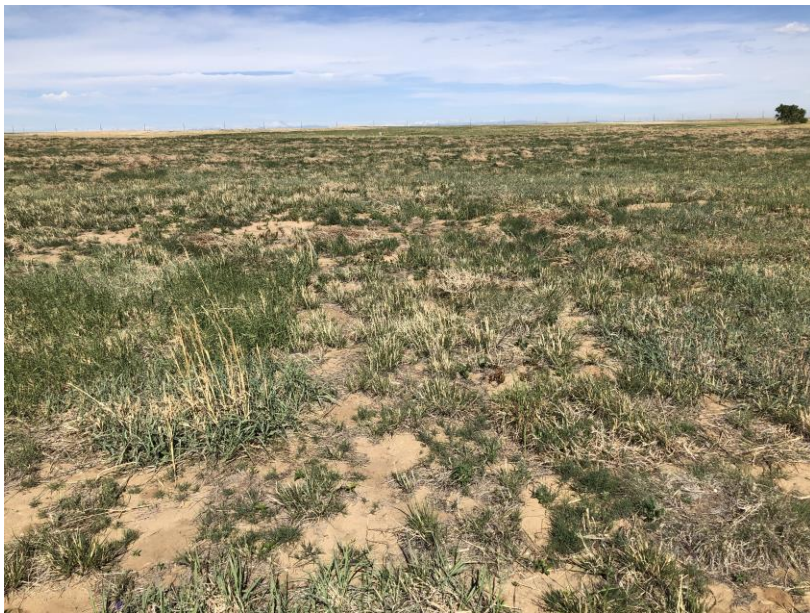
**Center of Area 25**
