**PERMIT INFORMATION**

<b>Permit Number:</b> C-1981-037 <b>Mine Name:</b> GEC Strip Mine <b>Operator:</b> GEC Minerals, Inc. <b>Operator Address:</b> Dr W Corley 2605 Constellation Drive Colorado Springs, CO 80906	<b>County:</b> Freemont <b>Operation Type:</b> Surface <b>Permit Status:</b> Revoked <b>Ownership:</b> Private
	<b>Operator Representative Present:</b>  N/A
<b>Operator Representative Signature:</b> (Field Issuance Only)

<b>Inspection Start Date:</b> June 15, 2022 <b>Inspection Start Time:</b> 08:00 <b>Inspection End Date:</b> June 15, 2022 <b>Inspection End Time:</b> 08:10		<b>Inspection Type:</b> Coal Complete Inspection <b>Inspection Reason:</b> Normal I&E Program <b>Weather:</b> Clear	
<b>Joint Inspection Agency:</b>  None		<b>Joint Inspection Contacts:</b>  None	
<b>Post Inspection Agency:</b>  None		<b>Post Inspection Contacts:</b>  None	
<b>Inspector(s):</b>  Zach Trujillo	<b>Inspector's Signature:</b>

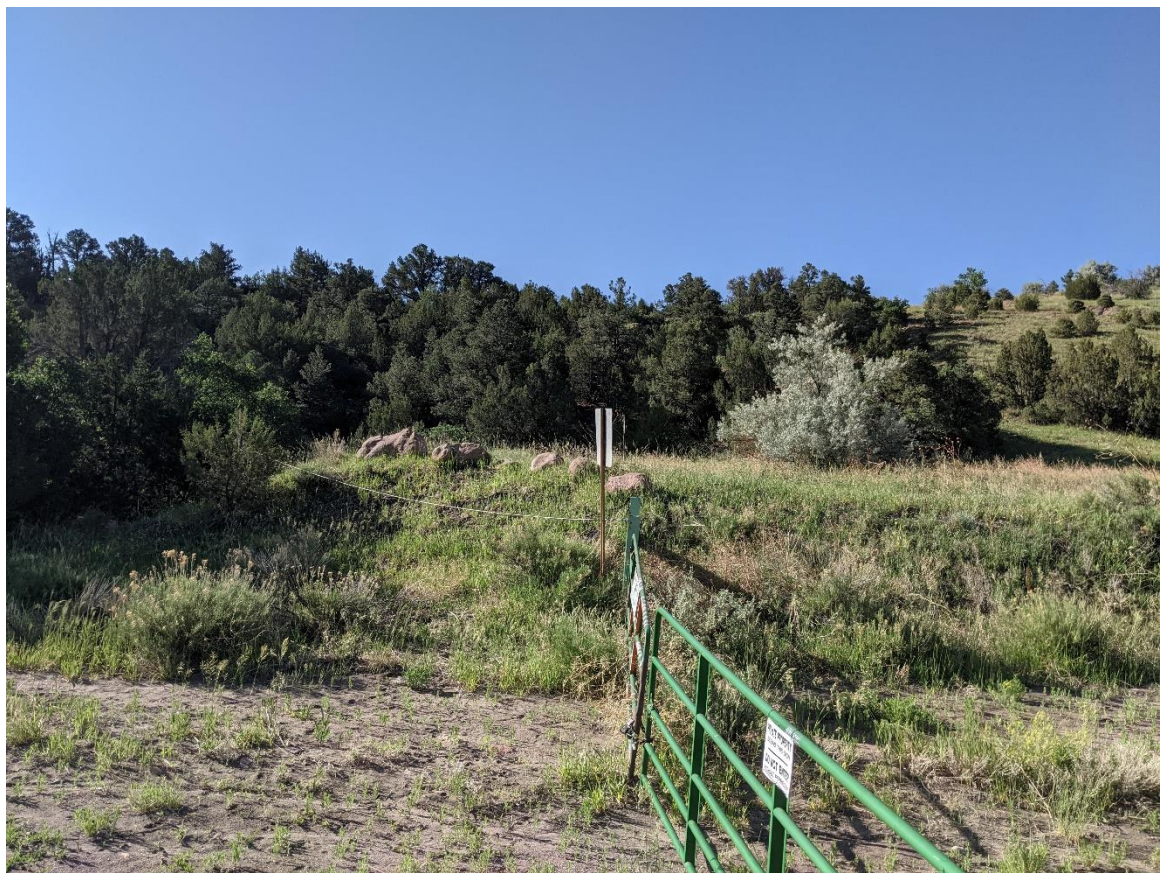
Pond A.

The inspection for the GEC Mine was done at the locked gate along the county road to the site. A portion of Chen's Hill was visible from this location. From the gate along the county road, the northern face of Chen's Hill can be observed. The slope shows established vegetative growth with mature shrubs. Erosional features can be partially seen along the slope and has been documented in previous inspections. Pond A was also inspected from the county road. While the interior of the pond was not visible, it has been previously reported as filled with sediment. The embankment is well vegetated and stable.
