MINERALS PROGRAM INSPECTION REPORT

MINE NAME: 2006/07 Geo-Hydro Drill & Core Prgm-Public-PRL's	MINE/PROSPECTING ID#: P-2006-037	MINERAL: Oil shale	COUNTY: Rio Blanco
INSPECTION TYPE: Monitoring	INSPECTOR(S): Amy Yeldell	INSP. DATE: May 31, 2022	INSP. TIME: 09:00
OPERATOR: Shell Frontier Oil & Gas Inc.	OPERATOR REPRESENTATIVE: Samantha Baker	TYPE OF OPERATION: MP - Mineral Prospecting	
REASON FOR INSPECTION: High Priority	BOND CALCULATION TYPE: None	BOND AMOUNT: \$168,818.66	
DATE OF COMPLAINT: NA	POST INSP. CONTACTS: None	JOINT INSP. AGENCY: U.S.BLM	
WEATHER: Clear	INSPECTOR'S SIGNATURE:

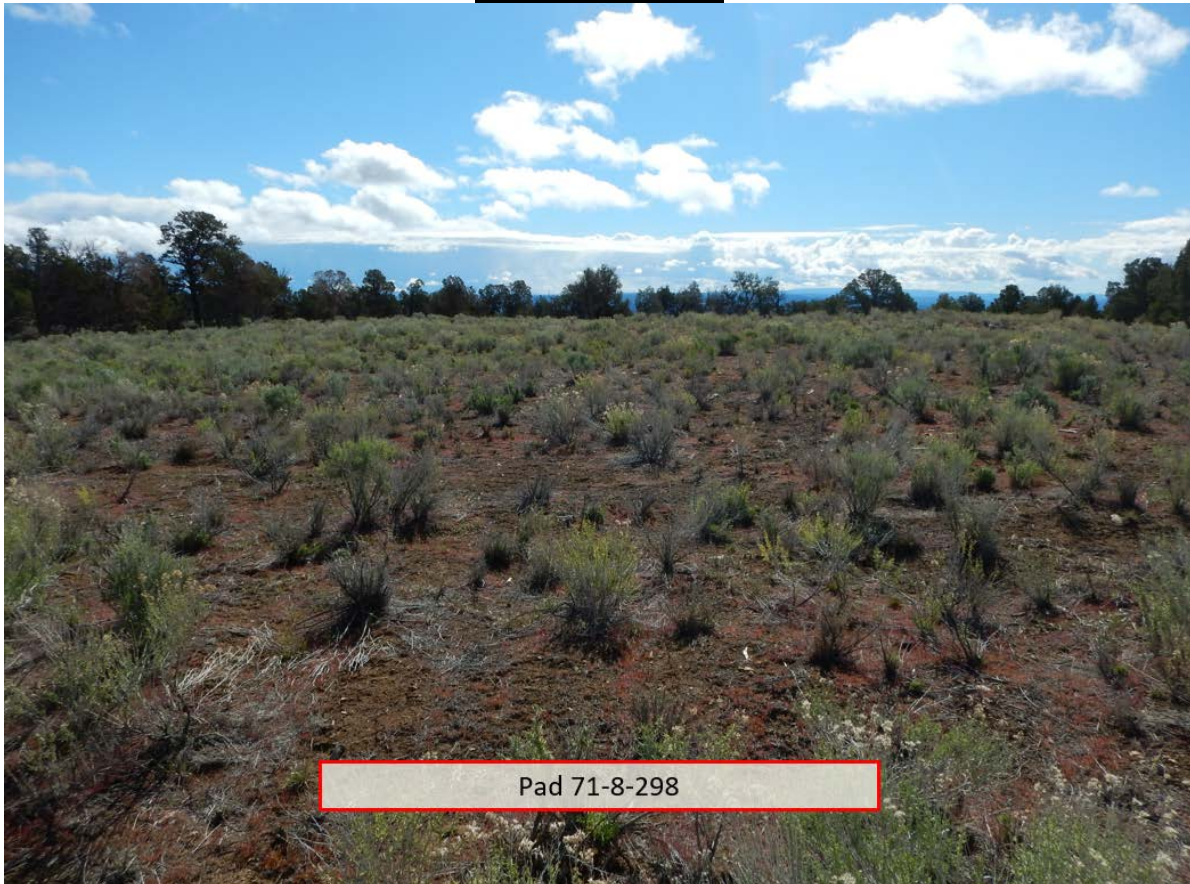
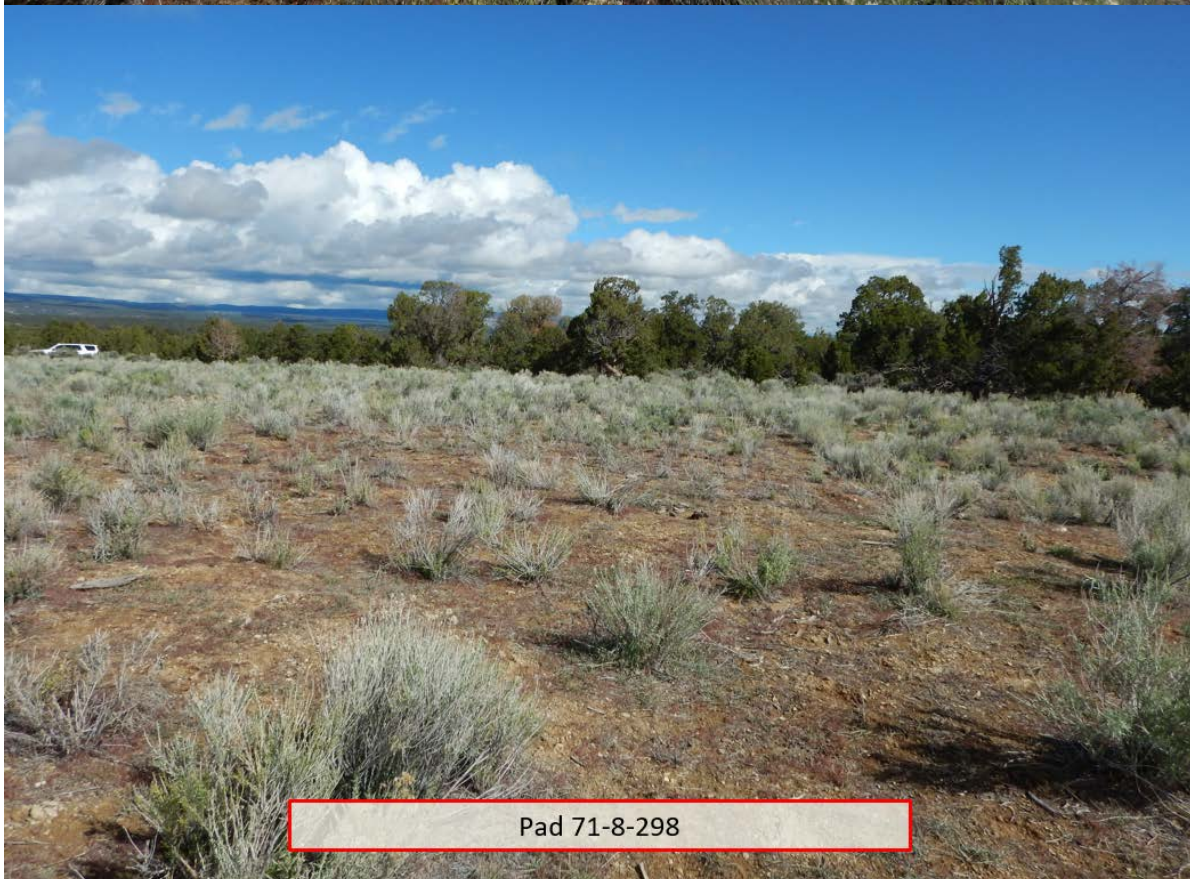
Pad 71-8-298: Culvert from the county road to pad has been removed. Desirable vegetation cover has significantly decreased since the previous inspection. Grazing pressures have drastically increased. The limited grasses have been eaten to the dirt. Cheatgrass populations appear to be increasing and pushing out the already limited desirable grass species. Evidence to recent weed treatments were observed. Hopefully summer monsoons will allow for desirable grasses to bounce back. The predominant cover type remains to be Rabbit brush which seem to be only minimally affected by grazing.

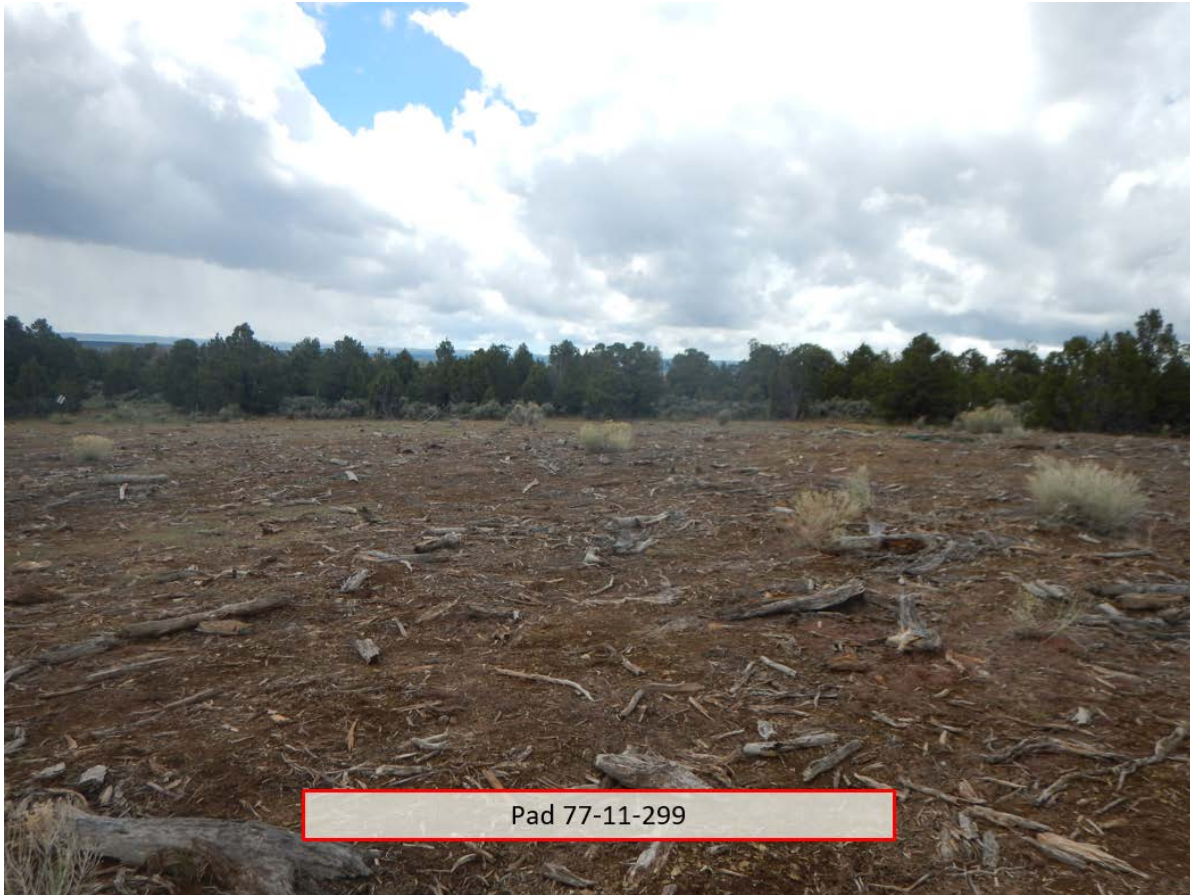
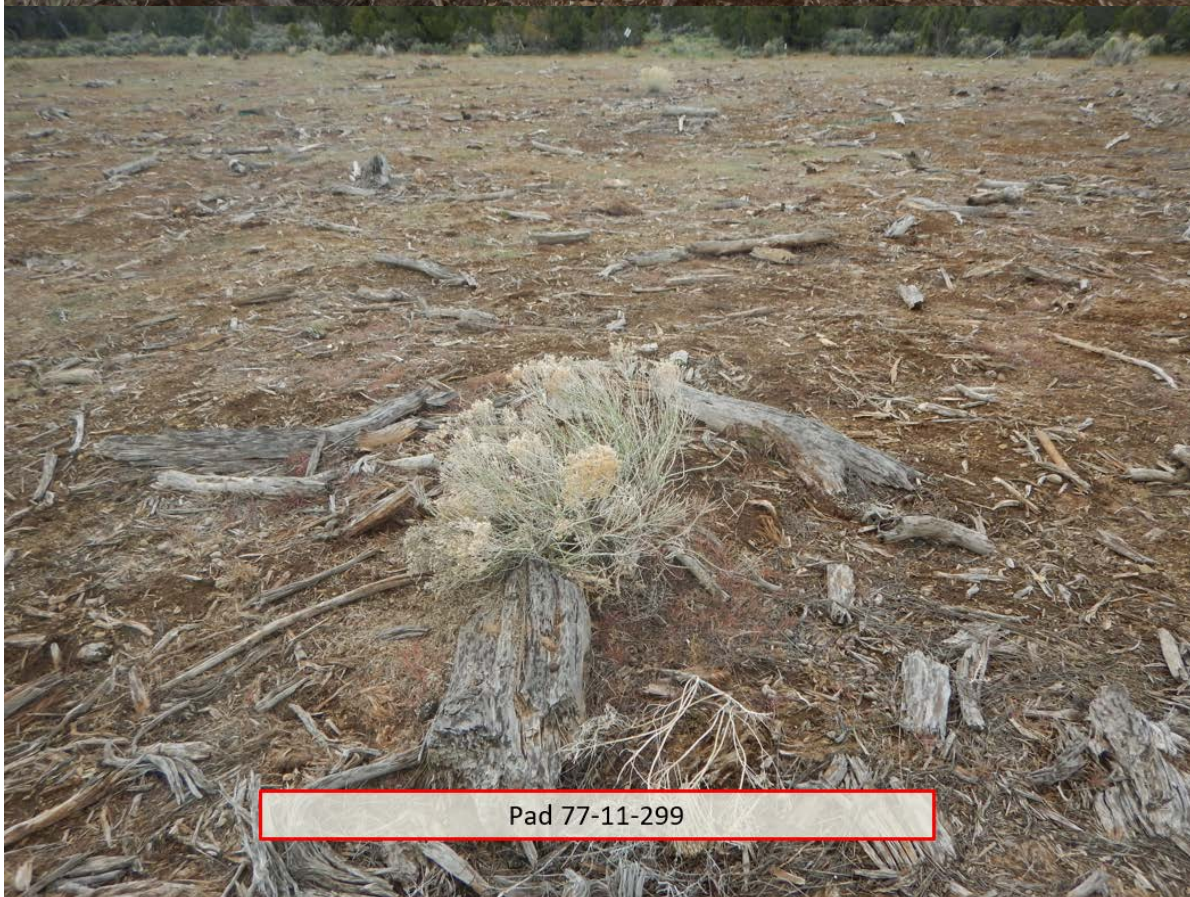
Pad 77-11-299: Nearly void of all desirable vegetation. Overall grasses are extremely low and sparse due to heavy grazing. Very few shrubs have established. Woody material is not deterring grazing impacts nearly as much as surrounding pads. Evidence of recent weed treatments observed. An exclusion fence or similar feature should be considered. Secondary seeding will likely be necessary to establish successful reclamation.
