MINERALS PROGRAM INSPECTION REPORT
PHONE: (303) 866-3567

MINE NAME: Select Materials	MINE/PROSPECTING ID#: M-1980-205	MINERAL: Sand and gravel	COUNTY: Weld
INSPECTION TYPE: Monitoring	INSPECTOR(S): Eric Scott	INSP. DATE: June 14, 2022	INSP. TIME: 11:00
OPERATOR: Leister Materials Limited DBA Select Materials	OPERATOR REPRESENTATIVE: Josh Louis	TYPE OF OPERATION: 112c - Construction Regular Operation	
REASON FOR INSPECTION: Normal I&E Program	BOND CALCULATION TYPE: None	BOND AMOUNT: \$7,500.00	
DATE OF COMPLAINT: NA	POST INSP. CONTACTS: None	JOINT INSP. AGENCY: None	
WEATHER: Clear	INSPECTOR'S SIGNATURE:

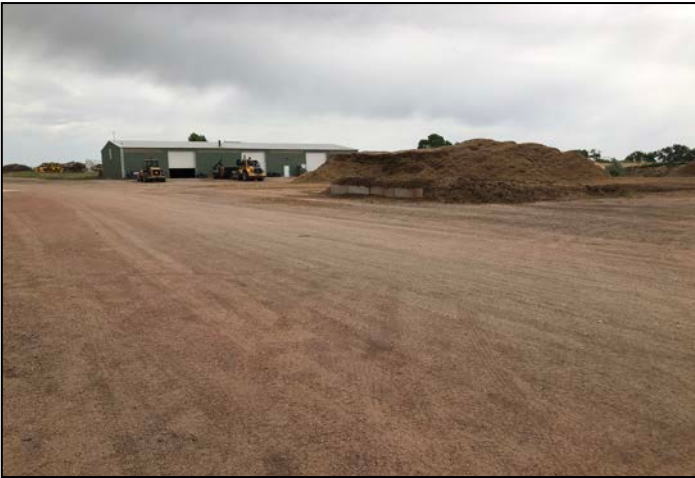
The current financial warranty for the 38.4 acre permit is \$7500. At this time, the total disturbance within the permit is approximately 28 acres, however, only about 5 acres of this affected area is a result of active material extraction. The remaining approximately 23 acres of disturbed area consists of a wood recycling and composting area, sales yard, material stockpiles, various workshop and supporting structures, and gravel parking and storage areas (photo 1).

Photo 1 – Equipment support and stockpile area on west side of permit area.

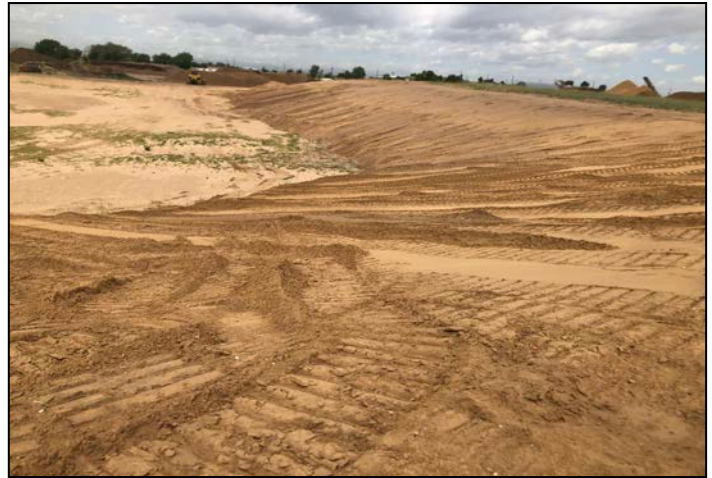
The perimeter of the existing material extraction area in the SE corner of the permit area has been re-sloped to roughly 3:1 horizontal to vertical slopes (photo 2), so minimal additional earthwork would be required, and the topsoil/growth media needed to fully reclaim the site is available within the permit area. Approximately 6 acres of the east-central area of the permit has not been impacted by mining activity at the time of this inspection and is still utilized for general agriculture (photo 3).

Photo 2 – Mining area in SE corner of permit with slopes reclaimed to 3:1.

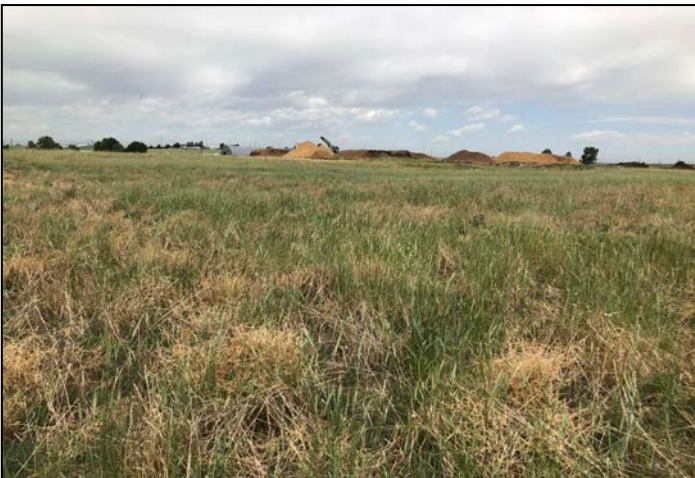
Photo 3 – Unaffected area in east center of permit area with composting operation visible in background.

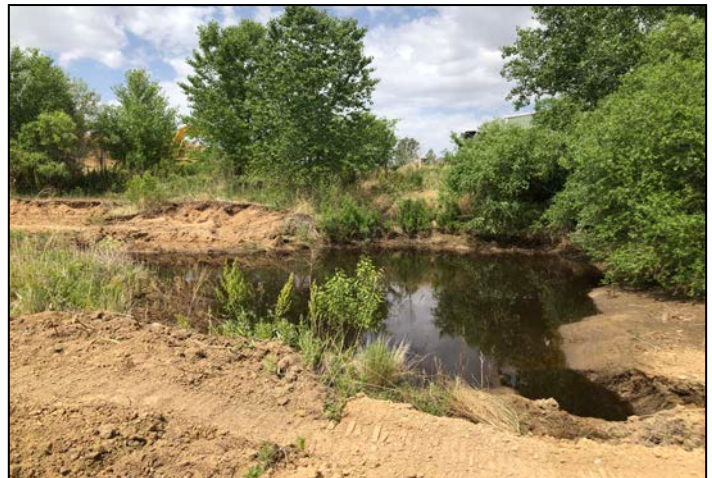
PROBLEM/POSSIBLE VIOLATION: Problem: The Division has no evidence that the operator has a valid well permit, substitute water supply plan, or approved water augmentation plan for the exposed groundwater at the site. This is a problem related to 34-32.5-116(4)(h) of the Colorado Revised Statutes and 3.1.6(1)(a) of the Construction Materials Rules and Regulations governing injury to existing water rights. Groundwater cannot be exposed on-site without appropriate permitting, and SEO regulations prohibit retaining stormwater/surface runoff for longer than 72 hours.

- 2) The small (<1ac) area of exposed groundwater/retained runoff in the west center of the permit will need to be eliminated (photo 4). This should be achieved either through backfilling that area to a minimum of 2 feet above exposed groundwater, or by discharging any captured runoff to the natural drainage within 72 hours in accordance with the State Engineer's regulations. Proof that this has been done should be provided to DRMS no later than August 1, 2022.
- 3) Trash and refuse were observed in several locations within the permit area, including unused fuel tanks outside of secondary containment (photo 5). This trash will need to be removed from the permit area and proof that this has been done provided to DRMS no later than August 1, 2022.

Photo 4 – Small area of exposed groundwater/impounded runoff in west center of permit that will need to be eliminated.

CORRECTIVE ACTIONS: The operator shall demonstrate that the operation is in compliance with the Office of the State Engineer, show evidence that the operator is taking measures to bring the site into compliance with the SEO, or backfill the pits to at least two feet above the groundwater surface and/or discharge any retained surface runoff to the natural drainage by the corrective action date specified.

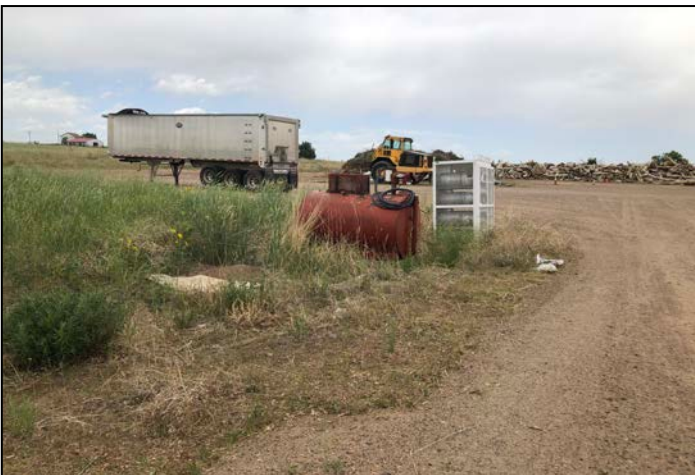
PROBLEM/POSSIBLE VIOLATION: Problem: Trash and refuse was noticed on the site, including unused fuel tanks outside of secondary containment. This is a problem at this time for failure to dispose of refuse in a manner that controls unsightliness or deleterious effects of such refuse pursuant to C.R.S. 34-32.5-116(4)(e).

Photo 5 – Unused fuel tank without containment that will need to be removed from site along with other trash/refuse.

CORRECTIVE ACTIONS: The operator shall submit a written notice to the Division with photo documentation, that the trash, including unused fuel tanks, has been removed from the site by the corrective action date.
