**MINERALS PROGRAM INSPECTION REPORT**  
**PHONE: (303) 866-3567**

<b>MINE NAME:</b> Nahcolite Project	<b>MINE/PROSPECTING ID#:</b> M-1983-194	<b>MINERAL:</b> Carbonates	<b>COUNTY:</b> Rio Blanco
<b>INSPECTION TYPE:</b> Monitoring	<b>INSPECTOR(S):</b> Amy Yeldell	<b>INSP. DATE:</b> June 17, 2022	<b>INSP. TIME:</b> 10:30
<b>OPERATOR:</b> Natural Soda LLC	<b>OPERATOR REPRESENTATIVE:</b> Kirk Daehling	<b>TYPE OF OPERATION:</b> 112d-3 - Designated Mining Operation	
<b>REASON FOR INSPECTION:</b> Normal I&E Program	<b>BOND CALCULATION TYPE:</b> None	<b>BOND AMOUNT:</b> \$3,913,706.00	
<b>DATE OF COMPLAINT:</b> NA	<b>POST INSP. CONTACTS:</b> DRMS	<b>JOINT INSP. AGENCY:</b> None	
<b>WEATHER:</b> Clear	<b>INSPECTOR'S SIGNATURE:</b>

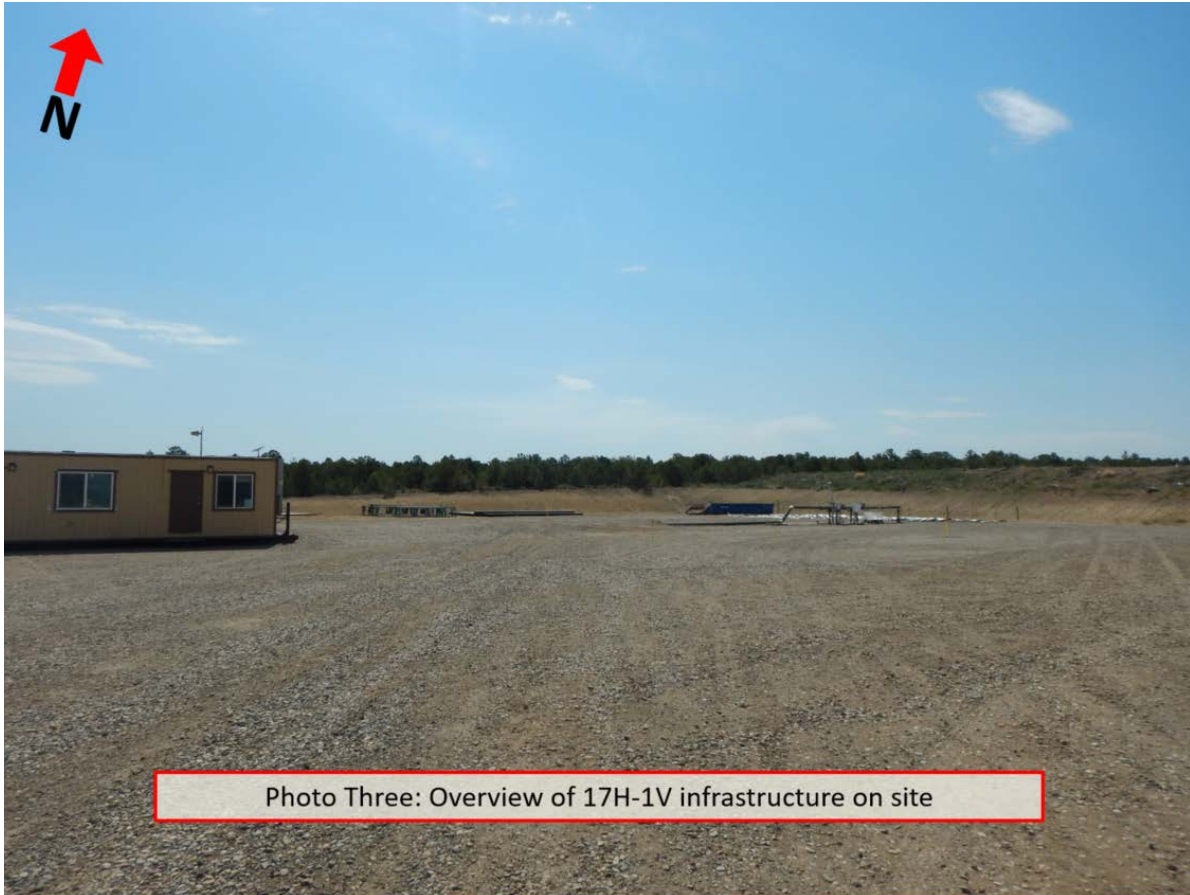
17H-1V will be the first well to be drilled. The conductor casing is set and ready for the drill rig, once on location. In the back corner (NW) of the pad is the Office trailer and Drilling Supervisors living quarters. Once the rig is on site there will also be the tool pusher's equipment. A cuttings bin and pit remain on site and open from setting the conductor casing. No additional disturbances will be necessary for support services or drilling.

Photo Three: Overview of 17H-1V infrastructure on site

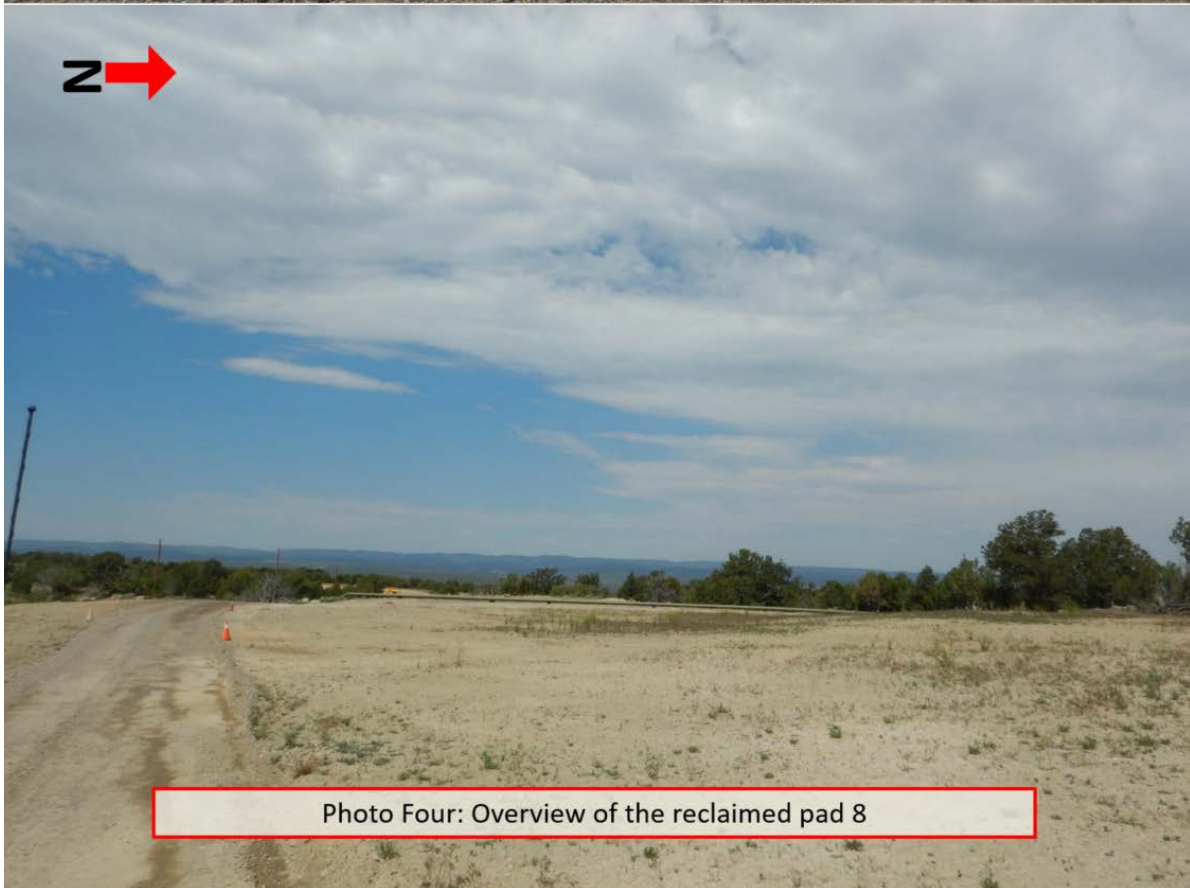
Pad 8 reclamation is sparse. Very limited amounts of early spring rain was received this year. All reclaimed areas are stable with little to no weeds. Reclamation success should be monitored. If germination and re-growth next spring results in the pad having less than 40% cover additional reclamation (seeding) should be employed in the fall.

Photo Four: Overview of the reclaimed pad 8
