MINERALS PROGRAM INSPECTION REPORT
PHONE: (303) 866-3567

MINE NAME: Angie Pit	MINE/PROSPECTING ID#: M-2000-049	MINERAL: Gravel	COUNTY: Montrose
INSPECTION TYPE: Monitoring	INSPECTOR(S): Dustin Czapla	INSP. DATE: June 23, 2022	INSP. TIME: 13:45
OPERATOR: Louisiana Land and Gravel Company, LLC	OPERATOR REPRESENTATIVE: None	TYPE OF OPERATION: 112c - Construction Regular Operation

INSPECTION TOPIC: Gen. Compliance With Mine Plan

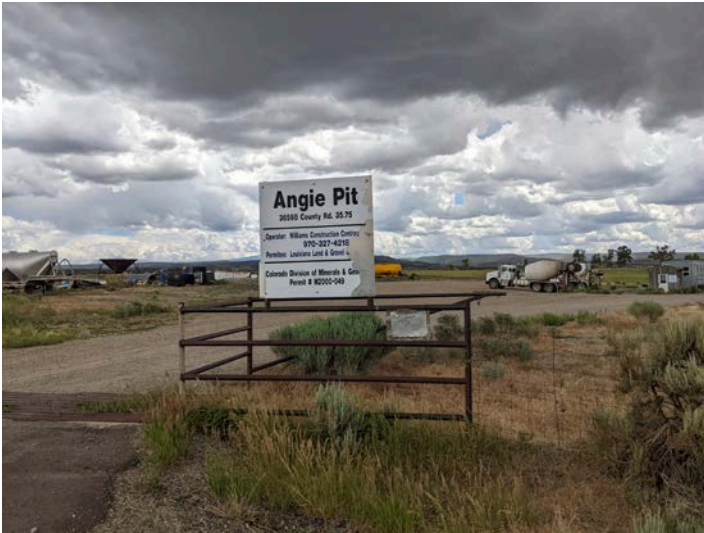
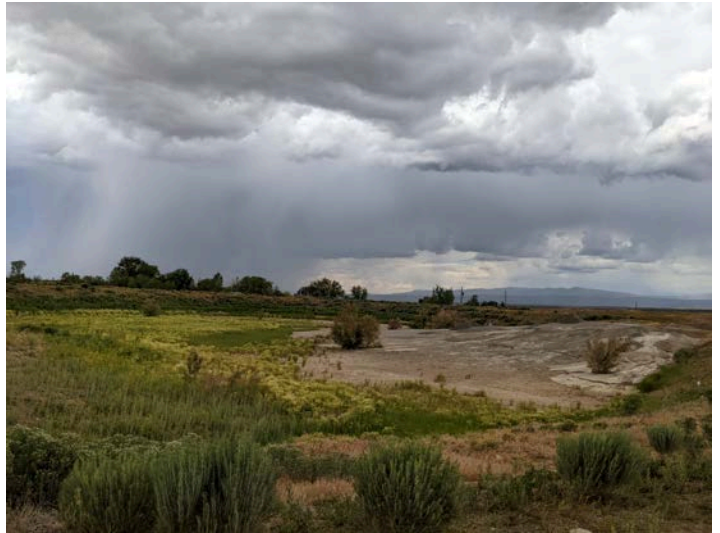
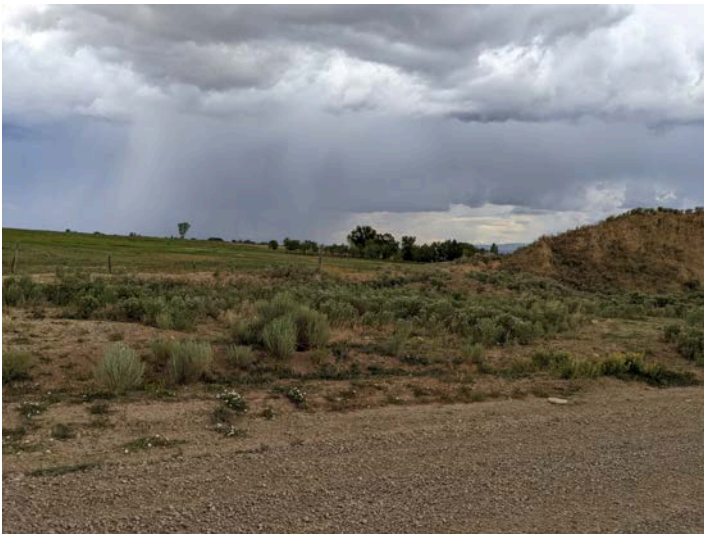
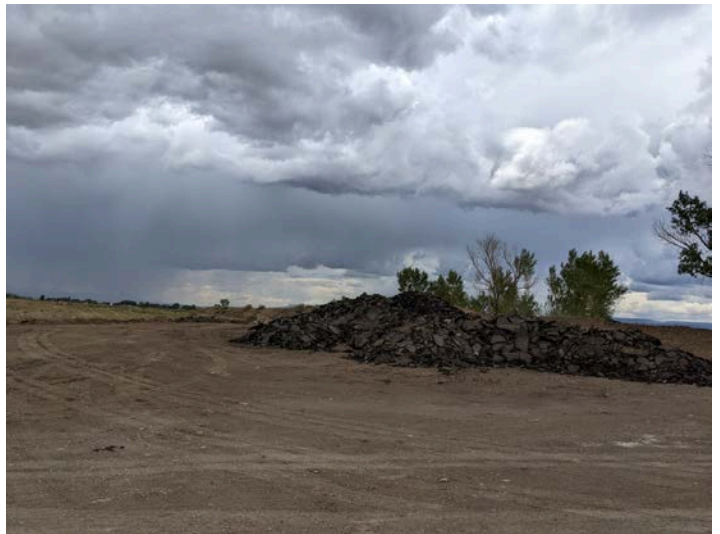
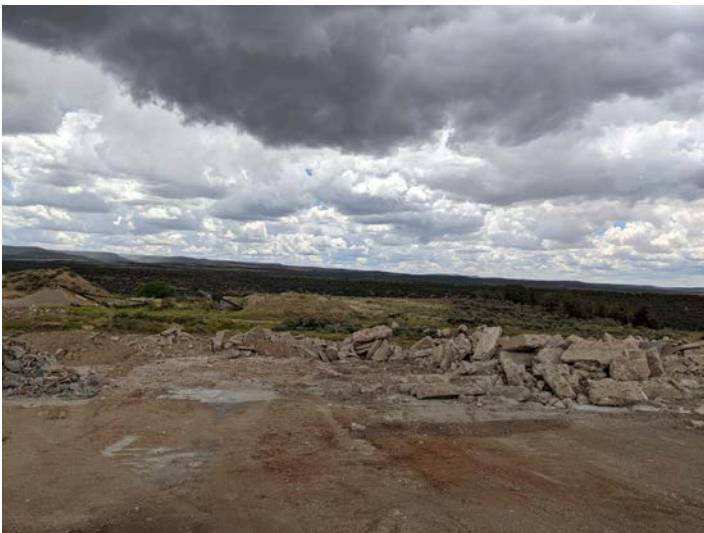
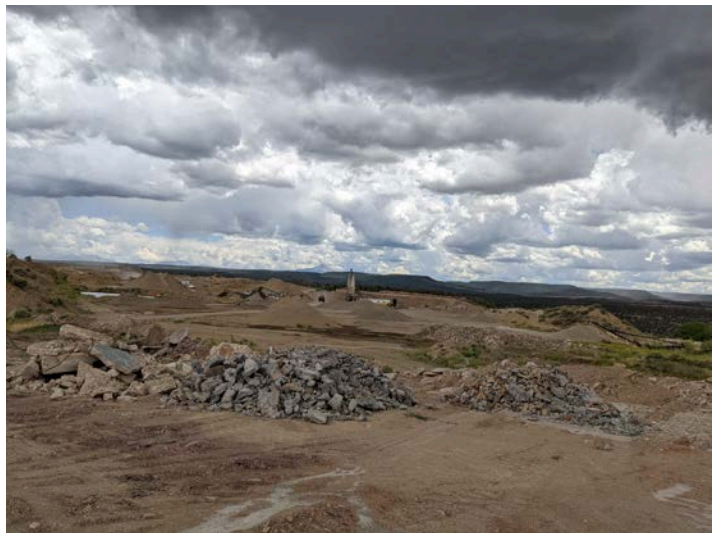
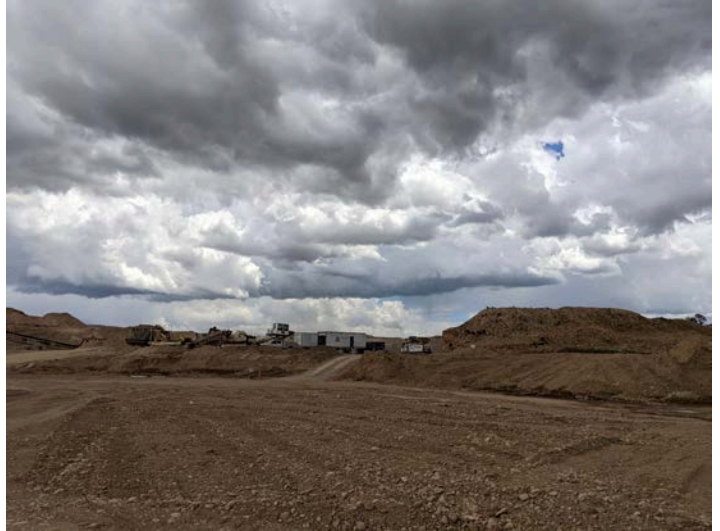
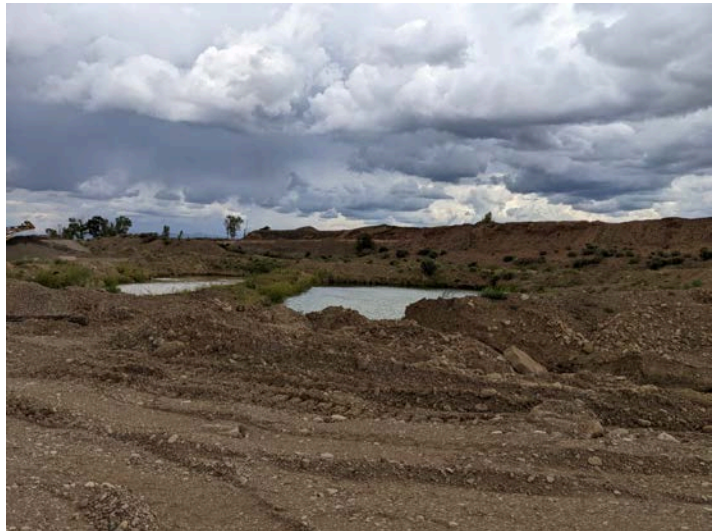
A scalehouse, washout area and stored equipment are located in the north part of the permit area near the site entrance. The area is maintained and orderly. **Small patches of knapweed were observed around this area that will need to be treated.**

Mining is currently taking place in the Phase 1 area in the south part of the permit area. A wash pond, batch plant, crusher and conveyors are located in the Phase 1 area. Materials stockpiles are located throughout the pit floor. During the Division's May 2019 inspection the operator stated that they were pursuing an agreement with the adjacent landowner that would allow the highwall separating the south end of the Angie Pit from the north end of the adjacent Allen Pit (M-2002-094) to be mined out in order to combine the two pits, both of which are operated by the same Operator. The currently approved Reclamation Plan requires that the highwall be backfilled to 2.5H:1V. **The Operator will need to submit a Technical Revision for the permit in order to address this change to the Mine Plan and associated change to the Reclamation Plan. This has been noted as a problem.**

CORRECTIVE ACTIONS: Submit a Technical Revision to the permit to address the change to the Mine Plan and to update the final Reclamation Plan for the site.
