MINERALS PROGRAM INSPECTION REPORT

MINE NAME: Brighton Mine	MINE/PROSPECTING ID#: M-1977-436	MINERAL: Sand and gravel	COUNTY: Adams
INSPECTION TYPE: Monitoring	INSPECTOR(S): Nikie Gagnon	INSP. DATE: June 30, 2022	INSP. TIME: 10:00
OPERATOR: Aggregate Industries - WCR, Inc.	OPERATOR REPRESENTATIVE: Wyatt Webster	TYPE OF OPERATION: 112c - Construction Regular Operation	
REASON FOR INSPECTION: Normal I&E Program	BOND CALCULATION TYPE: Complete Bond	BOND AMOUNT: \$150,000.00	
DATE OF COMPLAINT: NA	POST INSP. CONTACTS: None	JOINT INSP. AGENCY: None	
WEATHER: Partially cloudy	INSPECTOR'S SIGNATURE:

PHOTOGRAPHS

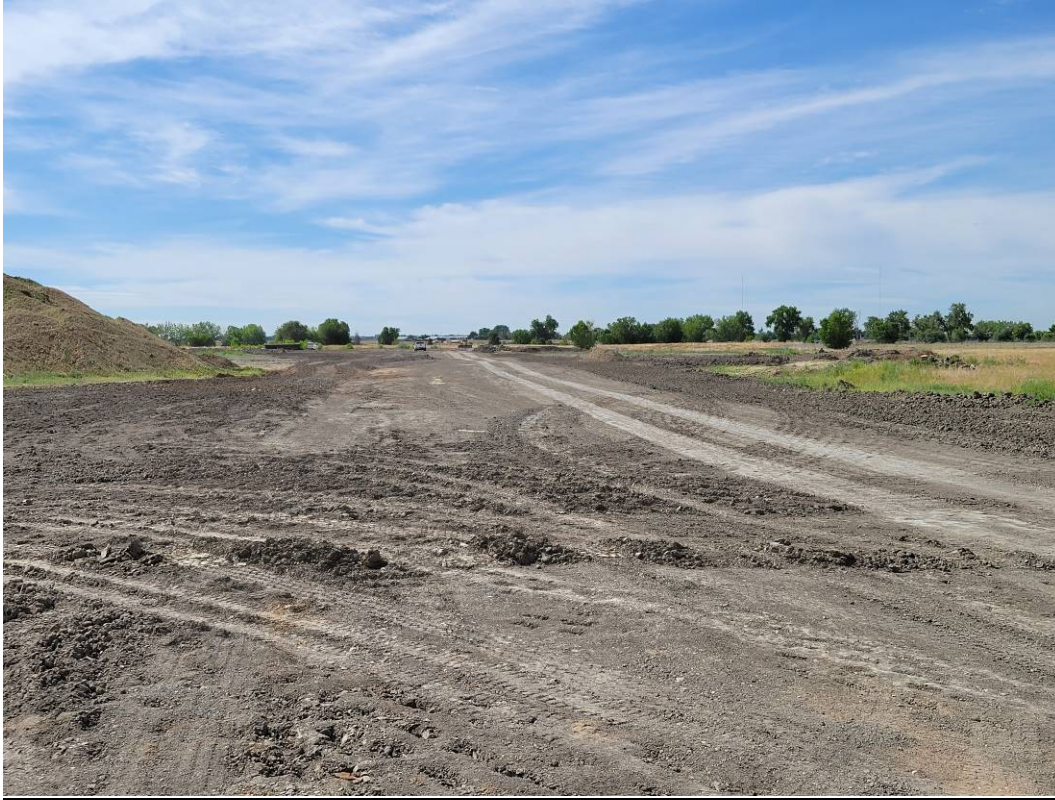
Looking south across North Pond parcel; area of active grading.

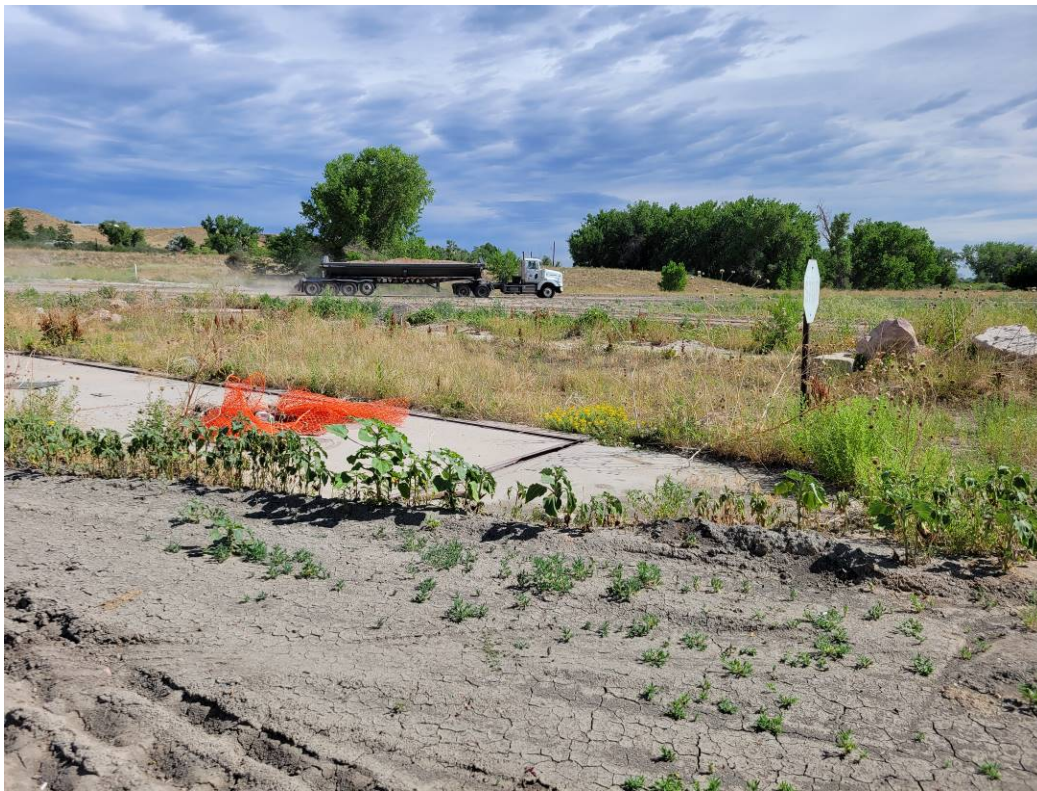
Reclamation Success: Mining is complete within the North Pond parcel and the area is undergoing reclamation. During the inspection, trucks were observed bringing fill material into the site. One bulldozer was observed grading the southern end of the permit area. Some minor reclamation disturbance was observed outside the permit boundary on the southern end. The landowner representative indicated the reclamation plan includes tying in with the existing contours of the adjacent lands. Portions of the old truck scale still remain near the entrance and will need to be removed.

Revegetation: Outside the area of active grading, the slopes have been graded and seeded. Dense grasses and forbs are established along the South Platte and on the western upland slopes. Noxious weeds were observed in the area of active grading, however, significant noxious weed problems were not observed in the revegetated area along the South Platte River and upland areas.

Truck entering North Pond parcel; annual weeds noted and remnants of old truck scale.

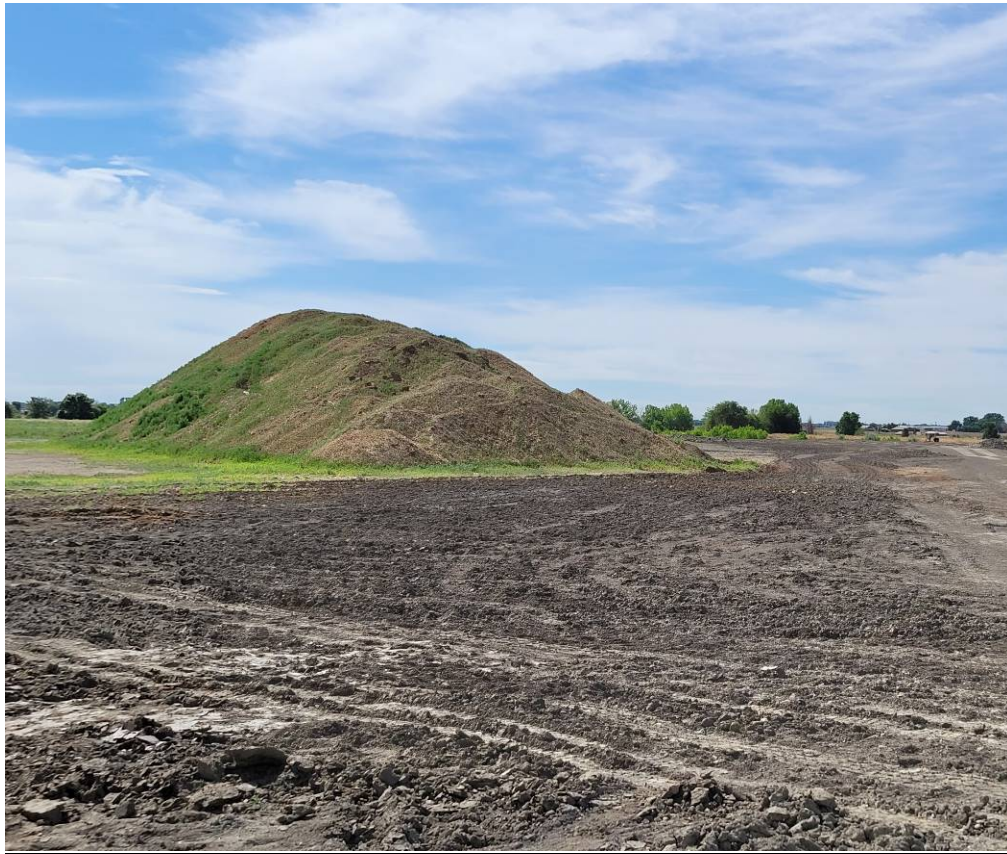
A large stockpile of topsoil was observed in the center of the mitigation area. The landowner representative indicated the topsoil will be spread across the area once the grading is complete. The pile was stable with vegetation growing on the slopes at the time of the inspection.

Looking south at topsoil pile in center of active grading area.

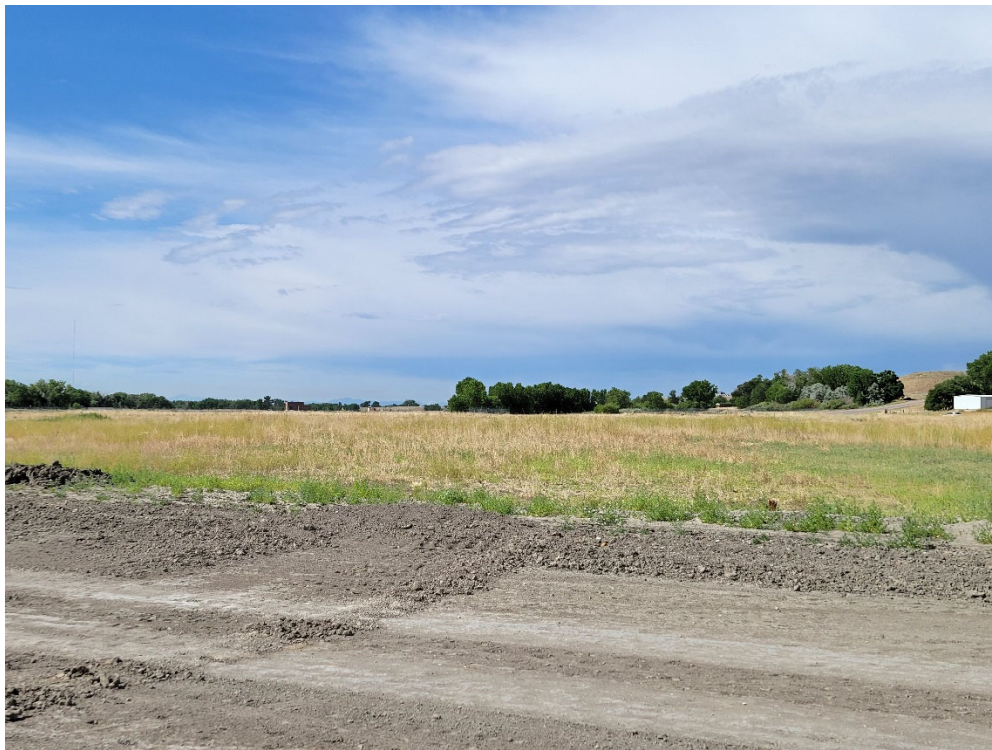
Upland area west of active reclamation area.

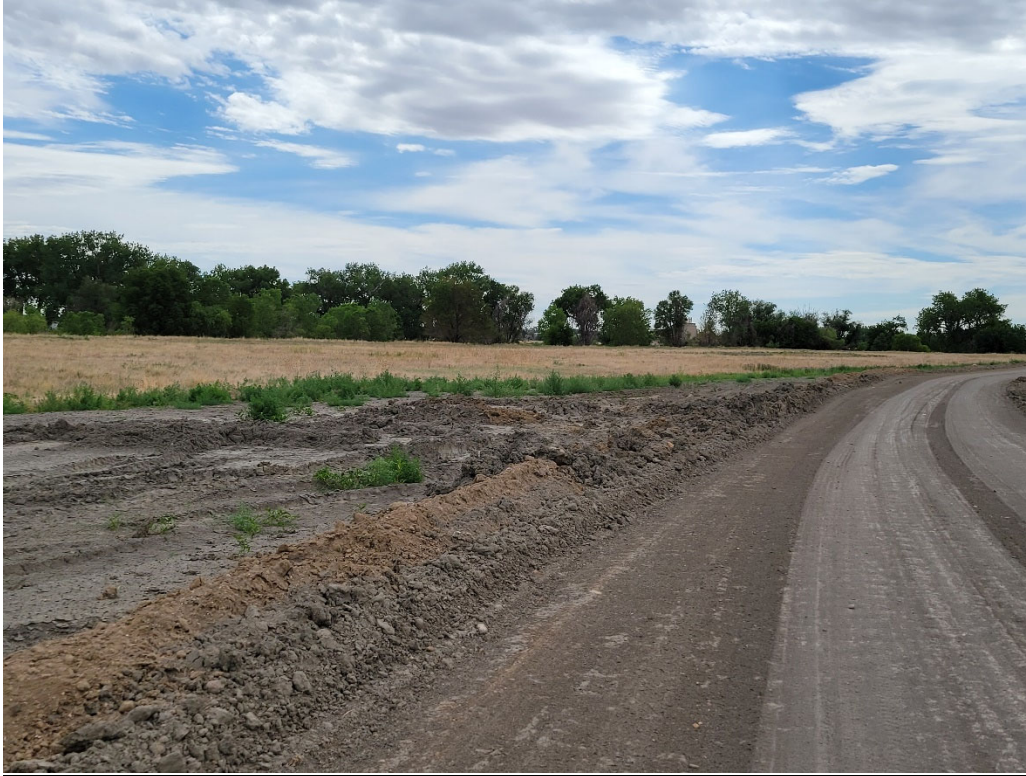
Looking east toward South Platte River reclaimed area along access road.
Native grasses surround area of active reclamation.

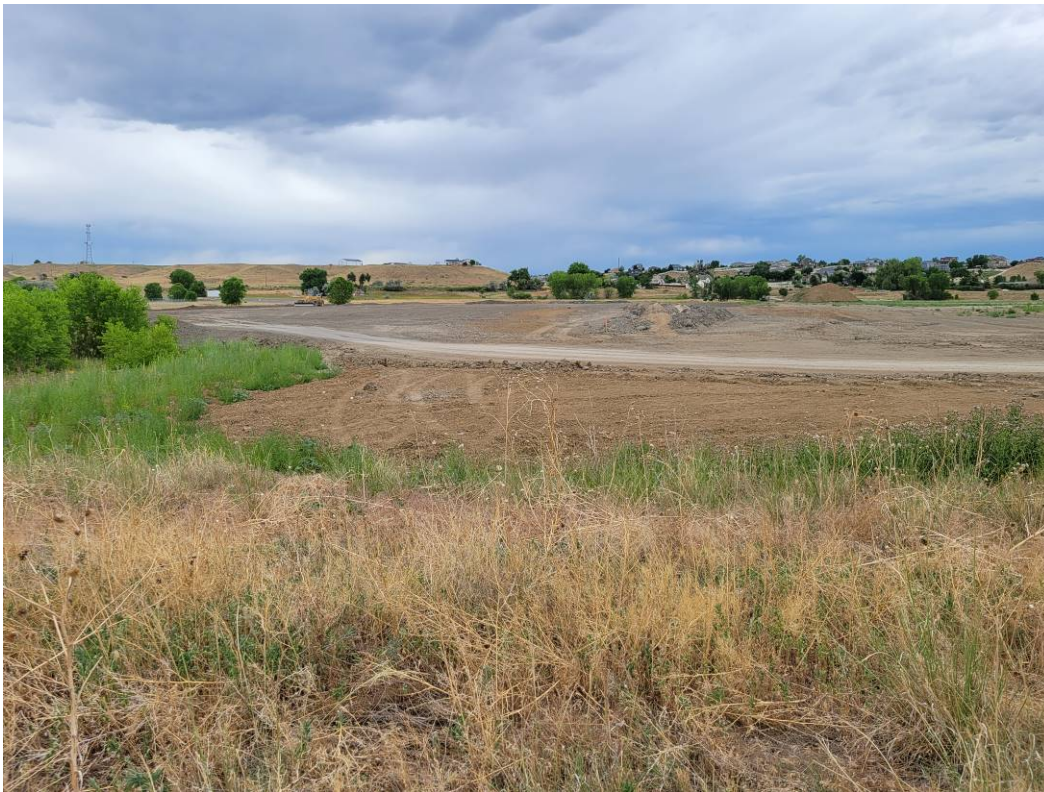
Looking northwest from southeastern corner of permit area.

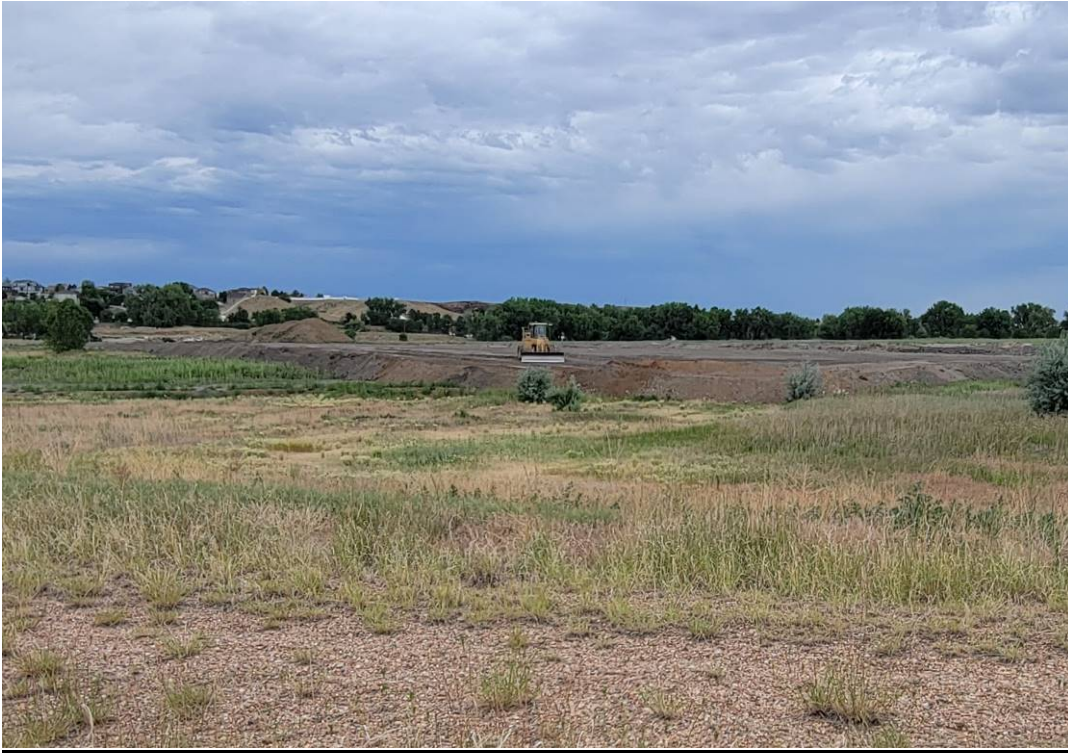
Looking north from southern boundary of permit area. Bulldozer grading North Pond area.

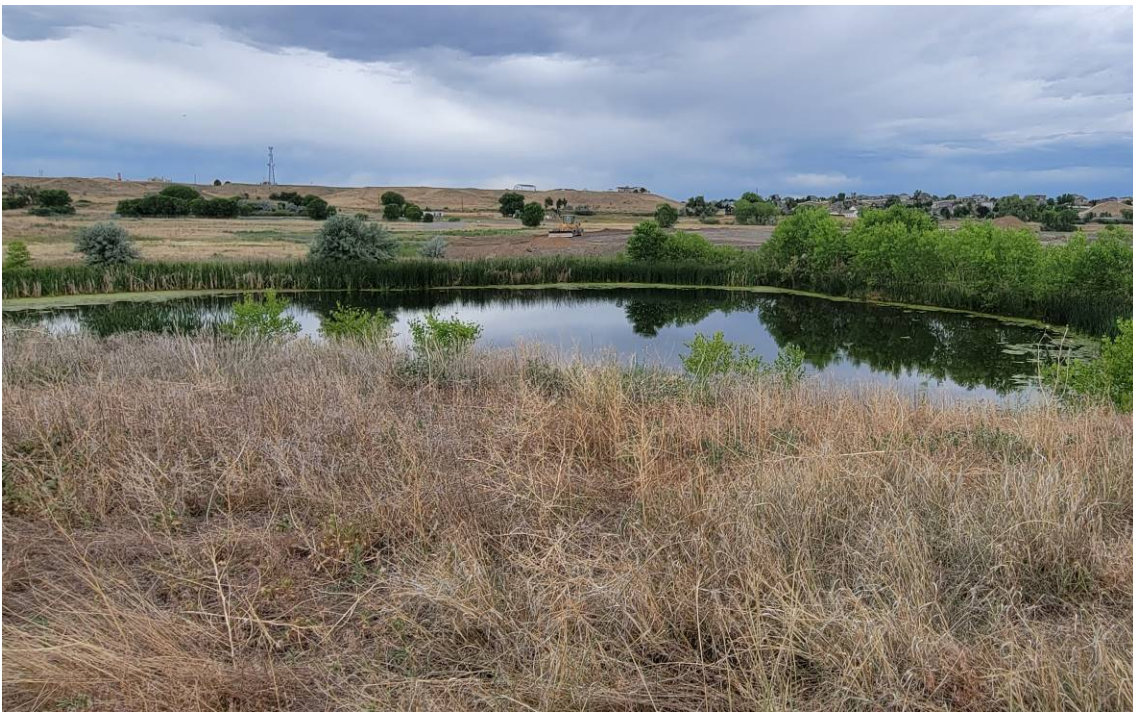
Hydrologic Balance: During the inspection, a small seasonal wetland/pond area was observed just outside the southern end of the permit boundary which appeared to be undisturbed by the reclamation activity.

Wetland outside southern boundary of permit area.

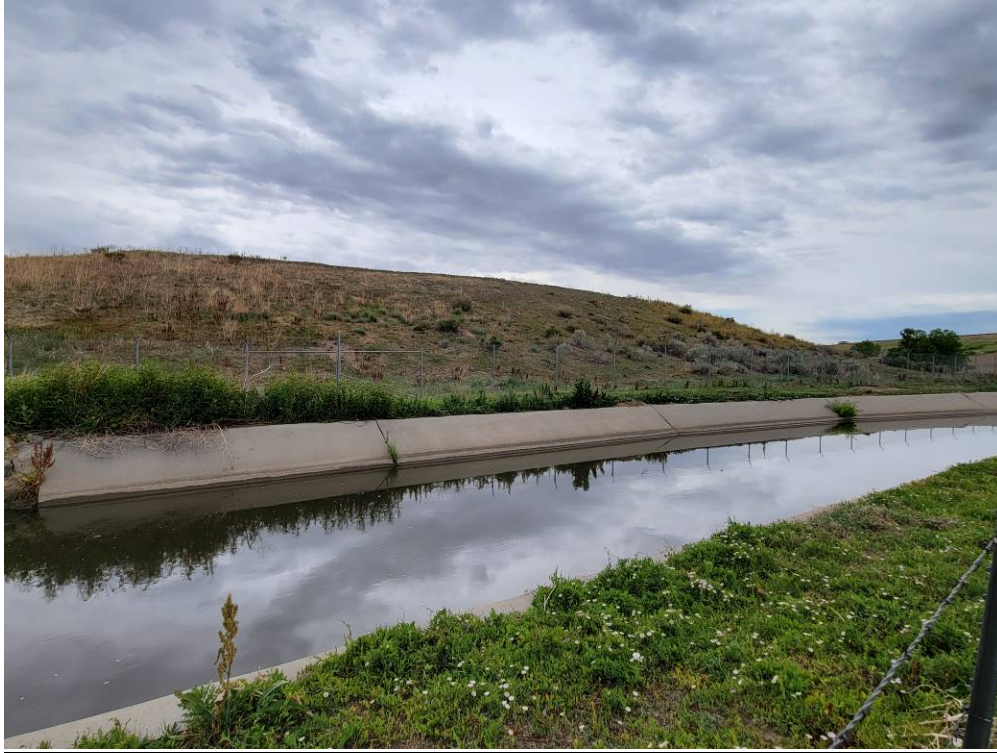
Stockpile in southwest corner of the South Pond reservoir.

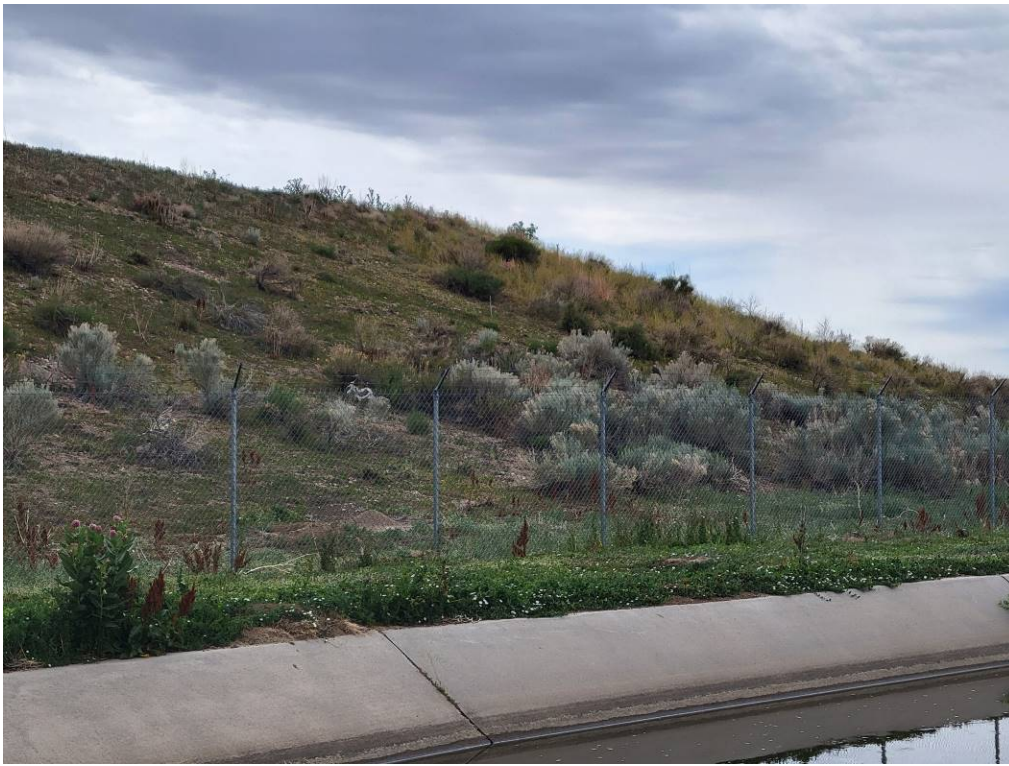
The large stockpile in the southwest corner of the South Pond was vegetated and stable. The Division noted some thistle and cheatgrass on the pile and recommends treatment to control noxious weeds.

Thistle and cheatgrass noted on top of stockpile in southwest corner of the South Pond reservoir.
