Job Number: 99-3983

Subject: Quarterly Observation Report, Refuse  
Pile, Foidel Creek Mine, Routt County, Colorado.

## NORTHWEST COLORADO CONSULTANTS, INC.

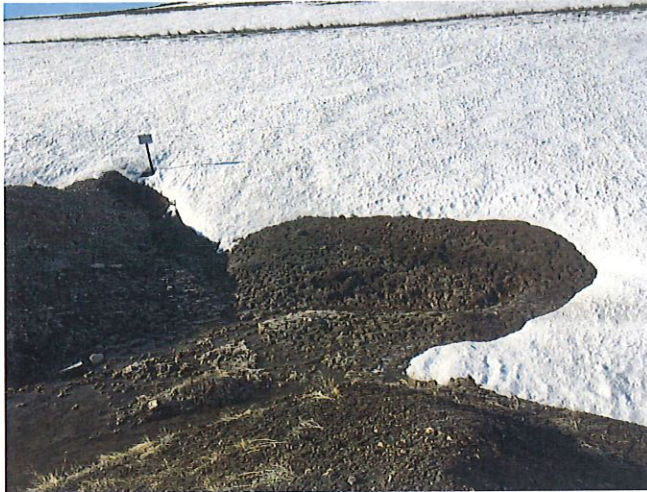
A seepage area at the toe of the northeast end of the refuse pile expansion area, approximately 30 feet northwest of the outlet of the underdrain, developed in fall 2014. At the time of our observations, the seepage was surfacing at the toe of the slope and flowing into the drainage from the undrain outlet then into the existing pond east of the Refuse Pile Expansion Area. The discharge was clear, with no evidence of sediment. No signs of washout, slumps or slope instability were observed at this time. The seepage area

will be monitored during future inspections and noted in our inspection reports. Photographs of the seepage area taken at the time of our inspection on March 31, 2022 are attached.

March 31, 2022-Drain Outlet and Seepage Area

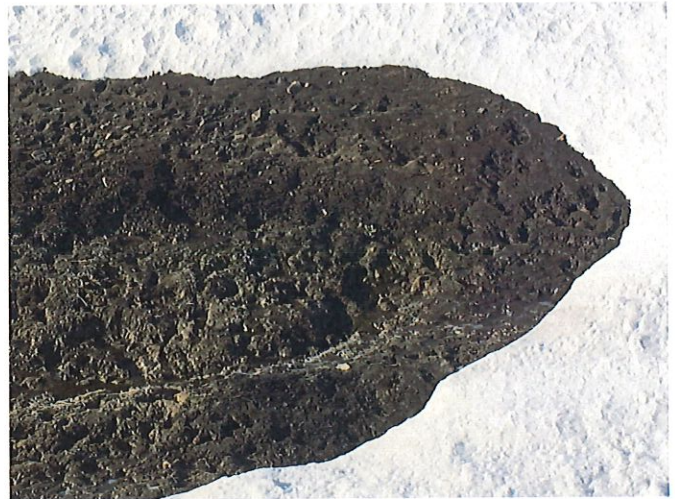
March 31, 2022-Seepage Area

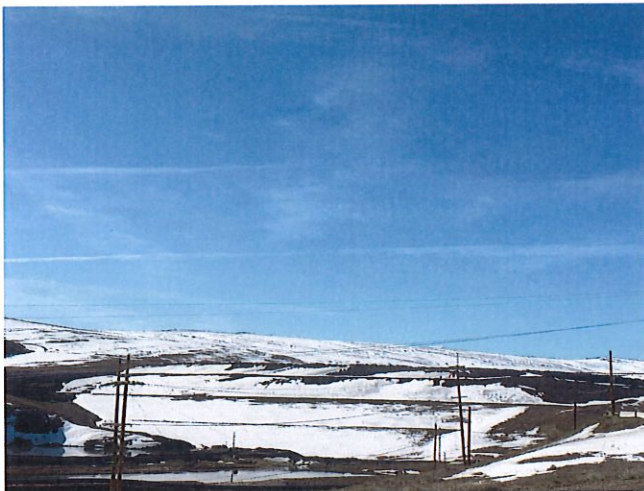
At the time of our site visit on March 31, 2022, NWCC completed a site inspection of the existing refuse pile. Based on our observations made during this visit, it appeared that the contractor was presently stockpiling, grading and compacting refuse coal in the new Expansion Area. At the time of our site visit, the refuse coal had been placed and compacted to an elevation above the third bench situated along the east side of the stockpile.

March 31, 2022- Benches on East Side of Refuse Pile

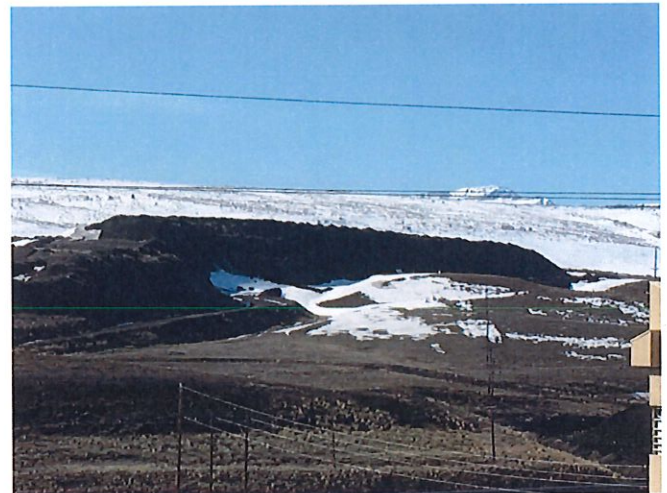
The internal roadways in the new expansion area of the pile are in good condition. The upper haul road to Areas 2, 3 and 4 of the refuse pile was not accessible at the time of our site visit, due to snow and mud.

March 31, 2022- Areas 2, 3 and 4
