Subject: Geotechnical Observation Summary  
Report, October 4, 2021 Site Visit, **Ralston  
Quarry**, Jefferson County, Colorado

Job No. 18-3046

### ***Slope Observation Summary***

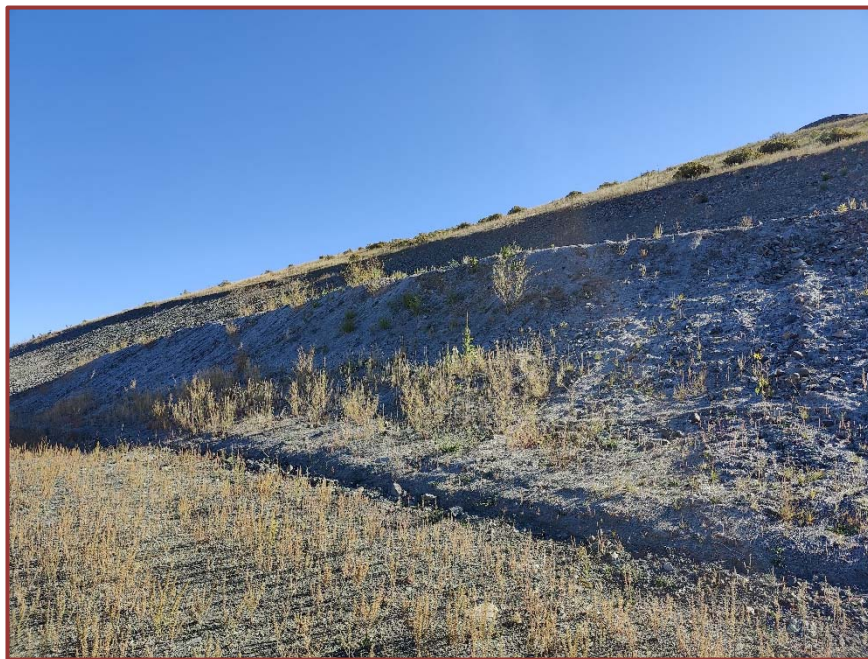
In general, the remediated slopes appeared to have largely remained in their as constructed forms. Relatively thin vegetation was observed on the site slopes although the vegetation density appeared to have increased and the site slopes appeared to have increased vegetation density from our March site visit. The greatest apparent increases in vegetation density were observed on the shallower slopes. On the steeper areas, such as the buttresses, some increase in vegetation density was observed, but other areas remained largely unvegetated. Large scale soil cracking or other signs of significant slope movement or instability were not apparent. However, rills and other relatively small, local erosional features were observed in the slope surfaces. Some of these features appeared to have increased in size and were typically several inches wide and several inches deep. These features were most apparent in the areas with less vegetation. The areas with denser vegetation did not appear to have prominent erosional features. None of the erosional features appeared to be adversely affecting the slope at this time, but such features could present a source of risk, if they are allowed to become larger. The erosional features should be monitored, and where they become enlarged significantly, they should be regraded.

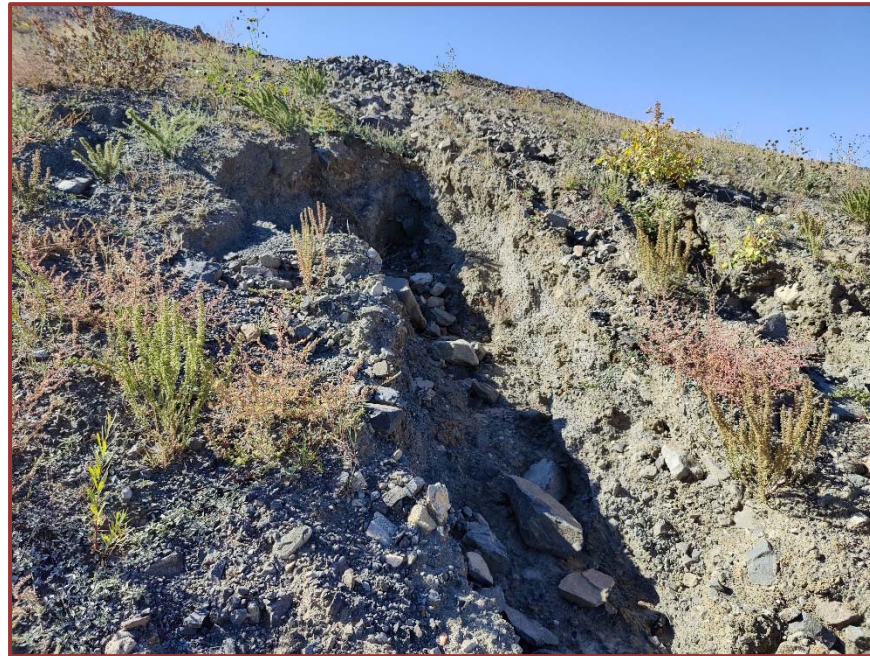
However, a much larger and more significant erosional feature was observed on the northern slope of Zone 1. This feature was several feet wide and about 1 to 4 feet deep. (See image below.) This feature was not observed during our March 2021 site visit and appeared to have

developed since that visit.

The feature did not appear to be an immediate threat to the slope's stability, but appears to have the potential to cause significant issues in the future. The area should be regraded and better control of the surface drainage on the slopes in that area should be developed.

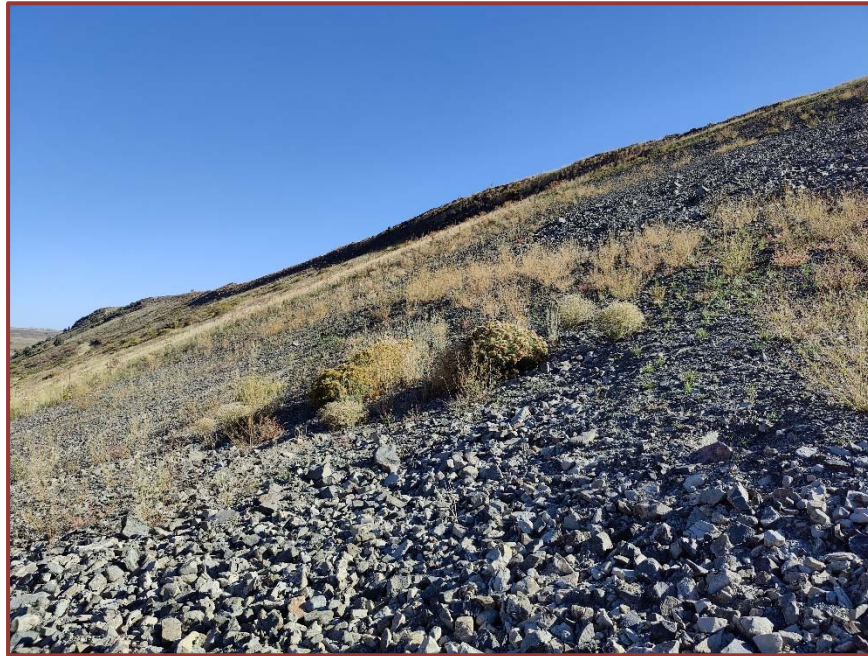
A relatively small depression was observed in the lower third of the northern portion of the remediated slope (Zone 4) during our March 2021 site visit. This depression was less apparent during our recent visit. This may have been the result of grading efforts or additional slope settlement. Additionally, the depression appeared to support vegetation that was generally denser than the surrounding graded slope. (See image below.) This suggests that this area is holding more water after precipitation events. The affected area should be filled with properly compacted fill to restore the design slope grades, and monitored for additional settlement.
