## Schwartzwalder Mine Revised AM-06

**Subject:** Response to Third Adequacy Review  
Application Amendment #6  
Mine Land Reclamation Permit M-1977-300, Schwartzwalder Mine, Golden, Colorado

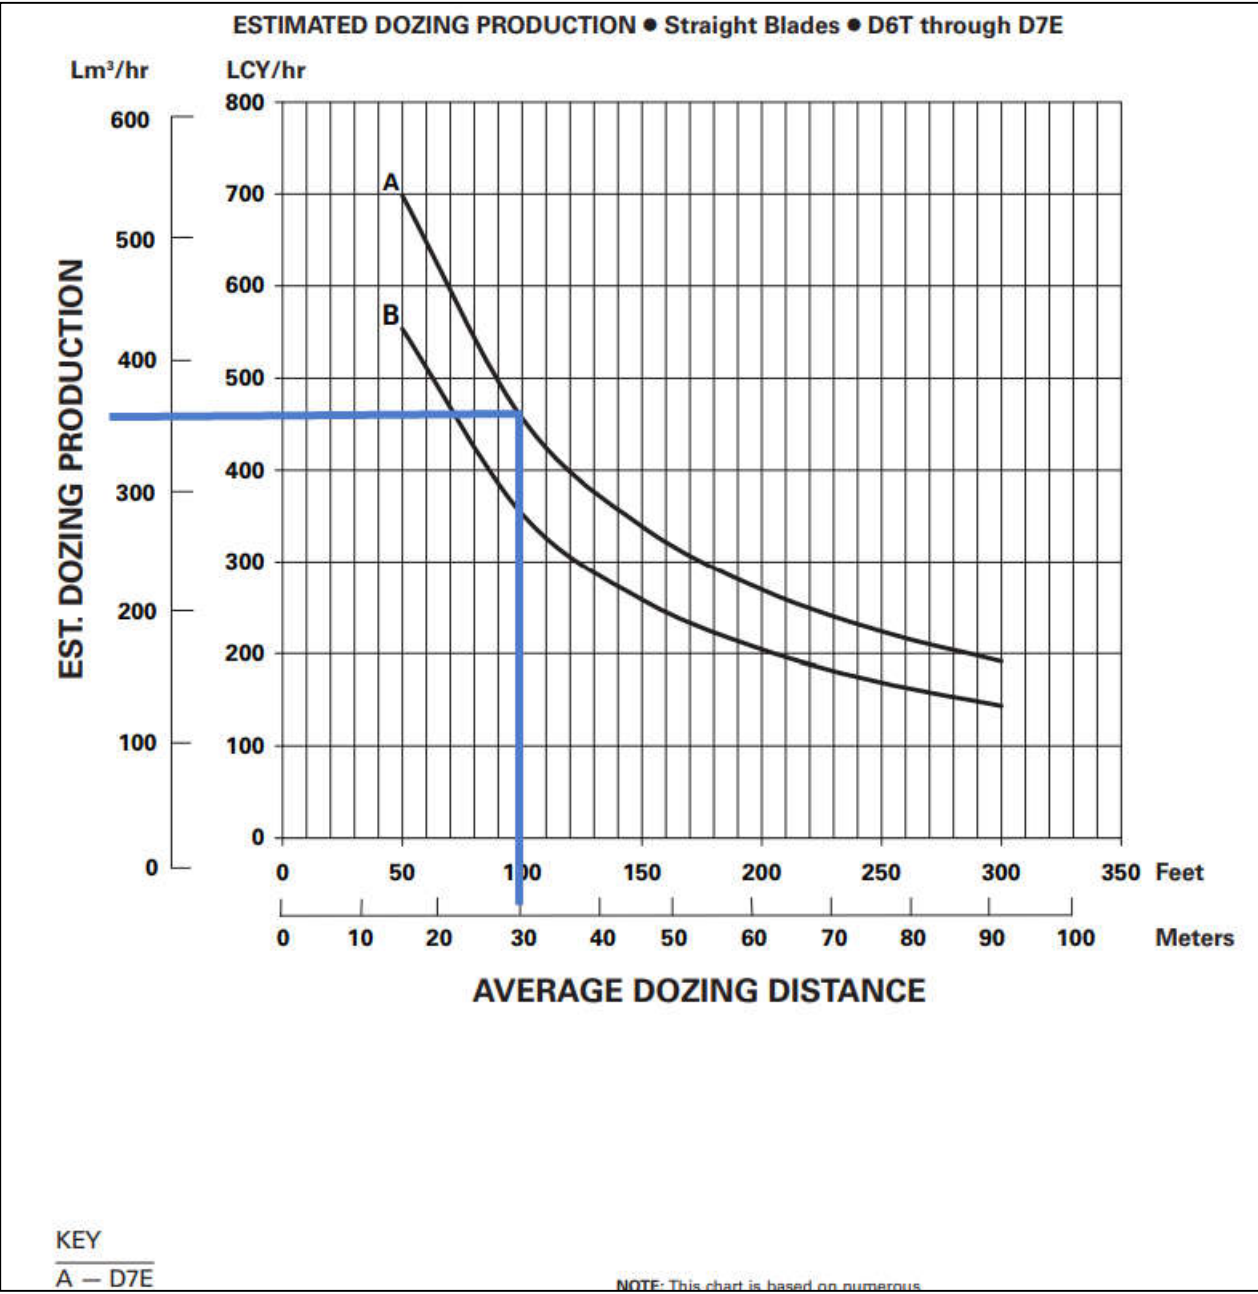
<p><b>ESTIMATED DOZING PRODUCTION • Straight Blades • D6T through D7E</b></p> <p>Y-axis: Lm³/hr (0-600), LCY/hr (0-800)  X-axis: Feet (0-350), Meters (0-100)</p> <p><b>KEY</b>  A – D7E</p> <p><small>NOTE: This chart is based on numerous</small></p>
3	<p>The operator states that no imported fill material will be needed because sufficient volumes of “clean” fill exist on site for use in reclaiming the valley after the excavation project is complete. The operator has not provided sufficient proof that enough “clean” soils are available on site for reclamation. In previous permit revisions, the operator had discussed plans to import inert fill material to the site in order to establish final grades in the valley after the contaminated soils have been removed. The operator had previously estimated that approximately 33,000 to 54,000 cubic yards of fill material may need to be imported (to replace the materials expected to be removed). In Amendment No. 5 (AM-5; approved on January 13, 2021),</p>	<p>In the course of the alluvial valley excavation project, CLL has learned that contaminated soils (concentration of radium-226 greater than 7pCi/g) occur in “pockets” adjacent to uncompacted soils (concentration of radium-225 less than or equal to 7pCi/g). This deposition is considered reflective of the historic ore-sorting practices that created the initial contamination. The fact that there are elevated uranium containing soils in the valley is evidence that mining operations added materials to valley, CLL’s reclamation work serves to return the alluvial valley to a more natural elevation present before mining operations occurred at the site. These uncompacted soils may be used as fill materials or growth media for reclaiming the valley or capping the expanded SWRP. Reclaiming with local soils is expected to reduce the likelihood of importing weeds or invasive species from outside fill material.</p>

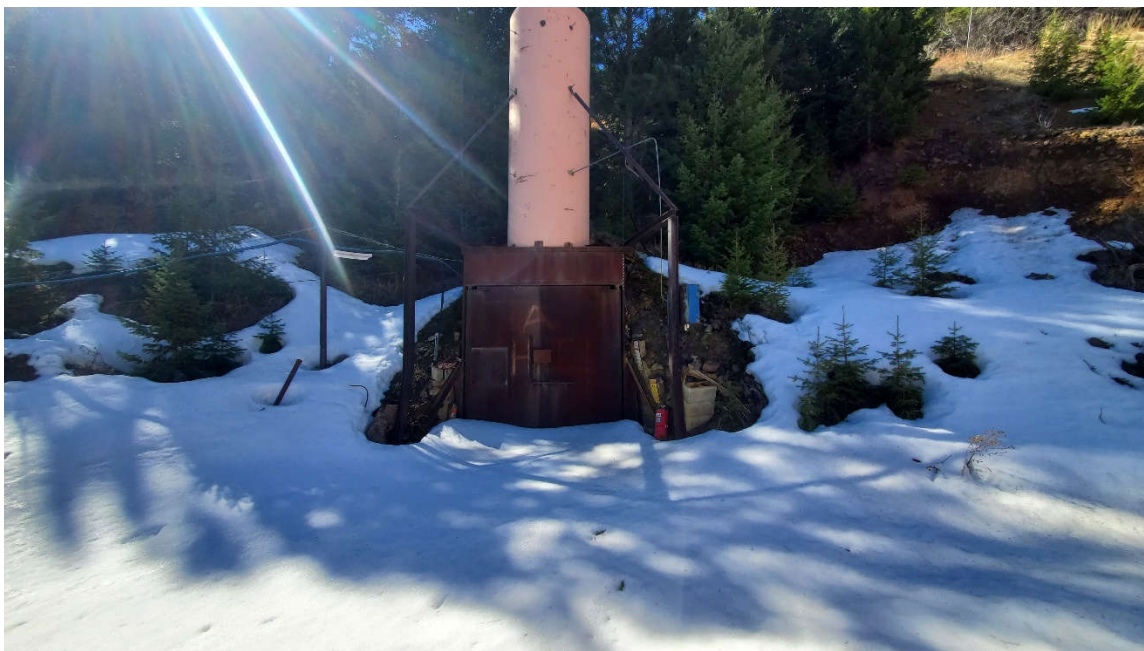
**FIGURE E-1: PHOTOS OF MINE OPENING CLOSURES**

**(A) CV / Charlie Adit, April 2022**

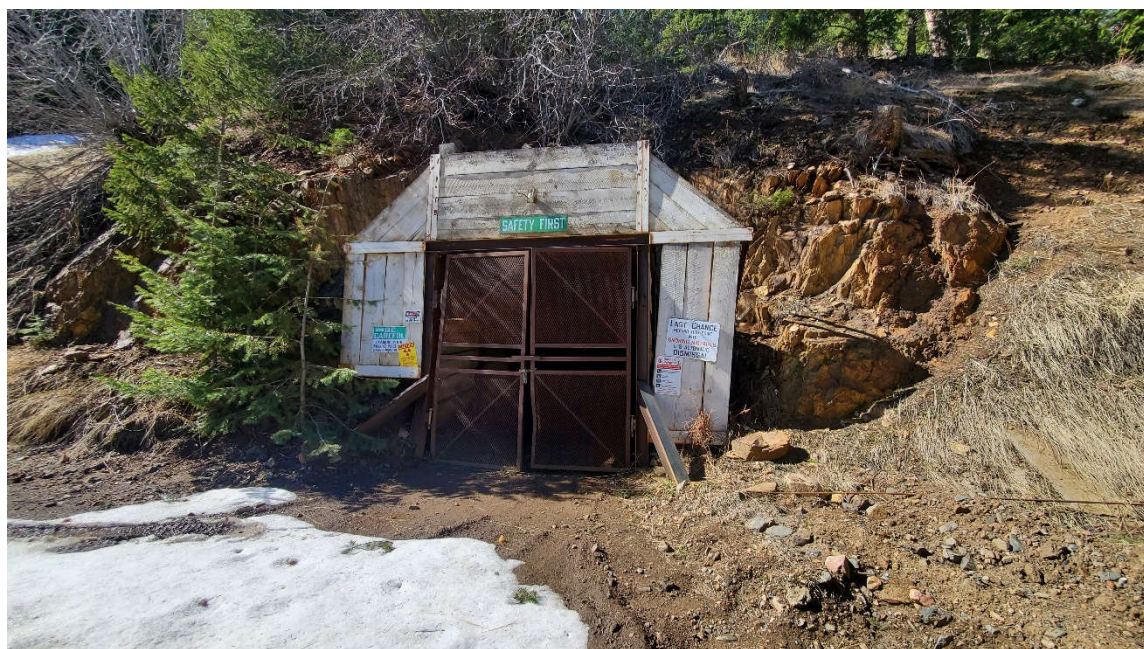
**(B) Minnesota Adit, April 2022**

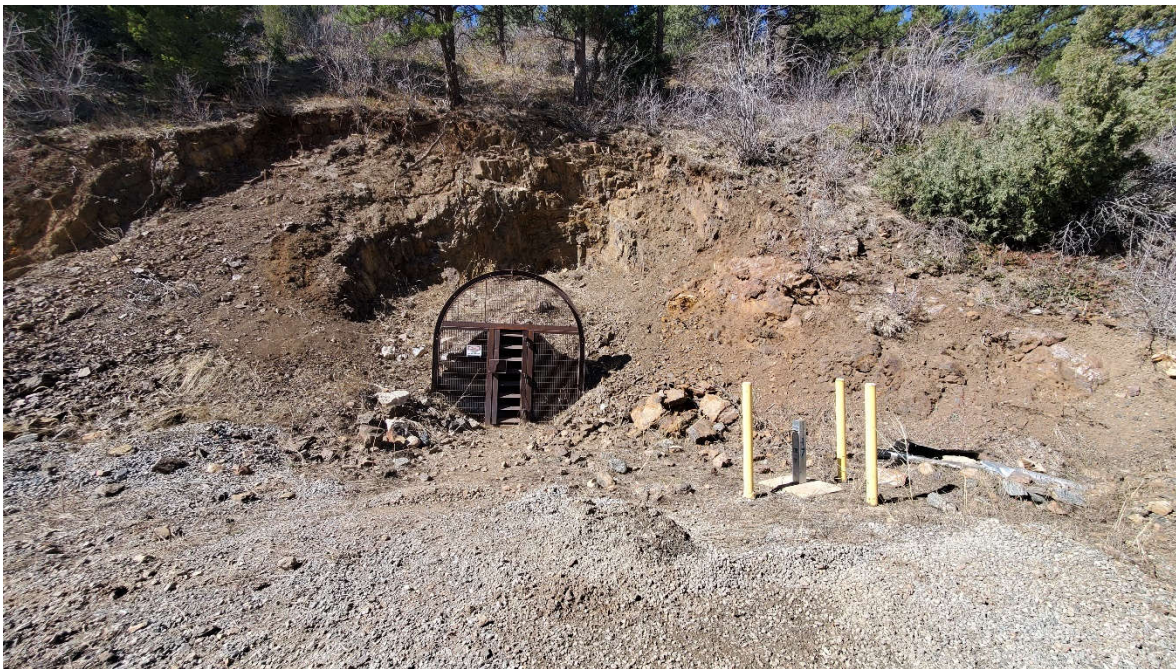
**FIGURE E-1: PHOTOS OF MINE OPENING CLOSURES**

**(C) Pierce Adit, April 2022**

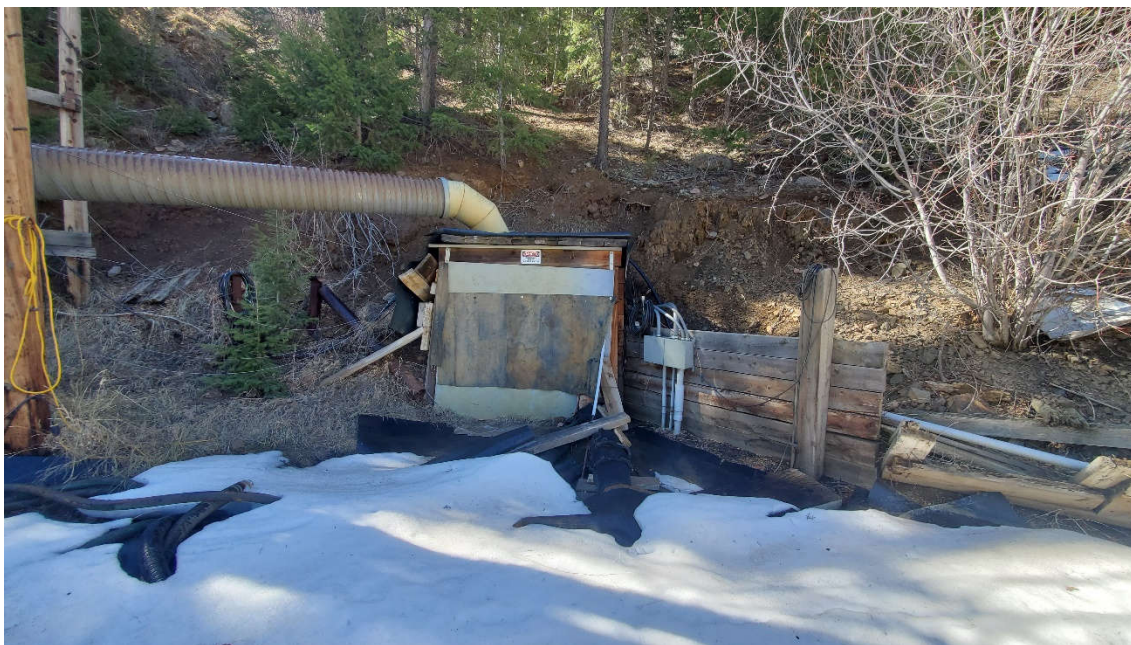
**(D) Steve Adit, April 2022**

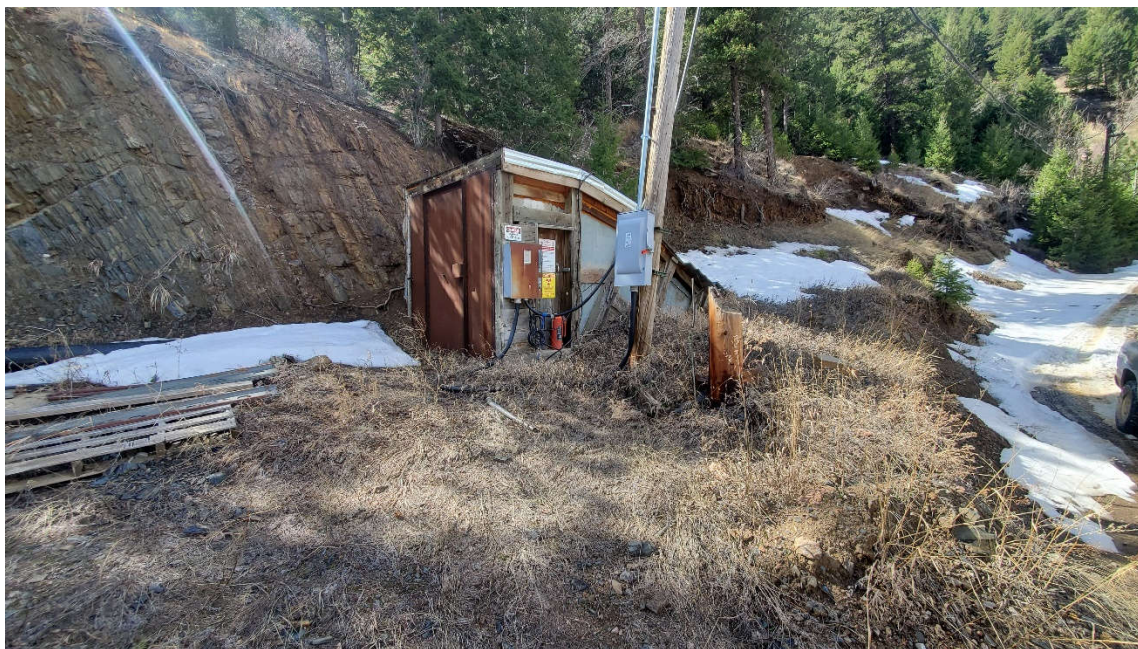
**FIGURE E-1: PHOTOS OF MINE OPENING CLOSURES**

**(E) Sunshine Decline, April 2022**

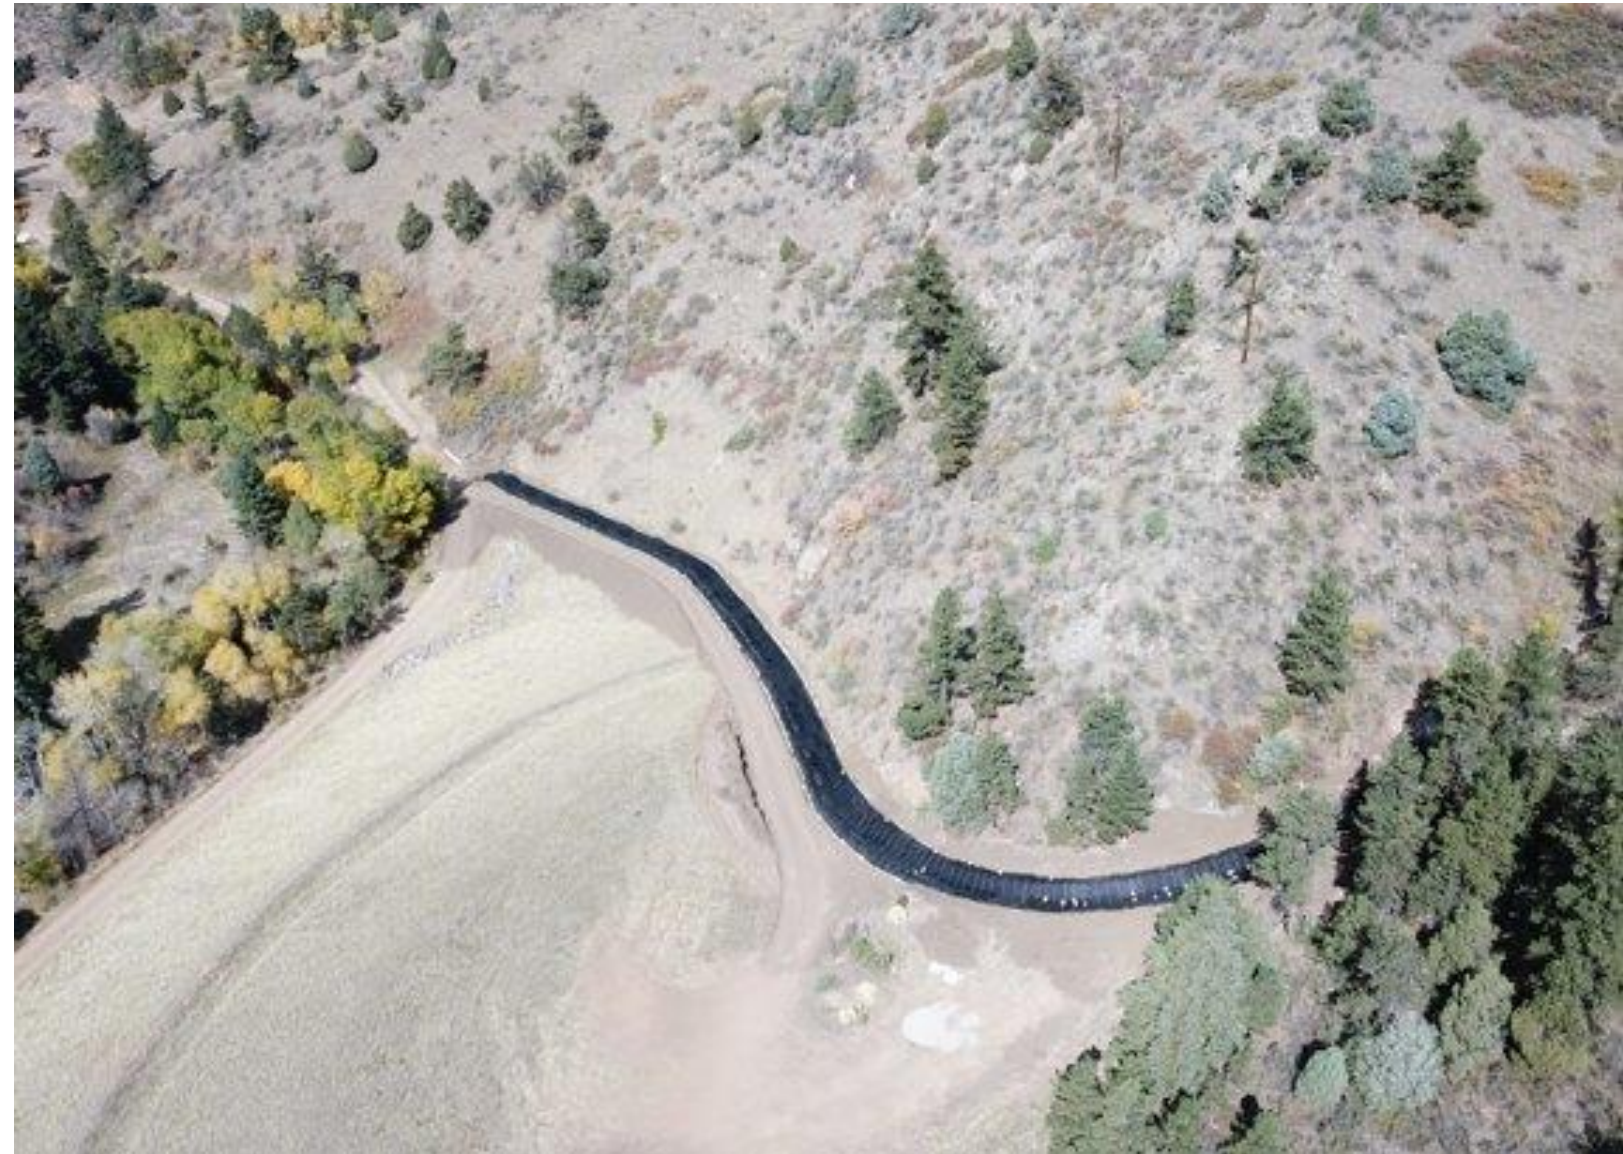
Fall 2020: NWRP channel during construction

- North Waste Rock Pile Construction Project was completed in 2020 (Technical Revision #28).
- Objective: Intercept and divert storm water around the North waste rock pile, prevent infiltration of runoff through the North waste rock pile, and avoid leaching of waste rock into Ralston Creek.
- Liner Materials: 4-inch thick Geoweb liner filled with concrete, underlain with impermeable geosynthetic liner (DuraSkrim), & non-woven geotextile.

- Waste rock dumps: In 2020, CLL constructed a diversion channel on the North Waste Rock Pile (NWRP). This channel diverts run-on water around the NWRP. Subsequent to the installation of this diversion, mass loading from the NWRP into Ralston Creek is now considered de minimus as observed seeps in the area of the NWRP have been largely eliminated.

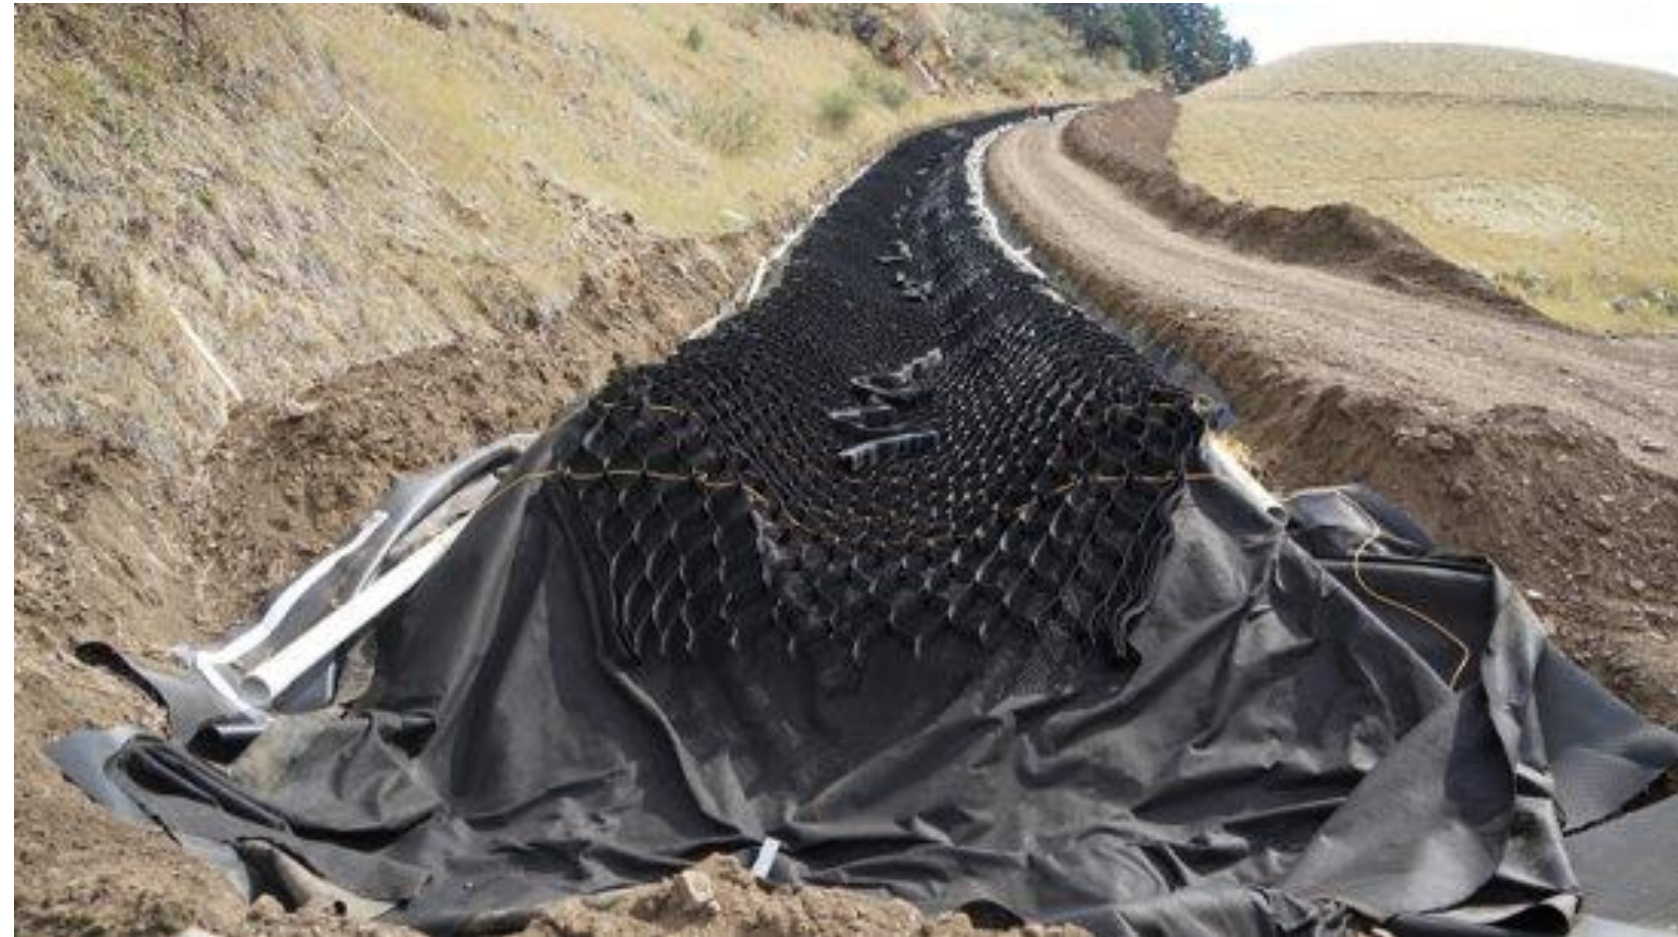
Fall 2020: NWRP channel during construction

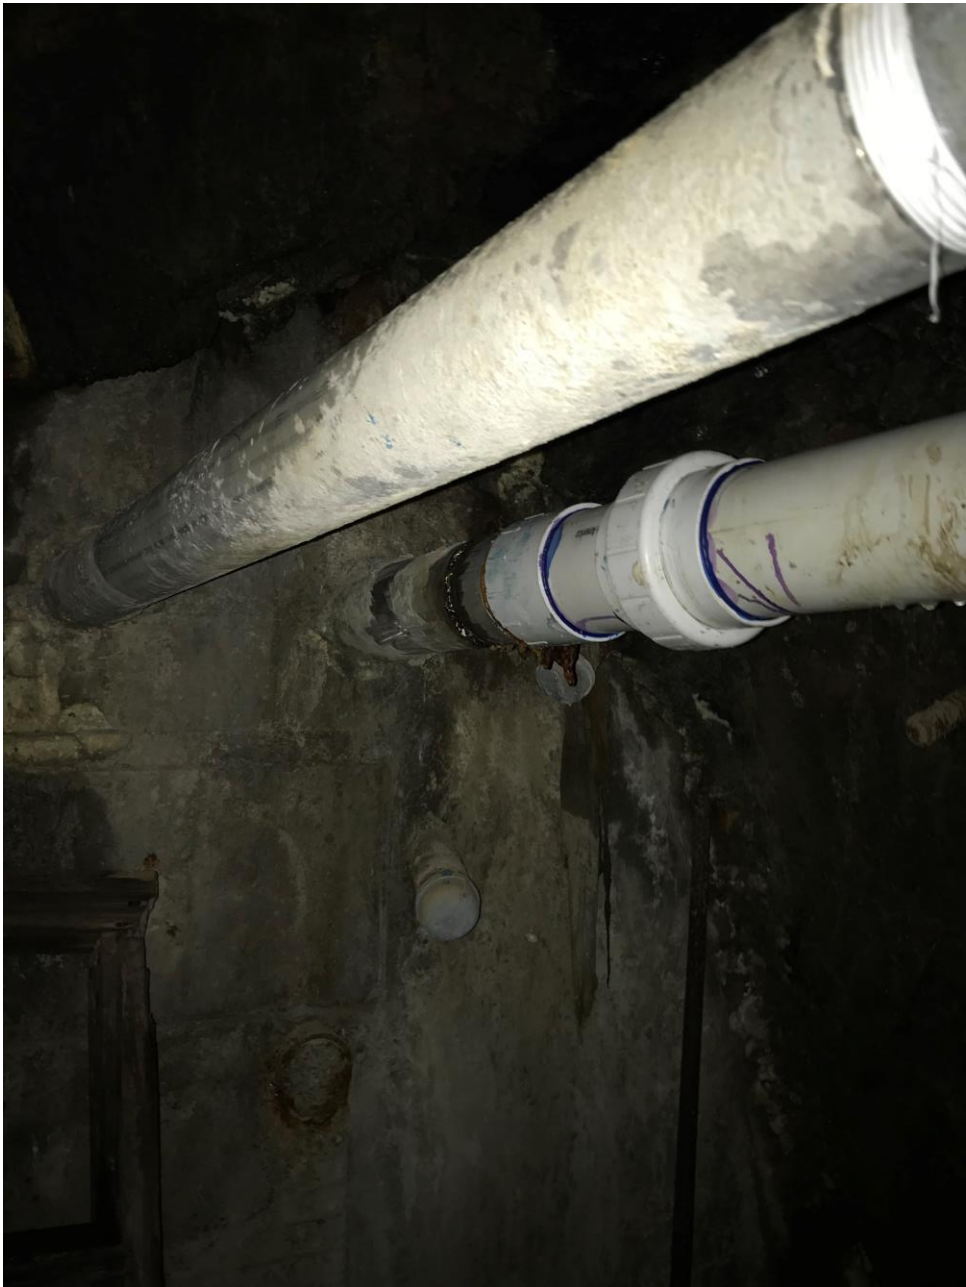
- The RO concentrate is injected into the deep mine workings through the Steve bulkhead into pipeline that discharges at the 1,100 level.
- The RO concentrate remains isolated in the deep workings because of inward hydraulic gradients.

Piping through Steve bulkhead

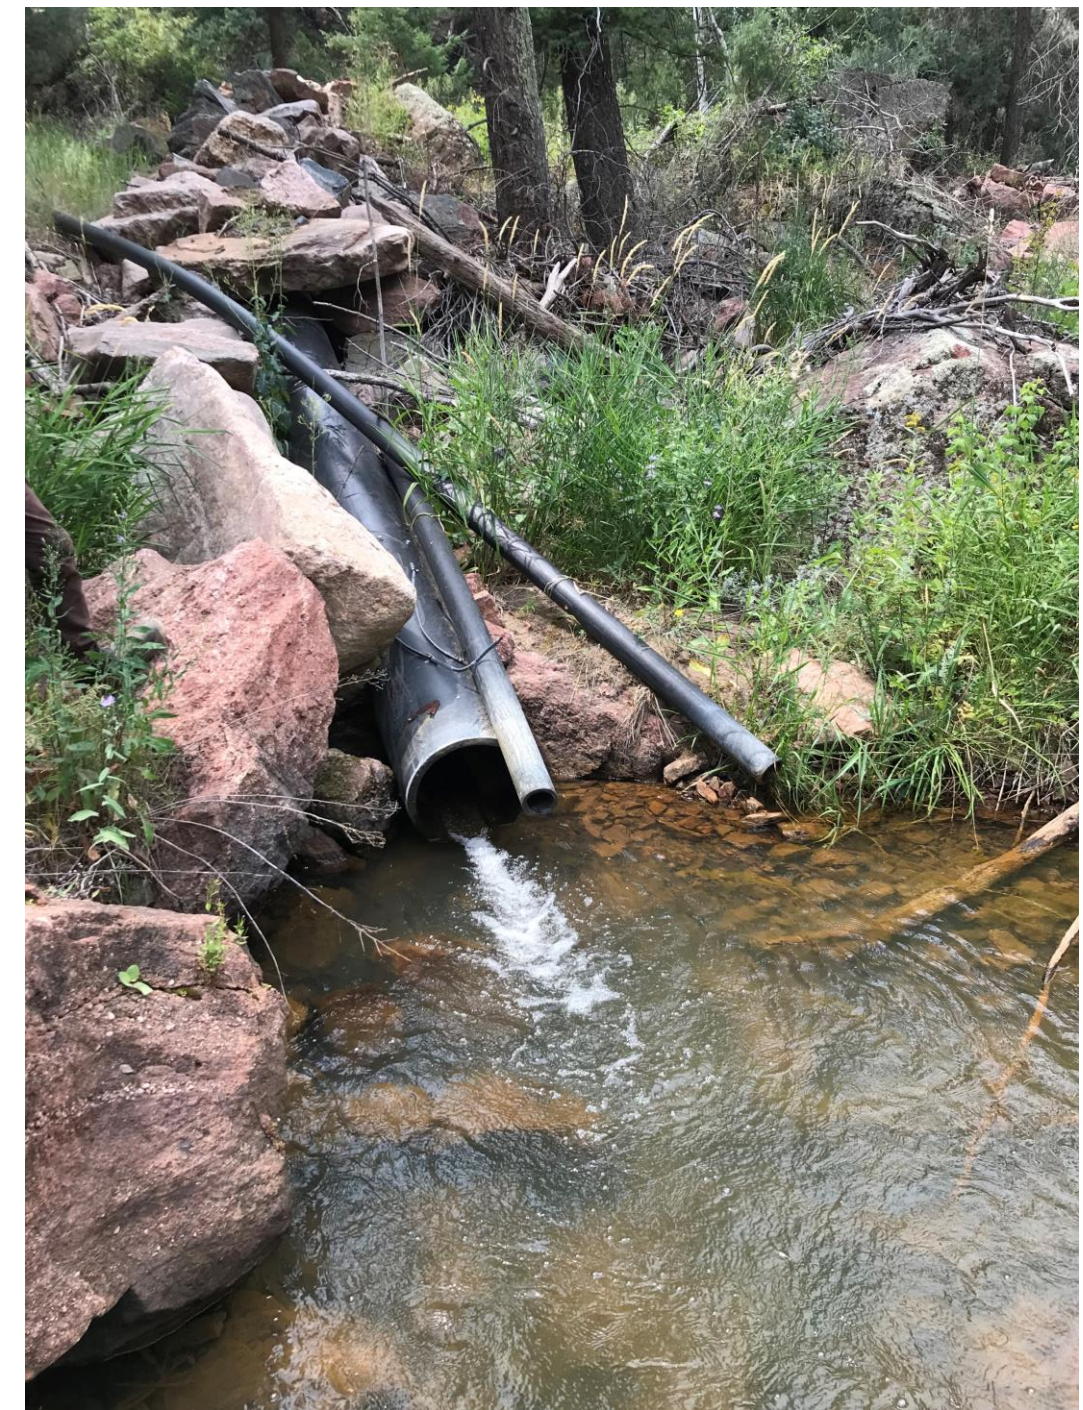
Spring 2018: Surface Water Sampling Station (SW-BPL).

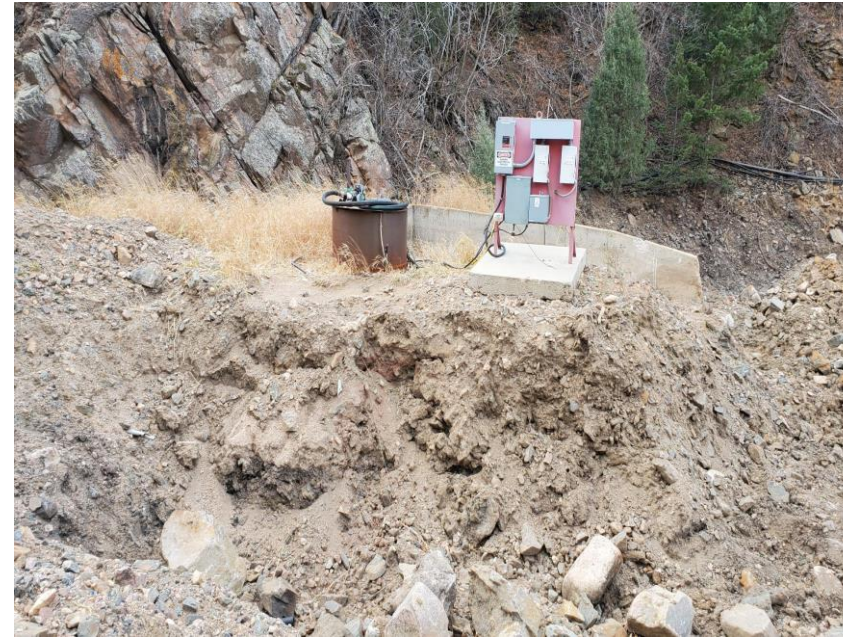
- Sumps were installed in 2011-2012 (Technical Revision #15) to prevent shallow alluvial water (from recognized contamination in alluvium and flooded mine pool) from leaving site.
- Sumps are large-diameter extraction wells installed in the alluvium and upper fractured bedrock.
  - CLL identified contaminated alluvium surrounding each sump and expects to remove all sumps to directly address source area contamination.
- 2021 Conditions: With the current dewatered mine pool, and bypass pipeline in place, sumps are typically dry. They only collect precipitation immediately following storm events.

Nov. 2021: Sump 1 near excavation area

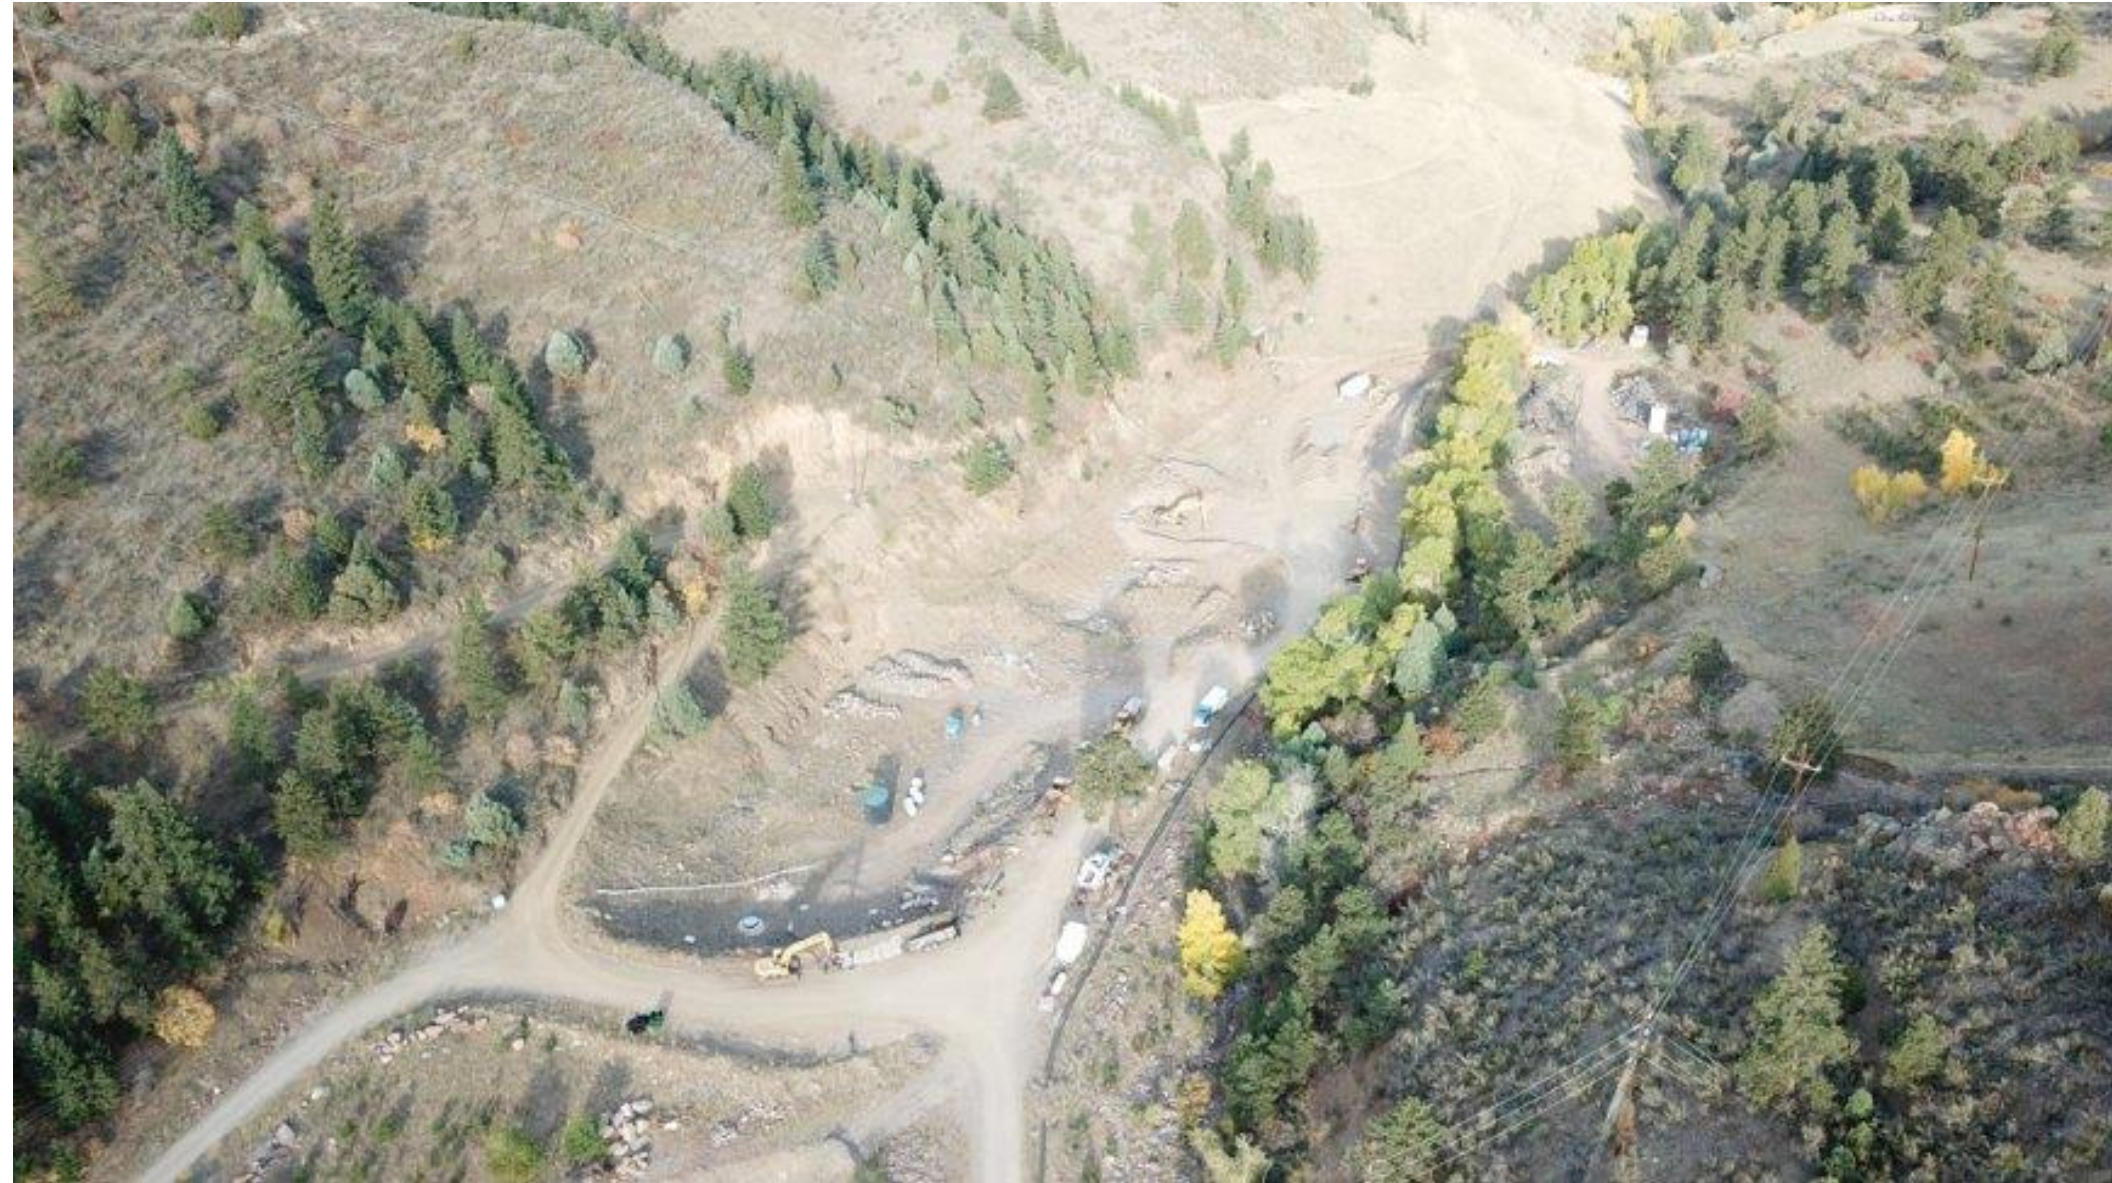
Fall 2021: Alluvial valley excavation.

- Alluvial valley excavation began in 2018 and is expected to finish in 2022. This work was originally scoped in 2011 (Technical Revision #14.)
- Objective: Remove any materials with the potential to leach uranium to groundwater above 0.03 mg/L.
  - Sumps and bypass pipeline have helped to dry out the alluvium for excavation work.
- Current excavation extents:
  - Yellow line = horizontal extent of contamination
  - Orange hatched area = vertical extent of excavation to bedrock.

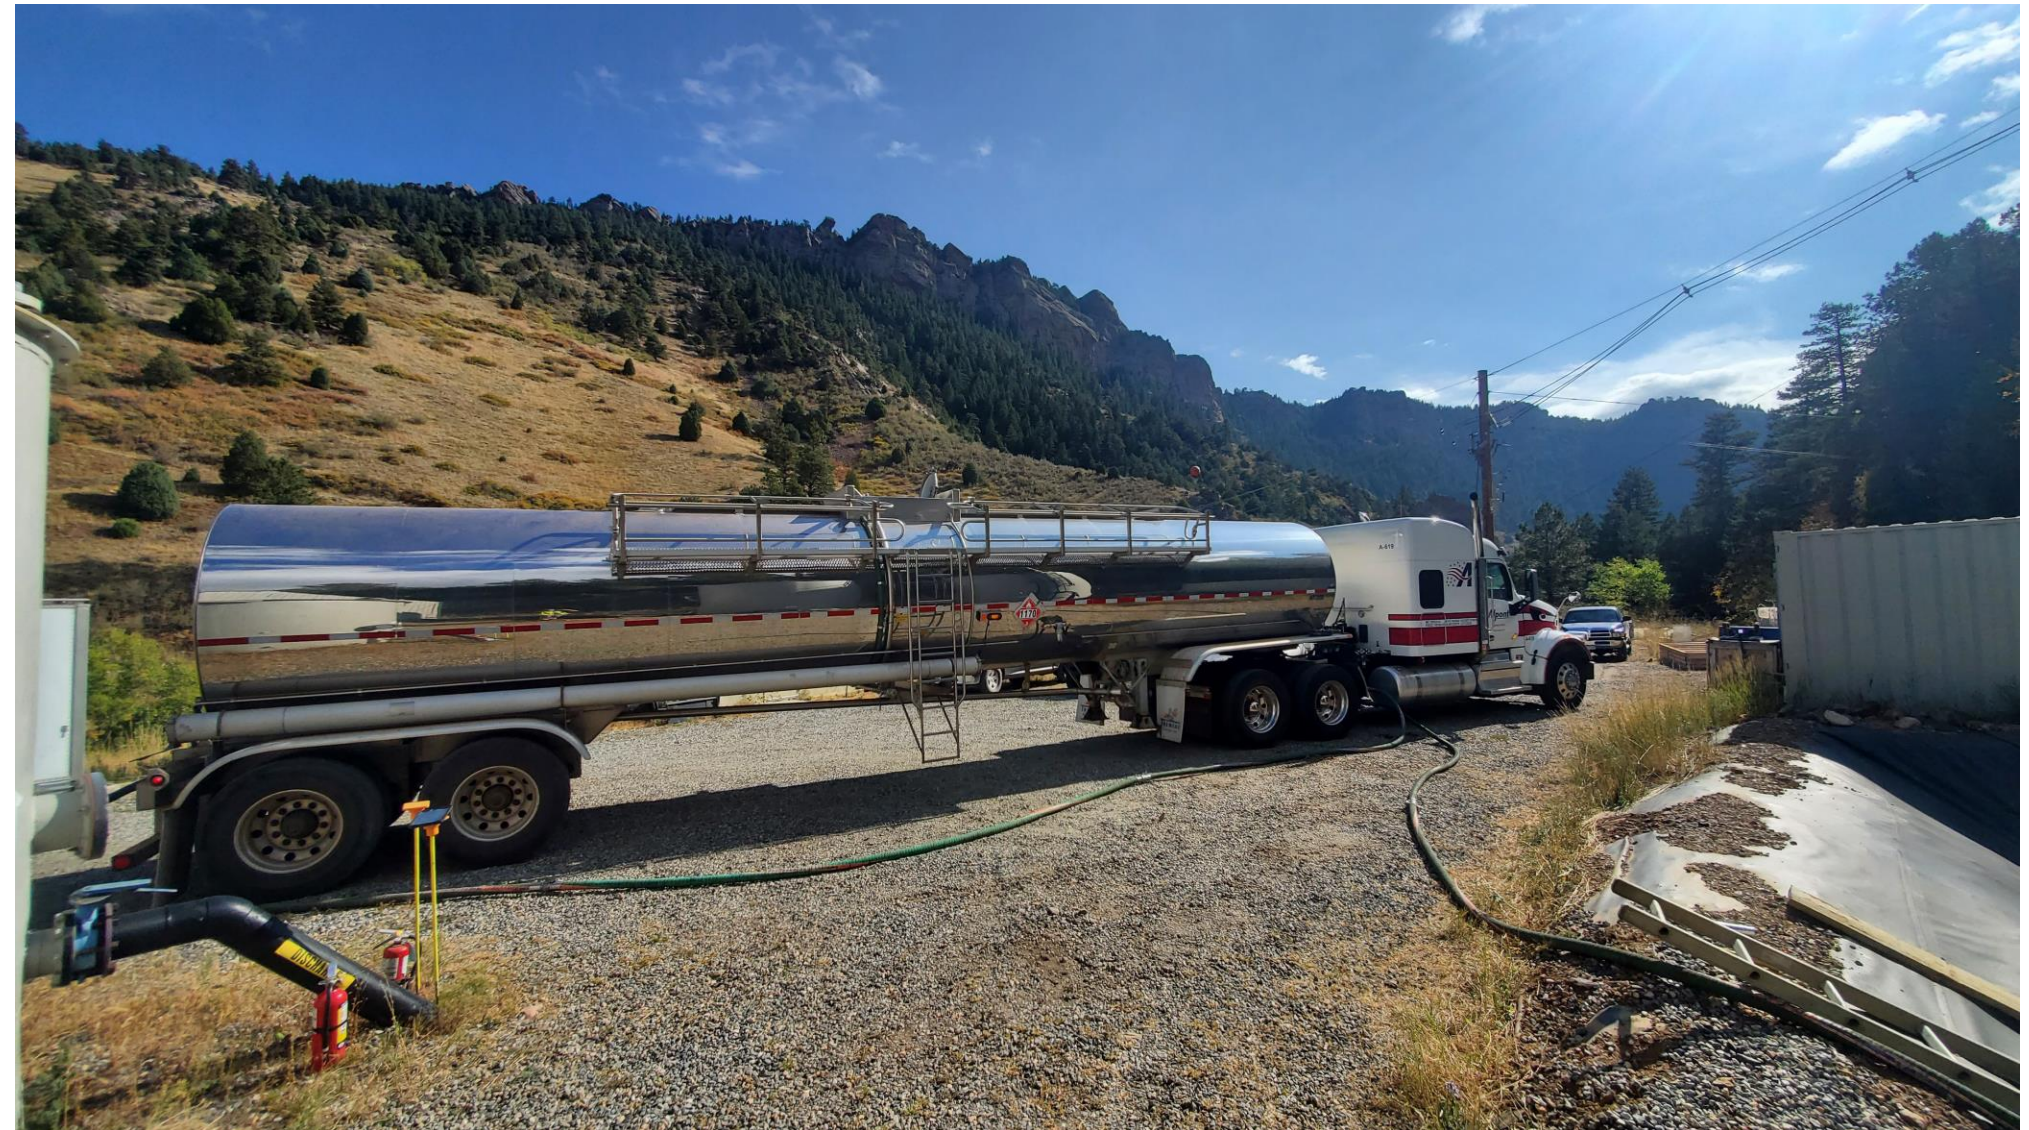
September 29, 2021. In-situ Injection Delivery

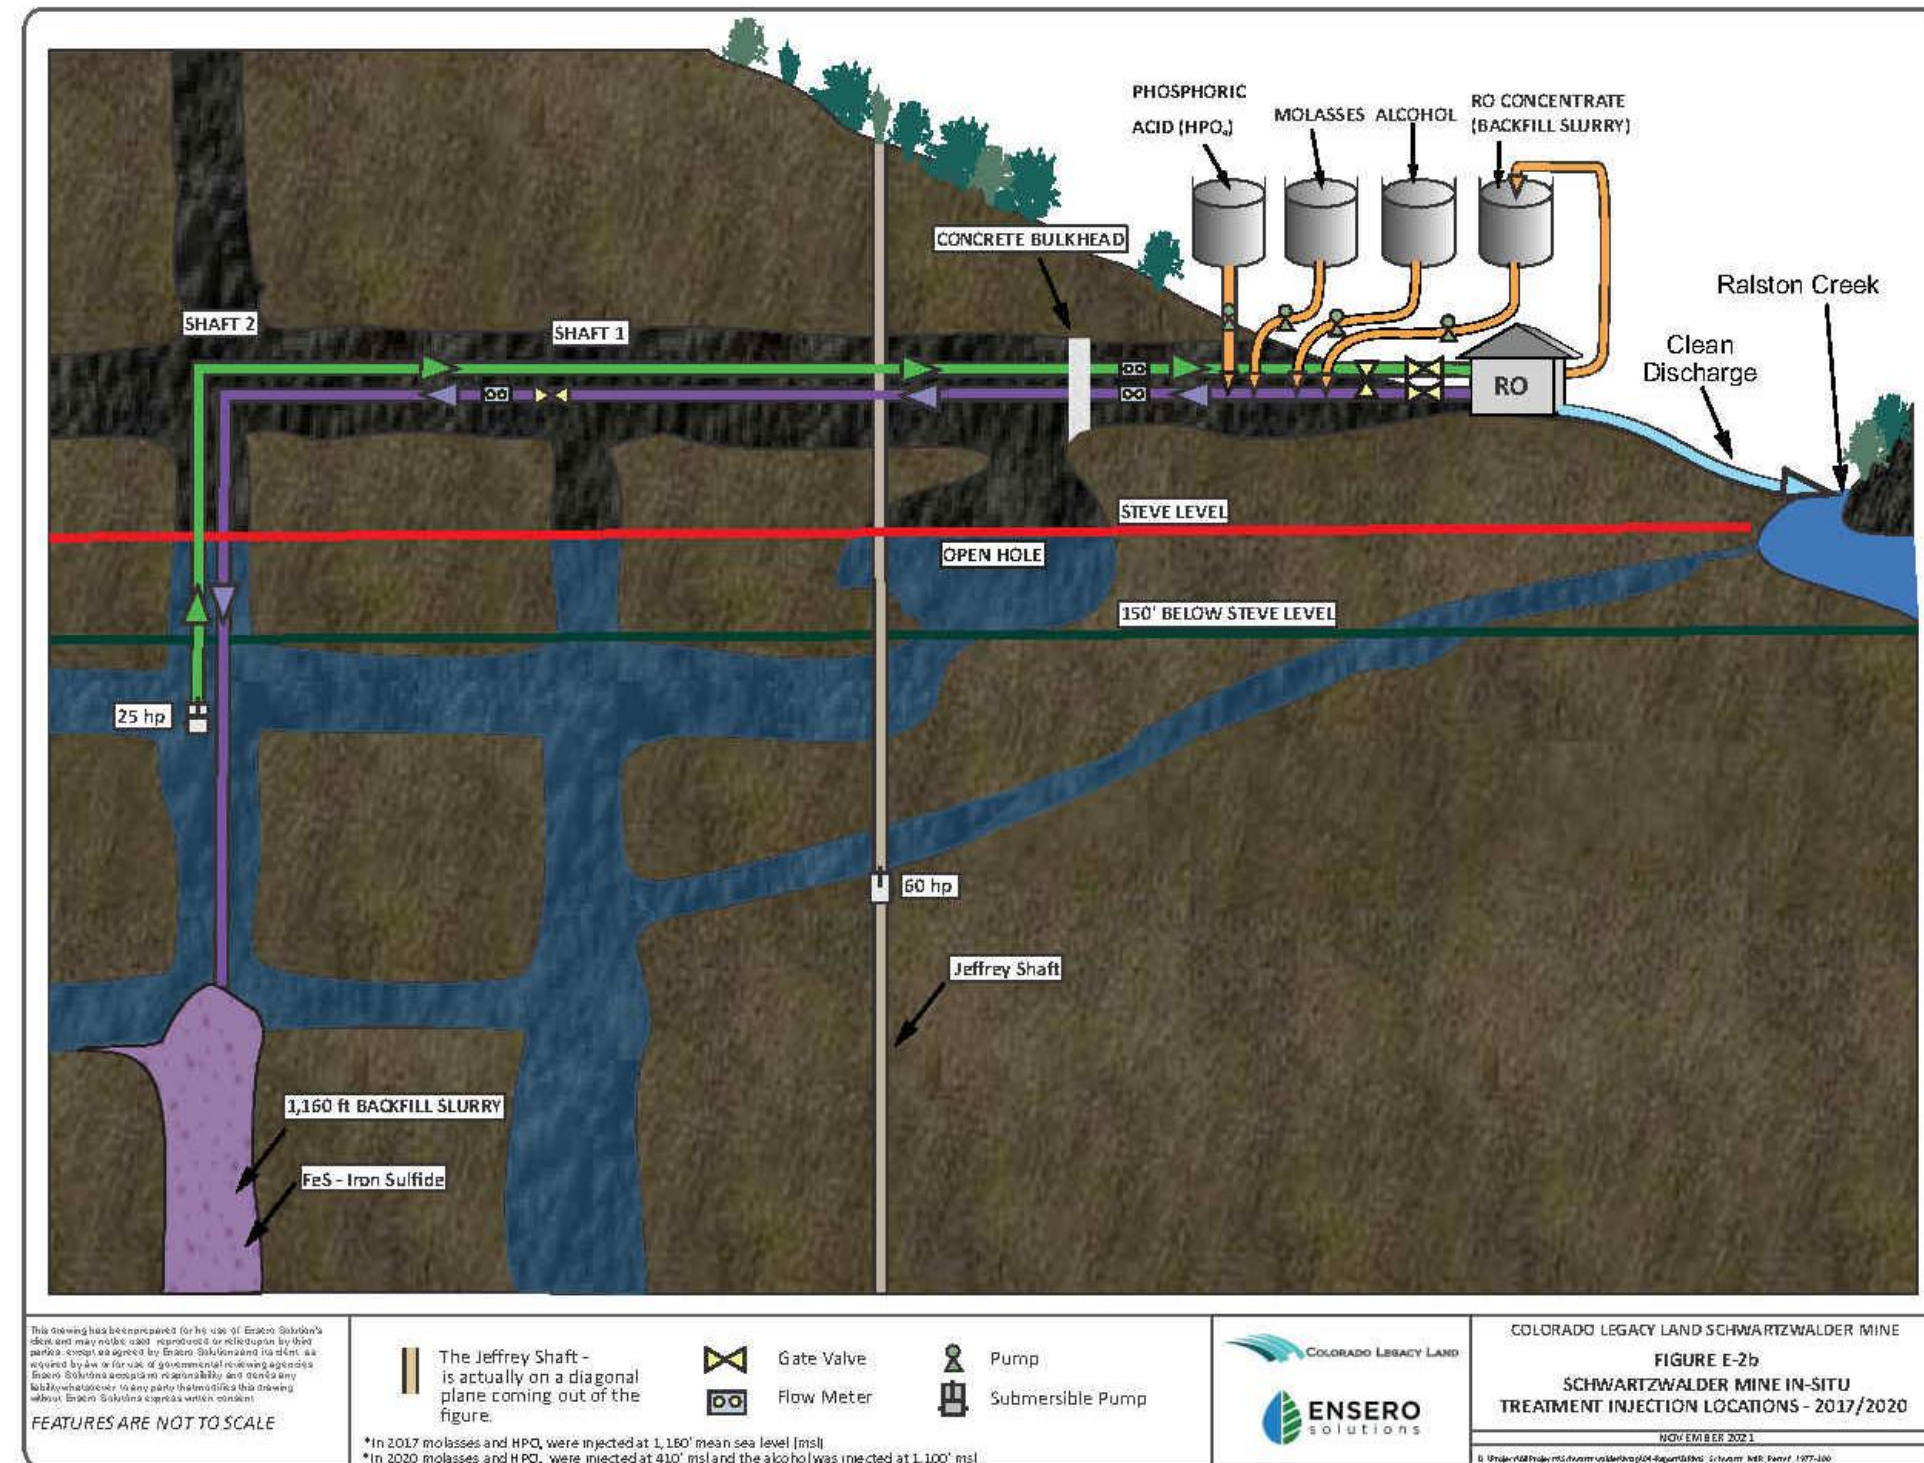
Schematic for 2017, 2020, and 2021 in-situ injection

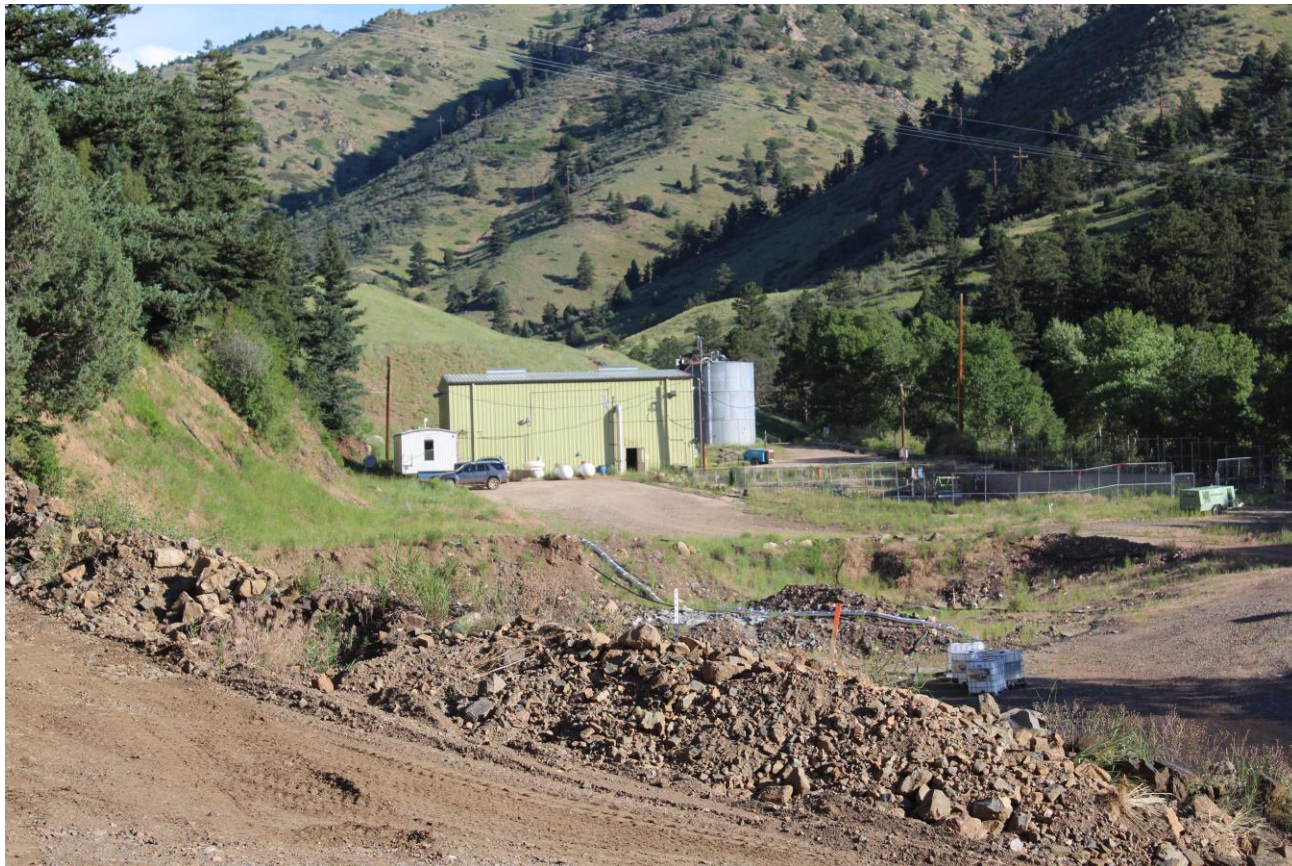
- Reroute sump collection and relocate utilities.
- Demolish old water treatment plant, office trailer, concrete containment, parking apron

Spring 2018: Old Water Treatment Plant
