## Schwartzwalder Mine Revised AM-06

**Subject:** Response to Third Adequacy Review  
Application Amendment #6  
Mine Land Reclamation Permit M-1977-300, Schwartzwalder Mine, Golden, Colorado

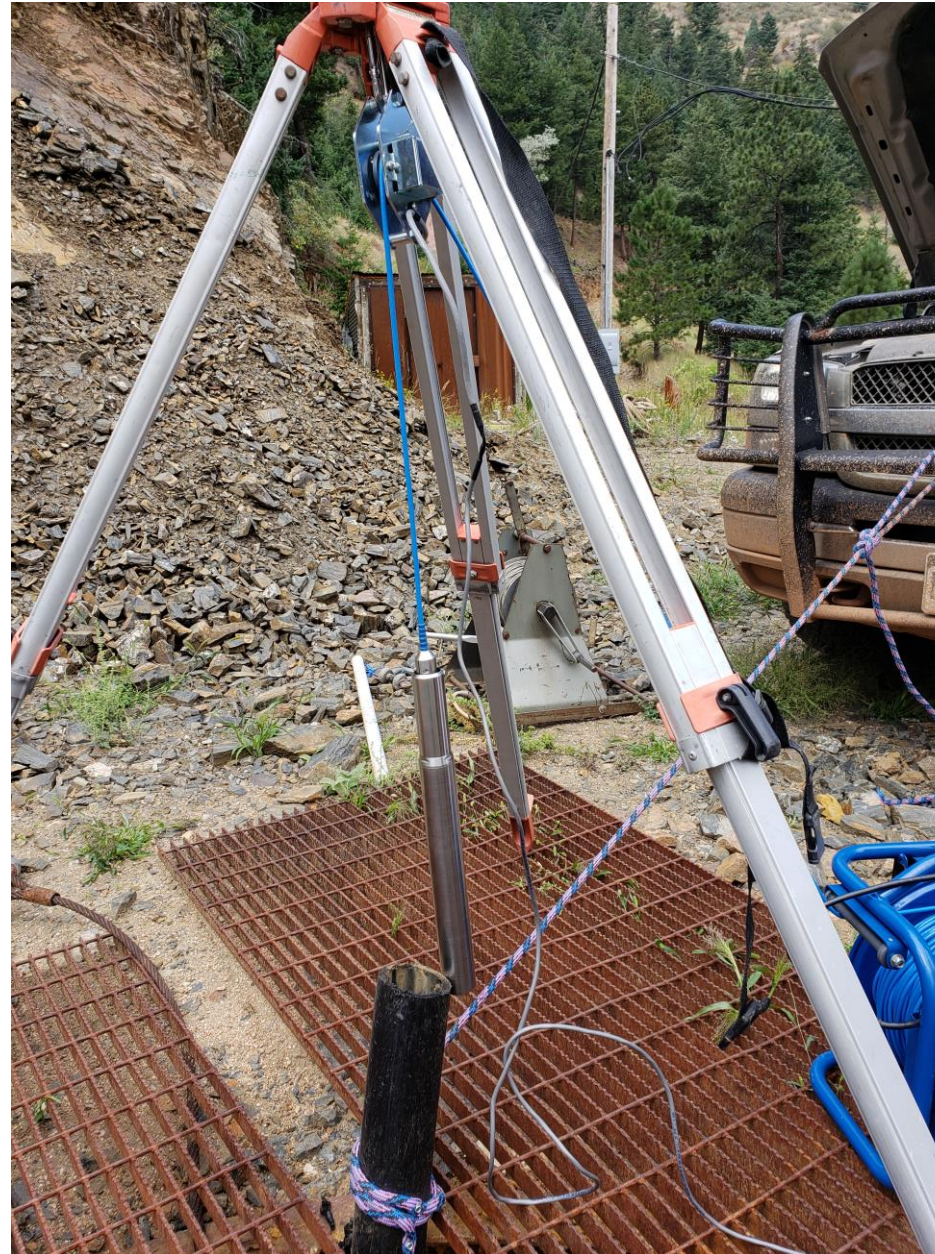
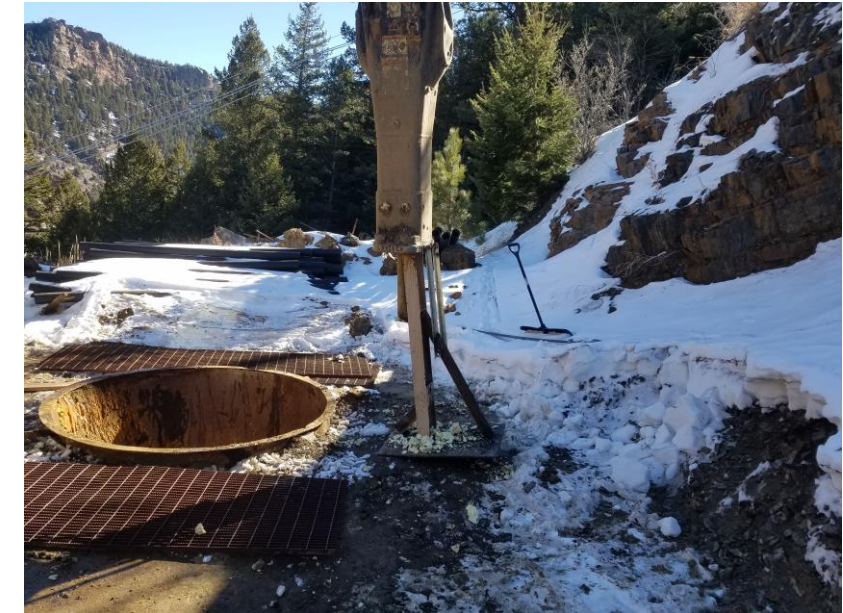
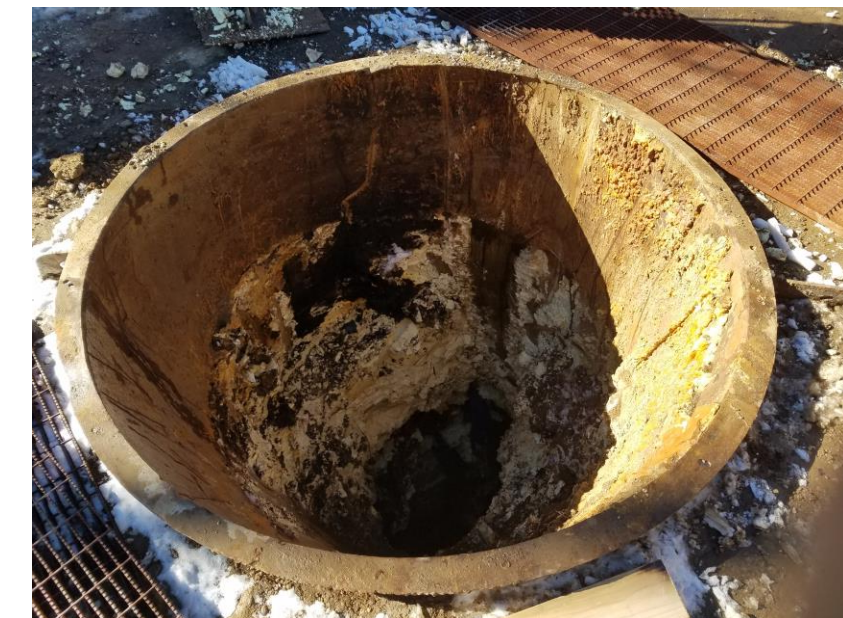
- Winter 2018 – 2019. Began installation of 60 hp pump in Jeffery Air Shaft to allow for seasonal operation of WTP.
- Uncovered air shaft and performed down-hole camera inspection.
- Technical Revision #26.

Winter 2018-2019: 60HP Intake Pump

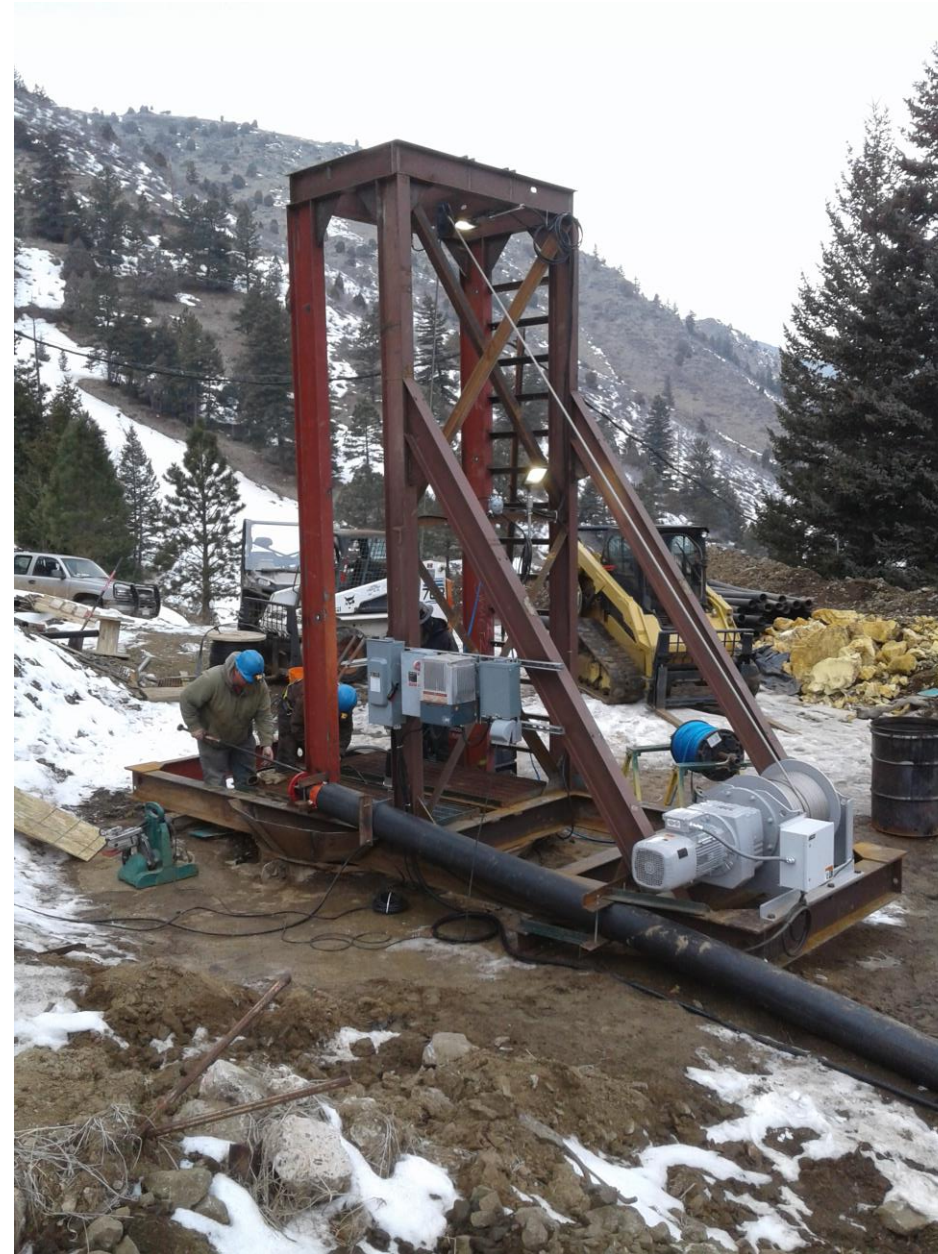
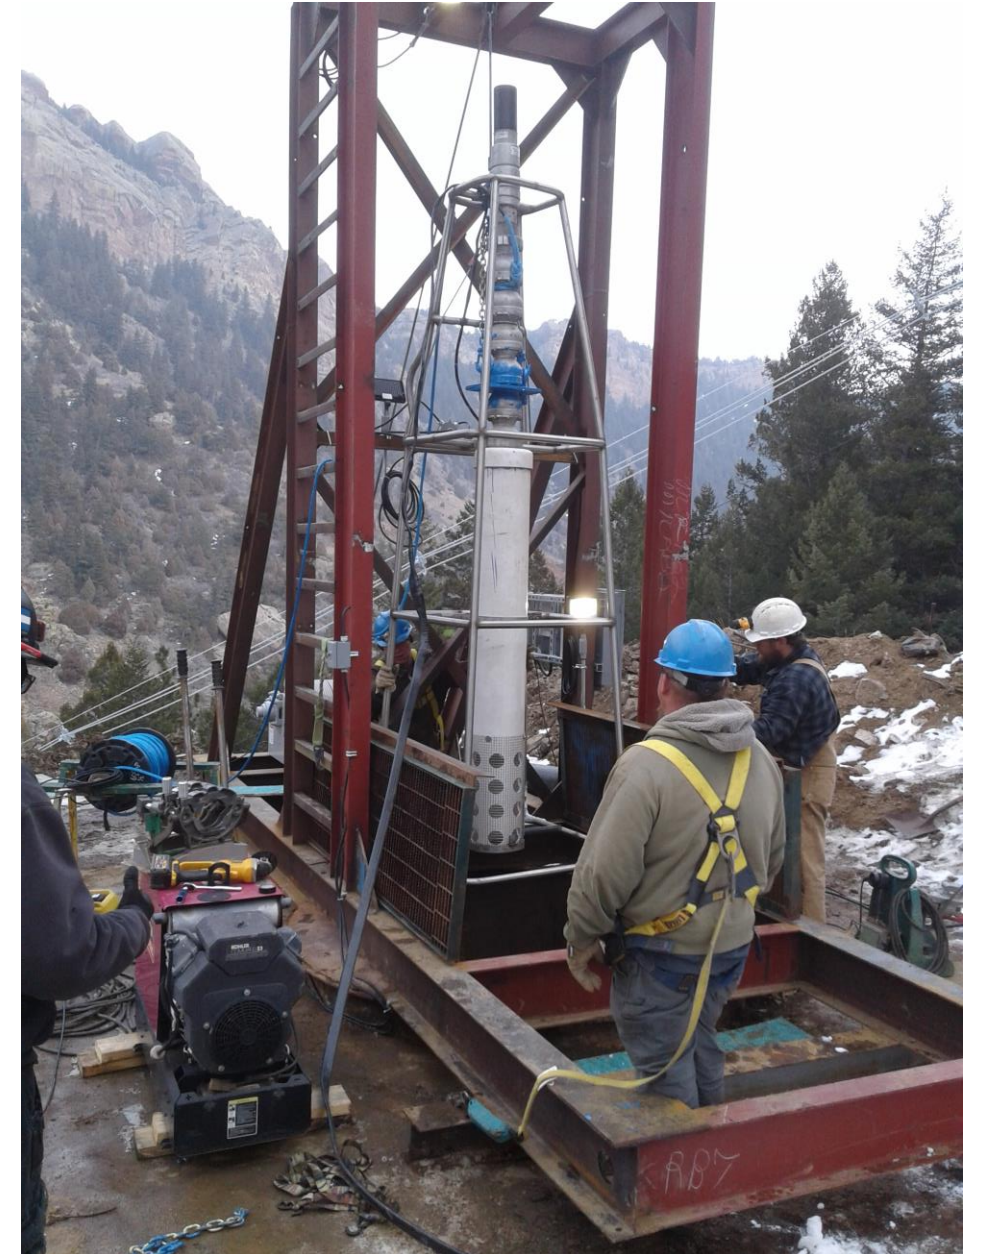
- Winter 2018 - 2019.
- Construct headframe, design pump & connect discharge line to WTP on mesa.
- Headframe / wench system allow CLL to service the pump without going underground.
- Intake at ~410 feet below the Steve Adit.
  - Jeffery Air Shaft is not perfectly straight.

Winter 2018-2019: 60HP Intake Pump

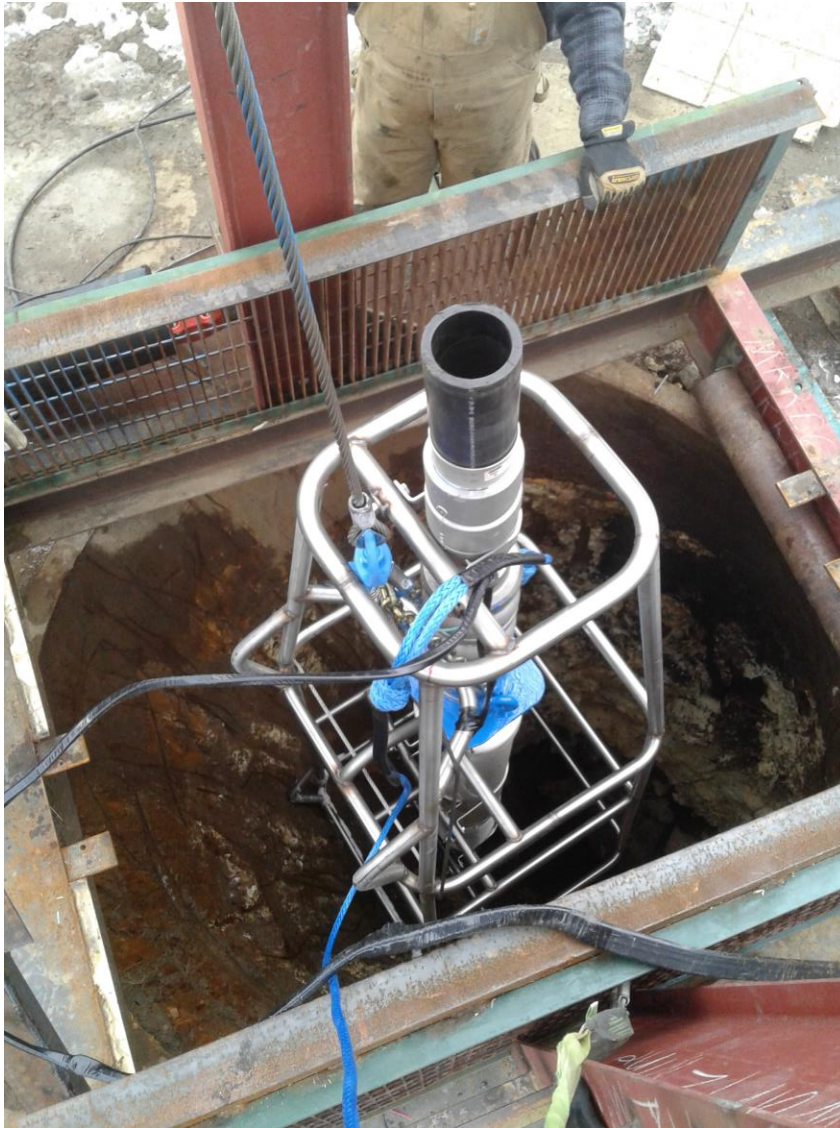
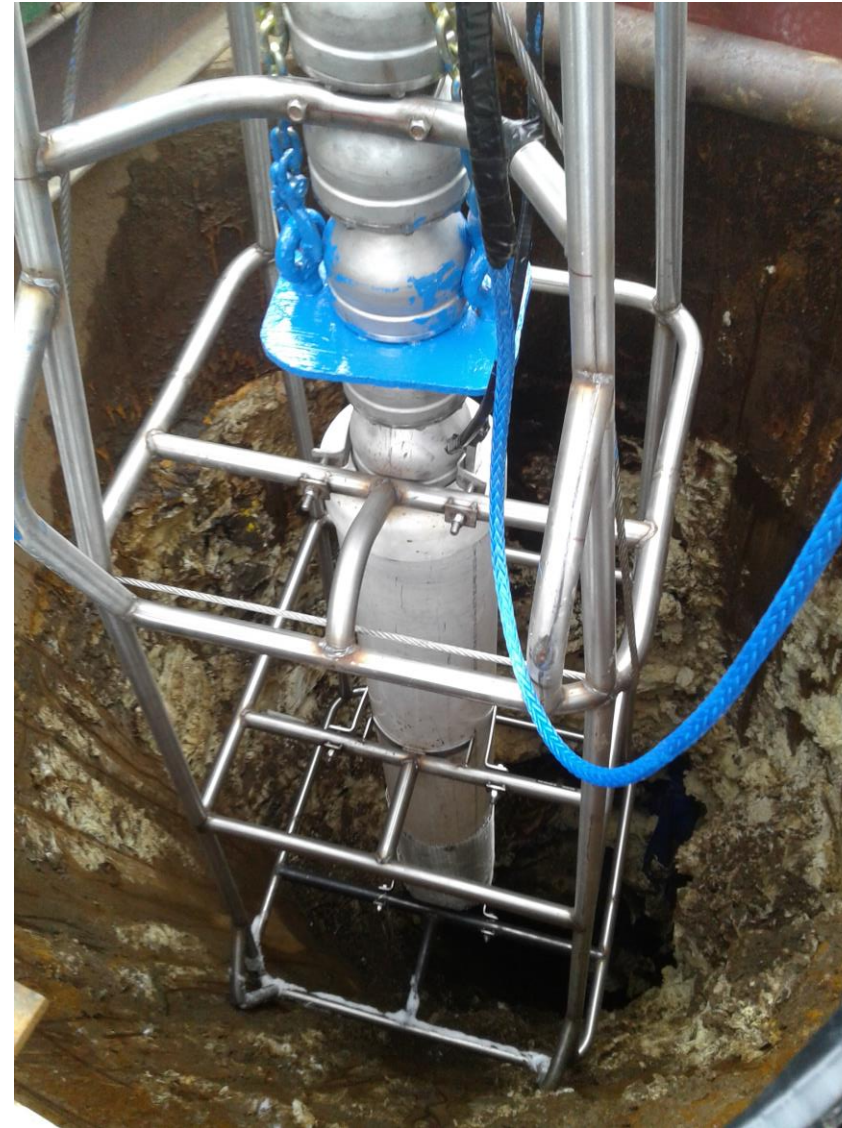
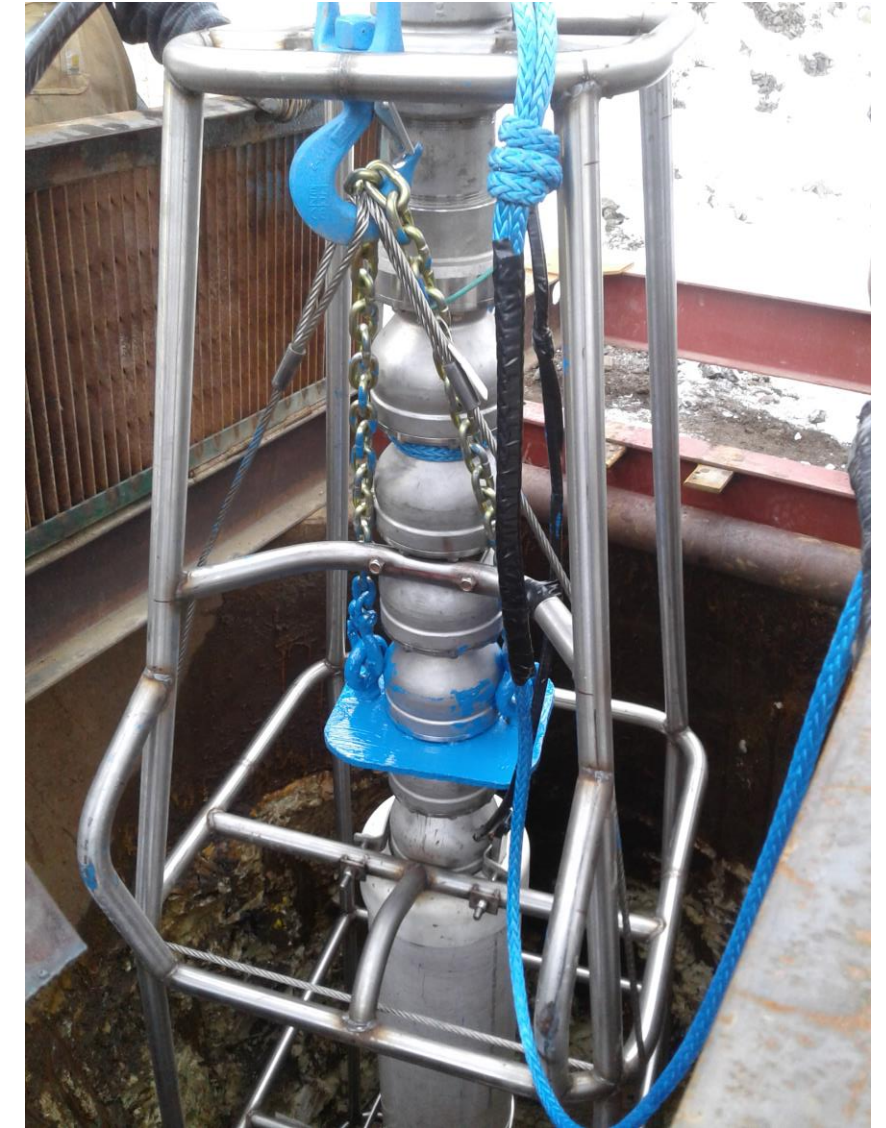
- Winter 2018-2019: Lower new pump to depth and perform commissioning.

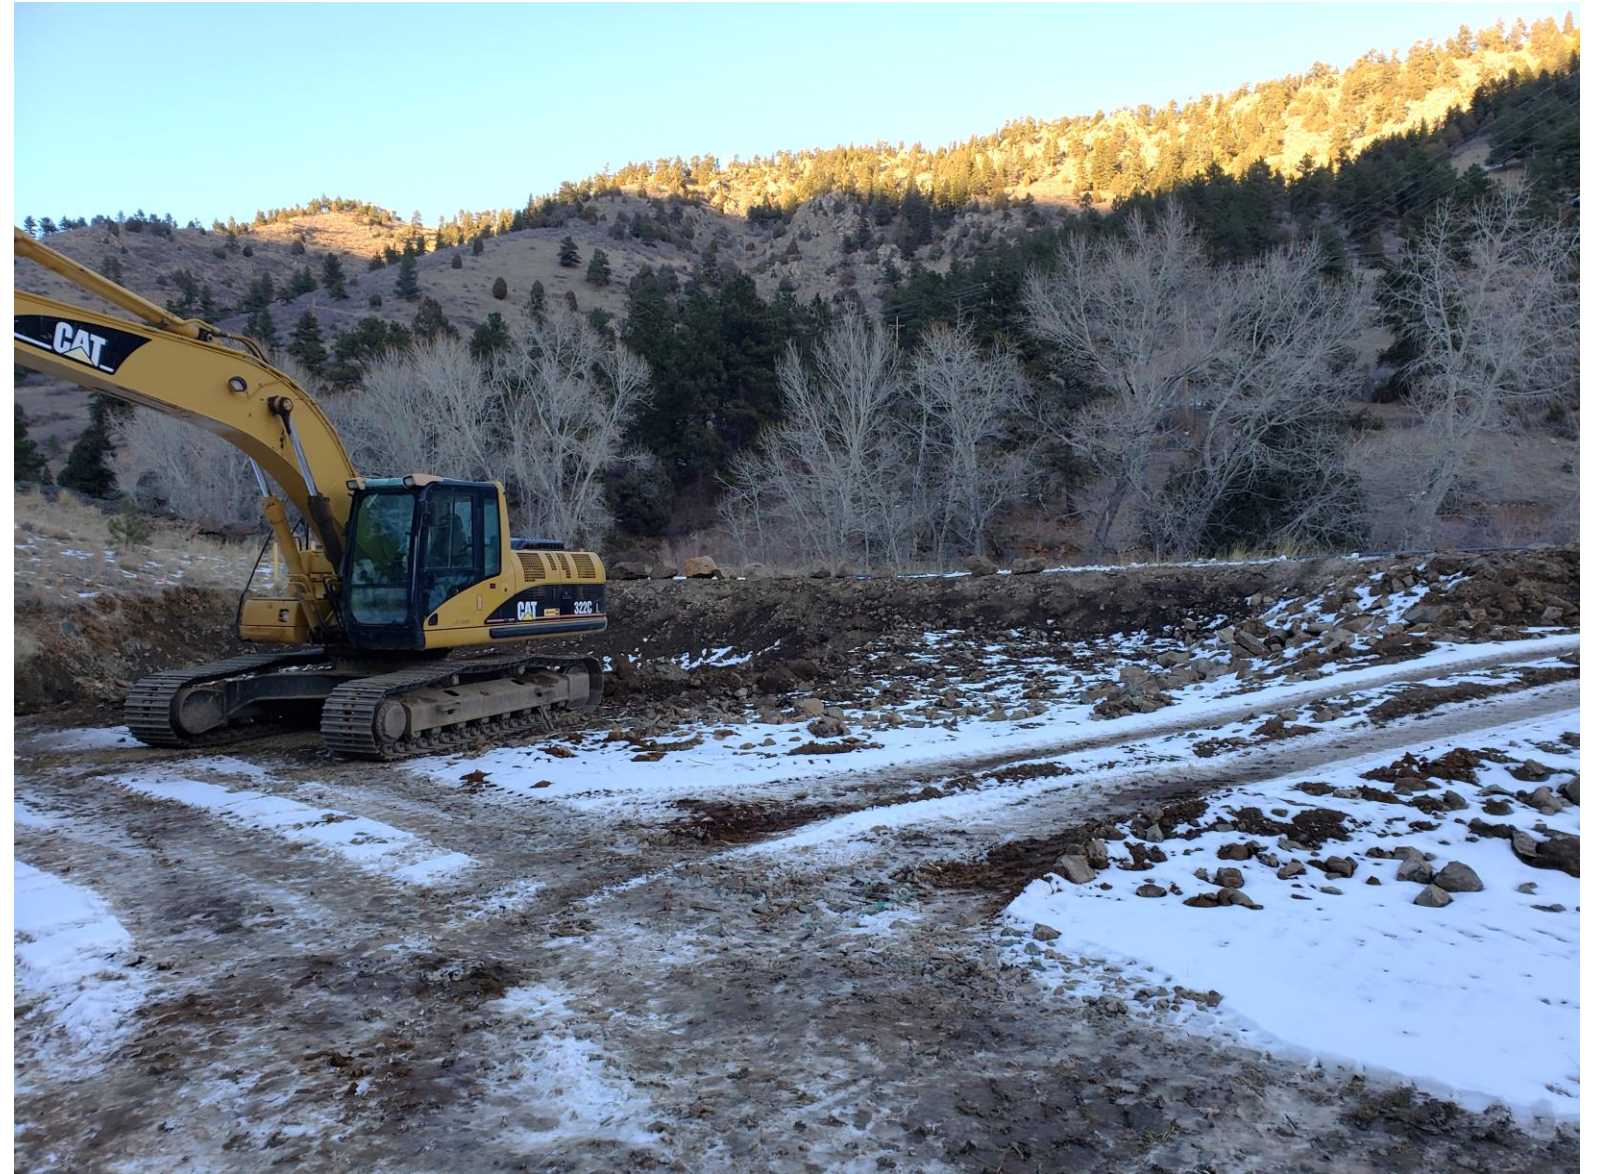
Winter 2018: Alluvial Valley Excavation

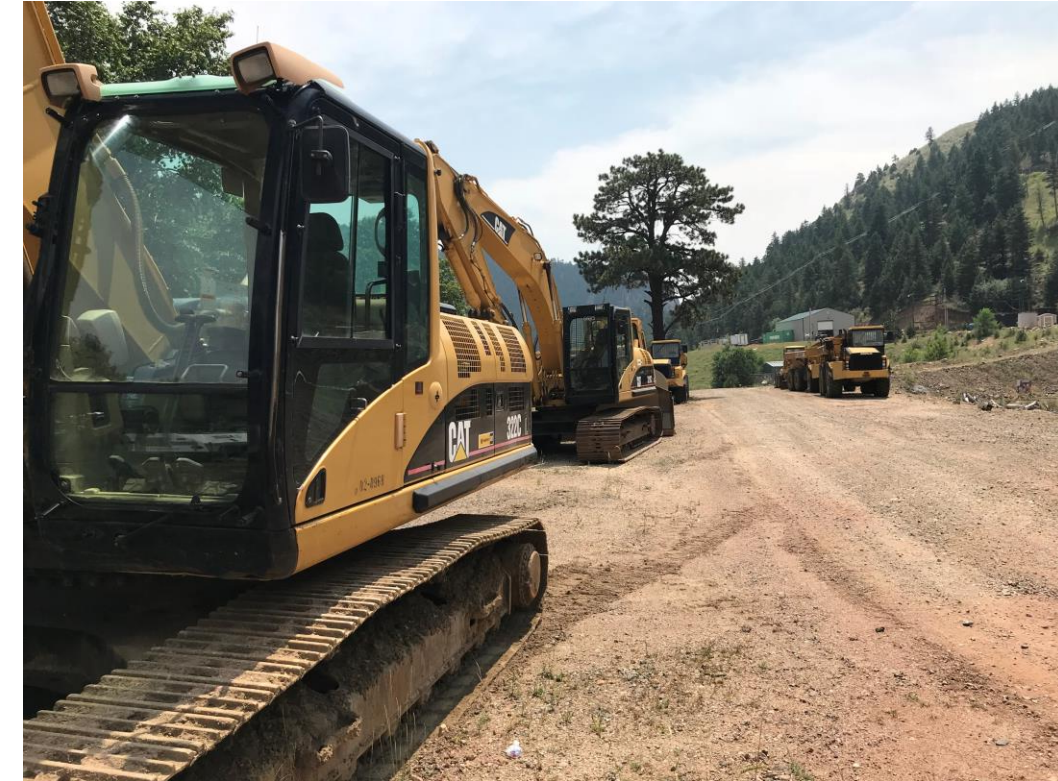
- Demolition and site prep (2018).
- Relocate Water Treatment Plant (2018).
- Install new intake pump (2018-2019).
- North waste rock pile diversion channel (2019- 2020).
- Alluvial valley excavation (2018 – present).
- Mine opening closure (2022).
- Excavation has removed alluvium around all sumps, except for Sump 1, eliminating their usefulness (2020-2021).

Summer 2019: Alluvial Valley Excavation Work

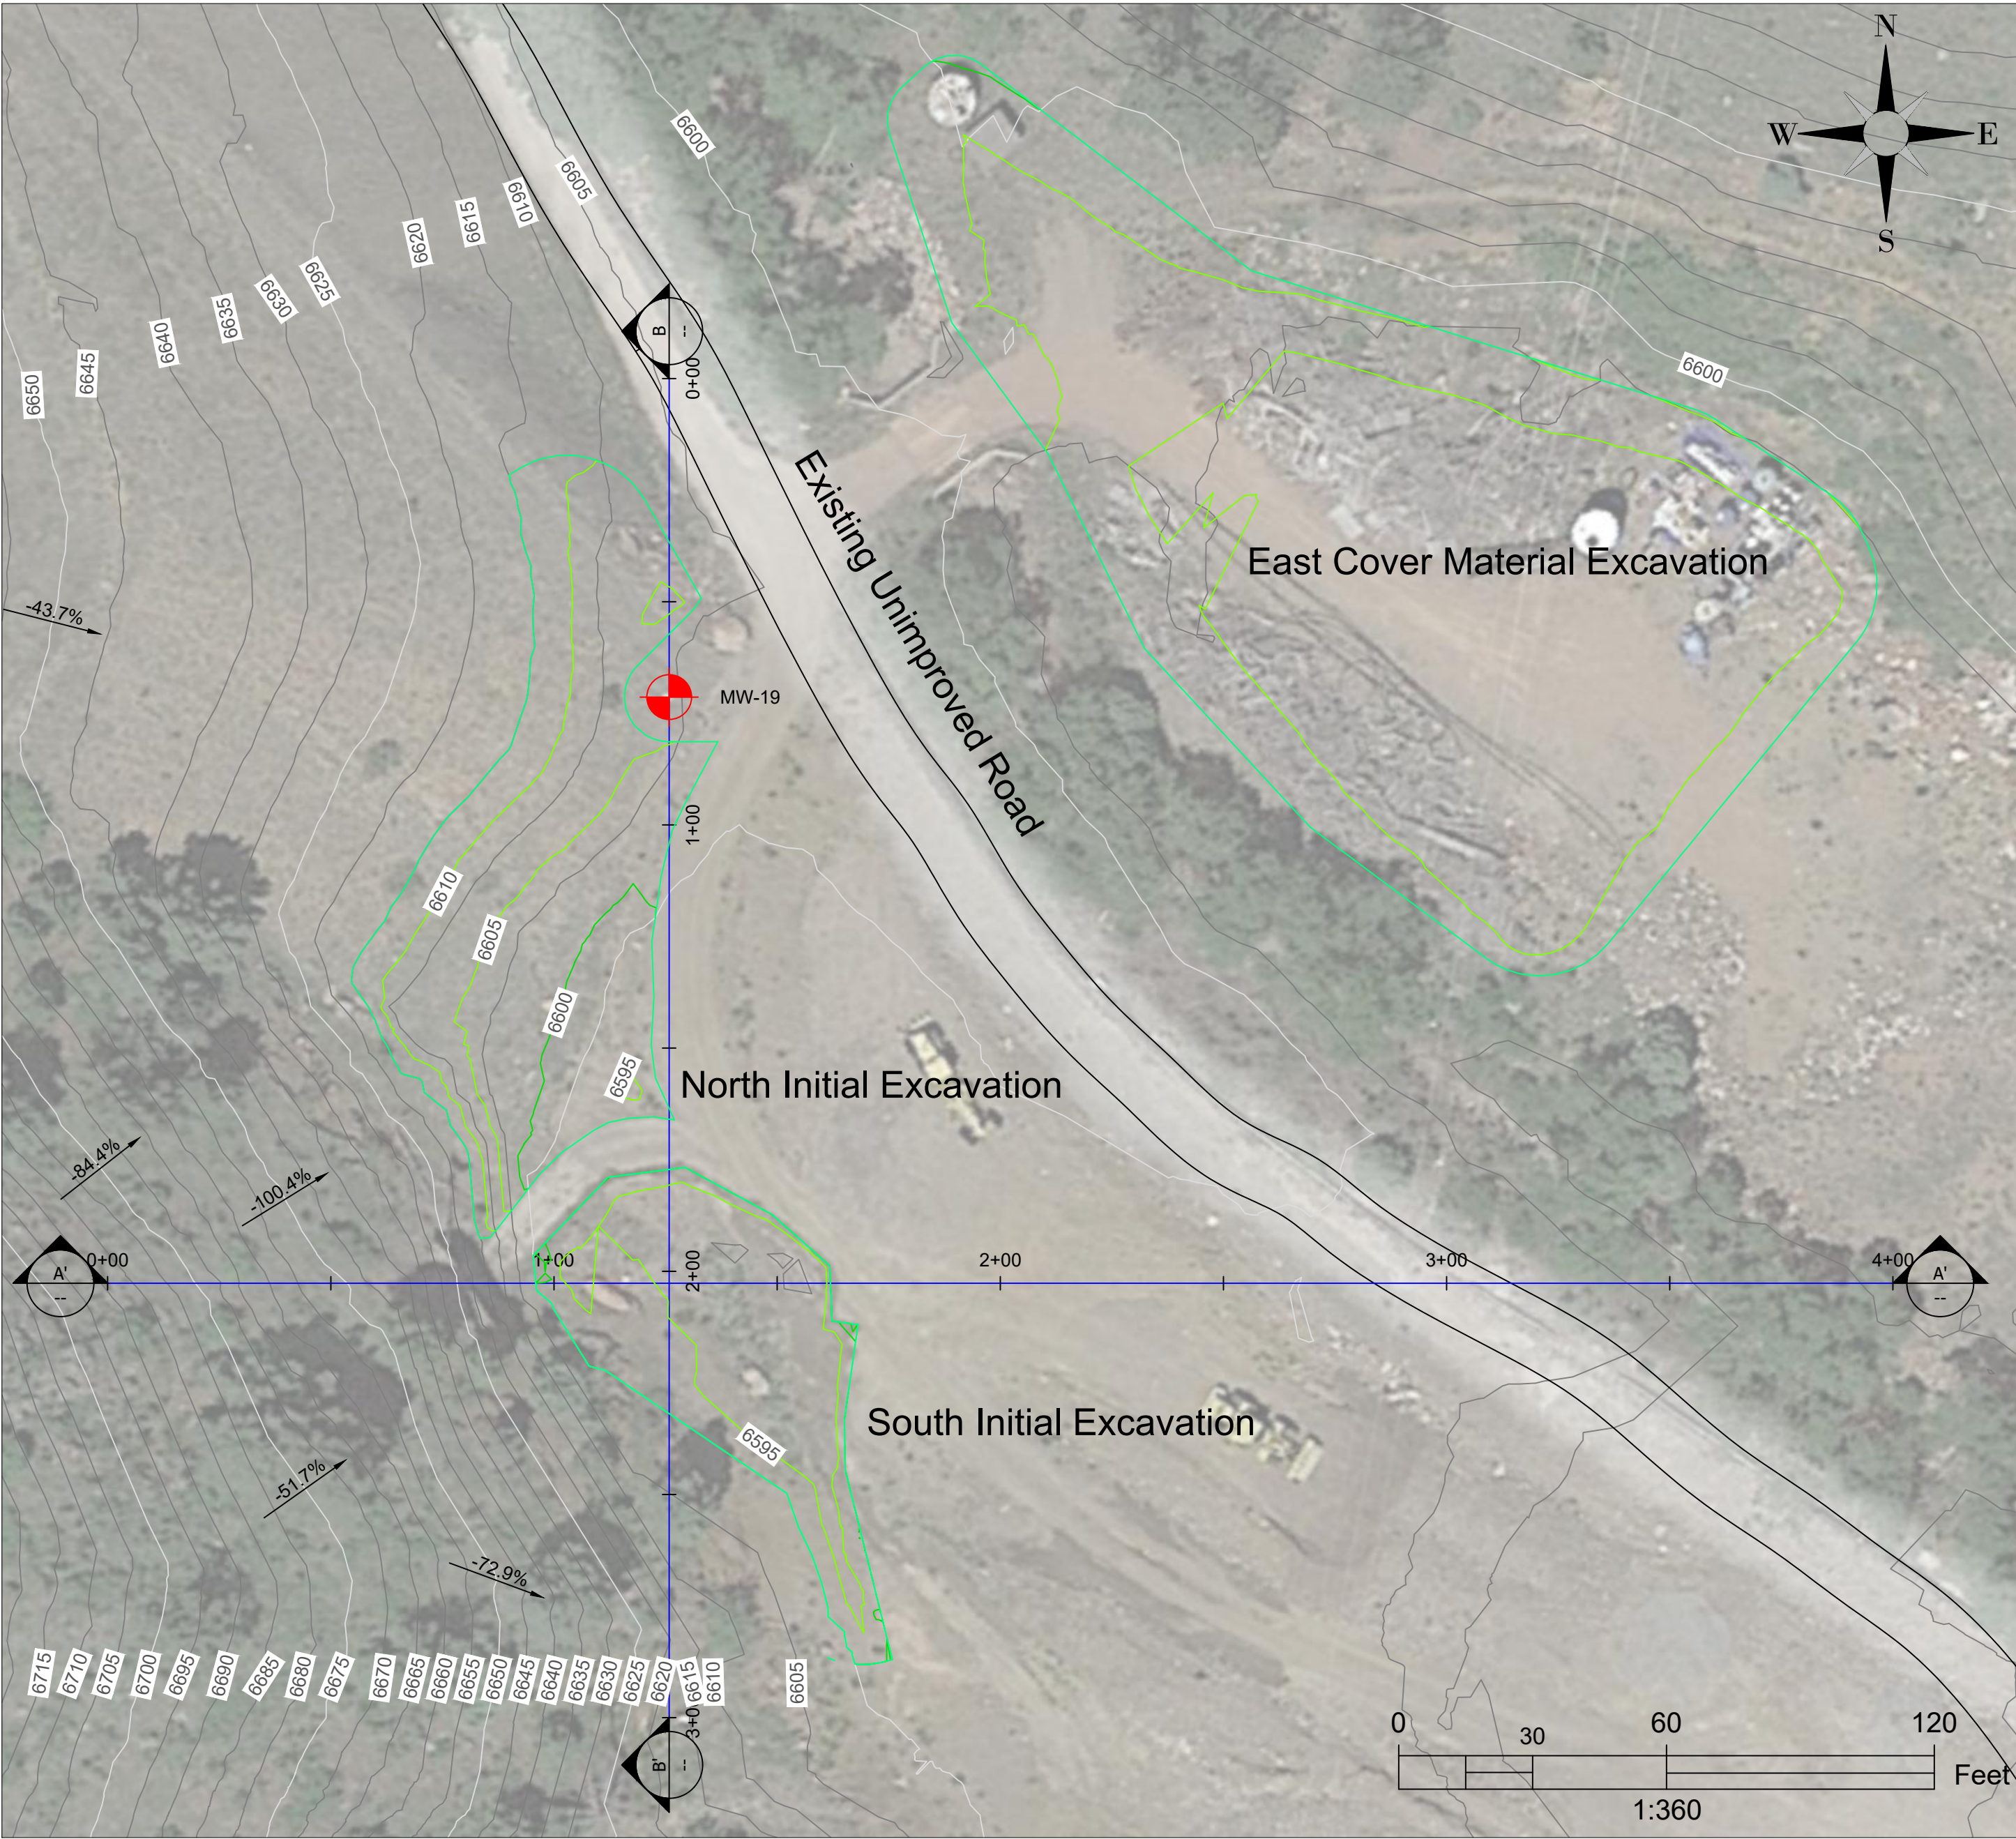
## **APPENDIX 4. SOUTH WASTE ROCK PILE EXTENSION PLAN SET**

- Notes:
1. LIDAR data: U.S. Geological Survey, 20140929, USGS Lidar Point Cloud (LPC) CO\_Denver\_2008\_000056 2014-08-27 LAS: U.S. Geological Survey.
  2. Aerial imagery provided by Bing, circa 2017.
  3. Contour interval: 5ft.
  4. Alignment A-A' bisects the Black Forest Mine Entrance.
  5. Alignment B-B' intersects MW-19.
  6. All excavation areas have perimeter slopes of -33%.
  7. North Initial Excavation 2D surface area: 7,070 ft².
  8. North Initial Excavation cut volume: 450 yd³.
  5. South Initial Excavation 2D surface area: 3,807 ft².
  6. South Initial Excavation cut volume: 200 yd³.
  7. North and South Initial Excavation cut depth is 2 ft. below grade.
  5. East Cover Material 2D surface area: 21,287 ft².
  6. East Cover Material cut volume: 2,940 yd³.
  7. East Cover Material cut depth is 5 ft. below grade.
  8. Profiles have 2:1 vertical exaggeration.

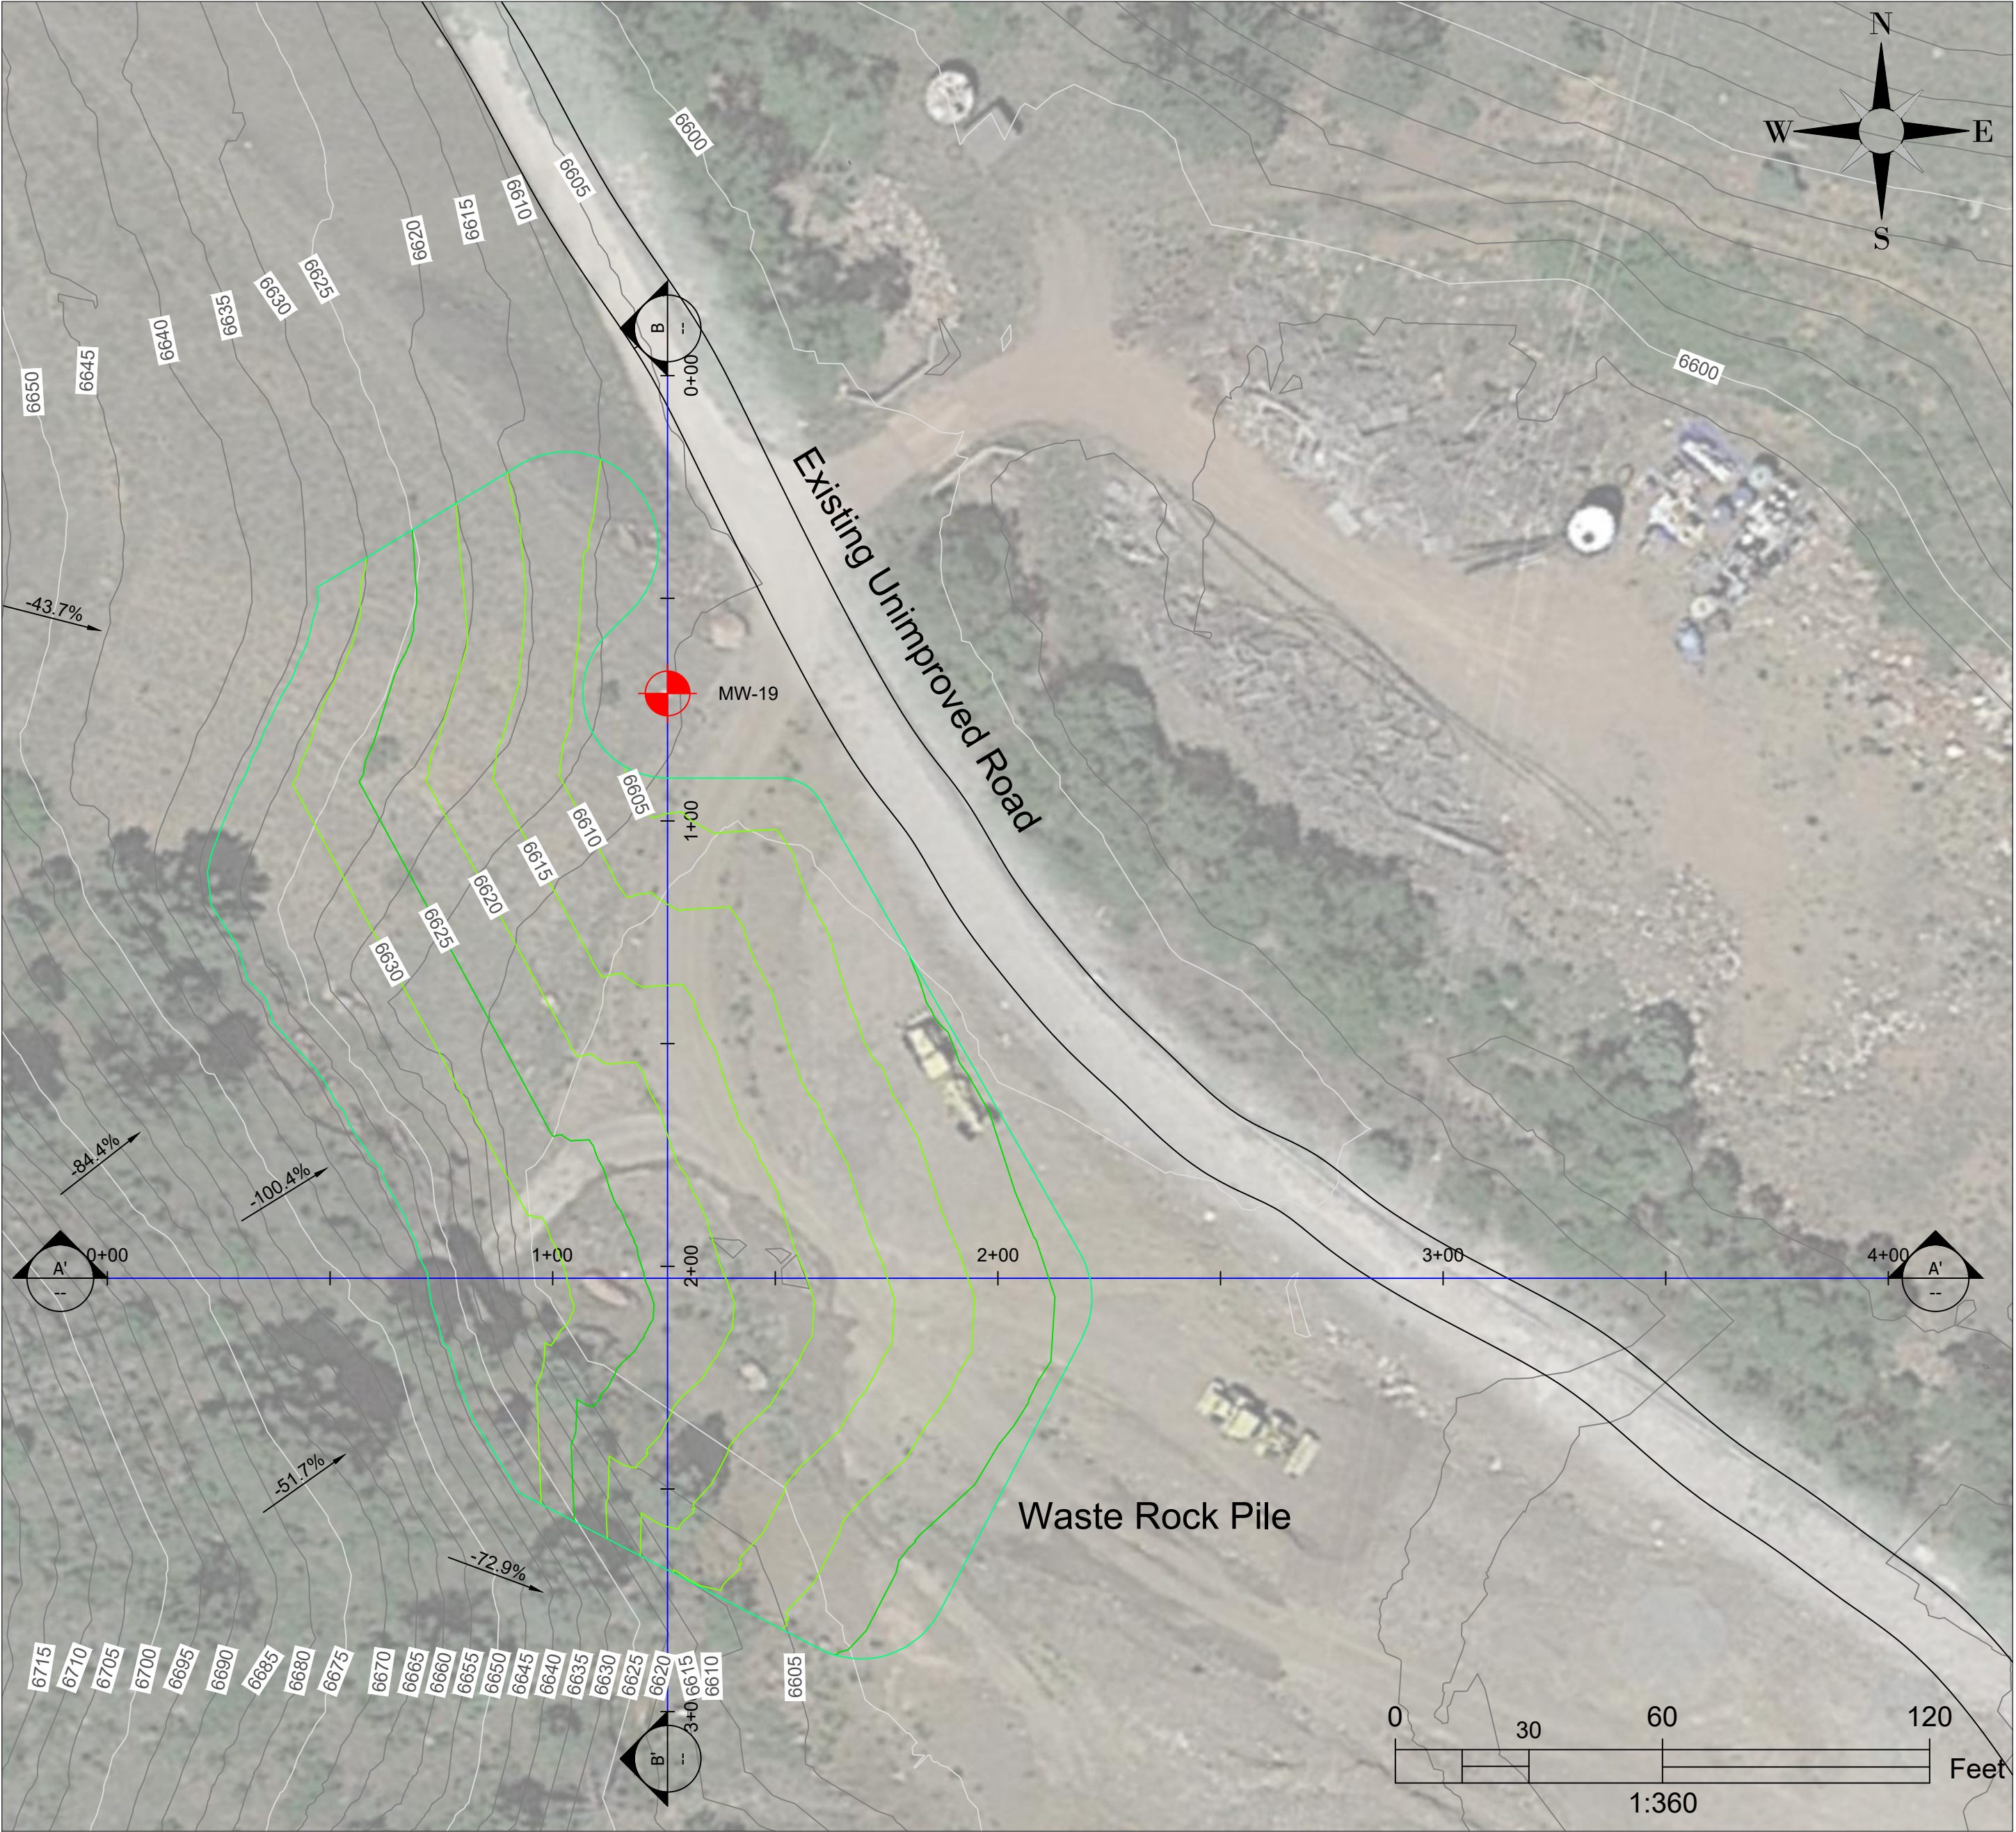
- Notes:
1. LiDAR data: U.S. Geological Survey, 20140929, USGS Lidar Point Cloud (LPC) CO\_Denver\_2008\_000056 2014-08-27 LAS: U.S. Geological Survey.
  2. Aerial imagery provided by Bing, circa 2017.
  3. Contour interval: 5 ft.
  4. Alignment A-A' bisects the Black Forest Mine Entrance.
  5. Alignment B-B' intersects MW-19.
  6. Waste Rock Pile 2D surface area: 29,685 ft².
  7. Waste Rock Pile Capacity: 12,313 yd³.
  8. Profiles have 2:1 vertical exaggeration.

Alignment A-A' Profile View

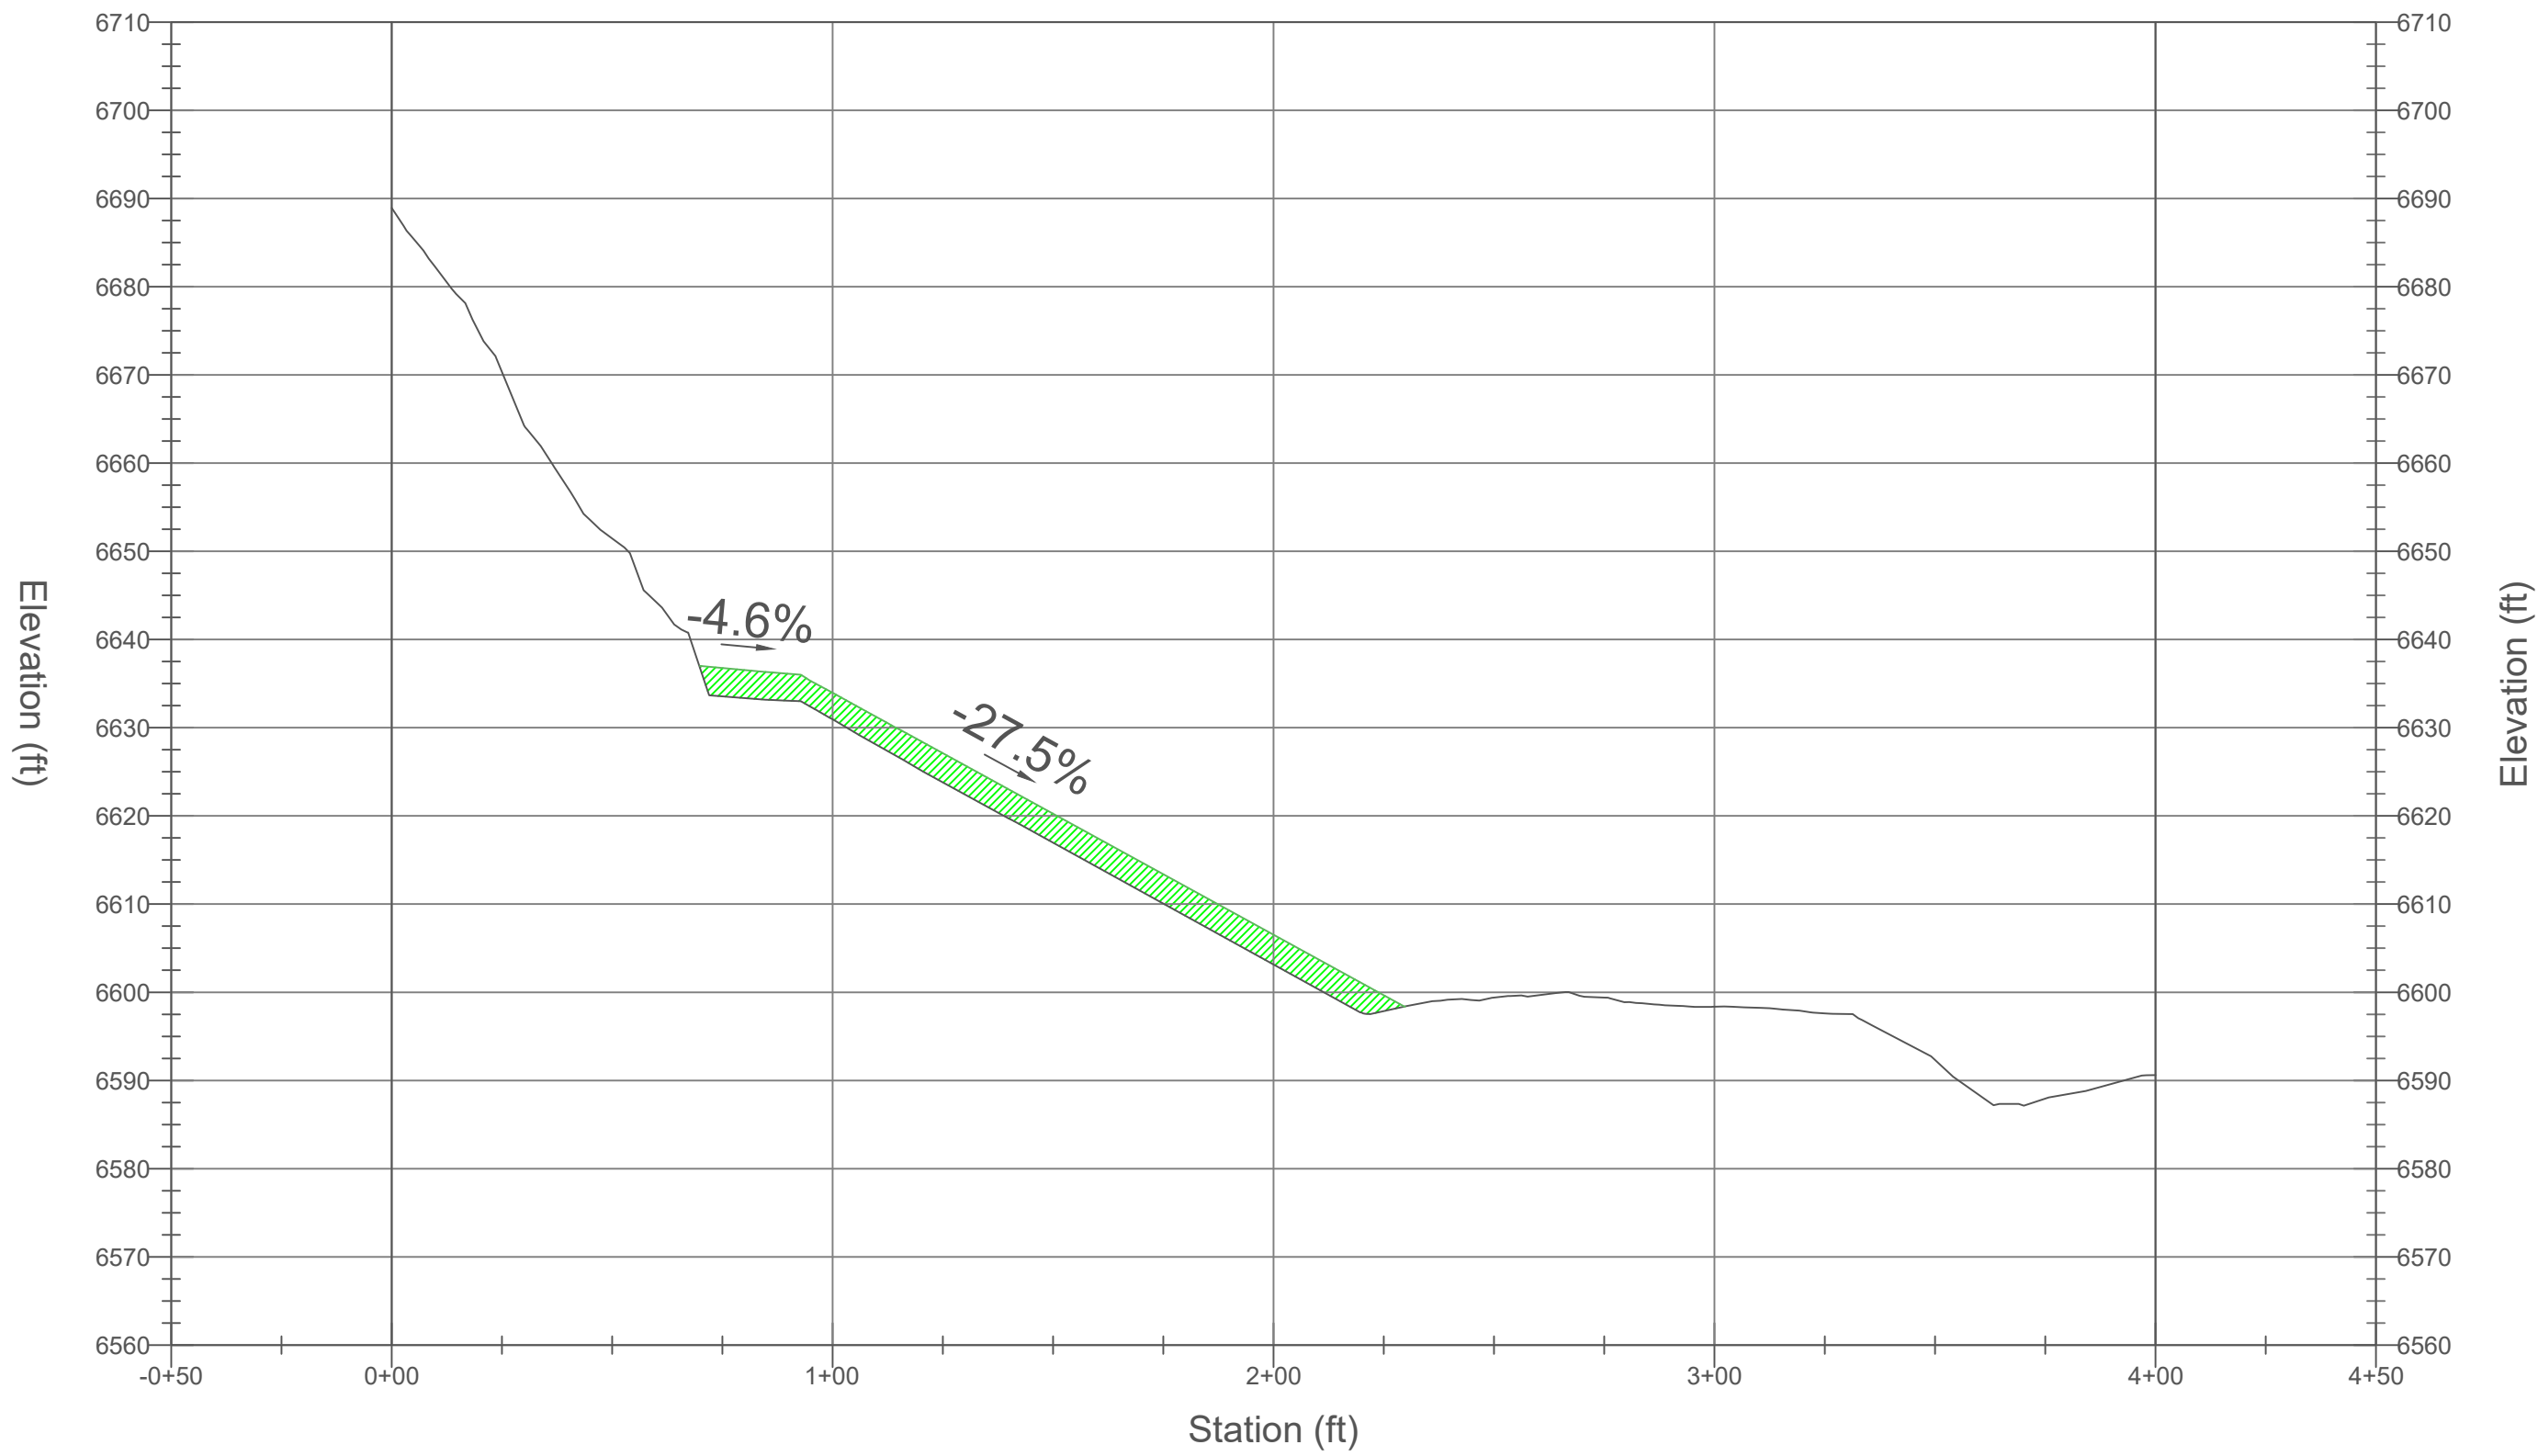
Alignment B-B' Profile View

- Notes:
1. LiDAR data: U.S. Geological Survey, 20140929, USGS Lidar Point Cloud (LPC) CO\_Denver\_2008\_000056 2014-08-27 LAS: U.S. Geological Survey.
  2. Aerial imagery provided by Bing, circa 2017.
  3. Contour interval: 5 ft.
  4. Alignment A-A' bisects the Black Forest Mine Entrance.
  5. Alignment B-B' intersects MW-19.
  6. Cover is 3 ft. deep.
  7. Cover Material 2D surface area: 35,635 ft².
  8. Cover Material volume: 3,895 yd³.
  9. Profiles have 2:1 vertical exaggeration.
