## MINERALS PROGRAM INSPECTION REPORT

| <b>MINE NAME:</b><br>Ranch Land Rock Pit #1 | <b>MINE/PROSPECTING ID#:</b><br>M-2002-096 | <b>MINERAL:</b><br>Sandstone (silica, stone, quartzite), limestone (general) and sand and gravel | <b>COUNTY:</b><br>Fremont |
| <b>INSPECTION TYPE:</b><br>Surety-Related Inspection | <b>INSPECTOR(S):</b><br>Timothy Cazier, P.E. | <b>INSP. DATE:</b><br>July 19, 2022 | <b>INSP. TIME:</b><br>13:20 |

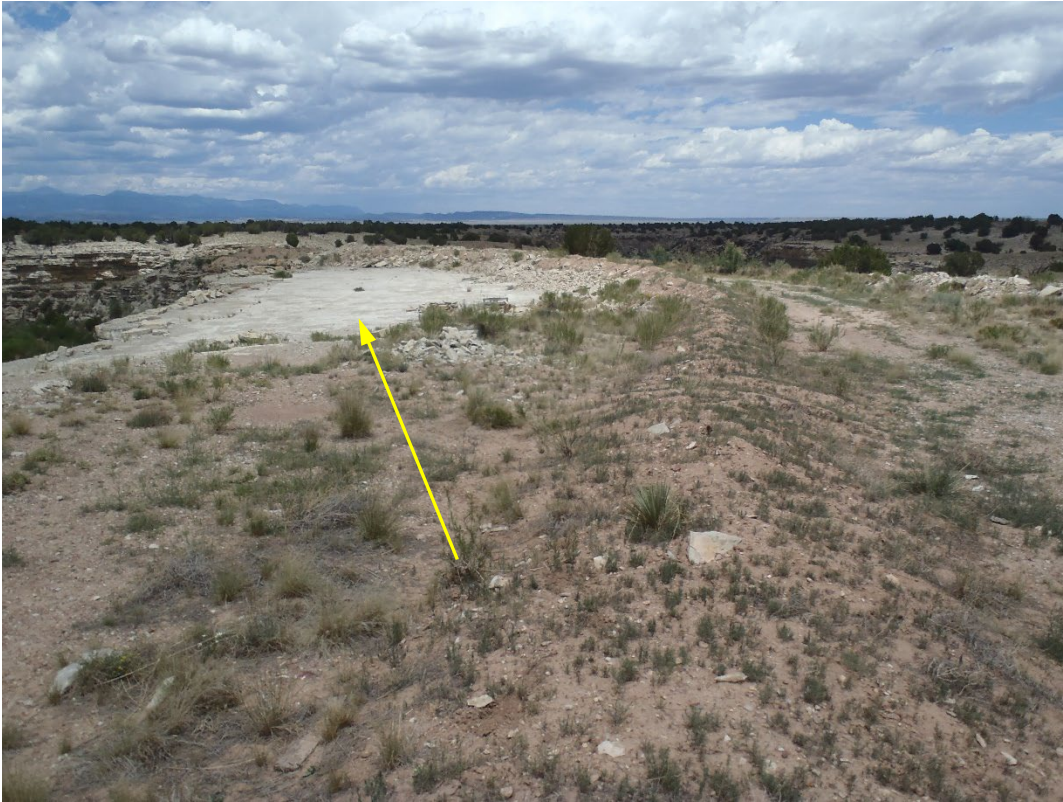
Gen. Compliance With Mine Plan: No change in disturbance was observed from the previous inspection (see **Photo 1**).

Photo 1. Active pit – no recent activity (looking north).

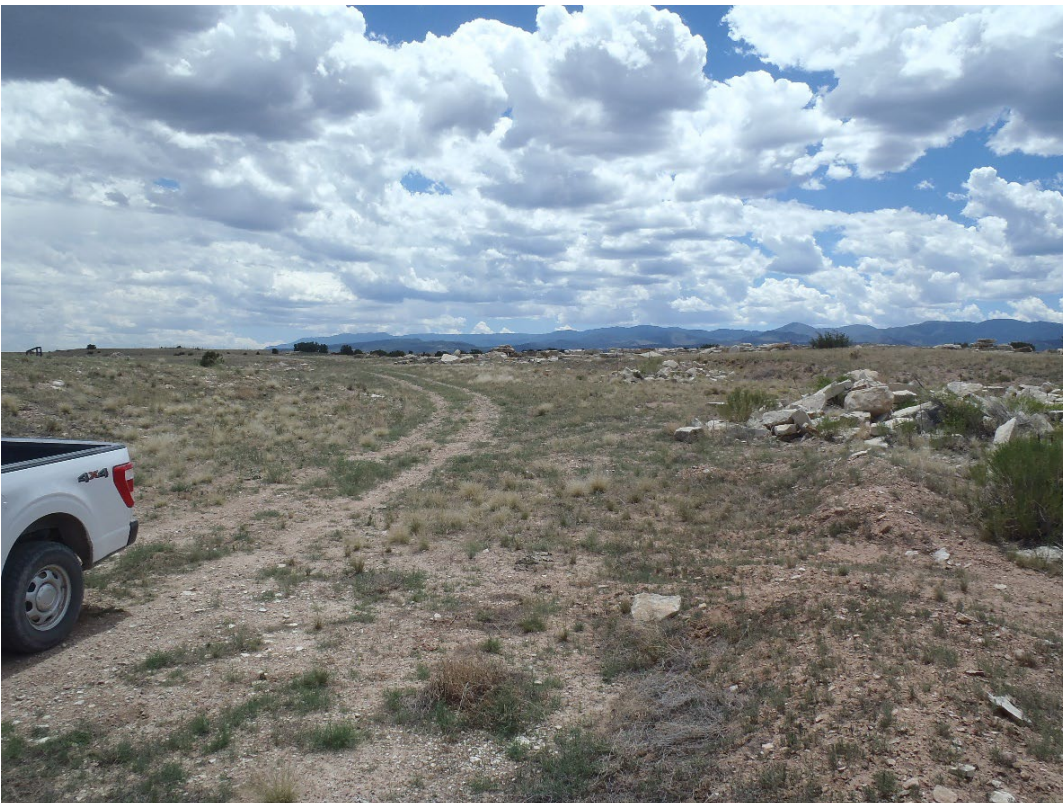
Roads: The majority of the access roads are unimproved two-track roads (see **Photo 2**). Mr. Mancera indicated the current plan for the amendment is construct new access roads alongside the conveyor system corridor to the Portland Plant. The site representatives were informed this corridor would be considered affected area by the DRMS and that any structures (including: the Minequa Canal, fences, power and gas lines and existing roads) would need to meet the requirements of Rule 6.4.19 to get structure damage compensation agreements, or where those cannot be obtained, an engineering evaluation demonstrating those structures shall not be damaged by activities occurring at the mining operation.

Photo 2. Typical two-track access road (road to active pit, looking south).

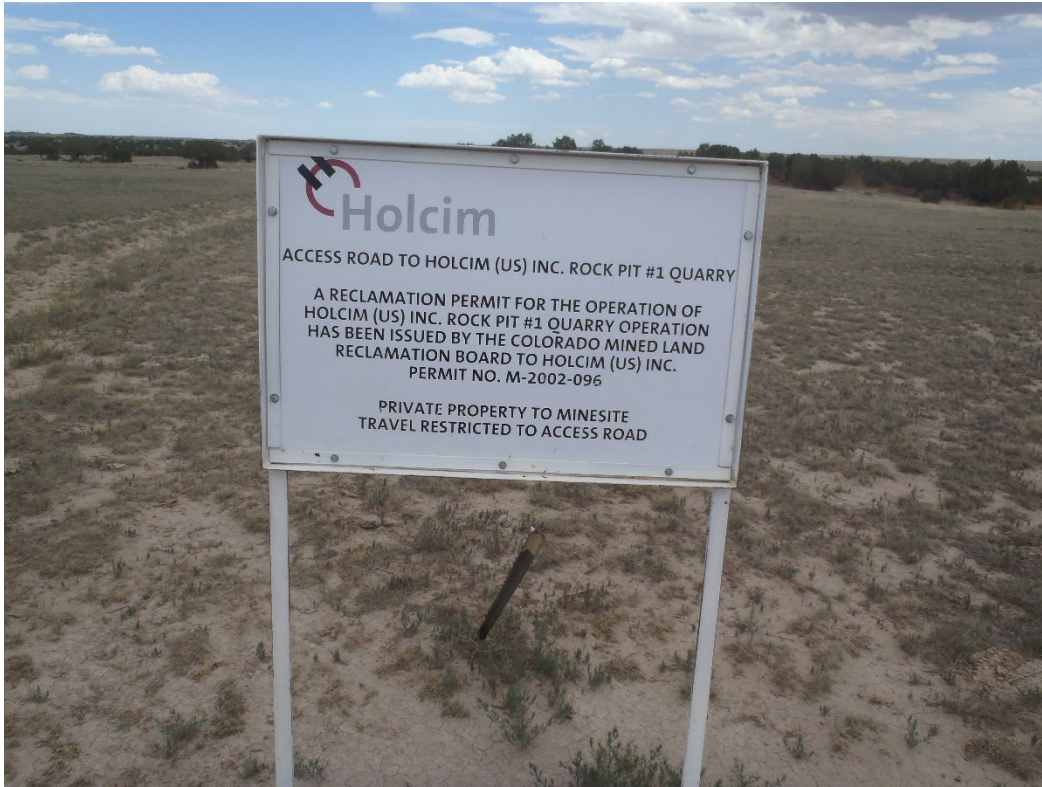
Signs and Markers: The permit sign at the northwest entrance was noted (see **Photo 3**).

Photo 3. Permit sign (NW corner of site).
