MINERALS PROGRAM INSPECTION REPORT
PHONE: (303) 866-3567

MINE NAME: Wiley Pit	MINE/PROSPECTING ID#: M-1977-223	MINERAL: Sand and gravel	COUNTY: Prowers
INSPECTION TYPE: Monitoring	INSPECTOR(S): Amy Eschberger	INSP. DATE: July 12, 2022	INSP. TIME: 13:30
OPERATOR: Five Rivers Ranch Cattle Feeding LLC	OPERATOR REPRESENTATIVE: Thane Milenski	TYPE OF OPERATION: 112c - Construction Regular Operation	
REASON FOR INSPECTION: Normal I&E Program	BOND CALCULATION TYPE: None	BOND AMOUNT: \$193,235.00	
DATE OF COMPLAINT: NA	POST INSP. CONTACTS: None	JOINT INSP. AGENCY: None	
WEATHER: Clear	INSPECTOR'S SIGNATURE:

M-1977-223 / Wiley Pit / Five Rivers Ranch Cattle Feeding LLC (112c)

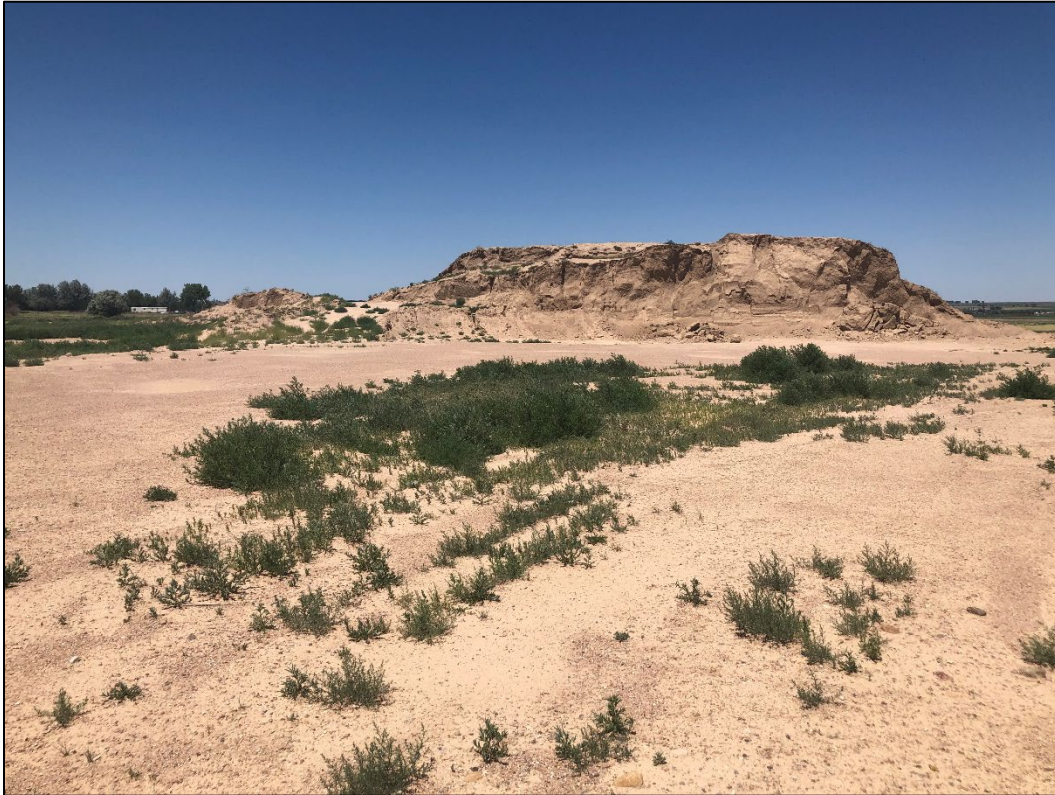
Photo 1. View looking west at large product stockpile stored northeast of reservoir. Note disturbed area around stockpile has very little to no vegetative cover, consisting primarily of annual weeds (e.g., kochia, russian thistle).

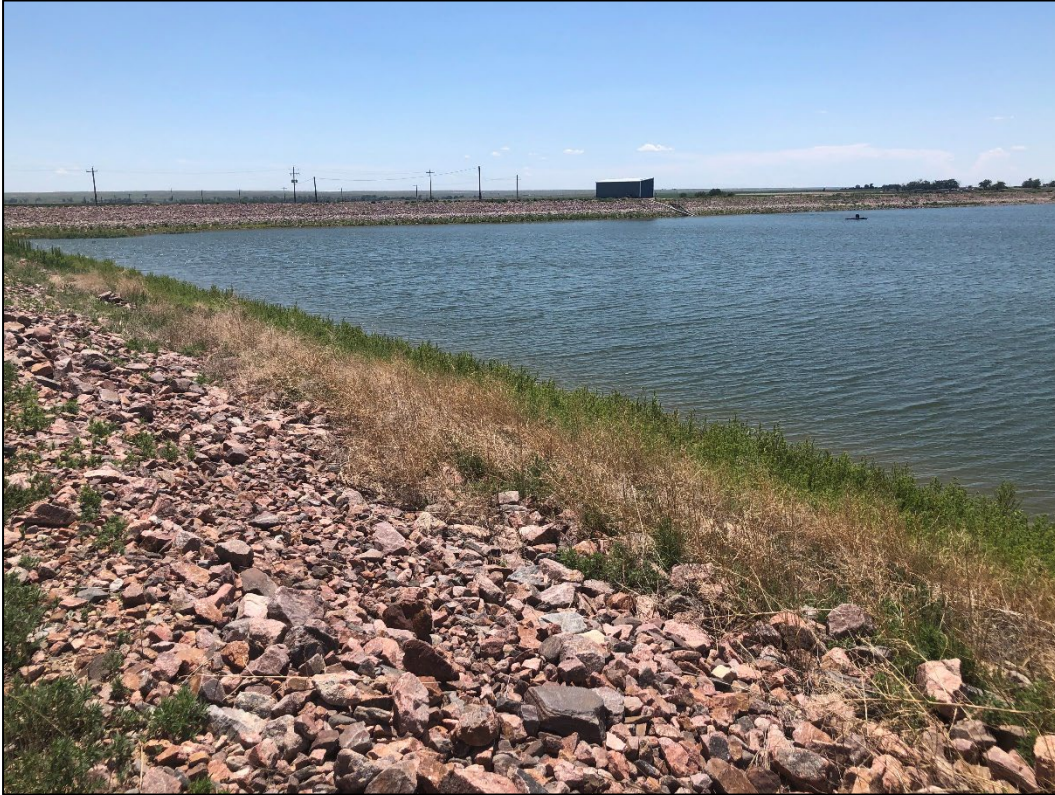
Photo 3. View looking southwest across southeastern portion of reservoir, showing riprap lined eastern (foreground) and southern shorelines.

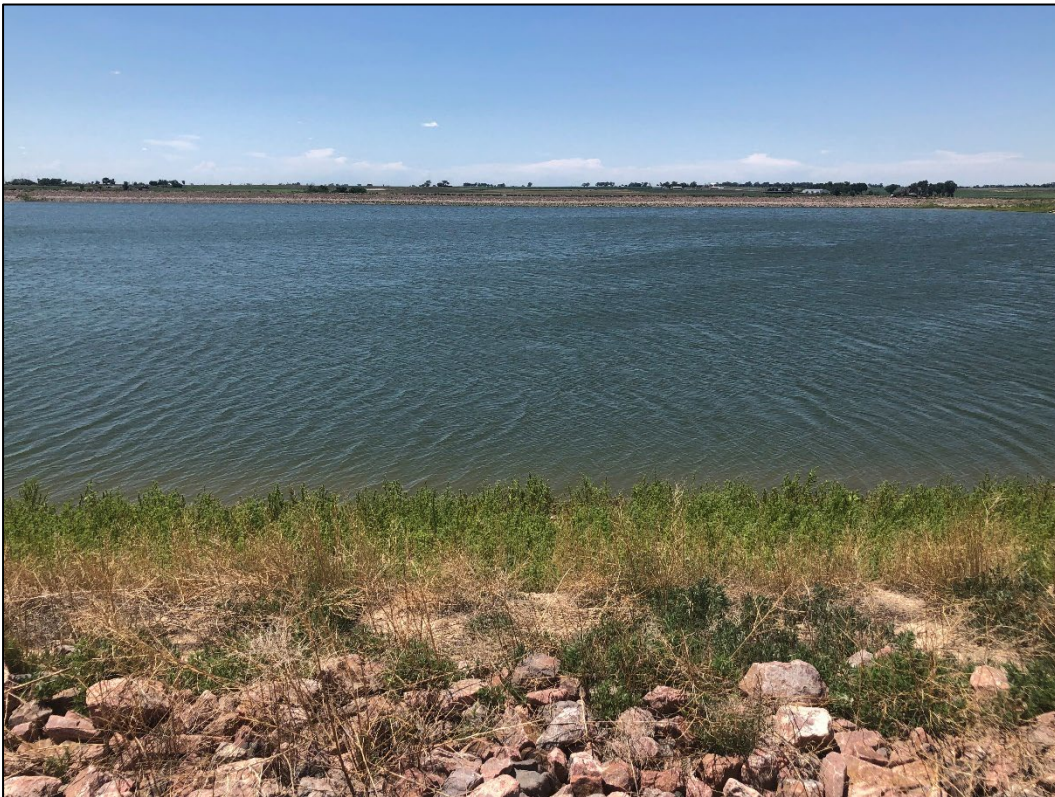
Photo 4. View looking west across reservoir from its eastern shoreline.

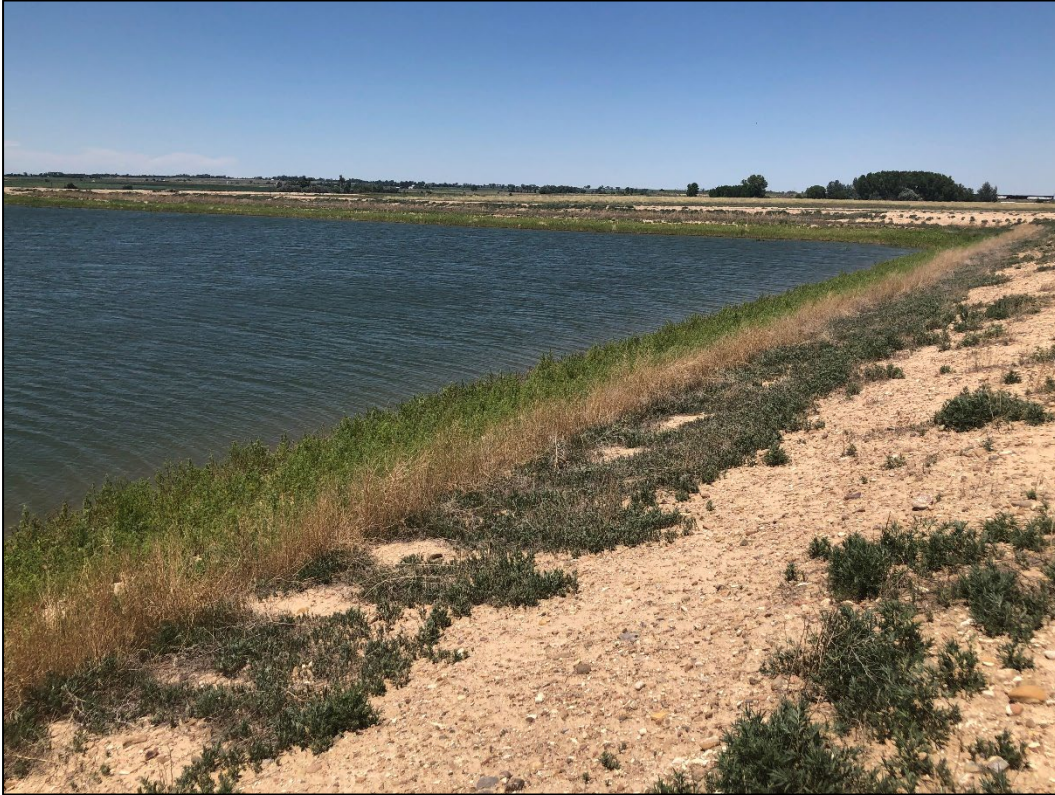
Photo 5. View looking northwest across northeastern portion of reservoir, showing portions of shorelines with no riprap and very little vegetative cover besides annual weeds (e.g., kochia, russian thistle).

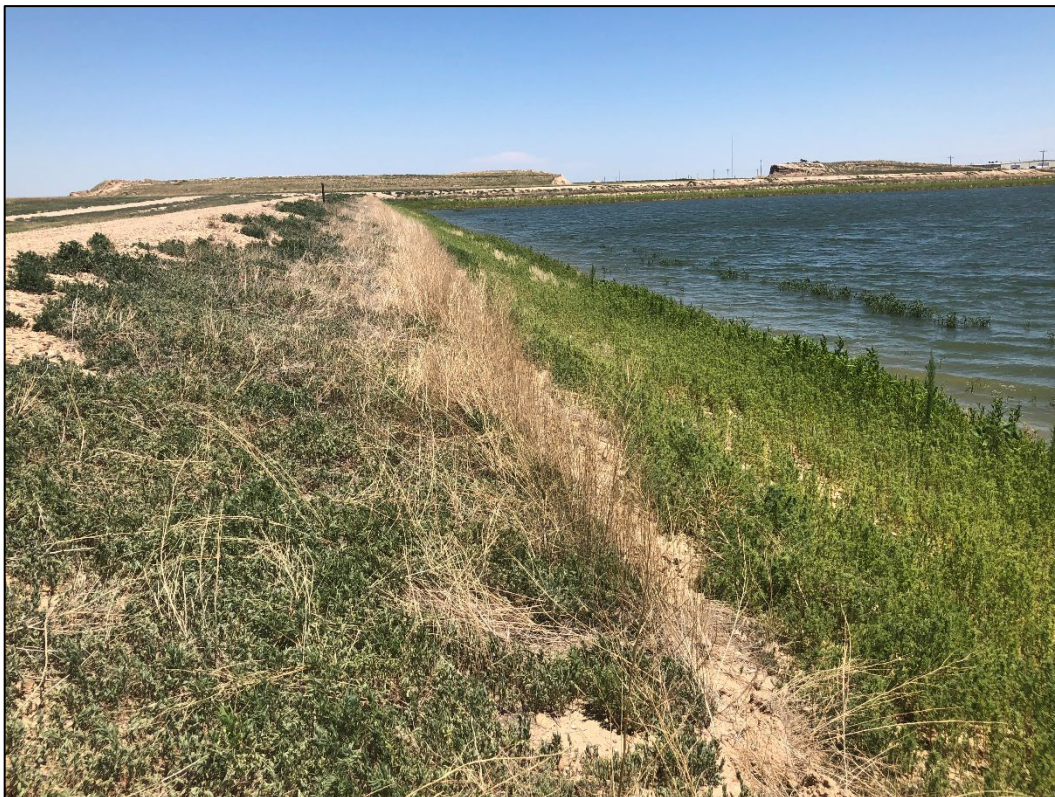
Photo 8. View looking east across northern reservoir shoreline with no riprap and vegetative cover consisting primarily of annual weeds (e.g., kochia, russian thistle).

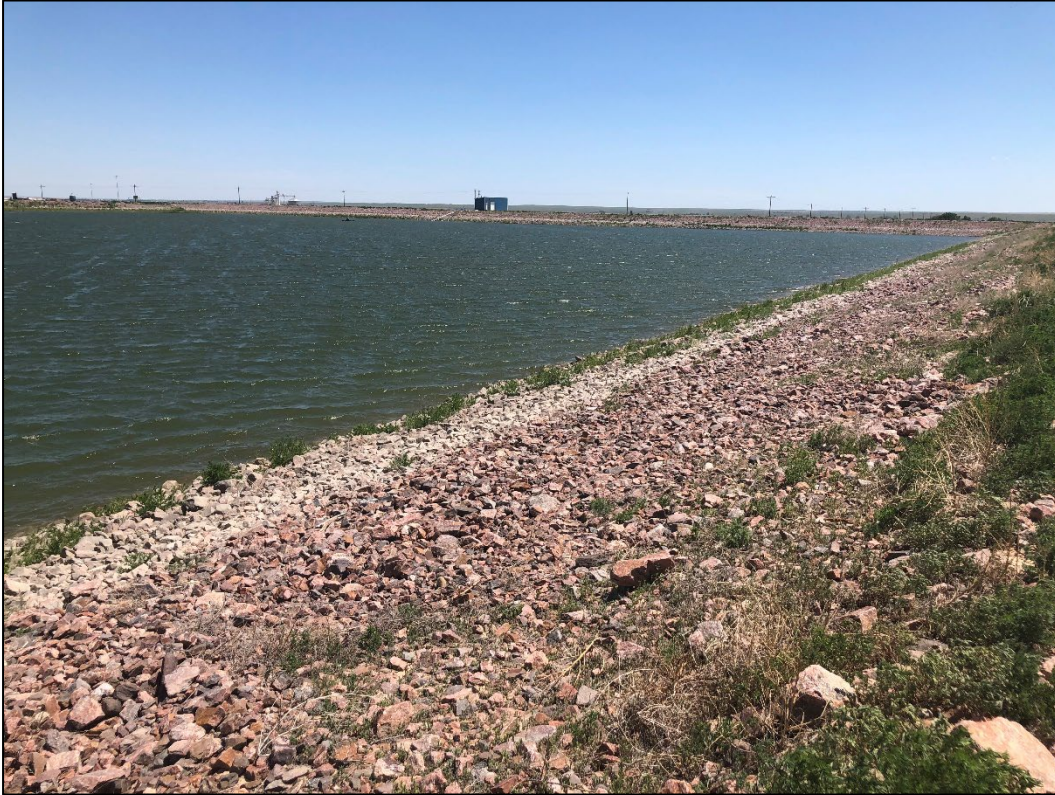
Photo 9. View looking southeast across southwestern portion of reservoir, showing riprap lined western (foreground) and southern shorelines.

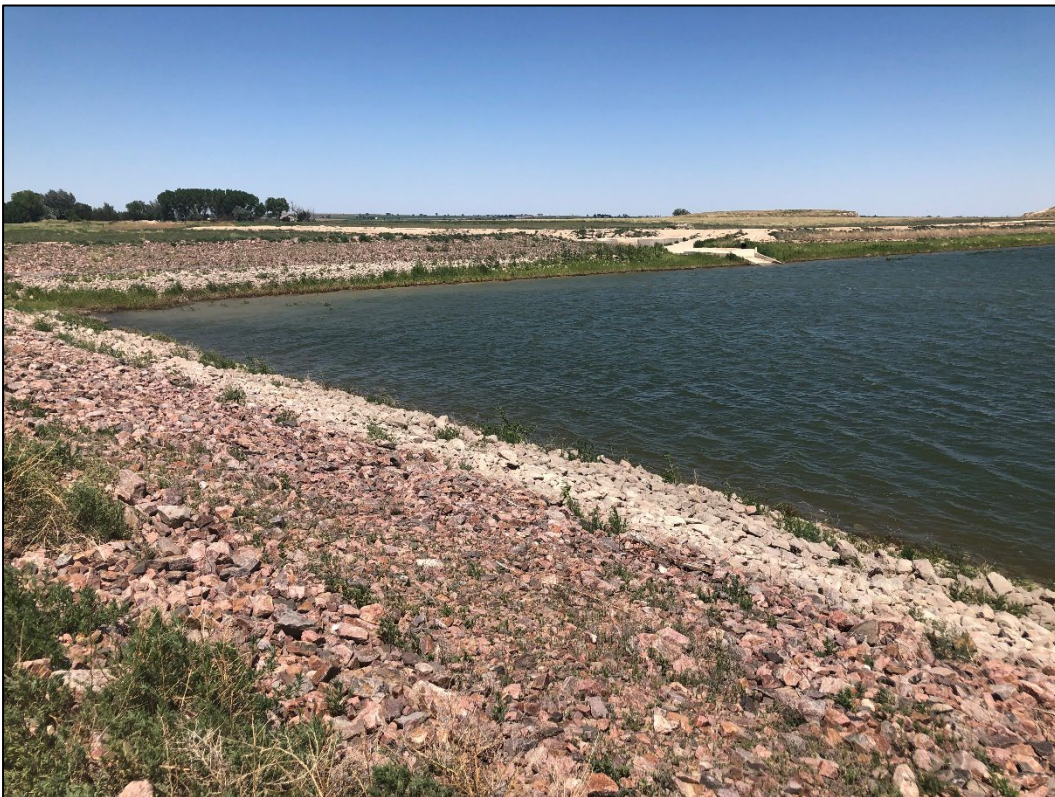
Photo 10. View looking northeast across northwestern portion of reservoir, showing riprap lined western (foreground) and northern shorelines.

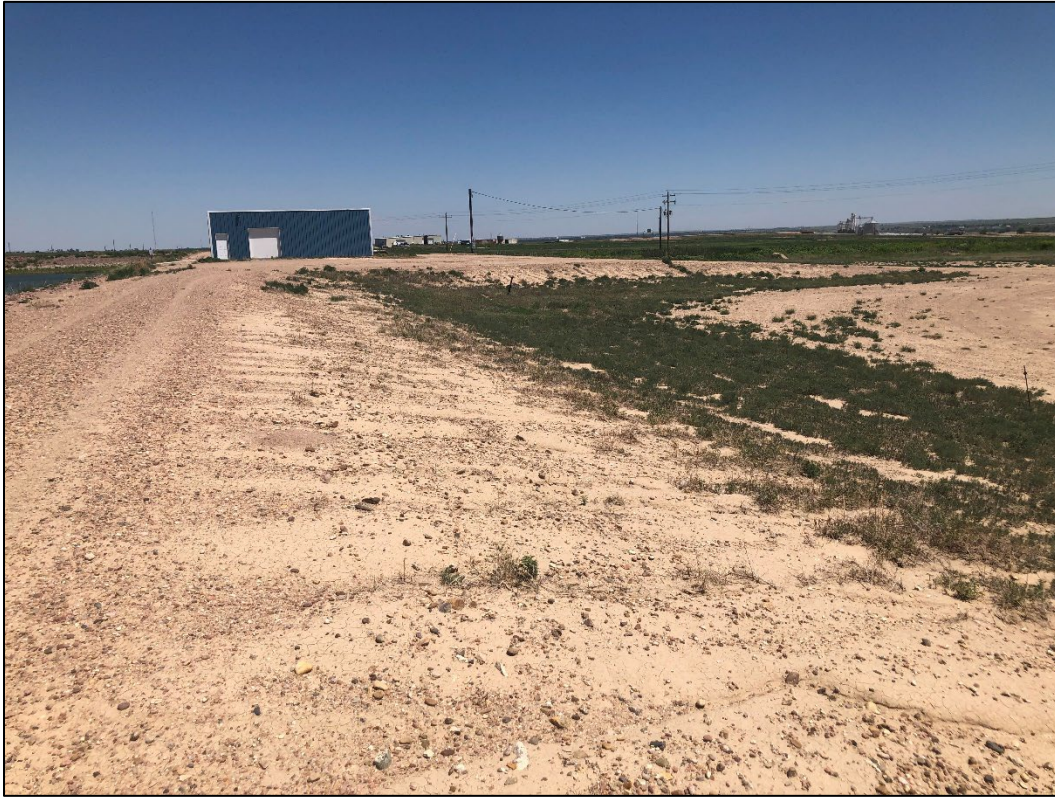
Photo 11. View looking east across southern edge of reservoir, showing pump house in background. Note disturbed area south of reservoir perimeter road (to the right) has very little to no vegetative cover consisting primarily of annual weeds (e.g., kochia, russian thistle).

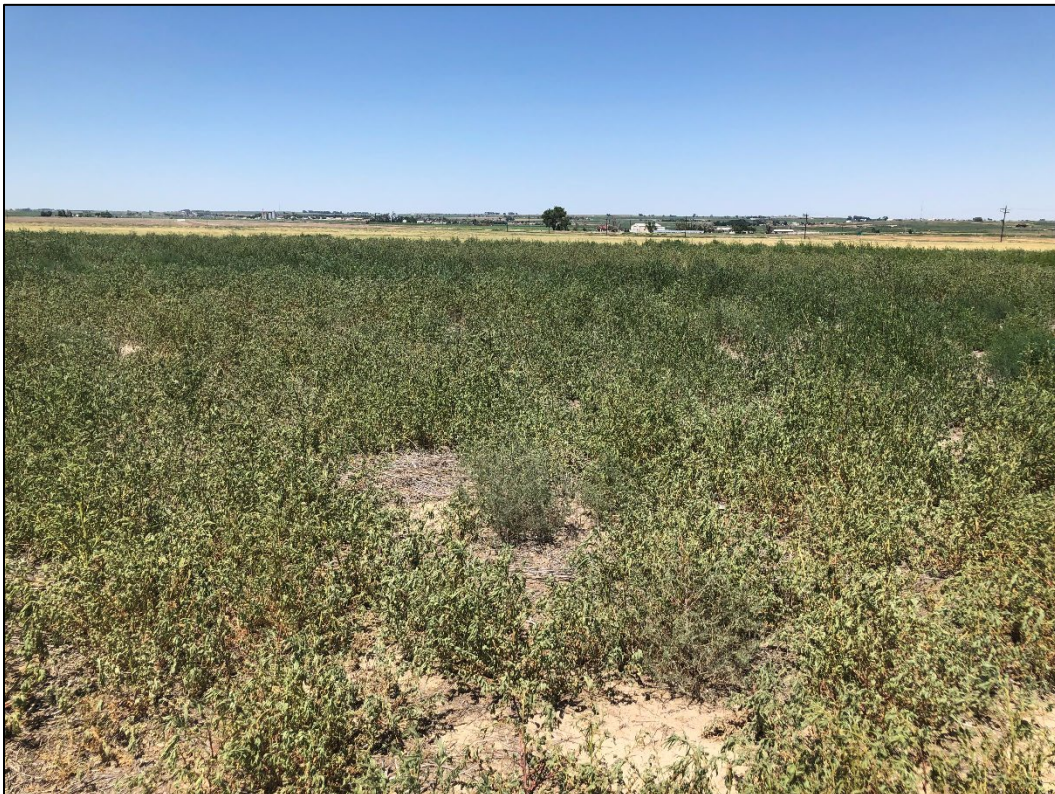
Photo 12. View looking east across eastern portion of permit area (east of stockpile area), with vegetative cover consisting primarily of annual weeds (e.g., kochia, russian thistle).

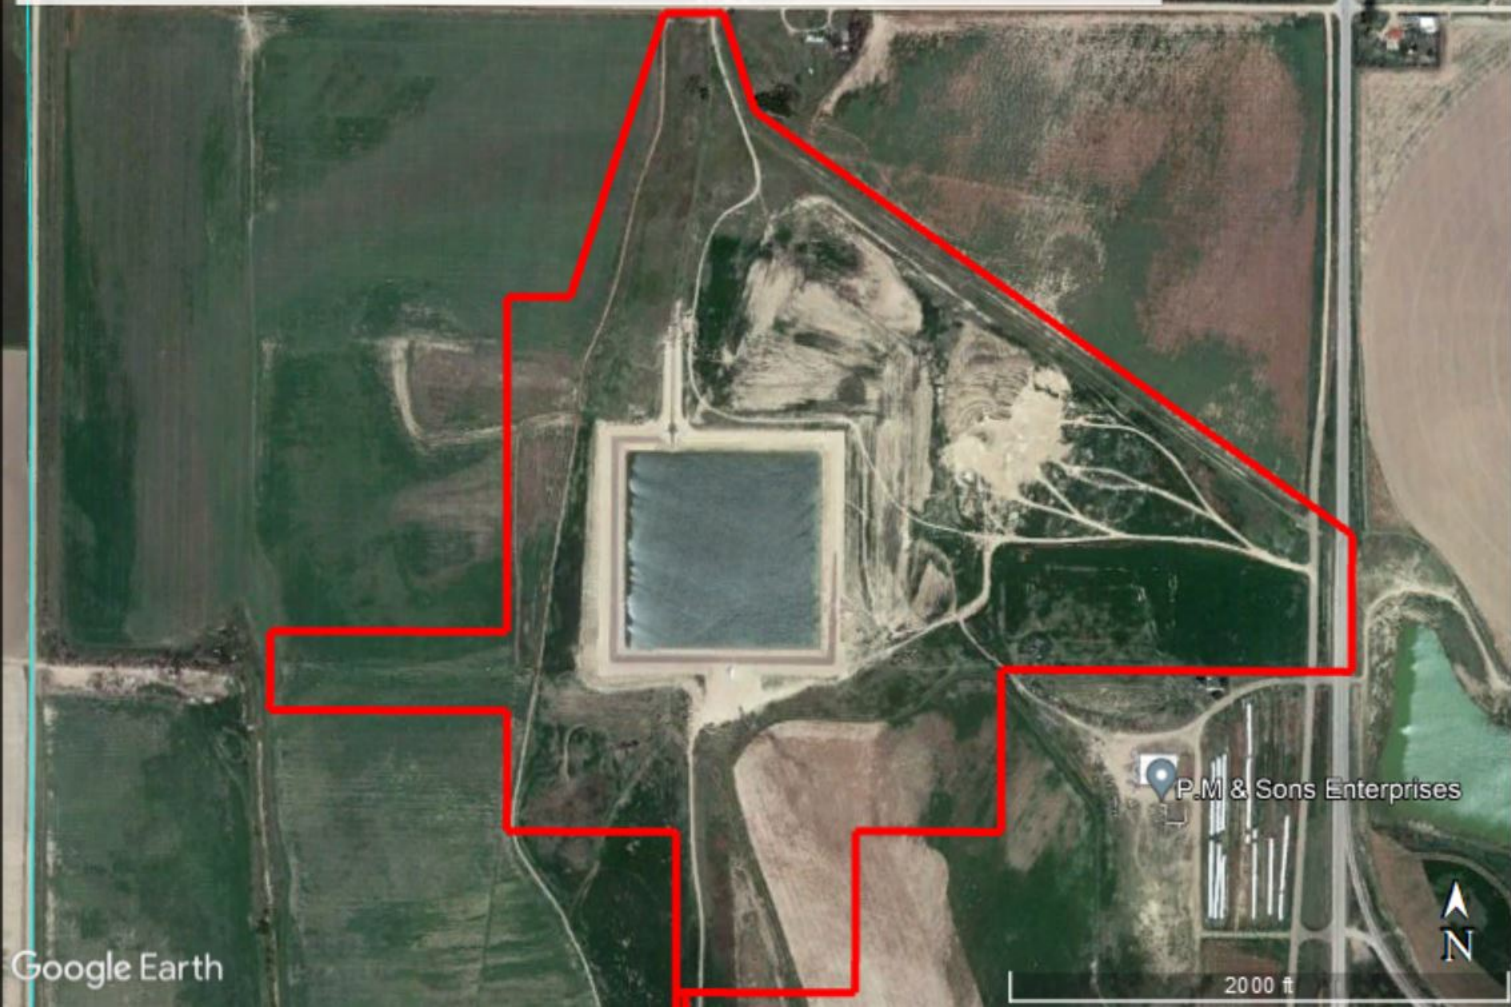
Close-up of disturbed area.

Red outline = 174.6 acres = Approved permit area (~169 acres mine site + ~5.6 acres water line to the south)
