MINERALS PROGRAM INSPECTION REPORT PHONE: (303) 866-3567

MINE NAME:	MINE/PROSPECTING ID#:	MINERAL:	COUNTY:
Rowe Gravel	M-1999-038	Sand and gravel	La Plata
INSPECTION TYPE:	INSPECTOR(S):	INSP. DATE:	INSP. TIME:
Monitoring	Dustin Czapla	August 16, 2022	16:20
OPERATOR:	OPERATOR REPRESENTATIVE:	TYPE OF OPERATION:	
Rowe Gravel	None	110c - Construction Limited Impact

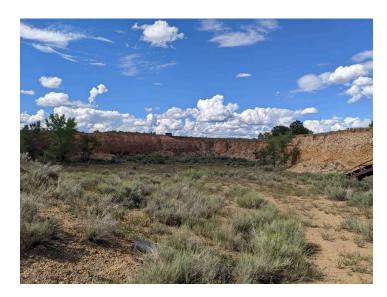
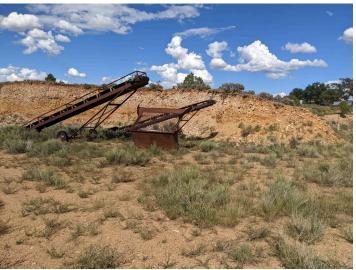
The disturbed mining area includes approximately 1.25 acres. A pit has been excavated to a depth of approximately 25 feet. The pit daylights on the south side. The highwall is near vertical around most of the pit, with sloughed material at the base of the highwall in spots. Vegetation is well established on the pit floor. Several pieces of old mining equipment are stored within the pit. No stockpiles of materials were observed within the pit.
