MINERALS PROGRAM INSPECTION REPORT
PHONE: (303) 866-3567

MINE NAME: San Juan Silver Project	MINE/PROSPECTING ID#: P-2008-037	MINERAL: Silver and gold	COUNTY: Mineral
INSPECTION TYPE: Monitoring	INSPECTOR(S): Lucas West	INSP. DATE: August 31, 2022	INSP. TIME: 08:30
OPERATOR: Rio Grande Silver, Inc.	OPERATOR REPRESENTATIVE: Randy McClure	TYPE OF OPERATION: MP - Mineral Prospecting

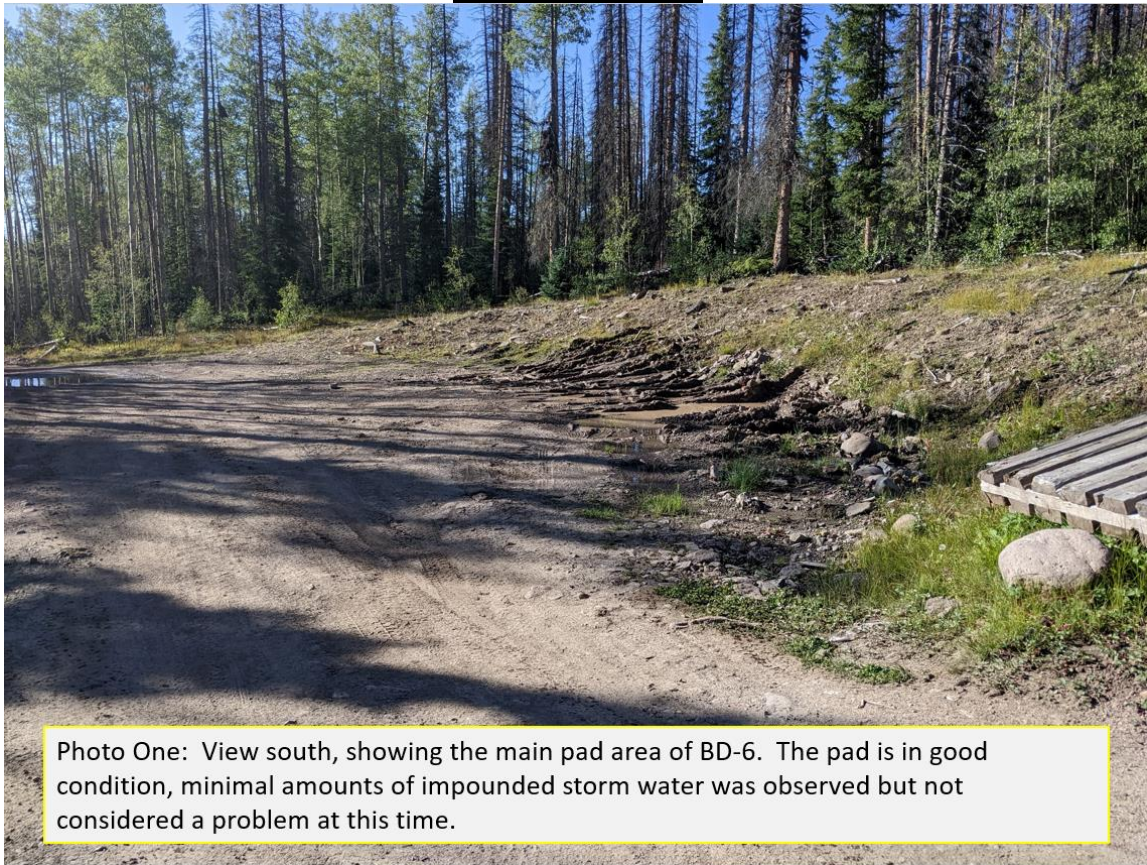
The entire NOI consists of 6 drill pads constructed in support of drilling operations. Of those 6 pads, 5 have been reclaimed (BD-1 through 5) along with the access road associated with those pads. The reclaimed pads and road sections were not observed as part of this inspection. The only active pad remaining on the project is the BD-6 pad which is currently being used as a water storage and transfer location in support of the Bulldog Project NOI, file no P-2010-014. The pad is leveled and cleared of most vegetation with the exception of a few volunteer plants that have become established. The cut slope on the western edge of the pad was stable at the time of the inspection and no evidence of settling, slumping or erosion was observed. The pad area can be seen in Photo One.

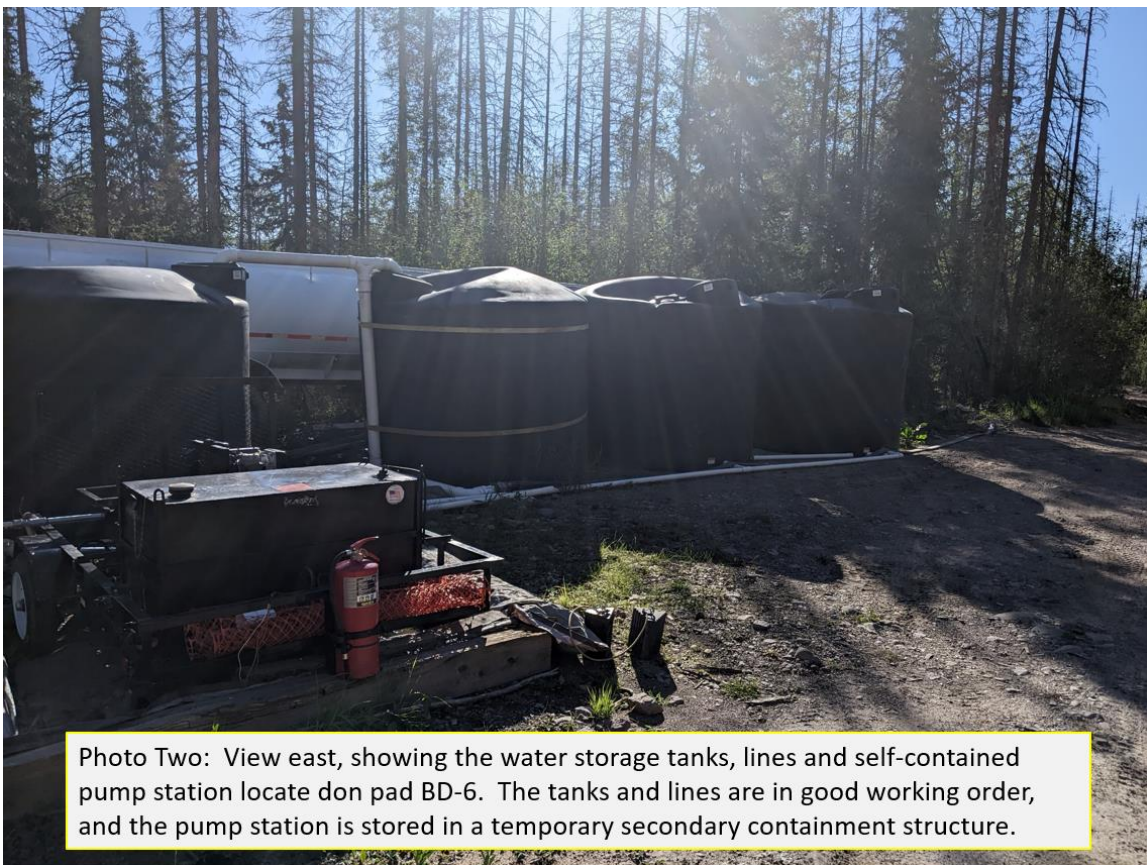
Water storage and transfer operations were active at the time of the inspection. The operator is extracting water from Willow Creek in accordance with their approved Forest Service Permit, hauling it to the BD-6 pad and storing in a series of four 2,500 gallon above ground storage tanks. The water is then pumped by way of a trailer mounted, self-contained water pump up the remainder of the access road to the Bulldog Exploration Project Area. The tanks and pump are in excellent condition, and the pump and trailer are set within a temporary secondary containment structure. The secondary containment structure is in excellent condition and of sufficient capacity to prevent any adverse impacts to the prevailing hydrologic balance. The tanks, piping and pump set up can be seen in Photo Two. The access road and BD-6 exhibit positive drainage and no excessive impounded storm water was noted. Minimal amounts of storm water was noted in response to recent precipitation, however is not considered a problem at this time.
