Inspection report for C-1981-028

Permit Number: C-1981-028 Mine Name: Keenesburg Strip Mine Operator: Coors Energy Company Operator Address: Mr. Ben Moline PO Box 4030 Golden, CO 80402	County: Weld Operation Type: Surface Permit Status: Permanent Cessation Ownership: Private
	Operator Representative Present: None
Operator Representative Signature: (Field Issuance Only)

Inspection Start Date: September 14, 2022 Inspection Start Time: 08:00 Inspection End Date: September 14, 2022 Inspection End Time: 09:30		Inspection Type: Coal Complete Inspection Inspection Reason: Normal I&E Program Weather: Cloudy	
Joint Inspection Agency: None		Joint Inspection Contacts: 	
Post Inspection Agency: None		Post Inspection Contacts: 	
Inspector(s): Robert Zuber, P.E.	Inspector's Signature: <i>Robert D. Zuber</i>		Signature Date: 9/14/2022

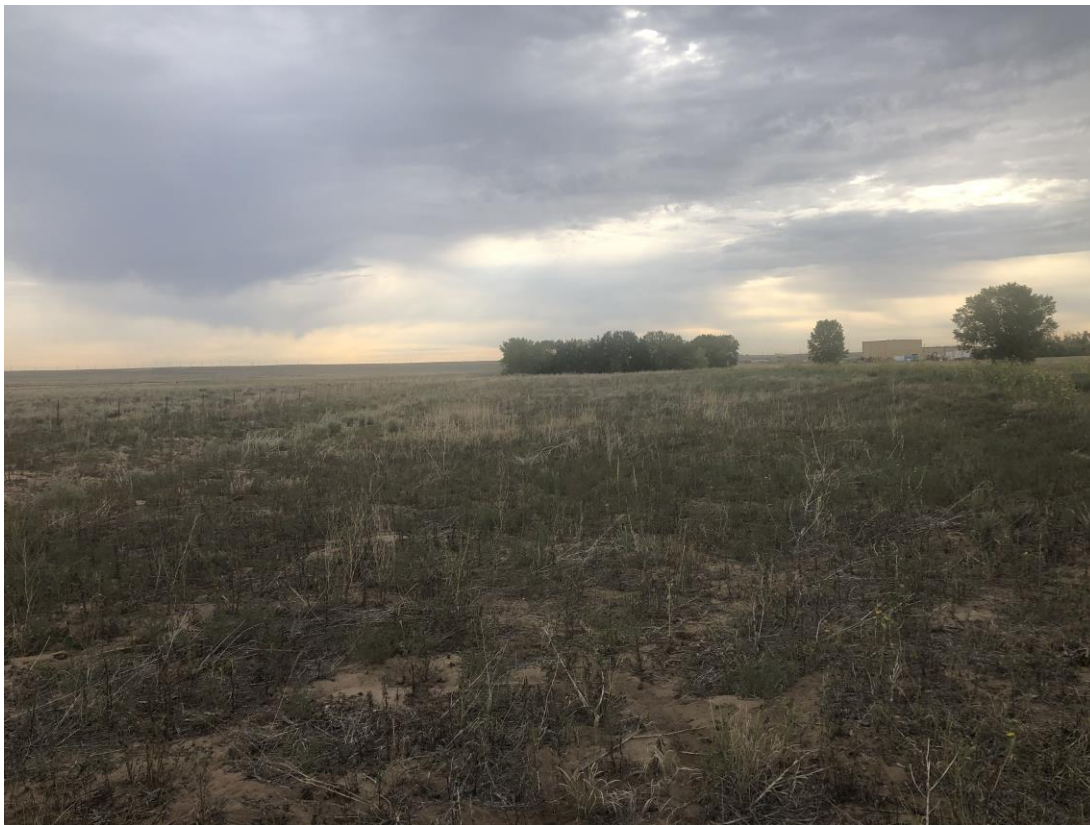
The northern boundary of the site (east side) was observed, and no signs of pollutant loading from the mine site, or any other problems, were seen. Grasses and other desirable species on the undisturbed area west of the reclaimed B Pit appeared healthy.

North boundary, looking east toward Sediment Pond 2

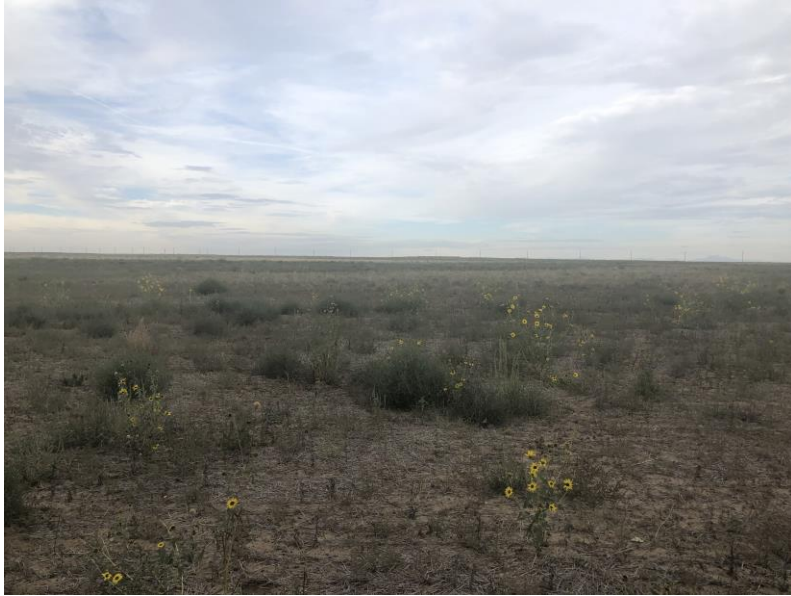
An owl was seen at Sediment Pond 2. A pronghorn antelope was seen in Area 37.

Area 37, looking southwest

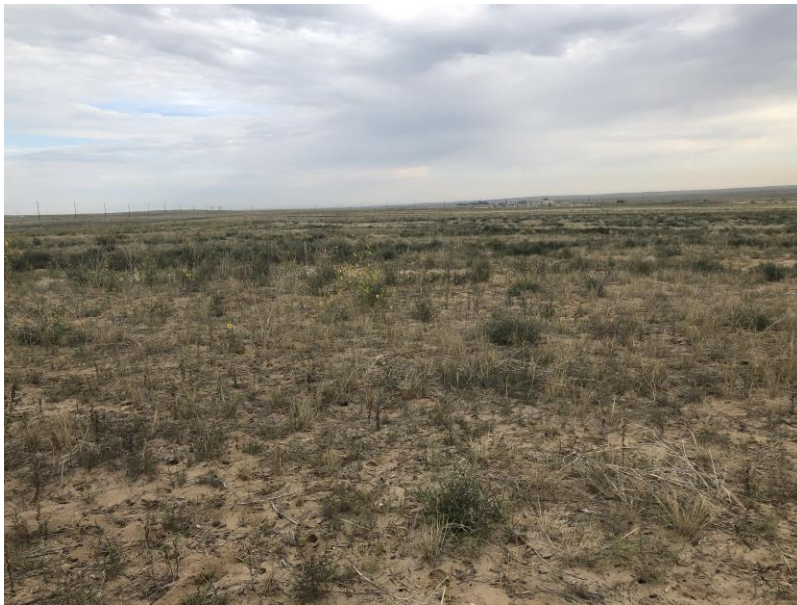
No erosion problems were seen onsite, and nearly the entire site was inspected (one exception is Area 29). A bare spot was seen at the north end of Area 35, roughly the middle of the reclaimed B Pit. The steep area east of the Dugout Pond was stable.

Much of the site where reclamation has been conducted in recent years is dominated by poor species such as Russian thistle. Many sunflowers were also seen, for example in Areas 34 and 35.

Reclaimed B Pit, looking north (Area 35 in foreground)

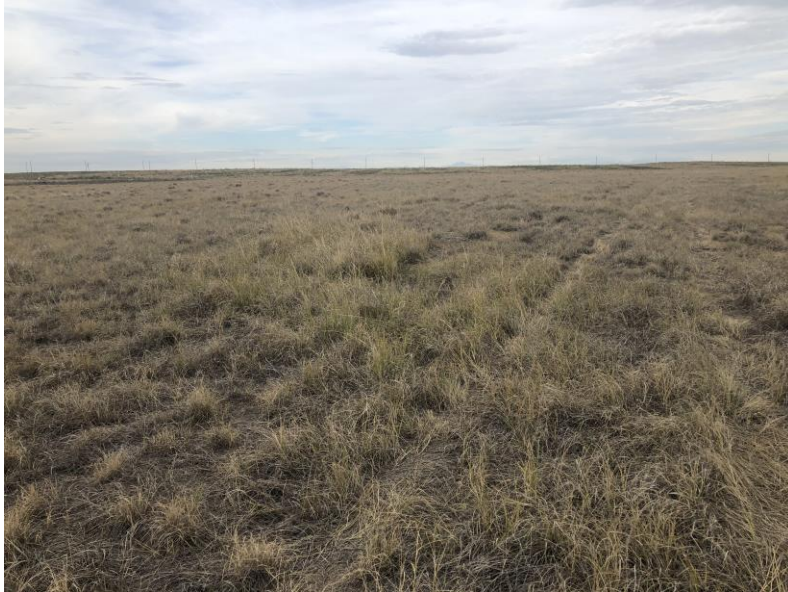
The older reclamation continues to look good. In particular, the southwest corner of the site (namely Areas 31, 32, and 33) looks very good.

Area 33 (looking west) with good vegetation

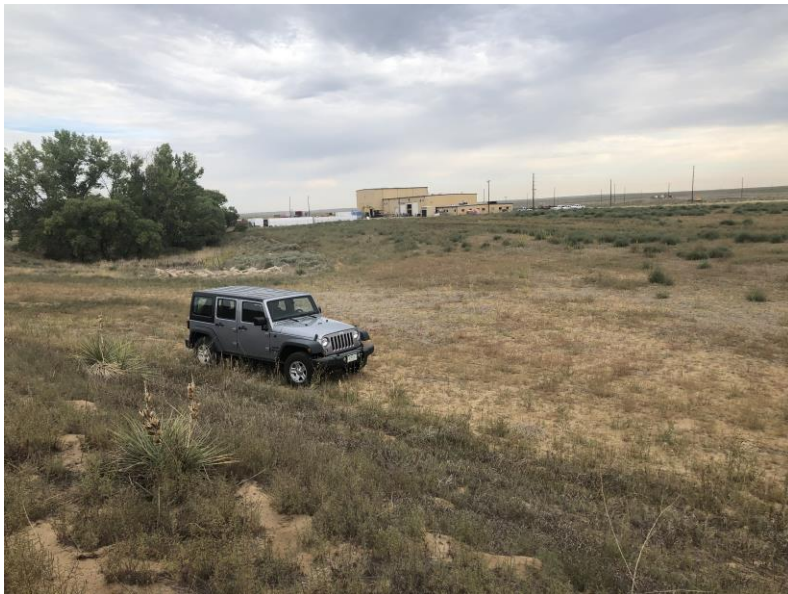
Area southeast of the Dugout Pond (reclaimed topsand piles on right)
