MINERALS PROGRAM INSPECTION REPORT
PHONE: (303) 866-3567

MINE NAME: Weaselskin	MINE/PROSPECTING ID#: M-1986-148	MINERAL: Sand and gravel	COUNTY: La Plata
INSPECTION TYPE: Monitoring	INSPECTOR(S): Dustin Czapla	INSP. DATE: August 17, 2022	INSP. TIME: 14:45
OPERATOR: Weaselskin Corp.	OPERATOR REPRESENTATIVE:	TYPE OF OPERATION: 110c - Construction Limited Impact	
REASON FOR INSPECTION: Normal I&E Program	BOND CALCULATION TYPE: Complete Bond	BOND AMOUNT: \$8,215.00	
DATE OF COMPLAINT: NA	POST INSP. CONTACTS: None	JOINT INSP. AGENCY: None	
WEATHER: Clear	INSPECTOR'S SIGNATURE:

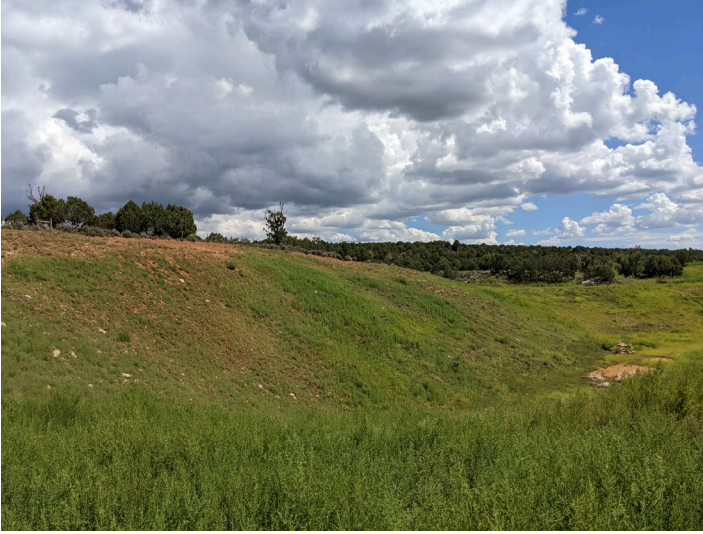
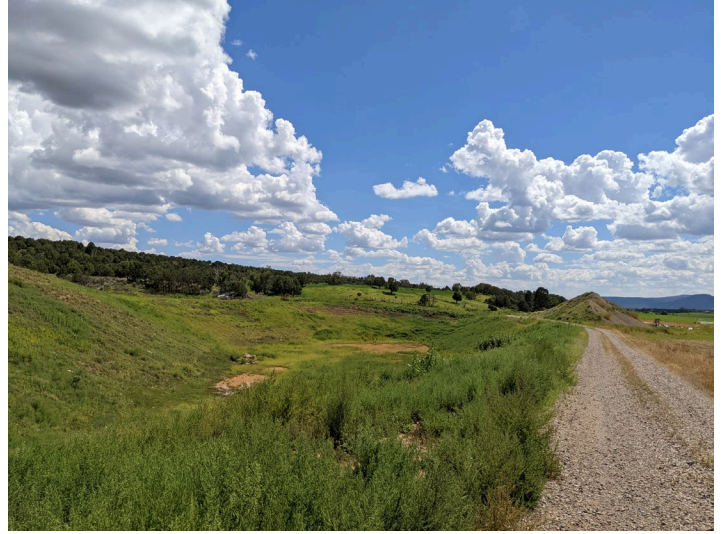
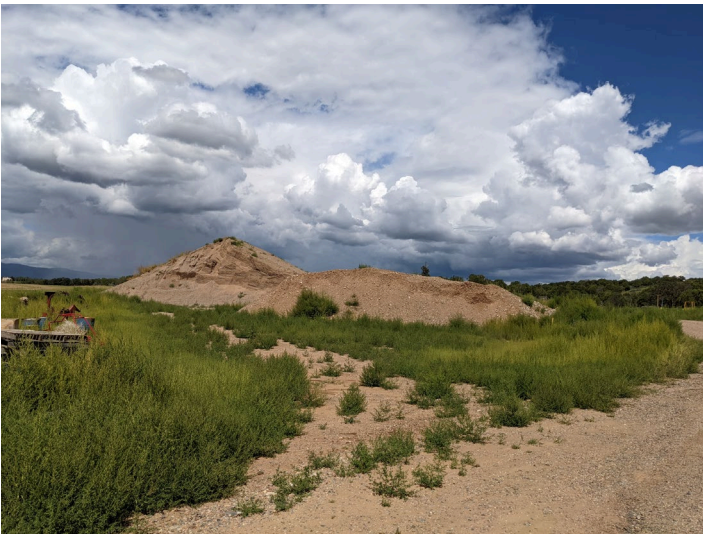
The site is in final reclamation. The slopes have been graded to 2H:1V. Vegetation on the slopes consisted of some native grasses, but was mostly kochia. The operator will need to perform weed control and reseed the site with the approved reclamation seed mix.

One stockpile of gravel remains on site.
