**MINERALS PROGRAM INSPECTION REPORT**  
**PHONE: (303) 866-3567**

<b>MINE NAME:</b> Zellitti Pit	<b>MINE/PROSPECTING ID#:</b> M-1980-246	<b>MINERAL:</b> Gravel	<b>COUNTY:</b> La Plata
<b>INSPECTION TYPE:</b> Monitoring	<b>INSPECTOR(S):</b> Dustin Czapla	<b>INSP. DATE:</b> August 17, 2022	<b>INSP. TIME:</b> 13:00
<b>OPERATOR:</b> Anthony Zellitti	<b>OPERATOR REPRESENTATIVE:</b>	<b>TYPE OF OPERATION:</b> 112c - Construction Regular Operation

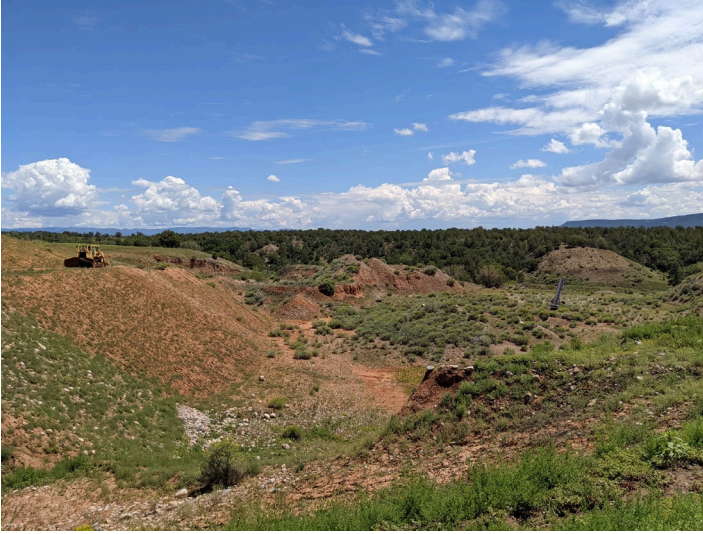
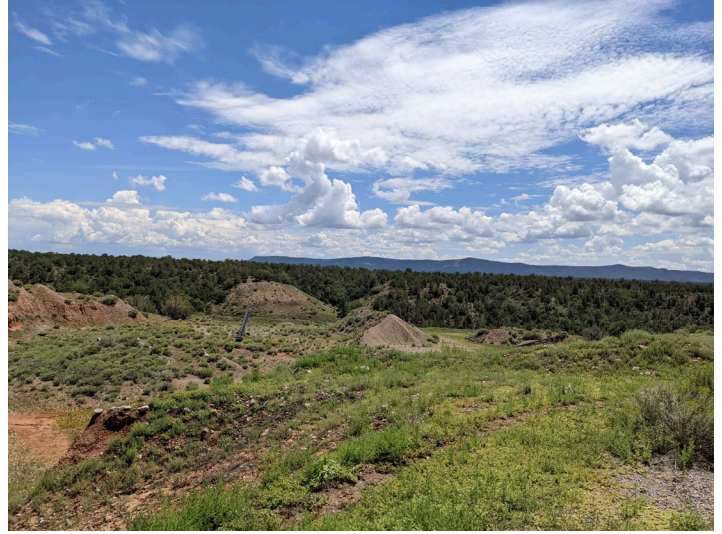
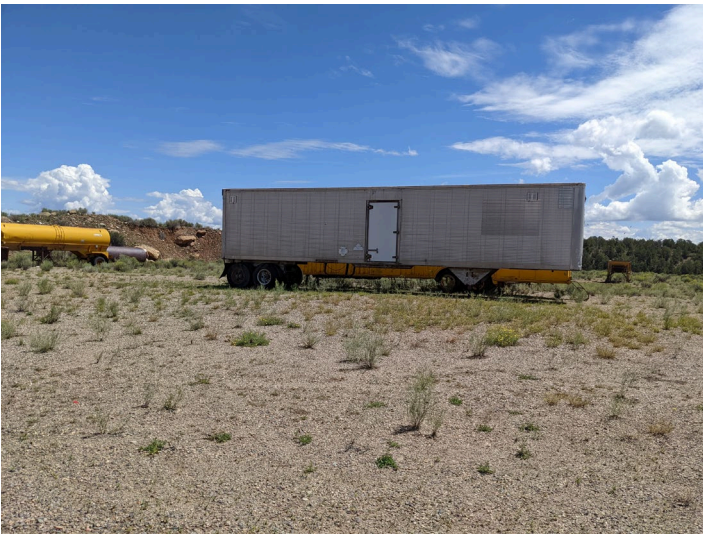
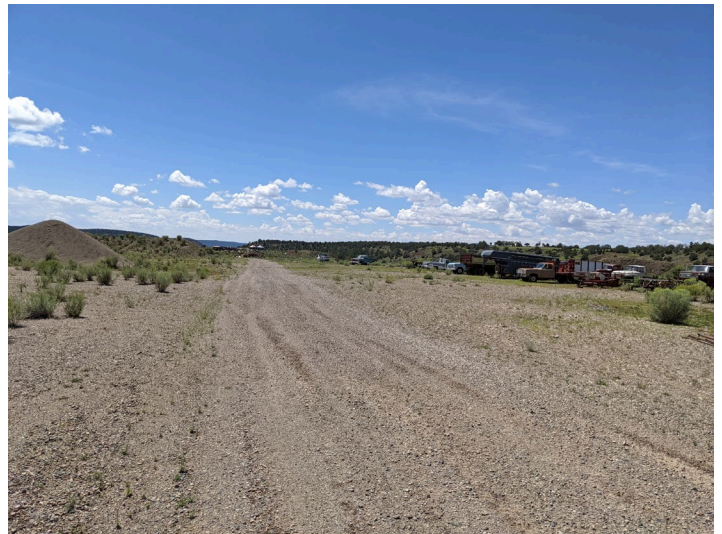
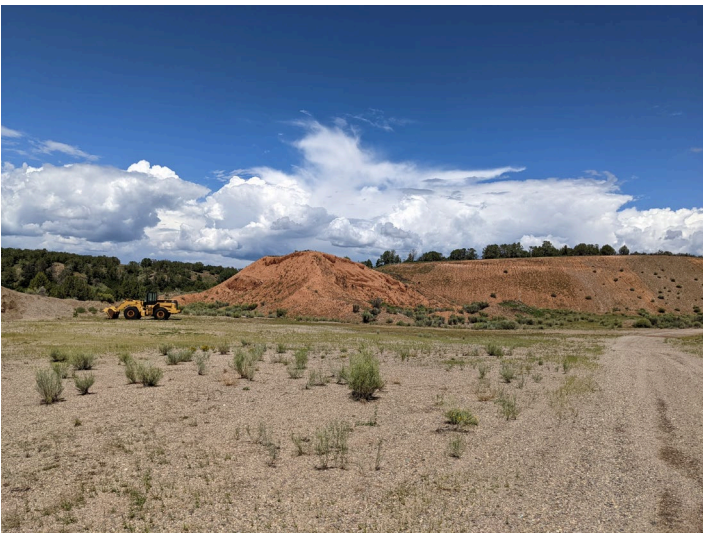
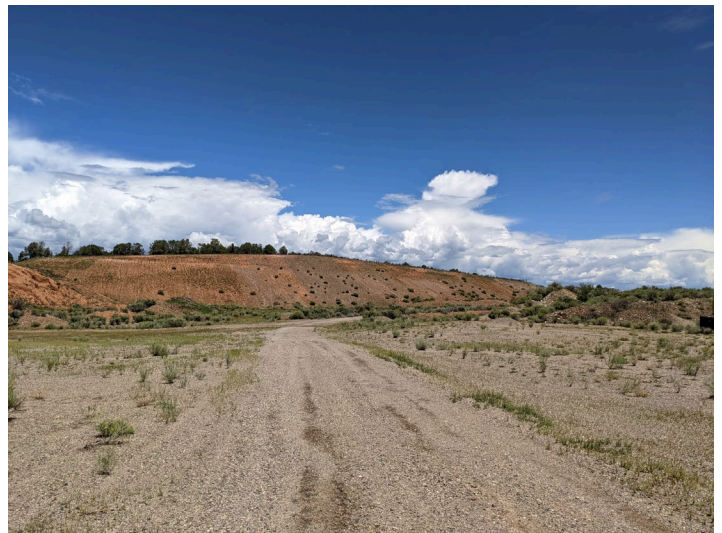
**Adequate mine identification signage was not noted at the entrance to the site. This has been noted as a problem on page one of this report.**

The affected area was marked by fencing and berms adequate to delineate the affected area boundary.

Mining was not occurring during this inspection. A dozer, loader, conveyors and other various equipment were stored on site. Several stockpiles of crushed gravel remain on site.

The mined slope at the west end of the Phase 1 area has been regraded to approximately 3H:1V and appears stable. The remainder of the highwall on the east side of the access road is approximately 1H:1V.

**CORRECTIVE ACTIONS:** The operator shall, at the entrance of the mine site, post a sign which shall be clearly visible from the access road with the following: the name of the operator, a statement that a reclamation permit for the operation has been issued by the Colorado Mined Land Reclamation Board; and the permit number. The operator shall submit photo documentation that a proper sign has been posted by the corrective
