Job Number: 99-3983

Subject: Quarterly Observation Report, Refuse
Pile, Foidel Creek Mine, Routt County, Colorado.

TCC Refuse Pile-Quarterly Inspection

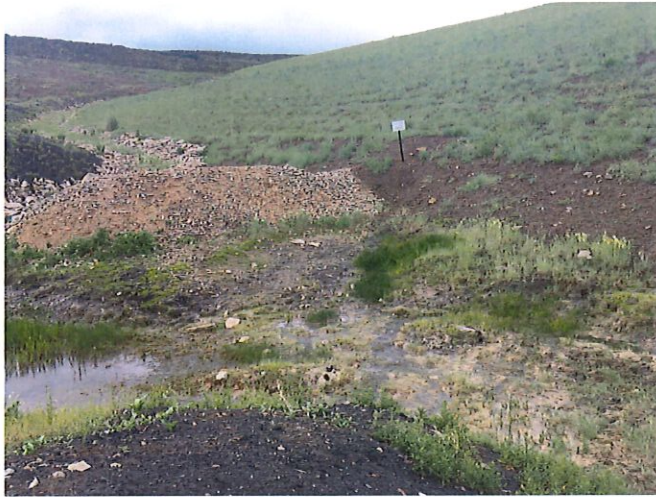
A seepage area at the toe of the northeast end of the refuse pile expansion area, approximately 30 feet northwest of the outlet of the underdrain, developed in fall 2014. At the time of our observations, the seepage was surfacing at the toe of the slope and flowing into the drainage from the undrain outlet then into the existing pond east of the Refuse Pile Expansion Area. The discharge was clear, with no evidence of sediment. No signs of washout, slumps or slope instability were observed at this time. The seepage area

will be monitored during future inspections and noted in our inspection reports. Photographs of the seepage area taken at the time of our inspection on June 30, 2022 are attached.

June 30, 2022-Drain Outlet and Seepage Area

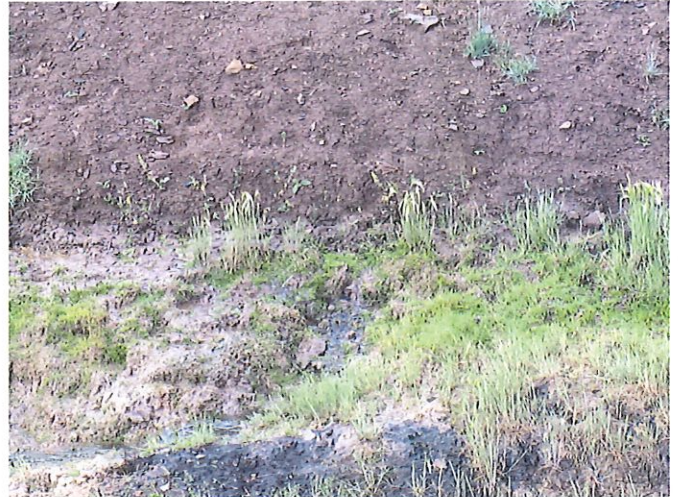
June 30, 2022-Seepage Area

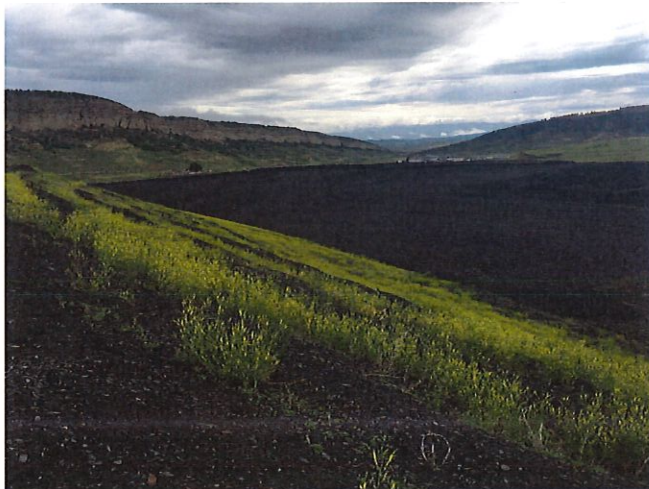
At the time of our site visit on June 30, 2022, NWCC completed a site inspection of the existing refuse pile. Based on our observations made during this visit, it appeared that the contractor was presently stockpiling, grading and compacting refuse coal in the new Expansion Area. At the time of our site visit, the refuse coal had been placed and compacted to an elevation above the third bench situated along the east side of the stockpile.

June 30, 2022- Expansion Area from Areas 2, 3 and 4

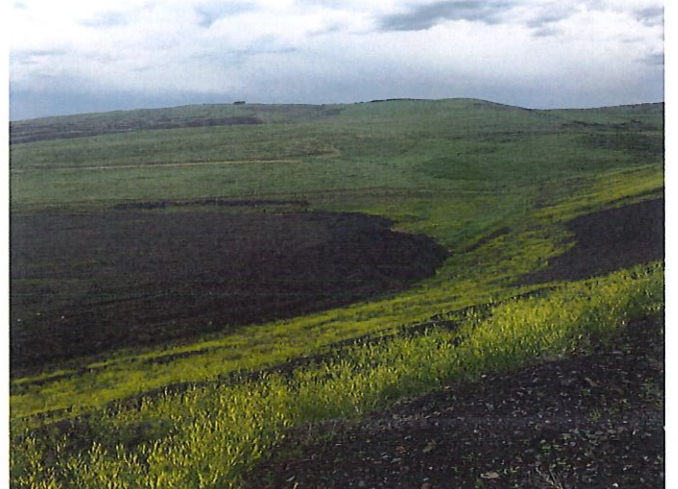
June 30, 2022- SW End of Drain in Expansion Area

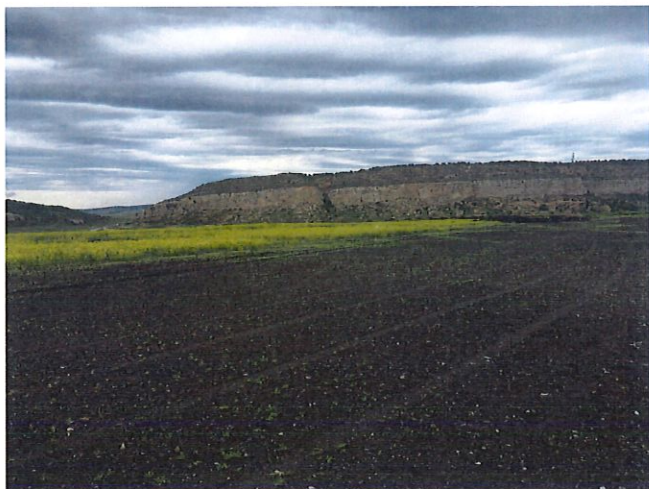
The internal roadways in the new expansion area of the pile are in good condition. The upper haul road to Areas 2, 3 and 4 of the refuse pile was accessible at the time of our site visit and in good condition.

June 30, 2022- Areas 2, 3 and 4

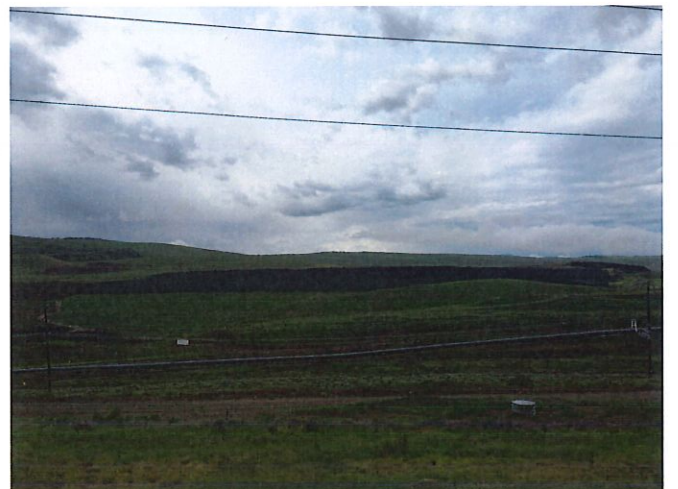
June 30, 2022- Benches on East Side of Refuse Pile
