MINERALS PROGRAM INSPECTION REPORT
PHONE: (303) 866-3567

MINE NAME: Durham Sand & Gravel Pit	MINE/PROSPECTING ID#: M-1978-056	MINERAL: Sand and gravel	COUNTY: Weld
INSPECTION TYPE: Monitoring	INSPECTOR(S): Robert Zuber, P.E.	INSP. DATE: September 1, 2022	INSP. TIME: 13:00
OPERATOR: Varra Companies, Inc.	OPERATOR REPRESENTATIVE: Garrett Varra, Brad Janes	TYPE OF OPERATION: 112c - Construction Regular Operation

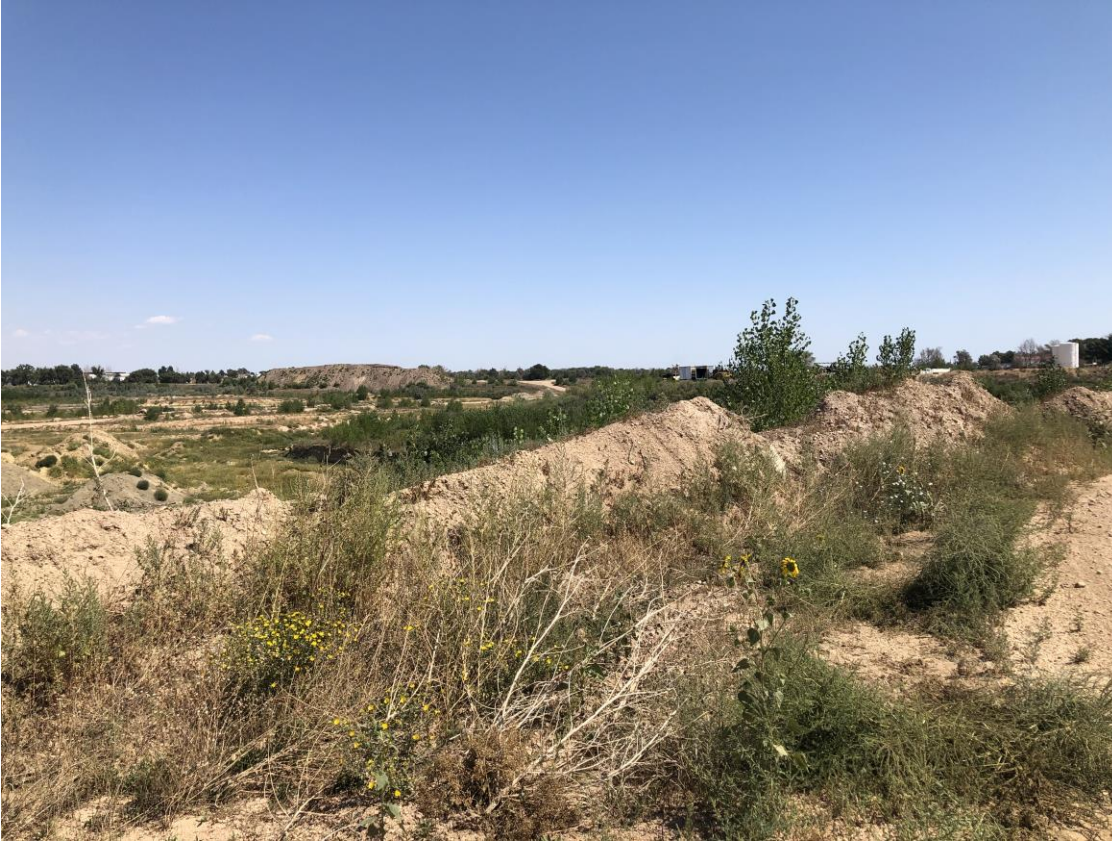
A large topsoil pile can be seen near the east end of Tract A. It is located on an old site for natural gas production. It is approximately 20 feet high, and the footprint is at least half an acre. Due to the location of this pile, there is little chance that the resource will be lost to erosion, however stabilization with a temporary cover crop is highly recommended.

East end of pit with soil pile in background

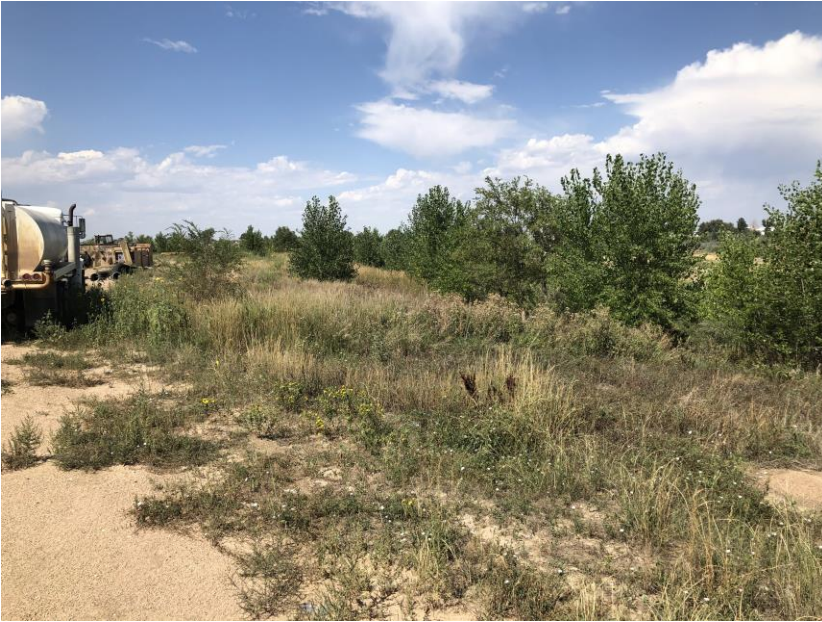
Old reclamation on pit slopes is well established with grasses and trees. In particular, slopes near the southeast corner of the site have very good vegetation.

Revegetated slopes near the southeast corner of the pit

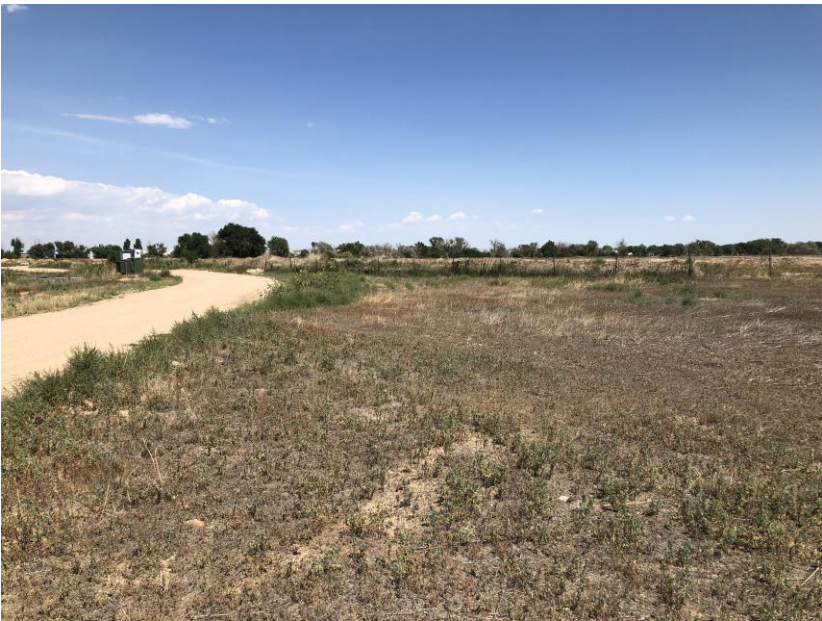
The entrance sign contained the necessary information. Boundary markers are in place around most of the site. These include fences on three sides and the Cache la Poudre River on the north side. An exception is the northern part of the east boundary where there is no fence or other marker.

East end of site – permit boundary is marked by fence

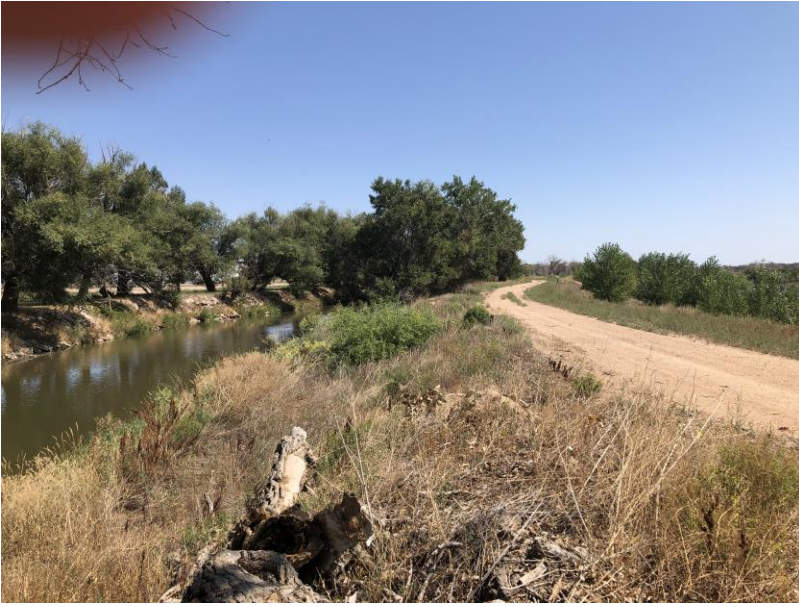
Road along north side with Cache la Poudre River on left

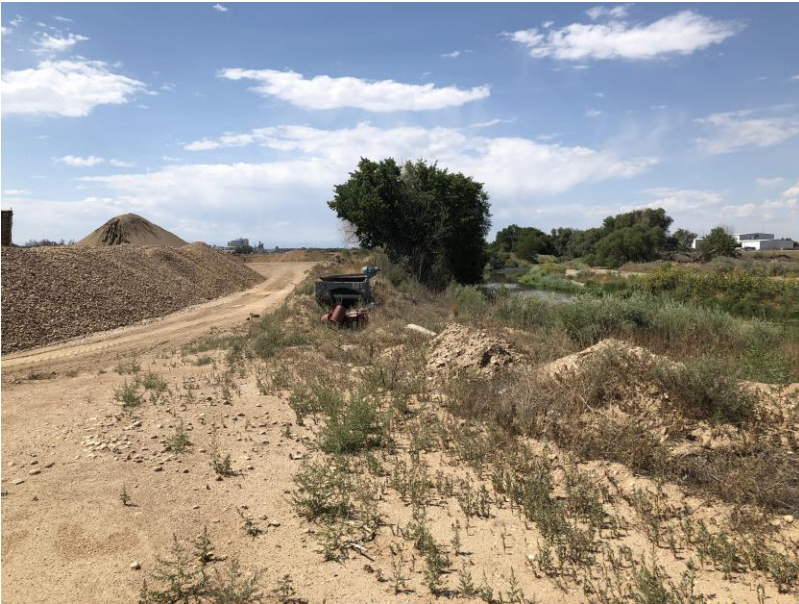
Processing stockpiles along the river, east of the pond in Tract C

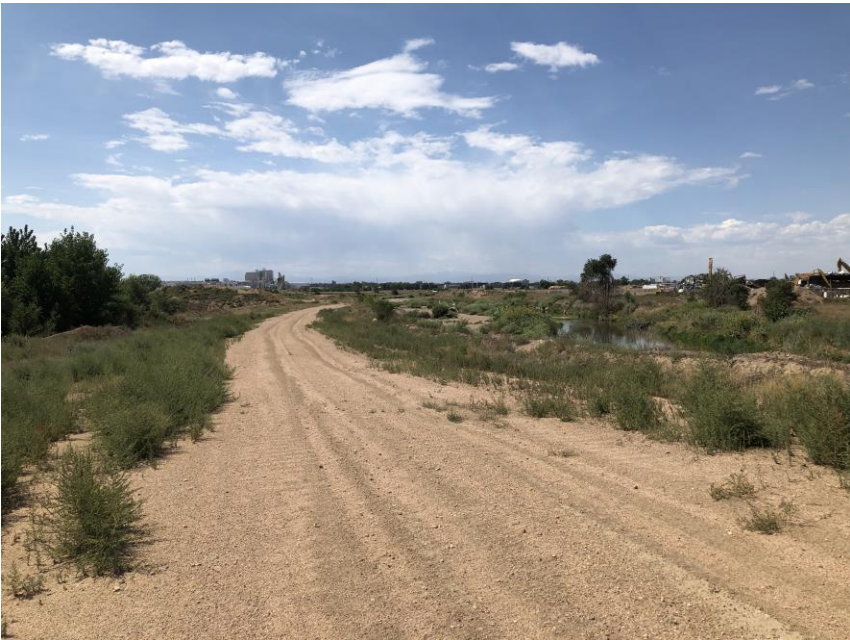
Berms were seen around the pit and process areas for safety compliance (generally four to six feet high). No berms were seen for flood protection along the river. At the low point where a breach happened in the flood of 2013 (per Mr. Janes), the road is very low, and does not act as a levee or berm. Also in this area, near Tract D, the remnant of a sill, which failed in the 2013 flood, is visible. A representative of Weld County, Diana Aungst, was contacted, and she indicated that the County has no issues with this site in the context of floodplain management.

Low point along river where breach occurred in 2013

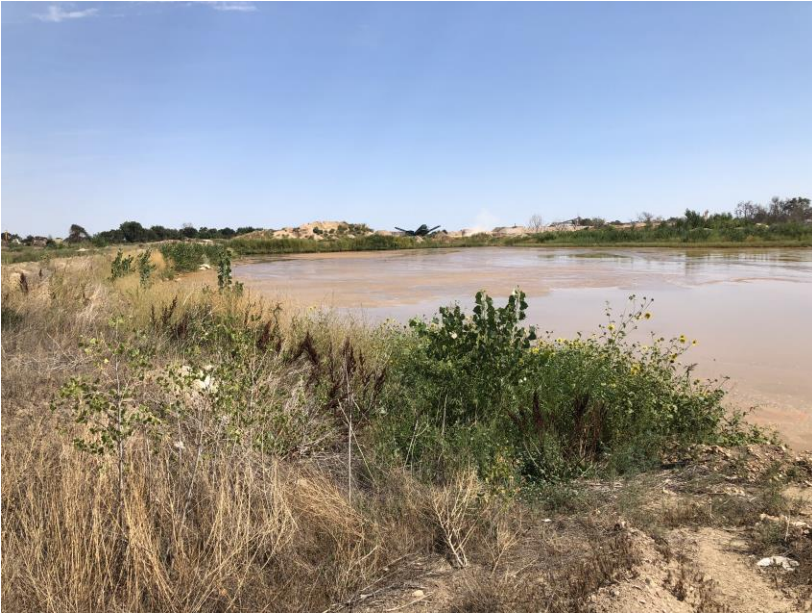
Significant areas of ponded water include the silt pond in Tract D, which has been filled considerably, and the clean water pond near the entrance (Tract B). No water was seen in the old silt pond (east of Tract D), but this structure is filled with riparian vegetation.

Tract D – silt pond nearly full

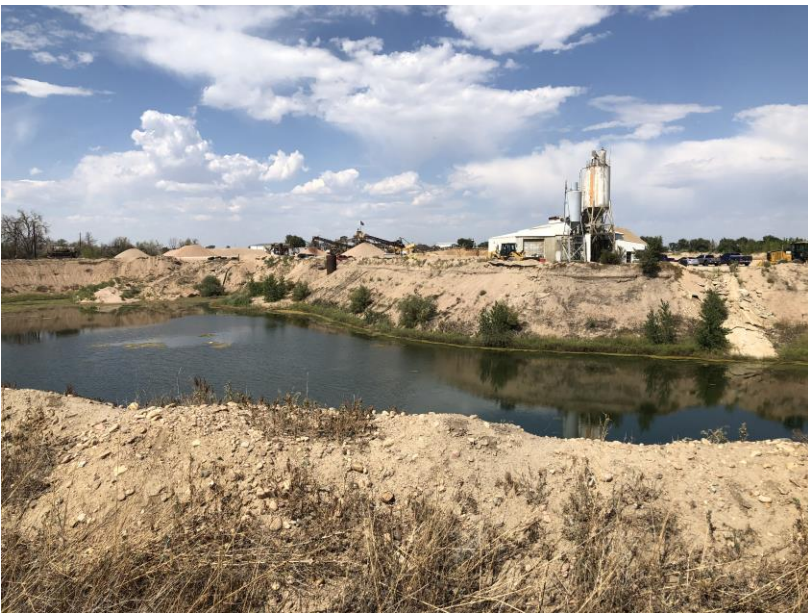
Fresh water pond and process area
