## MINERALS PROGRAM INSPECTION REPORT

<b>MINE NAME:</b> Red Mountain Exploration Drilling	<b>MINE/PROSPECTING ID#:</b> P-2011-014	<b>MINERAL:</b> Molybdenum	<b>COUNTY:</b> Clear Creek
<b>INSPECTION TYPE:</b> Surety Release Inspection	<b>INSPECTOR(S):</b> Peter Hays	<b>INSP. DATE:</b> August 25, 2022	<b>INSP. TIME:</b> 09:00
<b>OPERATOR:</b> Climax Molybdenum Company	<b>OPERATOR REPRESENTATIVE:</b> Geoff Niggeler	<b>TYPE OF OPERATION:</b> MP - Mineral Prospecting

<b>REASON FOR INSPECTION:</b> Surety Release Requested	<b>BOND CALCULATION TYPE:</b> None	<b>BOND AMOUNT:</b> \$108,000.00
<b>DATE OF COMPLAINT:</b> NA	<b>POST INSP. CONTACTS:</b> None	<b>JOINT INSP. AGENCY:</b> None
<b>WEATHER:</b> Clear	<b>INSPECTOR'S SIGNATURE:</b> 	<b>SIGNATURE DATE:</b> September 27, 2022

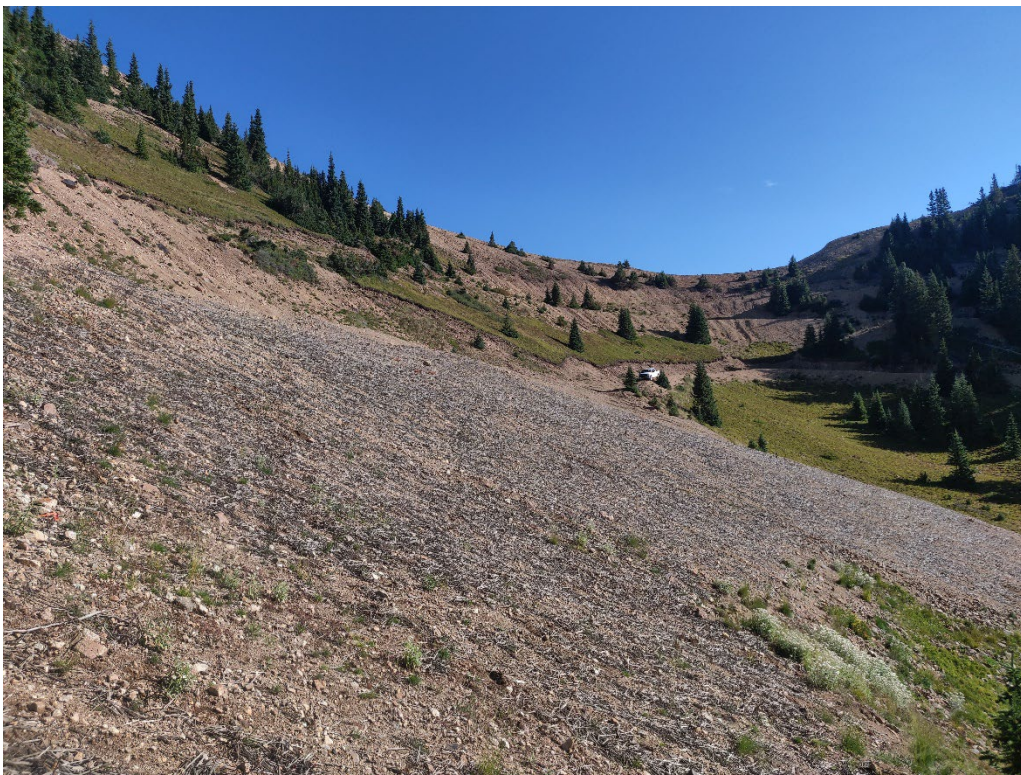
The vegetation on drill pads #5 and #6 was sparse and not well-established. The lack of vegetation on drill pad #5 might be due to over mulching. The lack of vegetation on drill pad #6 is likely due to the elevation and grade of the area. Drill pads #7-8 were not observed during the inspection due to the steep grades and impending weather.

View of drill pad #5

The lower access road appeared releasable from further reclamation responsibility by the Division, however the observed drill pads and upper access road require improved vegetation establishment prior to release consideration by the Division. The Red Mountain portion of the NOI site will be evaluated by the Division prior to issuing a determination on the final release request.

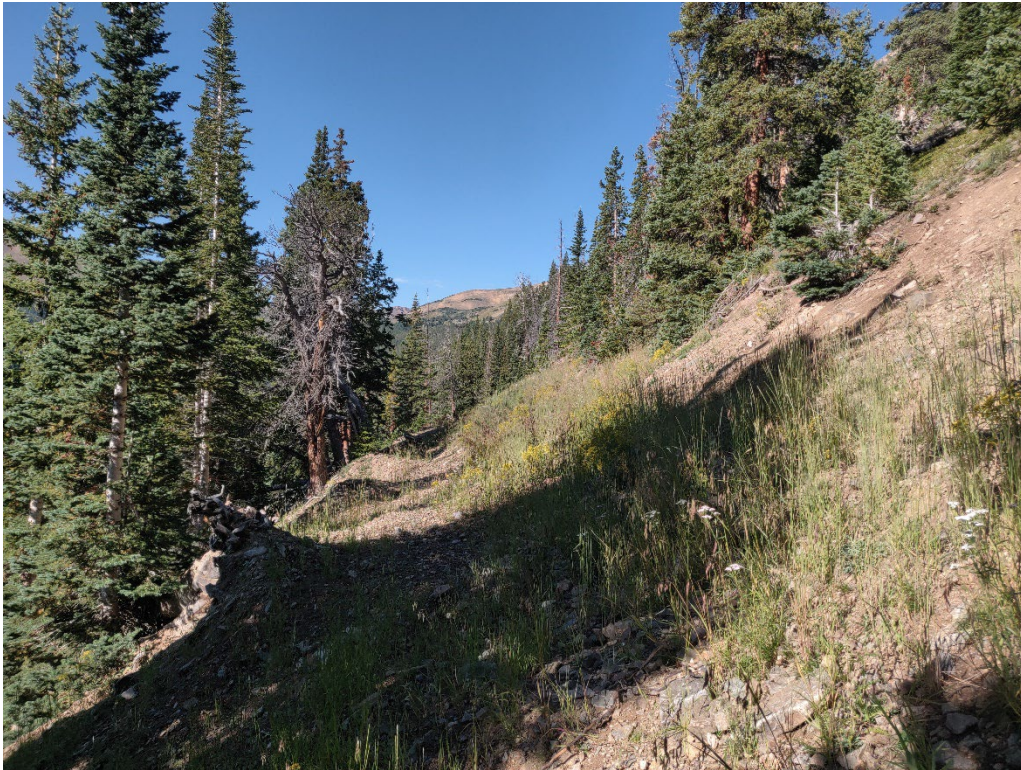
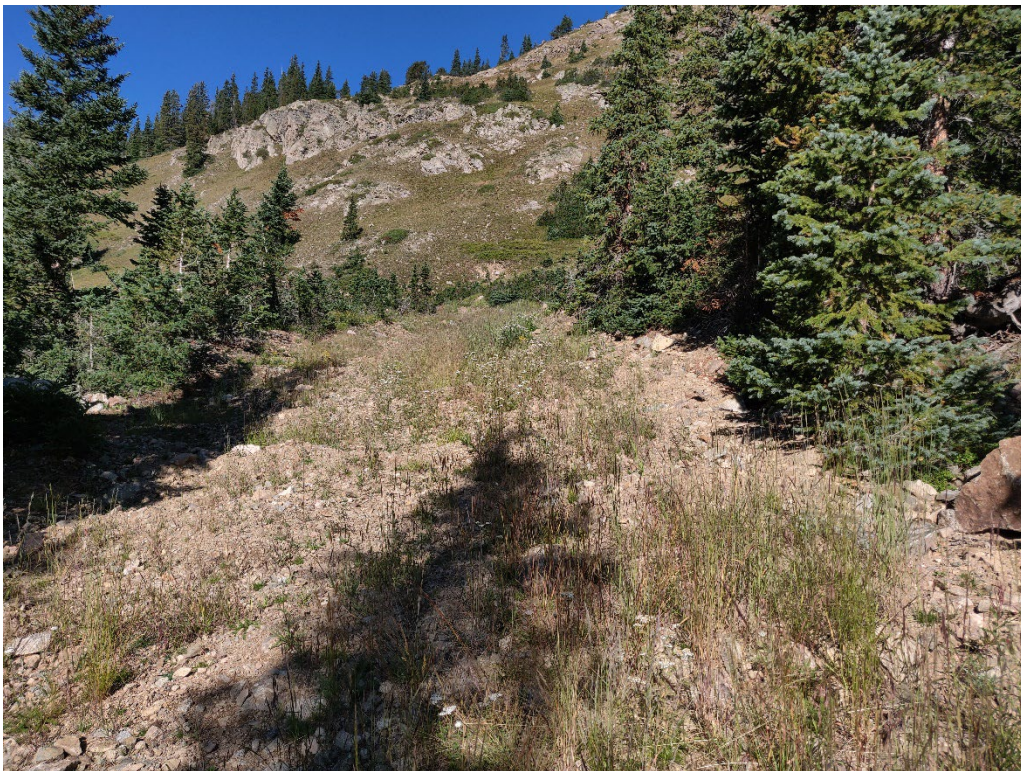
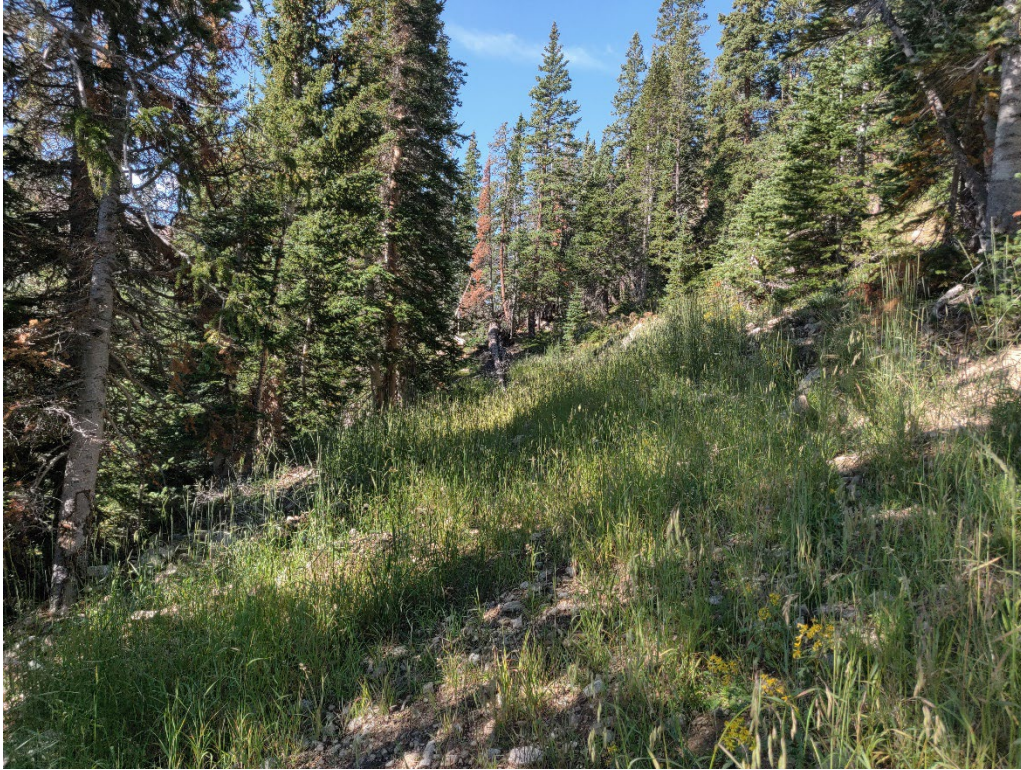
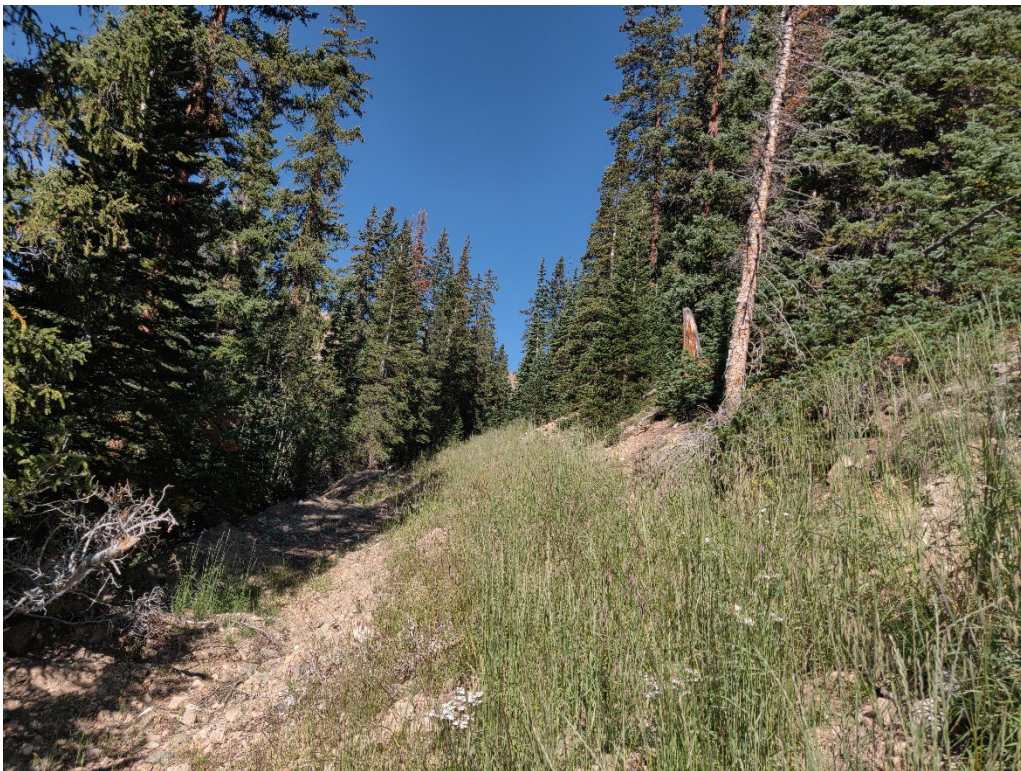
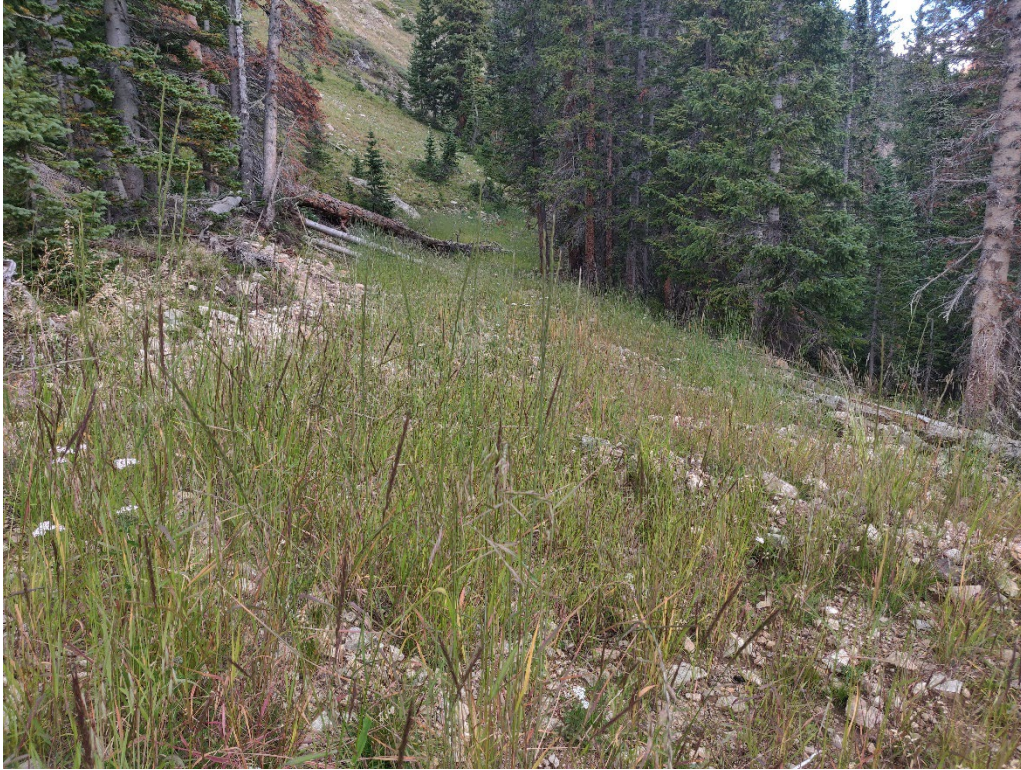
Minor erosion features were observed on the upper elevation access road and drill pad #6. No erosion features were observed on the lower access road. Overall, the access road and the observed drill pads appeared stable.

View of vegetation on the lower access road

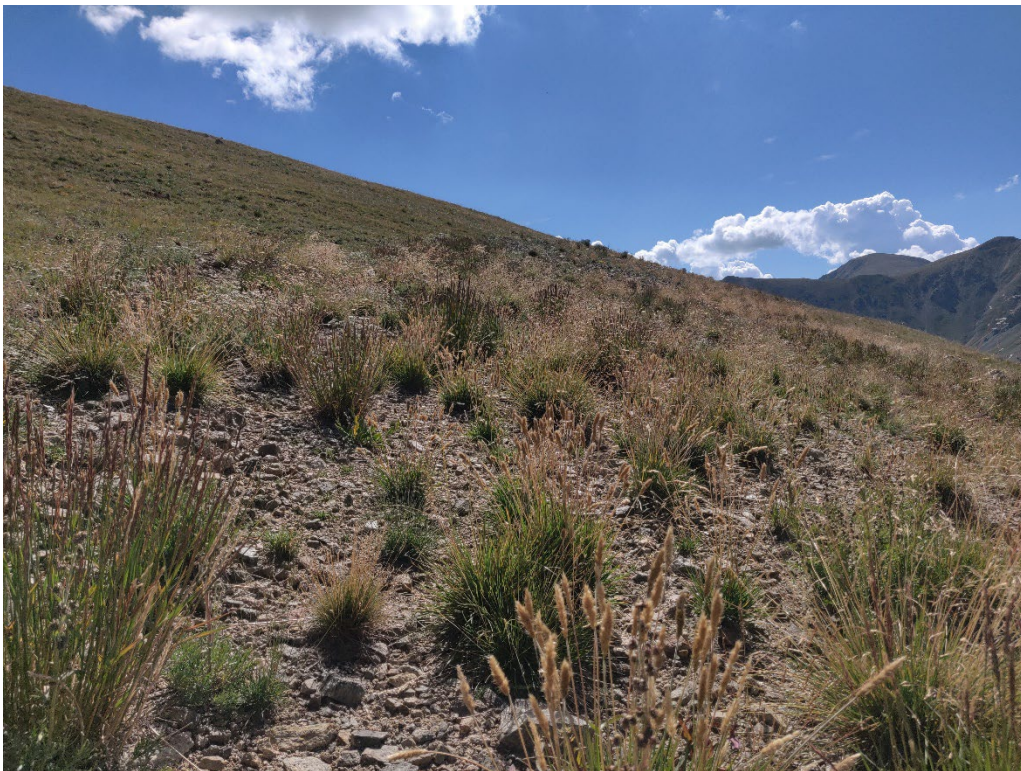
The access road between the drill pads was graded and filled to blend with the adjacent terrain and to maintain the natural drainage patterns. The access road was rough graded and topsoiled creating an angulating surface with shallow depressions between drill pad #5 and the access road switchback before drill pad #6. The rough grading technique creates micro climates which retain moisture to aid in the establishment of reclamation vegetation. Vehicle access to the drill sites and access road is no longer possible following reclamation. The vegetation on the access road was well-established and displayed evidence of several growth cycles with developed seed heads during the inspection. The access road grading above the switchback to drill pad #6 was smoother and more uniform compared to the lower access road. The vegetation on the upper access road was sparse and juvenile, however based on the elevation appeared to be developing well.

View of the upper access road vegetation below drill pad #6

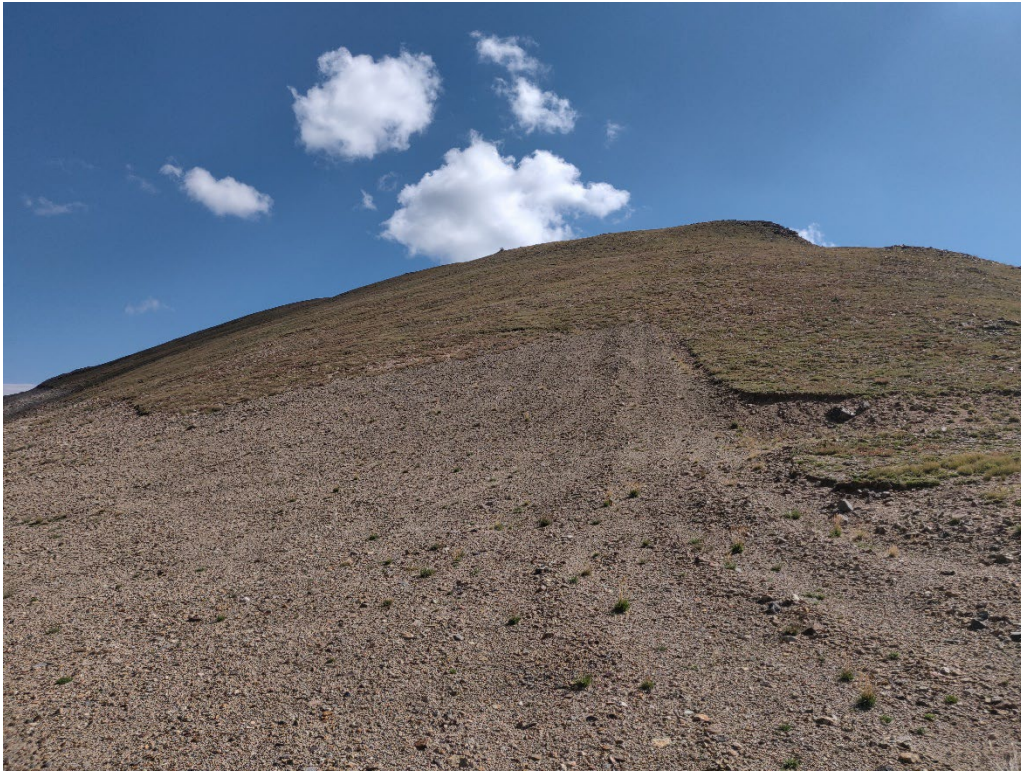
View of the drill pad #6 grading

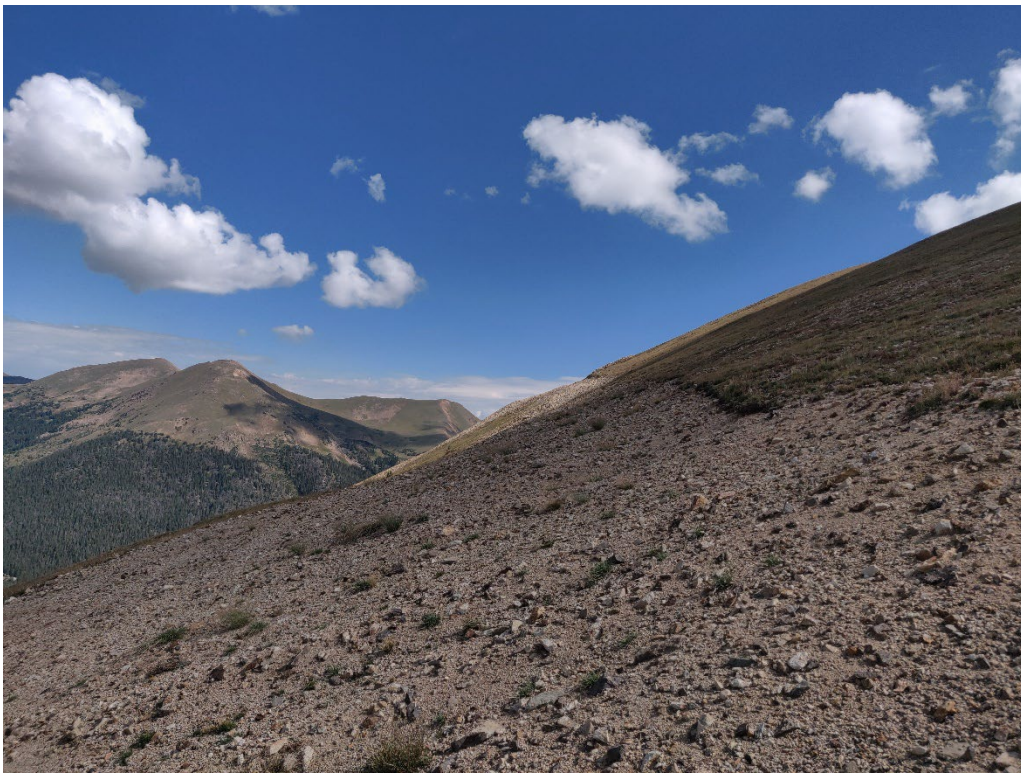
View of drill pad #6
