October 10, 2022

Job Number: 99-3983

Subject: Quarterly Observation Report, Refuse Pile, Foidel Creek Mine, Routt County, Colorado.

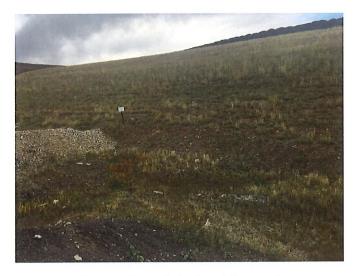
A seepage area at the toe of the northeast end of the refuse pile expansion area, approximately 30 feet northwest of the outlet of the underdrain, developed in fall 2014. At the time of our observations, the seepage was surfacing at the toe of the slope and flowing into the drainage from the undrain outlet then into the existing pond east of the Refuse Pile Expansion Area. The discharge was clear, with no evidence of sediment. No signs of washout, slumps or slope instability were observed at this time. The seepage area

September 29, 2022-Drain Outlet and Seepage Area

will be monitored during future inspections and noted in our inspection reports. Photographs of the seepage area taken at the time of our inspection on September 29, 2022 are attached.

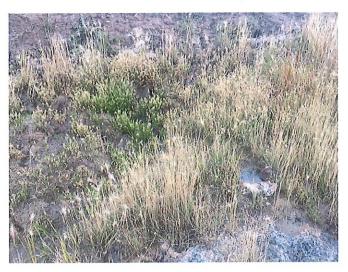
September 29, 2022-Seepage Area

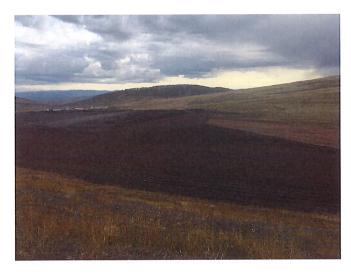
At the time of our site visit on September 29, 2022, NWCC completed a site inspection of the existing refuse pile. Based on our observations made during this visit, it appeared that the contractor was presently stockpiling, grading and compacting refuse coal in the new Expansion Area. At the time of our site visit, the refuse coal had been placed and compacted to an elevation above the third bench situated along the east side of the stockpile.

September 29, 2022- Expansion Area from Areas 2, 3 and 4

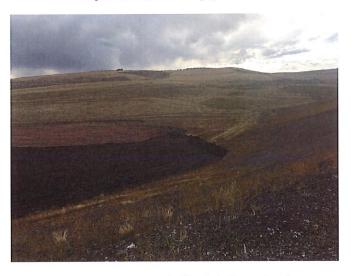
September 29, 2022- SW End of Drain in Expansion Area

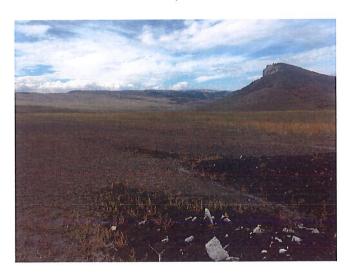
The internal roadways in the new expansion area of the pile are in good condition. The upper haul road to Areas 2, 3 and 4 of the refuse pile was accessible at the time of our site visit and in good condition.

September 29, 2022- Areas 2, 3 and 4

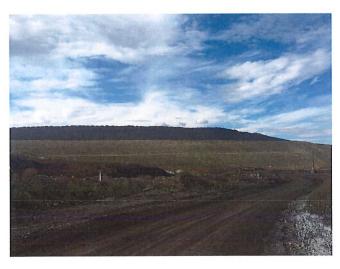
September 29, 2022- Benches on East Side of Refuse Pile
