**RE: Permit No. M-1980-244; Cripple Creek & Victor Gold Mining Company; Cresson Project;
Inspection Report Response: September 2, 2021**

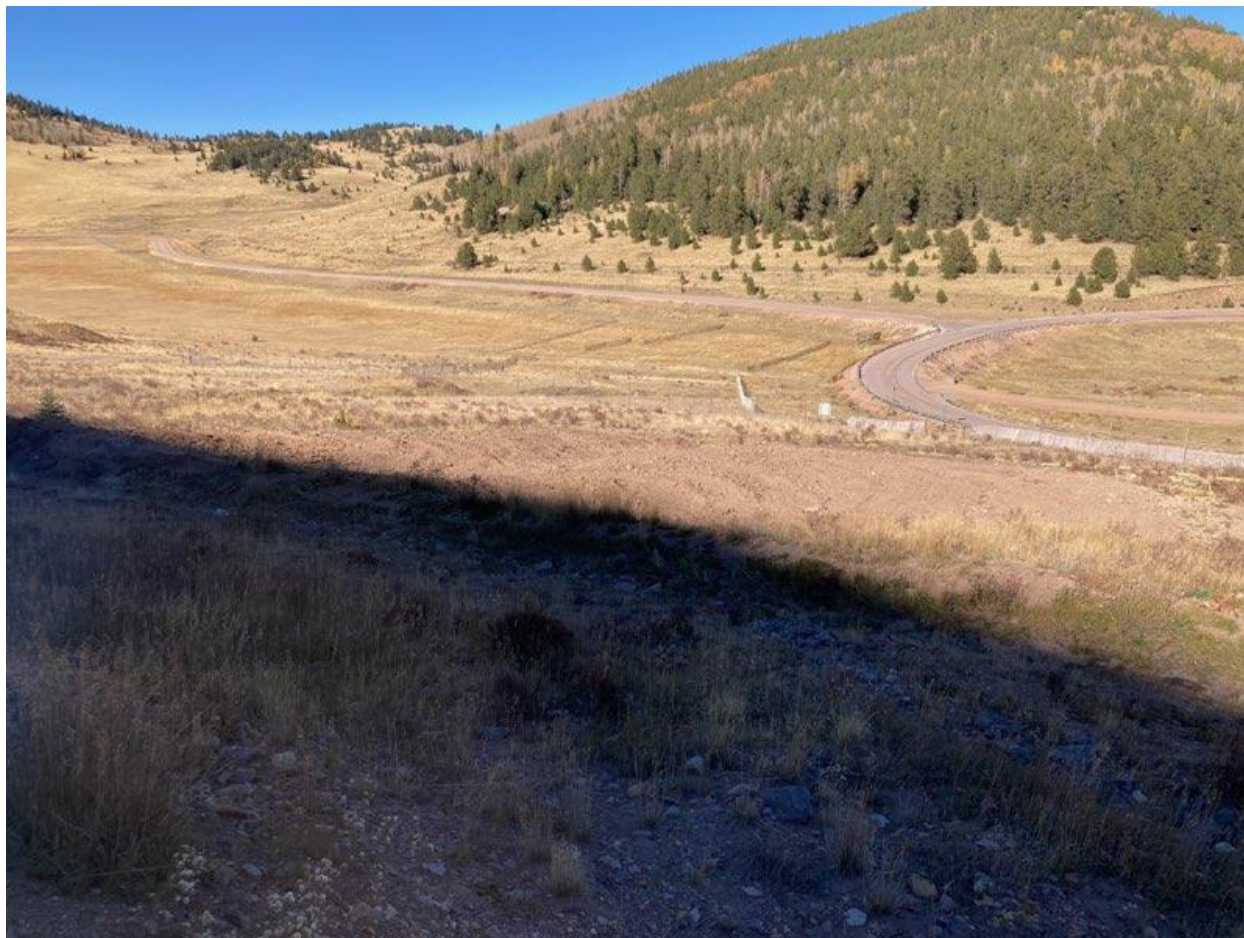
Photo 1: 10/15/21 ECOSA Drill Pad reclamation, facing north.

Please see Photos 1-3 in Attachment 1, documenting cleanup of sediment, regrading of the drill pad area, and installation of straw wattles for sediment control. Regrading of the drill pad area was completed on October 15th. The area will be seeded with an approved reclamation seed mix by the corrective action due date of December 13.

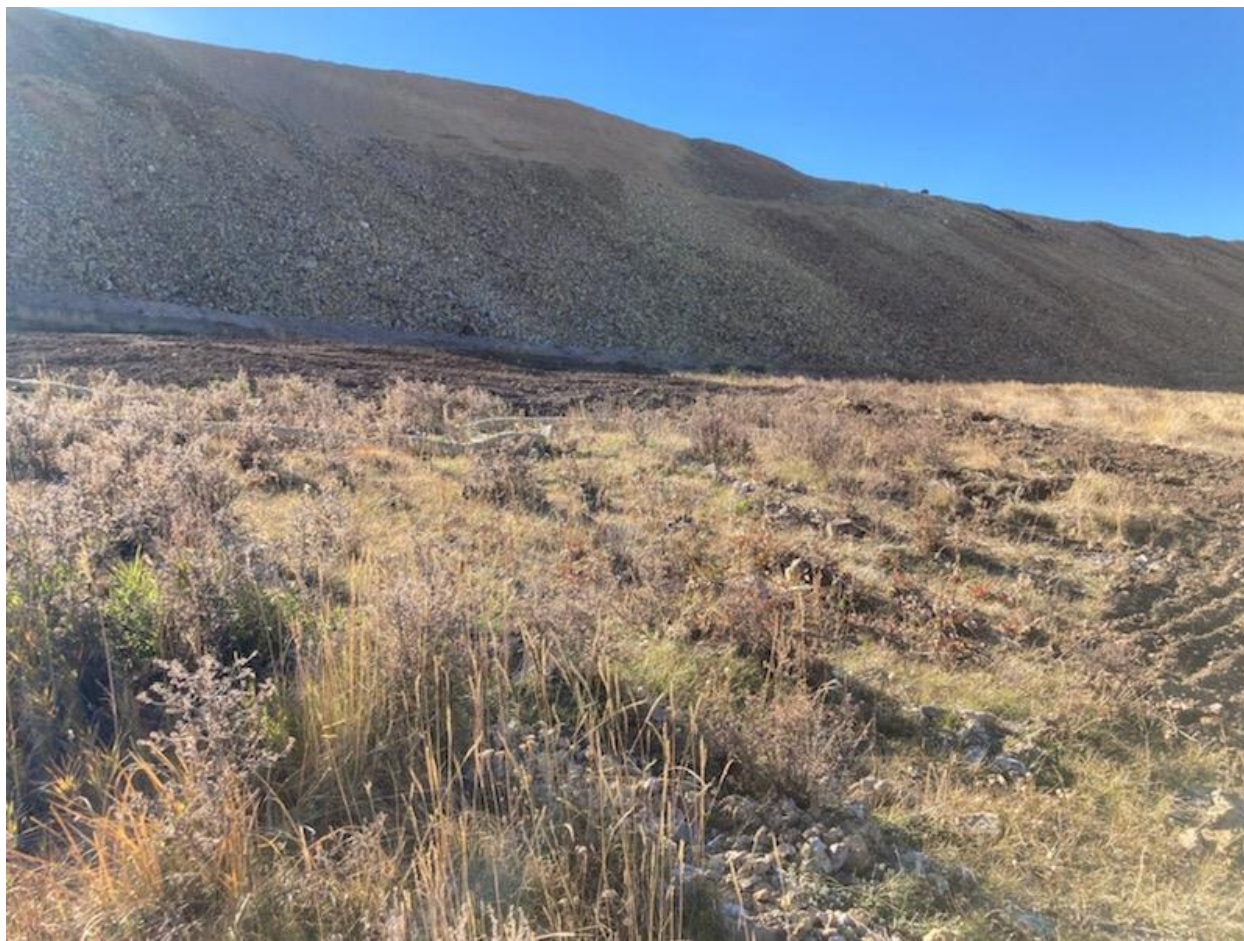
Photo 2: 10/15/21 ECOSA Drill Pad reclamation and straw wattles, facing west.

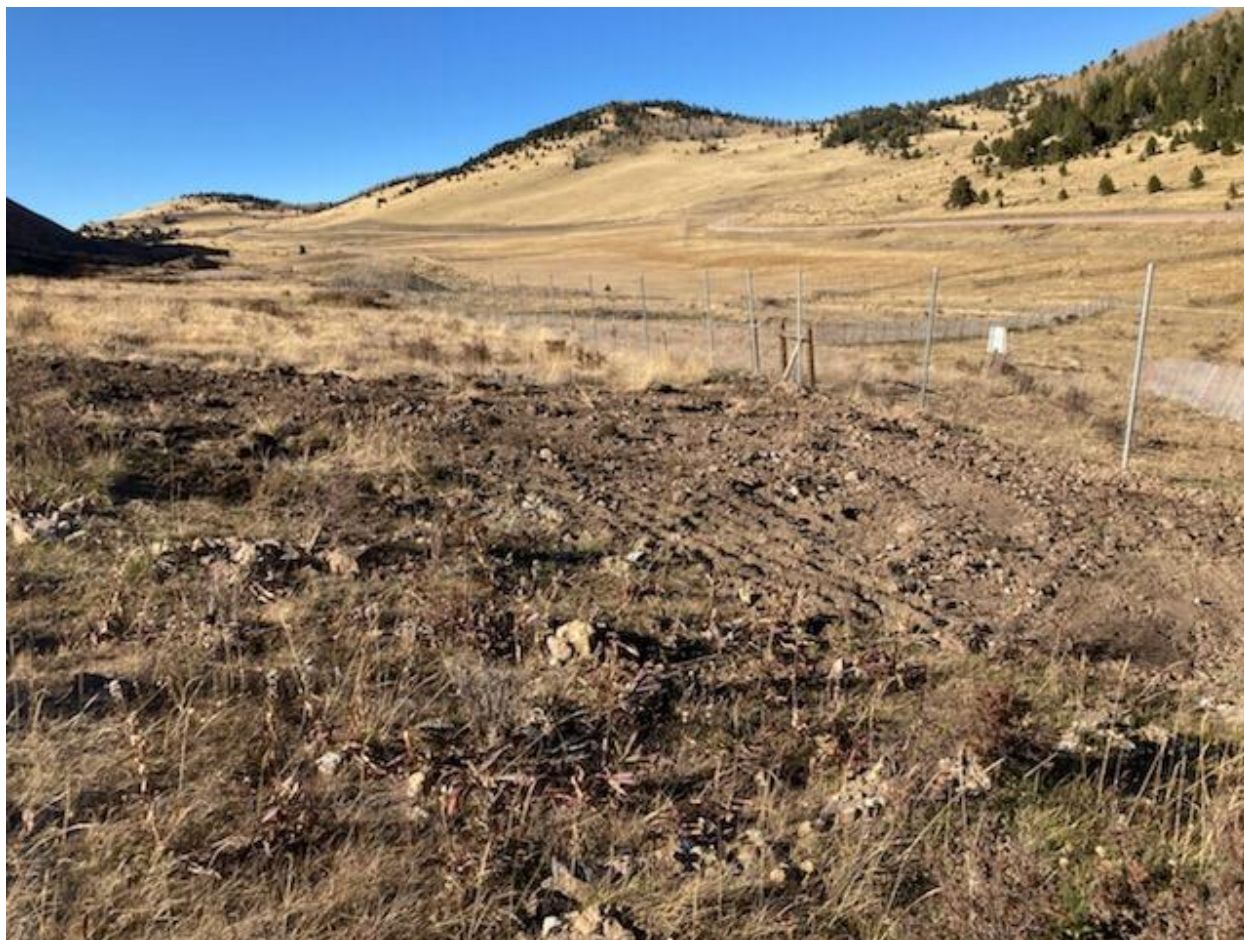
Photo 3: 10/15/21 ECOSA Drill Pad reclamation – sediment excavation near wildlife fence, facing north.
