MINERALS PROGRAM INSPECTION REPORT
PHONE: (303) 866-3567

MINE NAME: White River S & G Pit	MINE/PROSPECTING ID#: M-1991-009	MINERAL: Gravel	COUNTY: Rio Blanco
INSPECTION TYPE: Surety-Related Inspection	WEATHER: Windy	INSP. DATE: November 2, 2022	INSP. TIME: 10:20
OPERATOR: White River Aggregates, Inc.	OPERATOR REPRESENTATIVE: Kent Borchard	TYPE OF OPERATION: 110c - Construction Limited Impact	
REASON FOR INSPECTION: Surety Related	BOND CALCULATION TYPE: Complete Bond	BOND AMOUNT: \$33,814.20	
DATE OF COMPLAINT: NA	POST INSP. CONTACTS: None	JOINT INSP. AGENCY: None	
INSPECTOR(S): Amy Yeldell	INSPECTOR'S SIGNATURE:

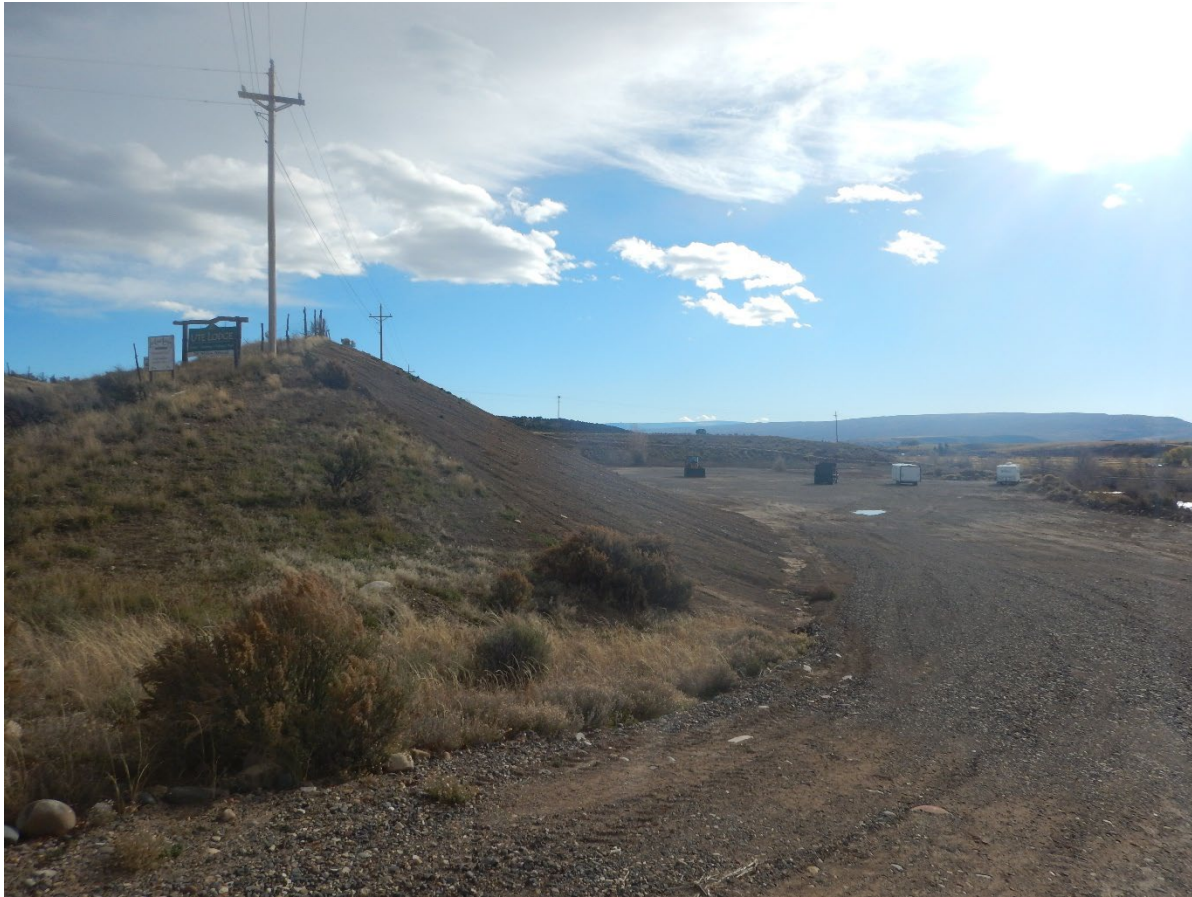
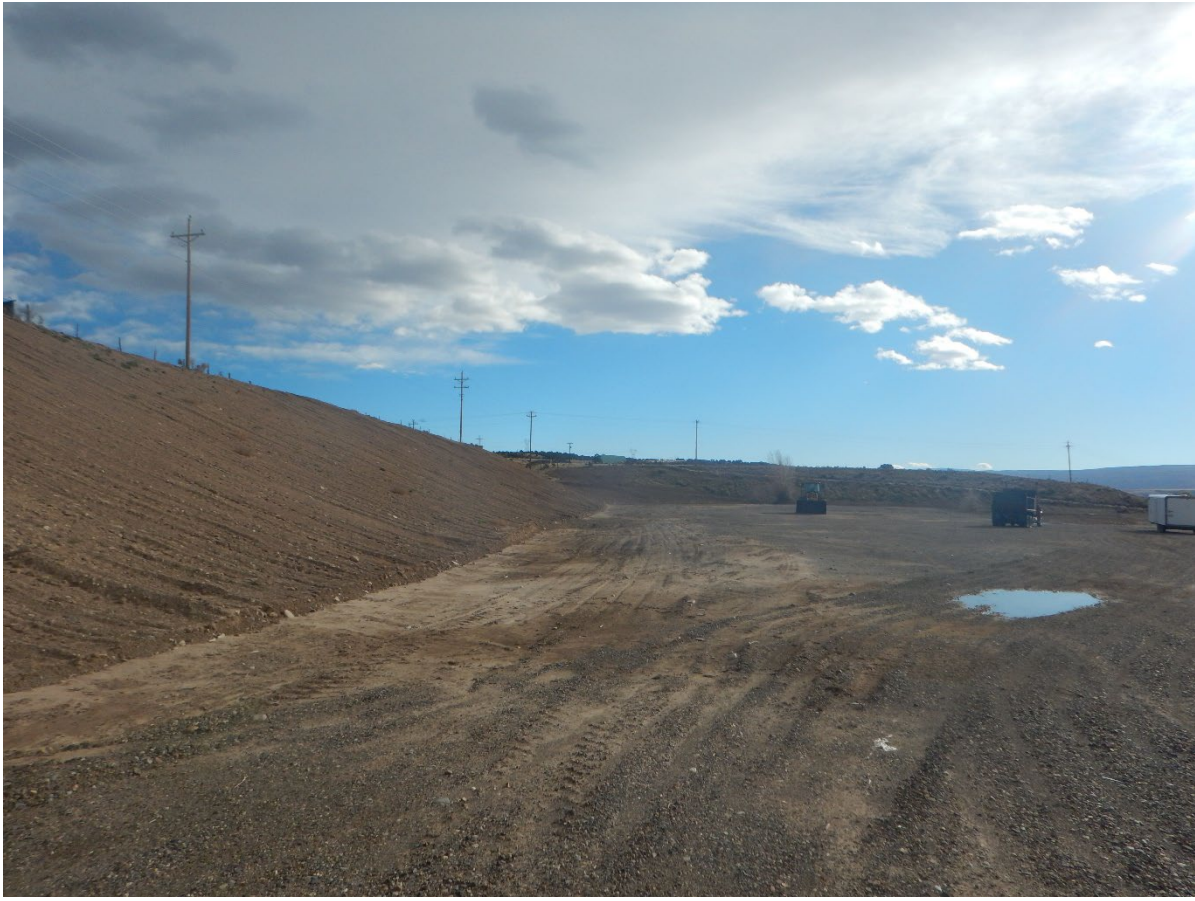
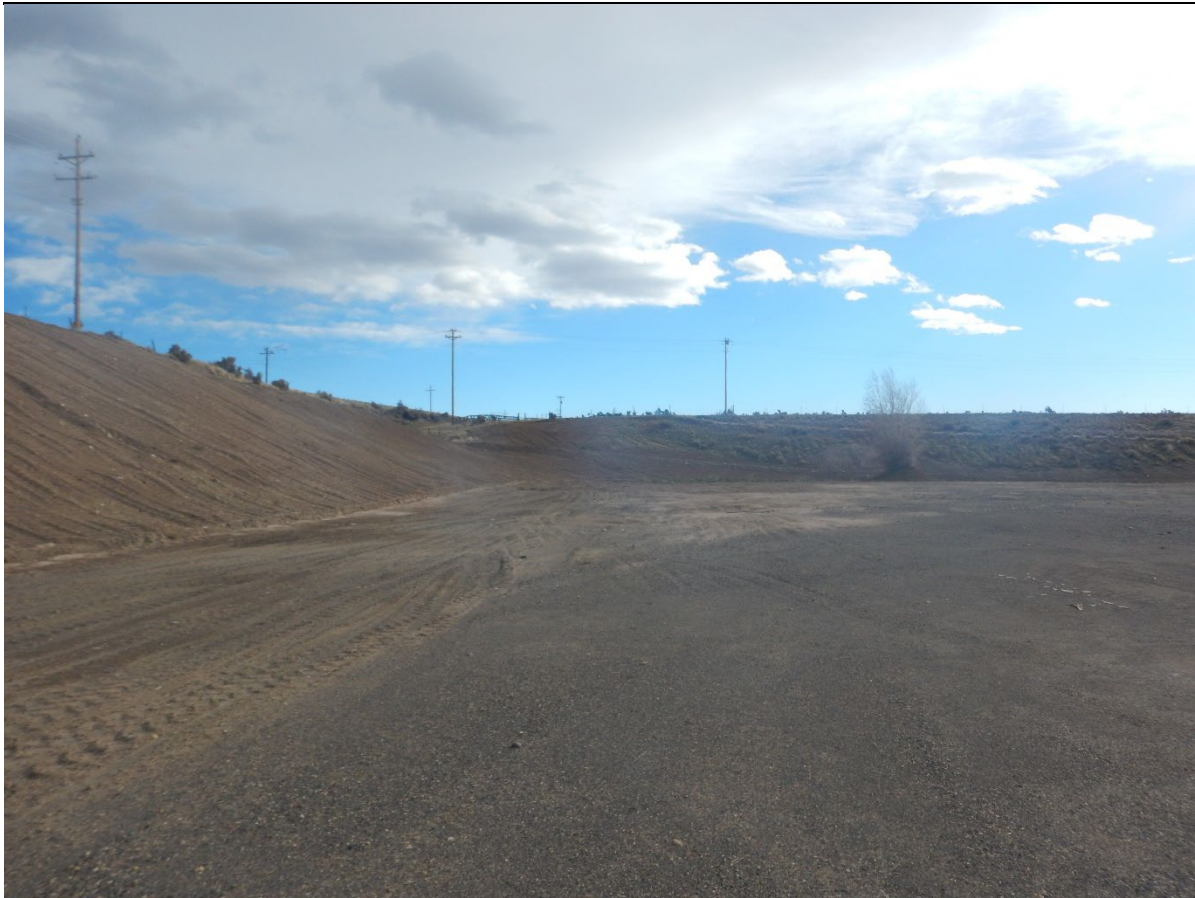
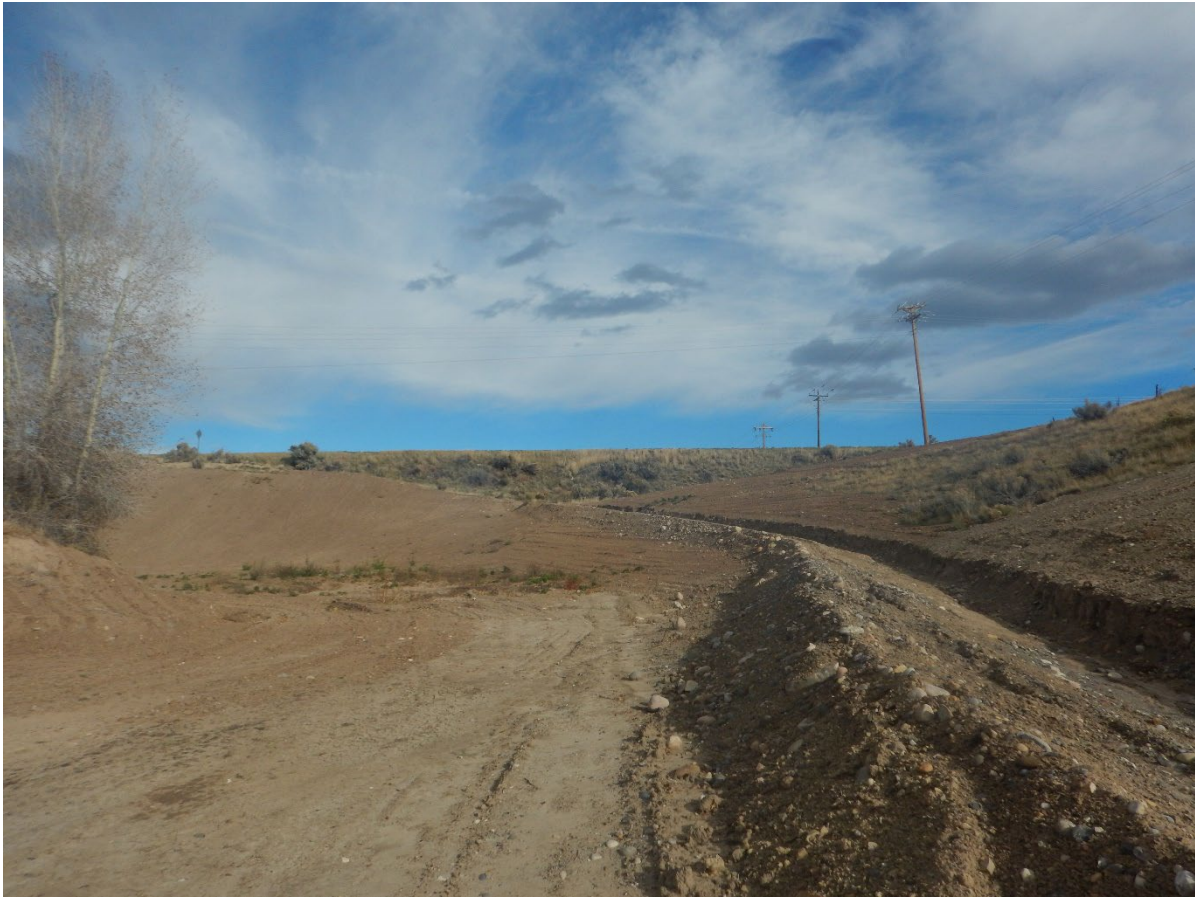
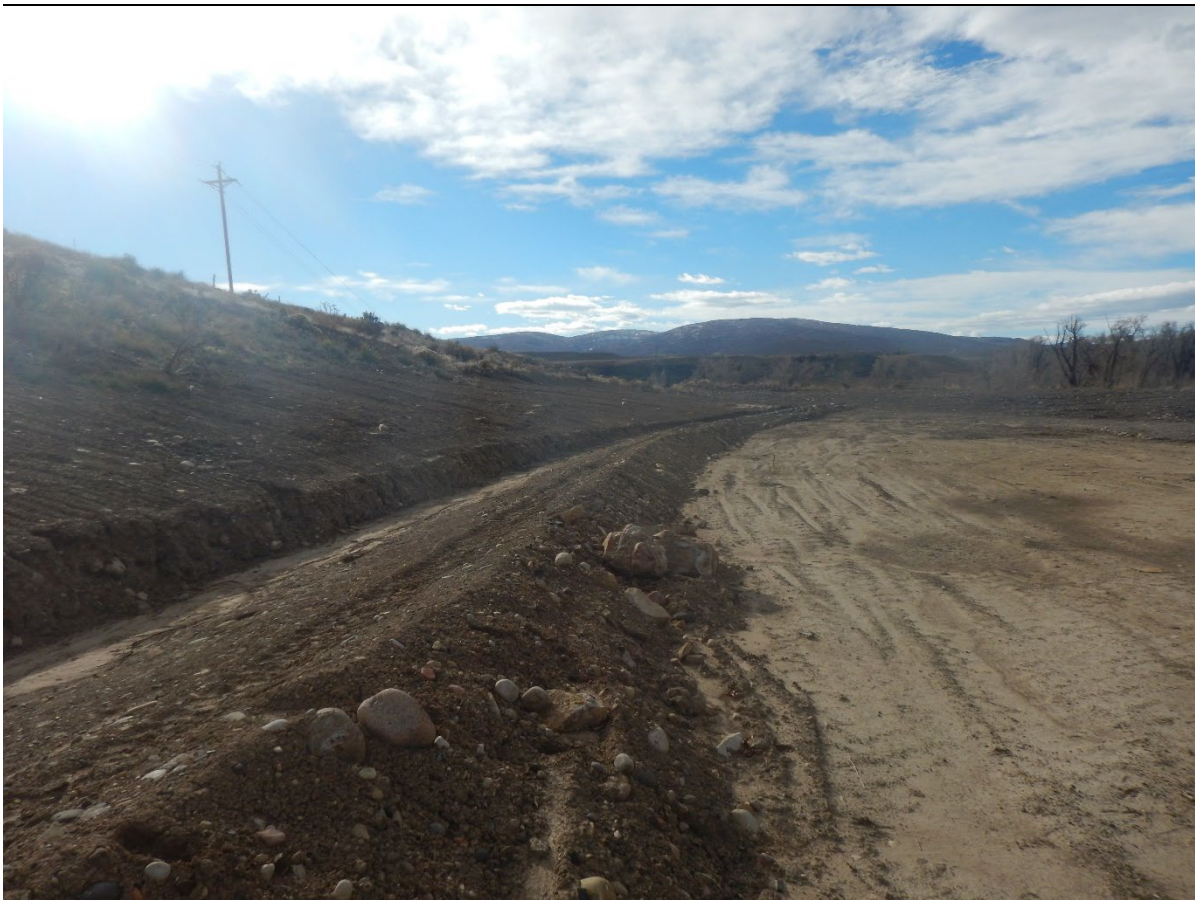
PHOTOGRAPHS

Significant reclamation progress has been made since the Division's last inspection on May 24, 2022. All mining related debris has been removed from the site and only equipment remains on site. All highwall slopes have been properly graded to a 2H: 1V or less and topsoil has been reapplied. Seeding has not yet occurred and is scheduled for this spring. The misc. stockpiles on the pit floor have all been graded out flat and are stabilized with remaining gravel. There is a drainage ditch along the east side of the pit conveying stormwater from CR 8 through the pit to a sediment pond on the southeast corner. A small berm has been left along the western edge of the pit floor to create a bowl, preventing run-off from going directly into the river adjacent to the permit.
