MINERALS PROGRAM INSPECTION REPORT

MINE NAME: West Pit	MINE/PROSPECTING ID#: M-1983-130	MINERAL: Sand and gravel	COUNTY: Elbert
INSPECTION TYPE: Surety Release Inspection	WEATHER: Clear	INSP. DATE: November 2, 2022	INSP. TIME: 10:00
OPERATOR: Elbert County	OPERATOR REPRESENTATIVE: Jason Kohring	TYPE OF OPERATION: 110c - Construction Limited Impact	
REASON FOR INSPECTION: Surety Related	BOND CALCULATION TYPE: None	BOND AMOUNT: \$0.00	
DATE OF COMPLAINT: NA	POST INSP. CONTACTS: None	JOINT INSP. AGENCY: None	
INSPECTOR(S): Amy Eschberger	INSPECTOR'S SIGNATURE:

M-1983-130 / West Pit / Elbert County (110c)

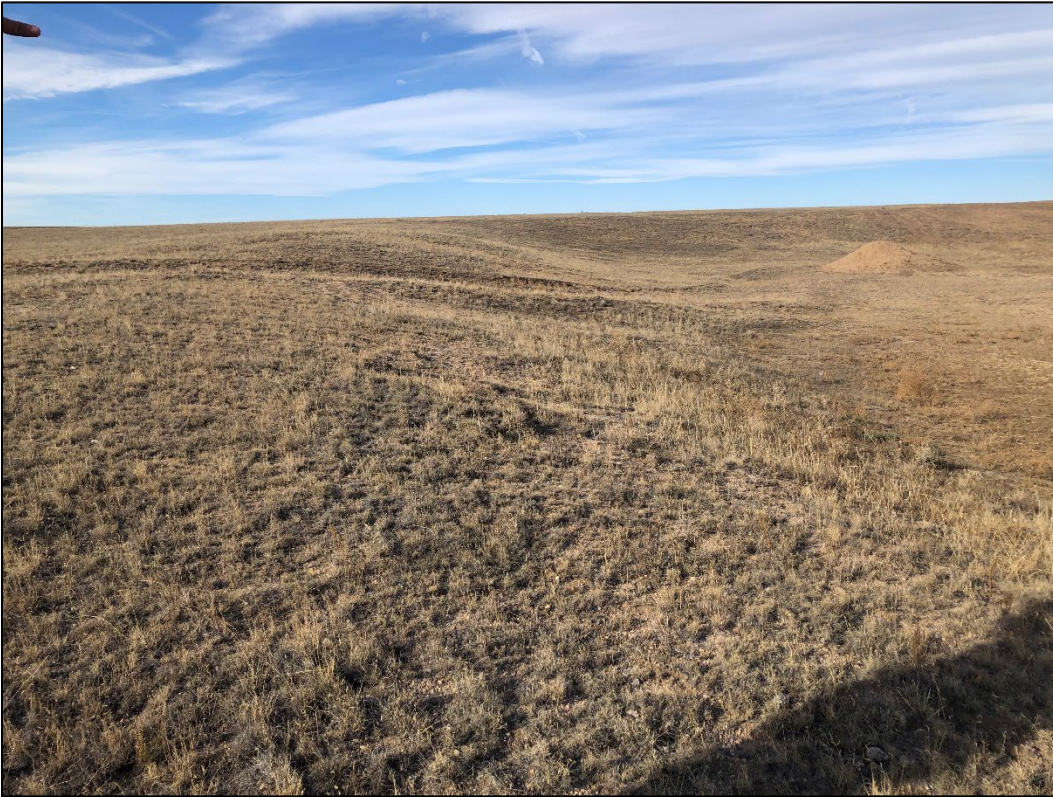
Photo 1. View looking west across reclaimed southern pit wall, showing slopes graded to 3H:1V or flatter with a good grass cover.

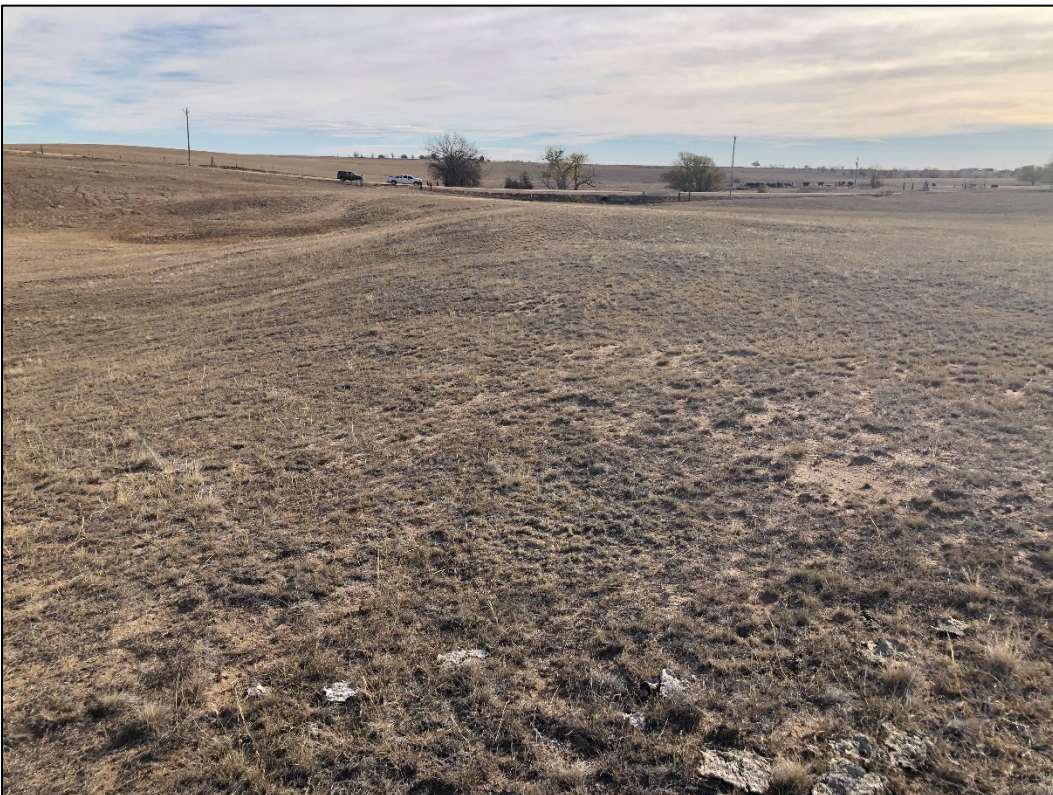
Photo 2. View looking east across reclaimed southern pit wall, showing slopes graded to 3H:1V or flatter with a good grass cover.

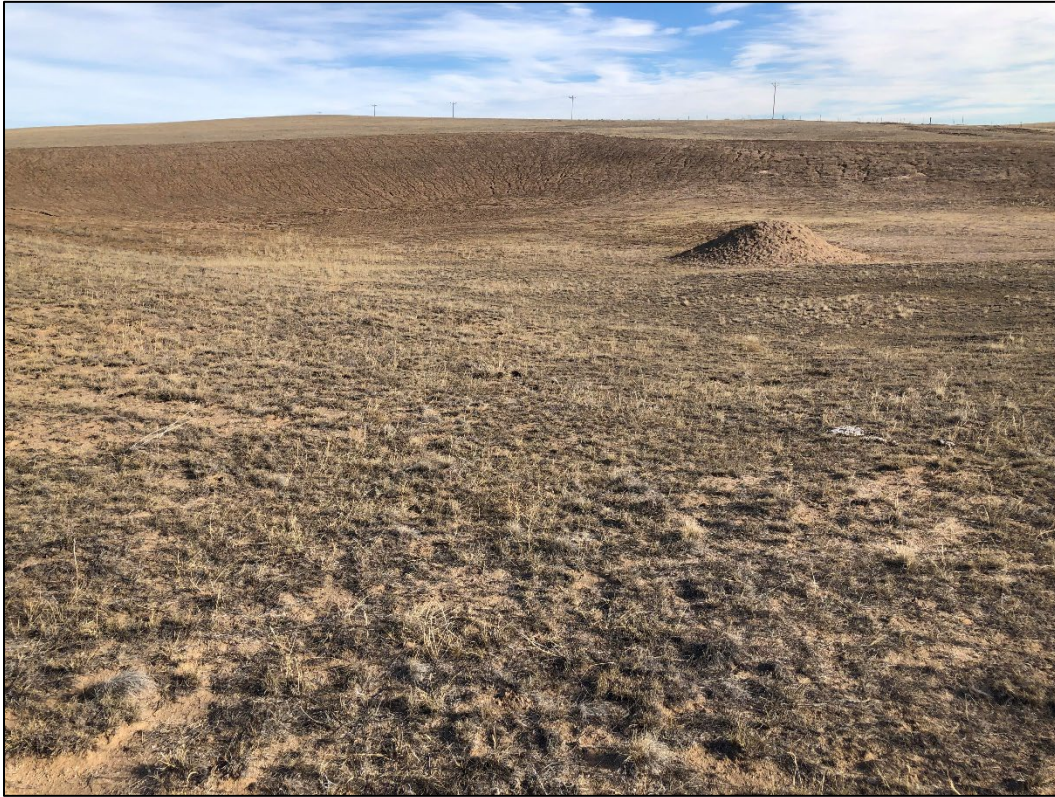
Photo 3. View looking north across reclaimed pit, showing slopes graded to 3H:1V or flatter with a good grass cover. Note small gravel pile (at right) left on pit floor for landowner use.

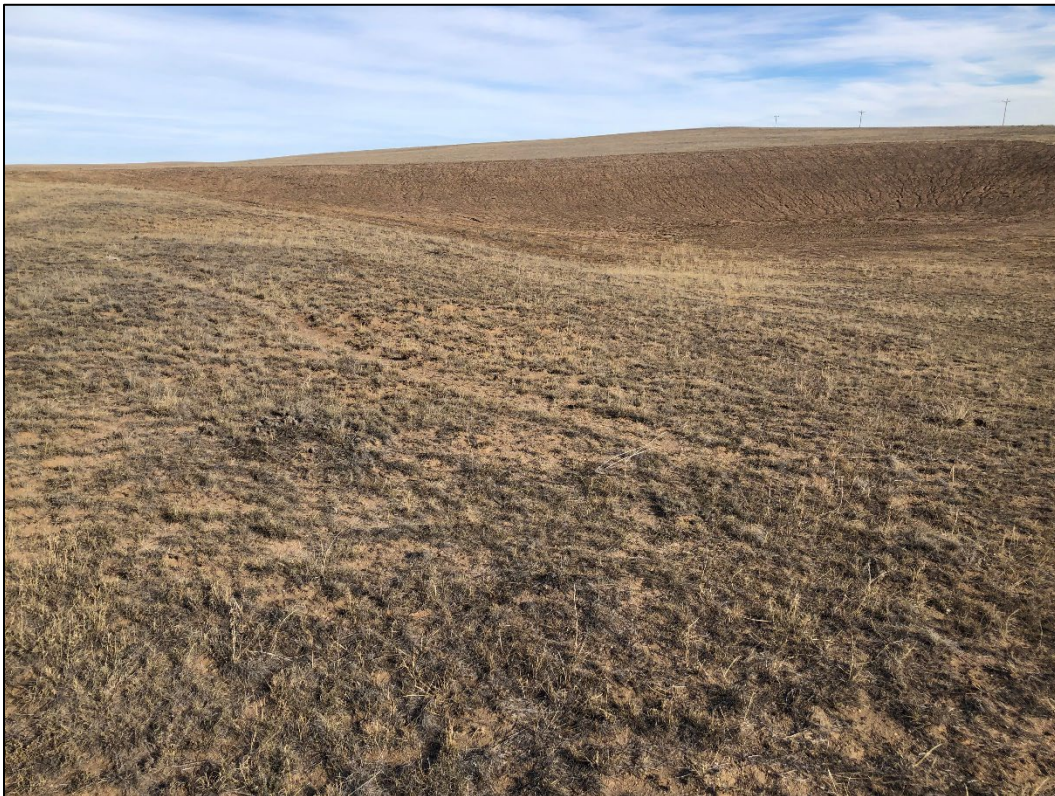
Photo 4. View looking north across reclaimed western pit wall, showing slopes graded to 3H:1V or flatter with a good grass cover.

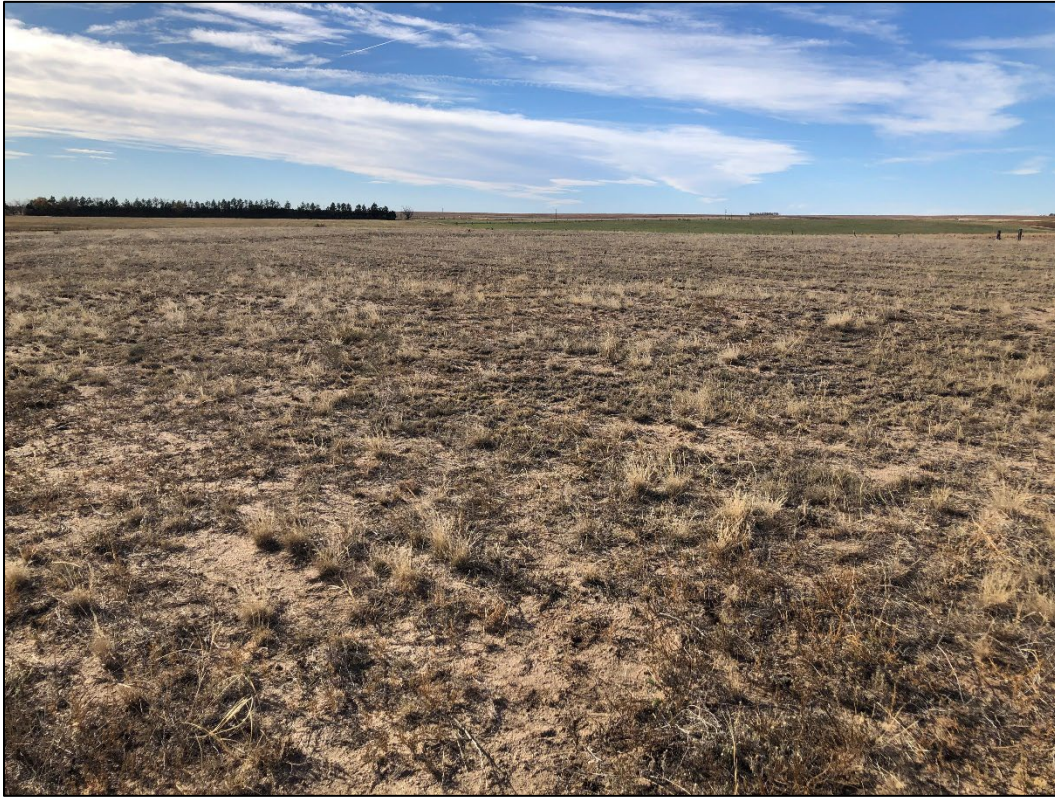
Photo 5. View looking south across reclaimed area west of pit.

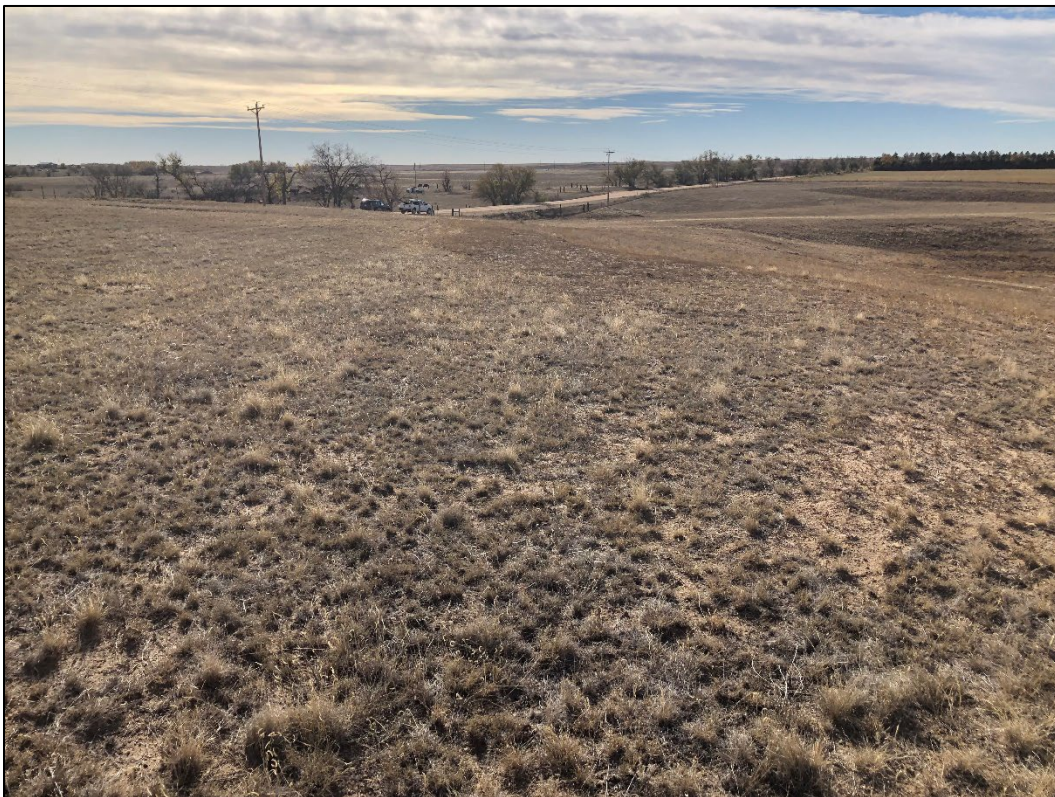
Photo 6. View looking southeast across reclaimed eastern pit wall, showing slopes graded to 3H:1V or flatter with a good grass cover.

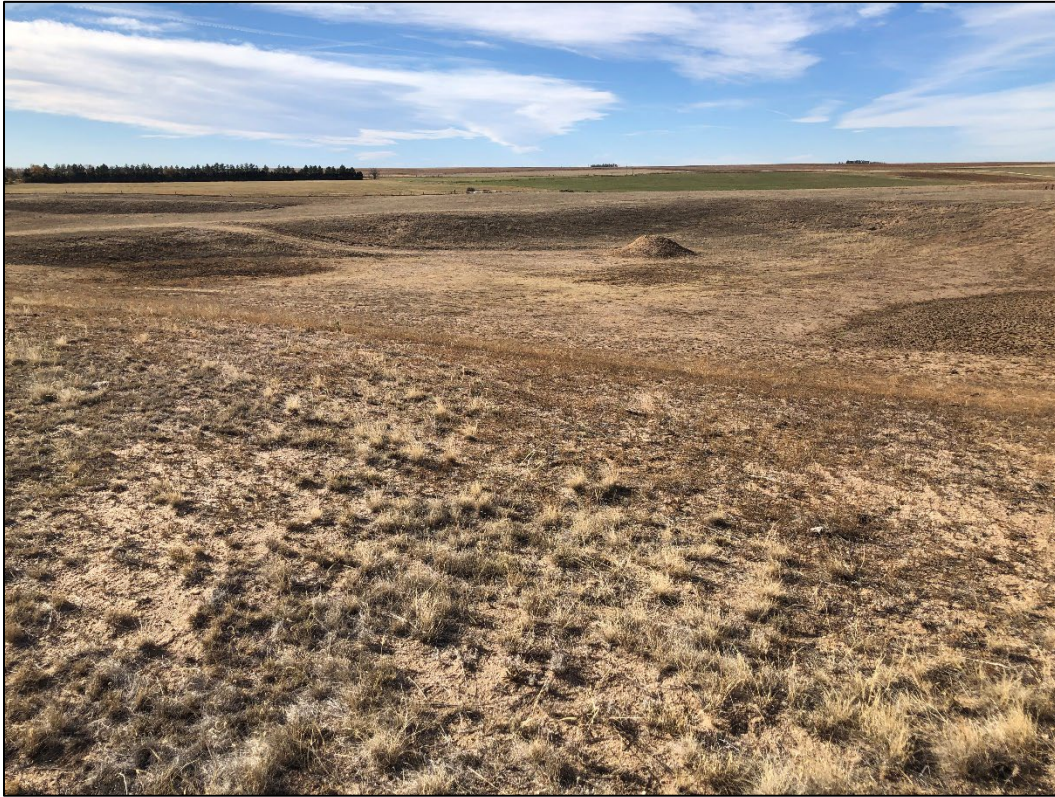
Photo 7. View looking southwest across reclaimed pit, showing slopes graded to 3H:1V or flatter with a good grass cover. Note small gravel pile (at center, right) left on pit floor for landowner use.

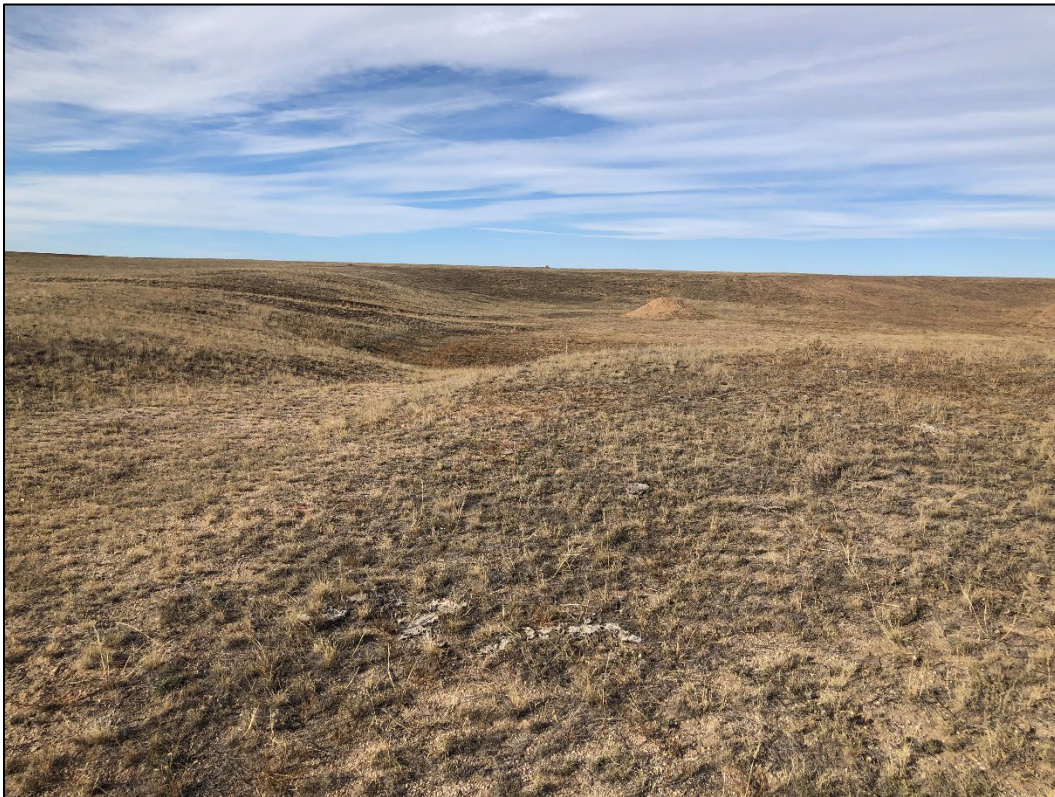
Photo 8. View looking west across reclaimed pit, showing slopes graded to 3H:1V or flatter with a good grass cover.
