MINERALS PROGRAM INSPECTION REPORT
PHONE: (303) 866-3567

MINE NAME: Silver Cliff Pit	MINE/PROSPECTING ID#: M-2011-015	MINERAL: Borrow material for	COUNTY: Custer
INSPECTION TYPE: Monitoring	WEATHER: Windy	INSP. DATE: November 9, 2022	INSP. TIME: 13:30
OPERATOR: Seifert Enterprises, LLC	OPERATOR REPRESENTATIVE: Eric Seifert	TYPE OF OPERATION: 112c - Construction Regular Operation

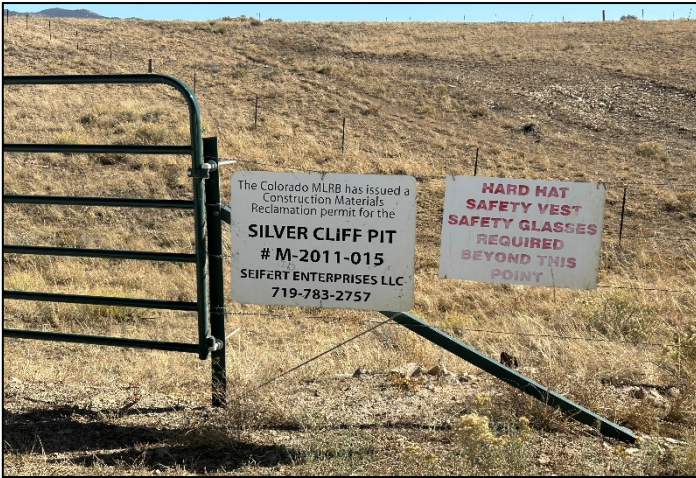
The site identification sign was present and the permit boundary is defined by fencing (photo 1). The current maximum allowable disturbed acreage for this permit is 37 acres. Based on this inspection and a review of available aerial photography only about 12 acres of the 41.5 acre permit have been affected. Mining appears to be taking place according to the approved mining plan at this time.

Photo 1 – Site identification sign at site entrance

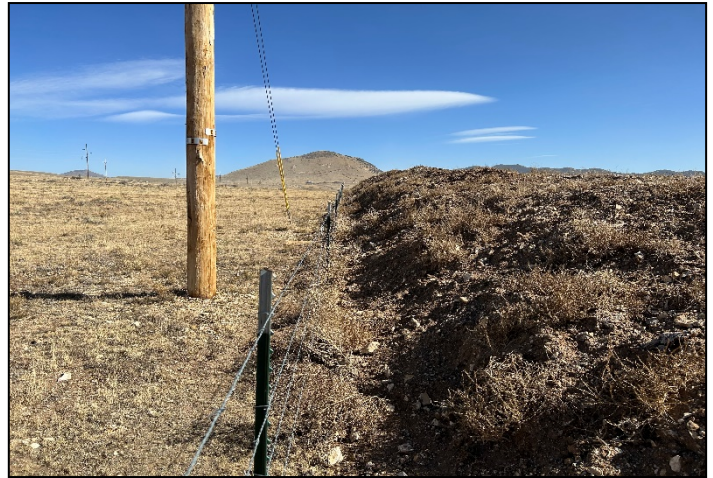
PROBLEM/POSSIBLE VIOLATION: Problem: Overhead utility lines are present within 200' of the affected area. The construction materials rules (6.4.19) state: Where the affected lands are within two hundred (200) feet of any significant, valuable and permanent man-made structure, the applicant shall:

The affected area is within 200' of overhead power lined located along the west side of the permit (photo 2). This issue was also noted in the previous inspection conducted in 2019, but does not appear to have been resolved. As stated on the first page of this report "Where the affected lands are within two hundred (200) feet of any significant, valuable and permanent man-made structure, the applicant shall:

Photo 2 – Overhead utility pole significantly closer than 200 feet from permit boundary fence.

CORRECTIVE ACTIONS: Provide documentation that the operator has complied with 6.4.19 of the construction materials rule as cited above.

This will require the permittee to provide documentation to demonstrate that they are in compliance with rule 6.4.19 as cited above by the corrective action date of 1/31/23.

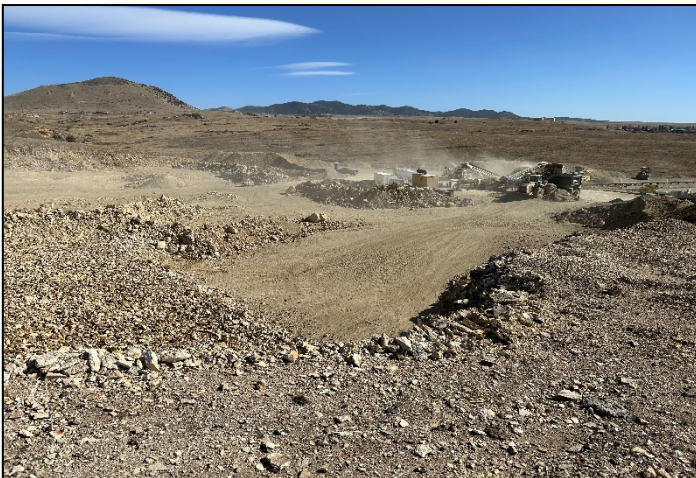
This was a routine monitoring inspection conducted by Eric Scott of the Division of Reclamation Mining and Safety (DRMS) of the Silver Cliff Pit, a 41.5 acre, 112c permit operated by Seifert Construction. Permittee representative Eric Seifert accompanied DRMS during the inspection. The Silver Cliff pit entrance/access road is located approximately 0.5 miles north of Silver Cliff and accessed from County Road 243/Spencer Street. Crushing was taking place at the site at the time of this inspection.

Photo 3 – Overview from NW to SE across active area of site with crusher operation.
