MINERALS PROGRAM INSPECTION REPORT
PHONE: (303) 866-3567

MINE NAME: Stiles Mining Resource	MINE/PROSPECTING ID#: M-2021-067	MINERAL: Sand and gravel	COUNTY: Weld
INSPECTION TYPE: Preoperation Inspection	WEATHER: Clear	INSP. DATE: January 12, 2023	INSP. TIME: 10:00
OPERATOR: Asphalt Specialties Co., Inc.	OPERATOR REPRESENTATIVE: David King, Greg Geras	TYPE OF OPERATION: 112c - Construction Regular Operation	
REASON FOR INSPECTION: Normal I&E Program	BOND CALCULATION TYPE:	BOND AMOUNT: No Bond Held	
DATE OF COMPLAINT: NA	POST INSP. CONTACTS: None	JOINT INSP. AGENCY: None	
INSPECTOR(S): Eric Scott Michael Cunningham	INSPECTOR'S SIGNATURE:

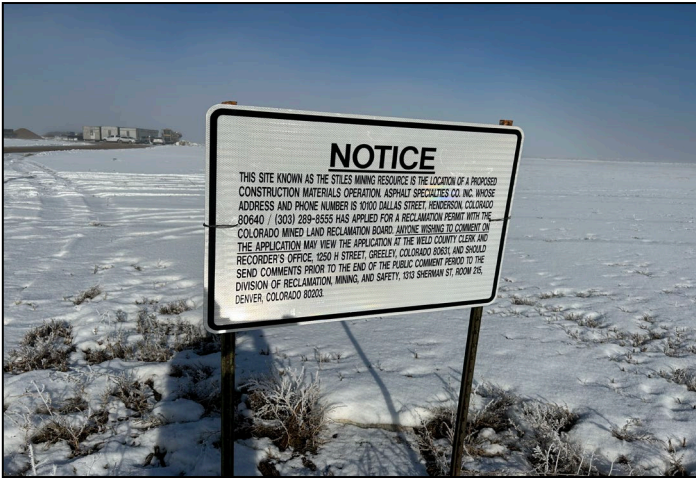
The site entrance is located on the north side of Hwy 394 immediately east of the intersection of WCR 35 and Hwy 394. The permit application notice sign was present at the site entrance (photo 1). The site property has been incorporated into the Town of Evans and is zoned industrial/commercial by the town. The asphalt plant was under construction at the time of the inspection, and raw materials were being imported and stockpiled for that operation, however, no mining was taking place (photo 2).

Photo 1 – Notice of permit application sign at site entrance from Hwy 394.

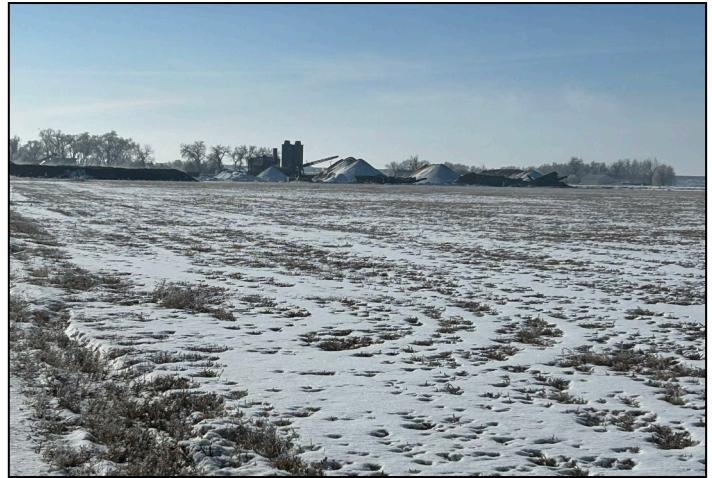
Photo 2 – SW corner of permit where asphalt plant is being constructed and imported materials staged.

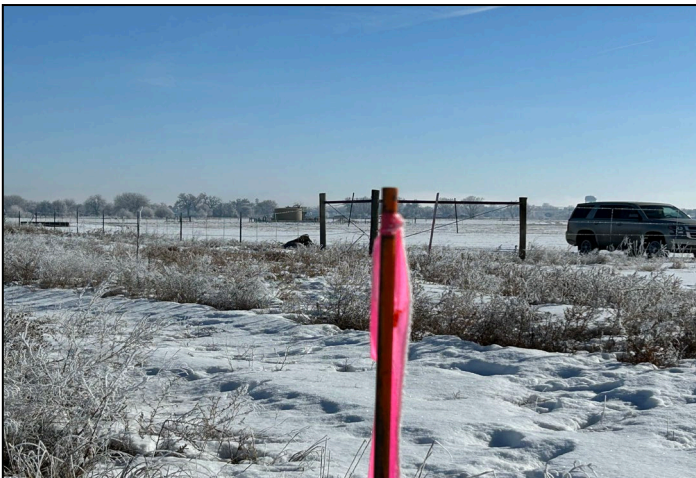
During this inspection DRMS noted that the existing structures and conditions of the proposed permit matched what has been provided in the application. Several of the oil and gas structures currently on the site will be removed prior to mining. The permit area was last used for irrigated pasture and livestock grazing. The permit boundary has been surveyed and marked, however, the permit boundary and existing fencing do not match in several areas. This is most pronounced on the west side of the permit, as well as along each side of the Town of Evans 35th Ave right-of-way which runs north-south through the west side of the permit area and separates Phases 1 and 2 of the proposed permit area. On the northwest and west side of the permit, the permit boundary lies outside of the existing fencing. If the mining offset is set 50' inside of the existing fencing, as shown in the current mining plan map, there should be no risk of out-of-bounds impacts due to this discrepancy (photo 3).

Photo 3 – Photo taken from surveyed NW corner of permit looking back to existing fences.

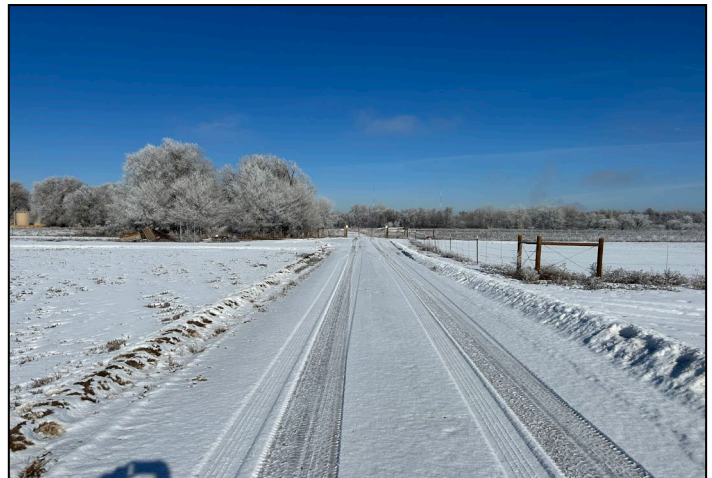
This is NOT the case on either side of the Town of Evans 35th Ave right-of-way, where the permit boundary is inside of the existing fences present on both sides (photo 4). The permit boundary and mining offsets along each side of this 120' wide R.O.W. will need to be clearly marked, especially on the south end where it widens. Use of the existing fences to delineate future activity in this area and along this ROW, may result in violations for out-of-bounds impacts. There is also an area in the north center of the proposed permit where the existing permit boundary does not match existing fencing that will need to be clearly delineated. DRMS also recommends that the 250 foot wide utility corridor that runs N-S through the permit also be clearly marked prior to any mining-related disturbances in this area.

Photo 4 – Photo of Evans 35th Ave ROW looking north. Permit boundary on each side will need to be clearly marked prior to mining activity to avoid out-of-bounds impacts.

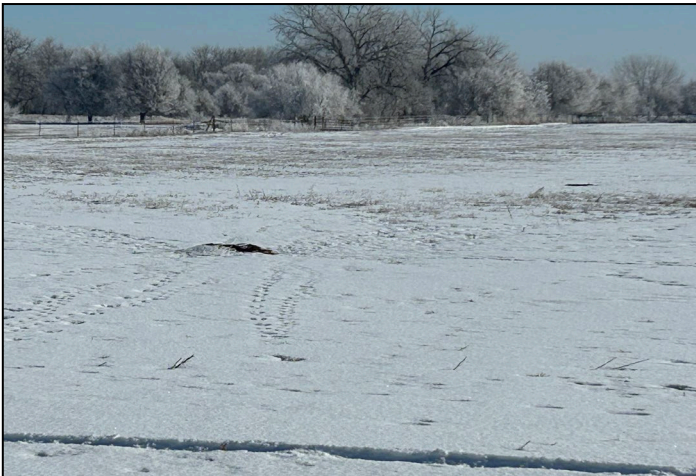
DRMS noted the presence of an active prairie dog colony within the east central portion of the proposed permit during this inspection (photo 5). Therefore, DRMS will require that the permittee commit, through the adequacy response process, to conducting a burrowing owl survey prior to mining activity as recommended by the CPW in their provided comment letter for this proposed operation. No other wildlife was observed during this inspection.

Photo 5 – Active prairie dog burrows and tracks observed in east-center of proposed permit area.
