Environmental & Disaster Restoration, Inc.

Client: ELAM Construction –

Location address: 67246 T Rd  
Montrose, CO, 81403

On 11/30/2022 ECOS Environmental and Disaster Restoration Inc. was contacted by Jim Doody with Elam construction to assist and collect soil samples due to diesel release. Jim advised the release was approximately 350 gallons caused by a fuel tank that supplies diesel to a generator at the above listed address. The spill site was cleaned up and isolated by personal at the facility.

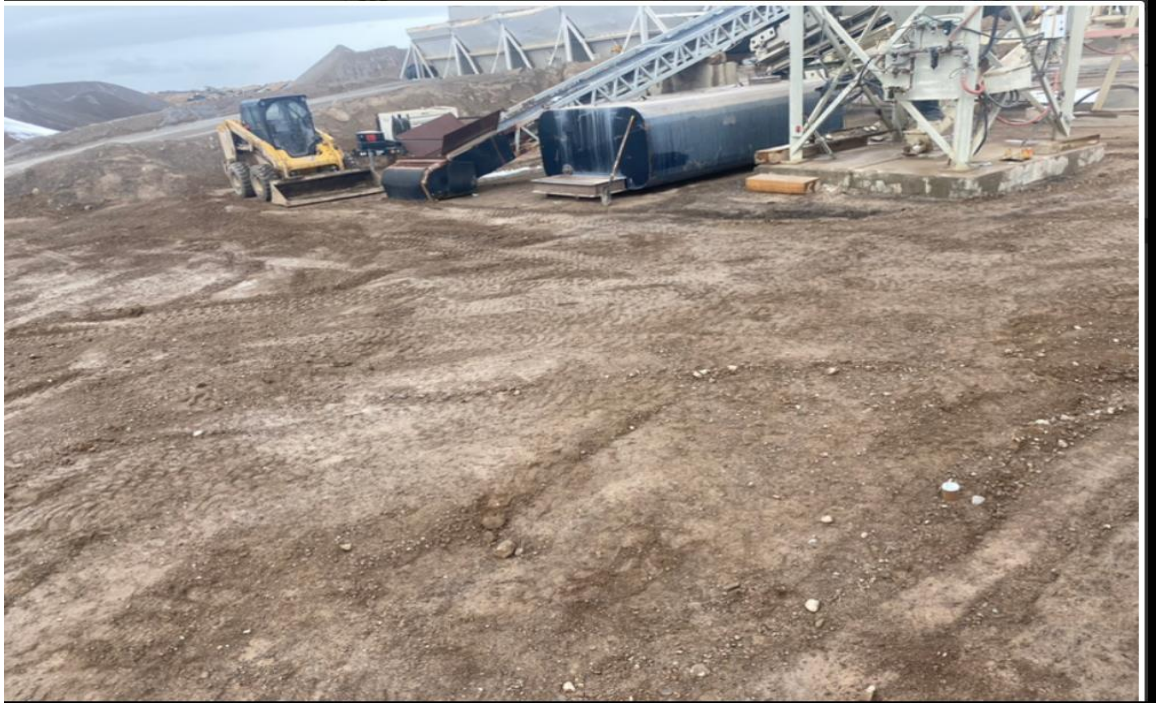
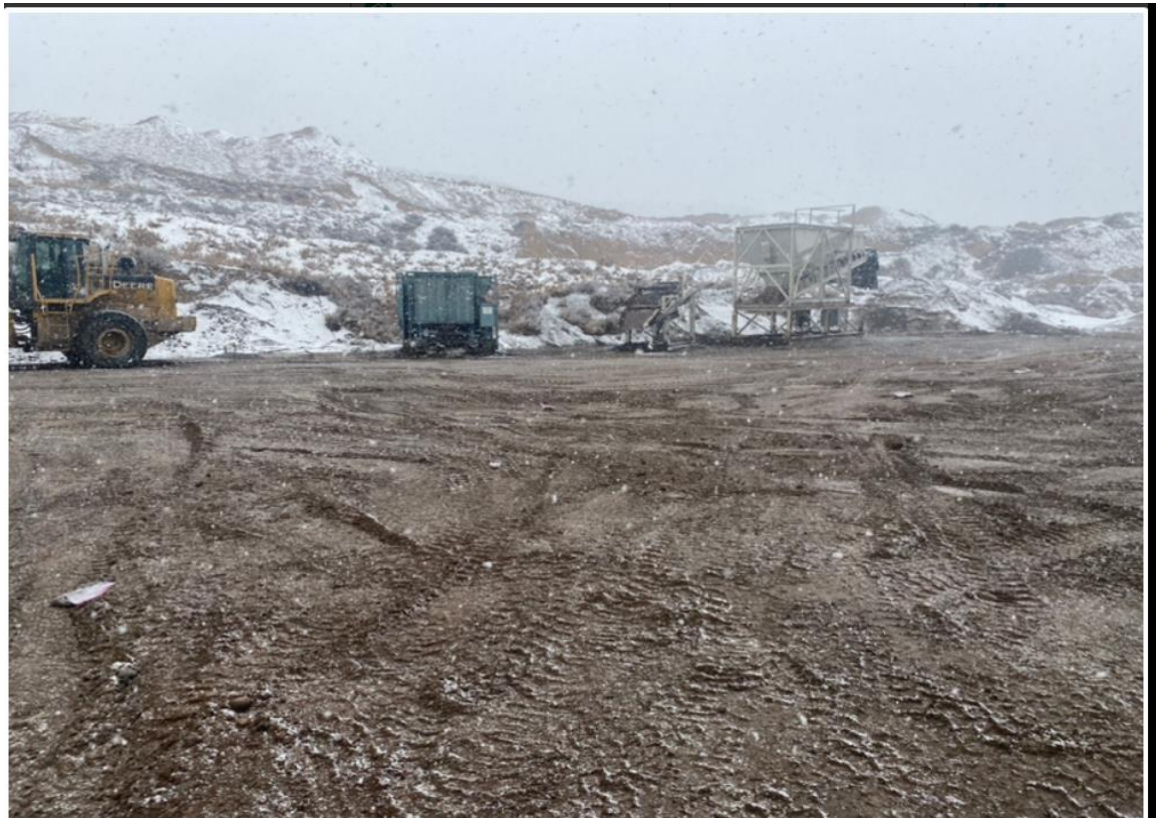
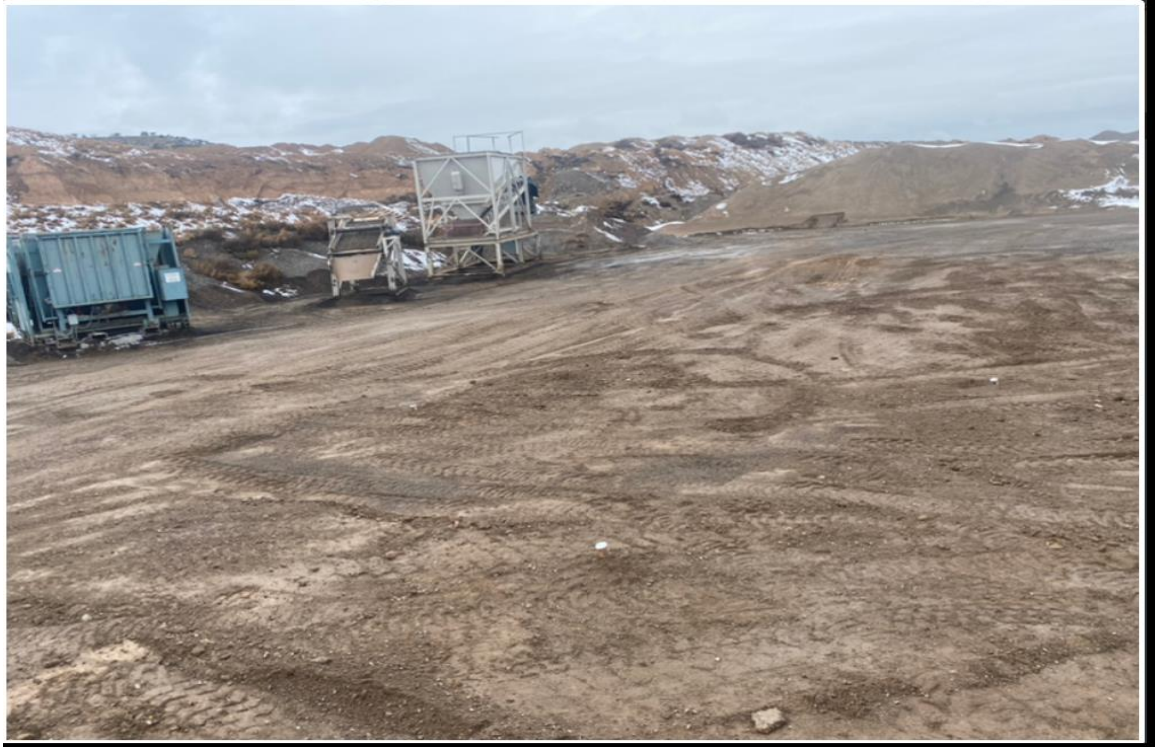
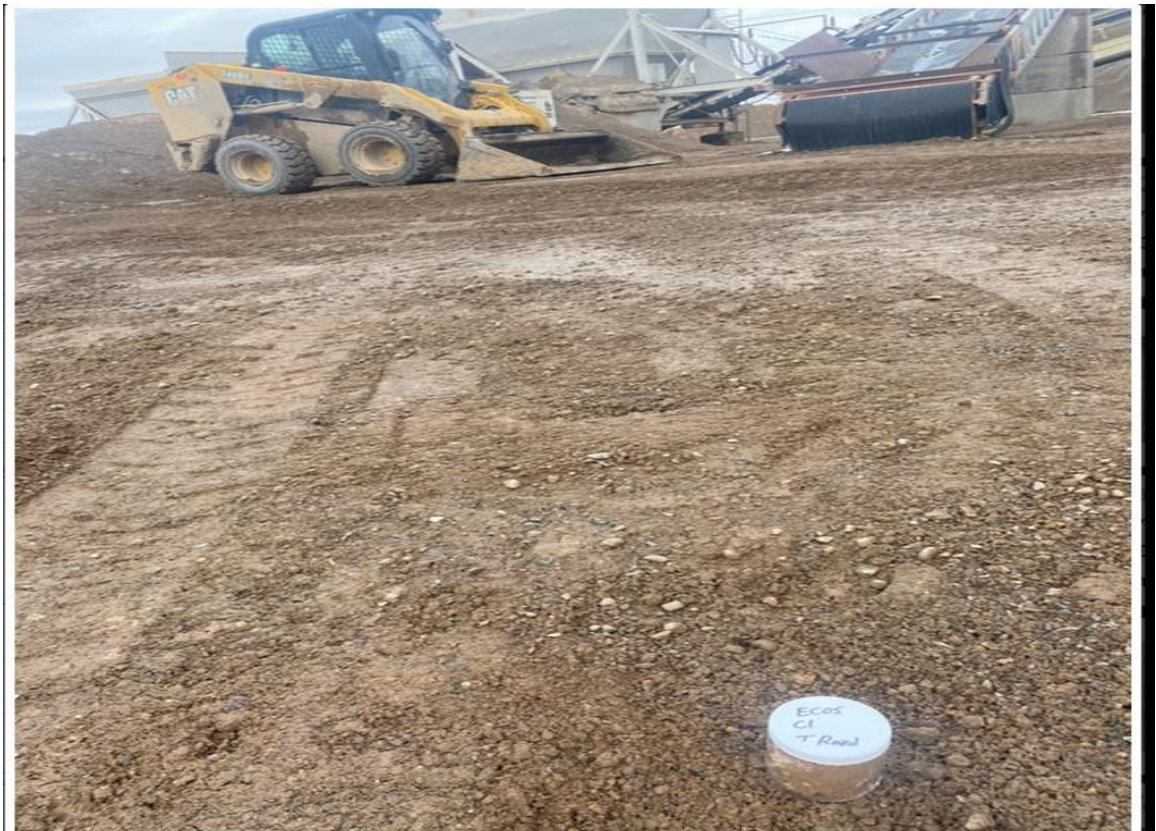
On 12/6/2022 ECOS Environmental performed a site visit once the impacted area was excavated. ECOS Environmental conducted a visual inspection and field PID testing of the impacted area. The impacted area was determined to be at acceptable PID readings, this was determined by placing the soil into sealed plastic bag, heating to ambient temperature of 75 degrees Fahrenheit, then inserting the PID probe into the bag headspace. The samples were collected from random locations at the initial site where the spill occurred and throughout the area of migration. The confirmation samples collected were placed into jars and prepared in a cooler for shipping and analysis by a independent laboratory.

The laboratory results, diagram of sample locations and photos are attached to this document for review.
