## Keenesburg Mine Site Inspection Report

4th Quarter

12/2/2022

# COORS ENERGY KEENESBURG MINE

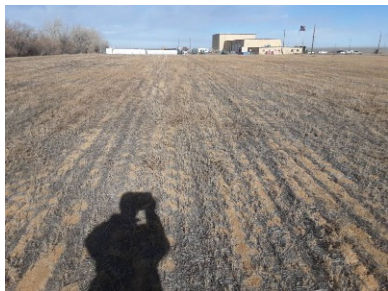
Area mowed during summer 2022 to control nuisance weeds. Minimal desirable vegetation establishment noted. Possible overseeding required 2023. (Photo 1)

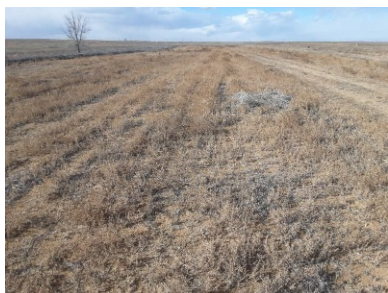
Area not mowed during summer due to nuisance weeds setting seed. Monitor in spring and mow in summer prior to seed set. (Photo 2)

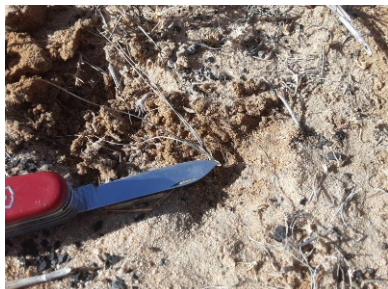
Observed grasses likely germinated following March seeding and now are desiccated. However, select species are showing signs of survival. (Photo 3)

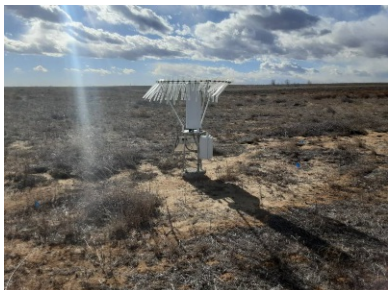
Weather station appears to be operational. (Photo 4)

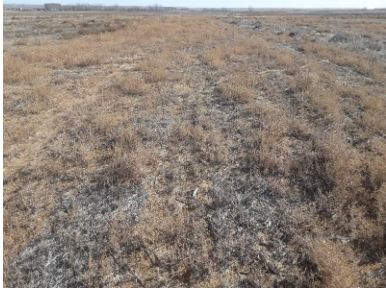
No sheet flowing or erosion observed following 2022 reseeding. (Photo 5)

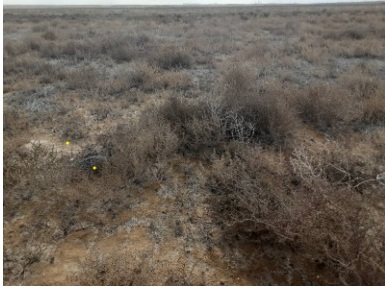
Area not mowed in 2022 due to nuisance weeds setting seed. Monitor area and mow in summer 2023 prior to flowering. (Photo 6)

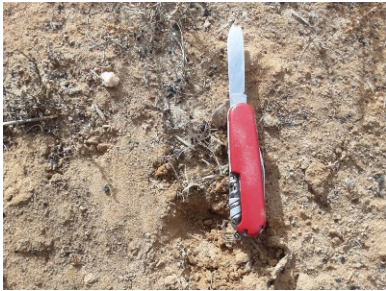
Rows of grass species germinated from March seeding have desiccated and will likely not recover next year. (Photo 7)

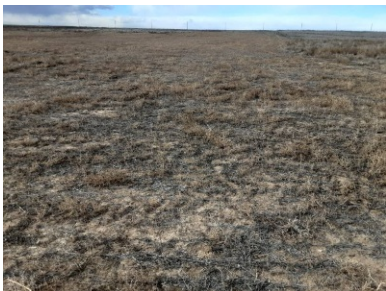
Area mowed in summer 2022 to control nuisance weeds. Monitor in 2023 for future mowing and reseeding. (Photo 8)

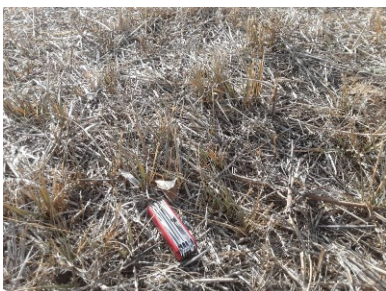
Desirable cool season grasses (Western wheat) are establishing in revegetation areas. Continue to monitor success of establishment in spring 2023. (Photo 9)

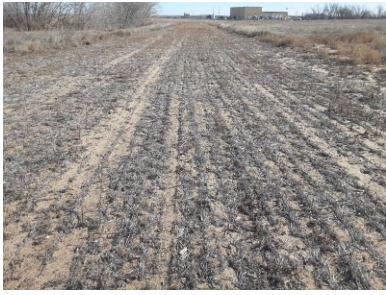
Minimal nuisance weeds establishment on northern haul road reclaimed area. Cheatgrass noted in area during previous inspections and prior to reseeding. Currently, minimal cheatgrass observed. Continue to monitor in 2023. (Photo 10)
