**MINERALS PROGRAM INSPECTION REPORT**  
**PHONE: (303) 866-3567**

<b>MINE NAME:</b> Heit Sand and Gravel Mine	<b>MINE/PROSPECTING ID#:</b> M-2003-016	<b>MINERAL:</b> Sand and gravel	<b>COUNTY:</b> Weld
<b>INSPECTION TYPE:</b> Surety-Related Inspection	<b>WEATHER:</b> Snowing	<b>INSP. DATE:</b> February 15, 2023	<b>INSP. TIME:</b> 09:30
<b>OPERATOR:</b> City and County of Broomfield	<b>OPERATOR REPRESENTATIVE:</b> Brennan Middleton	<b>TYPE OF OPERATION:</b> 112c - Construction Regular Operation	
<b>REASON FOR INSPECTION:</b> Normal I&E Program	<b>BOND CALCULATION TYPE:</b>	<b>BOND AMOUNT:</b> No Bond Held	
<b>DATE OF COMPLAINT:</b> NA	<b>POST INSP. CONTACTS:</b> None	<b>JOINT INSP. AGENCY:</b> None	
<b>INSPECTOR(S):</b> Eric Scott	<b>INSPECTOR'S SIGNATURE:</b>

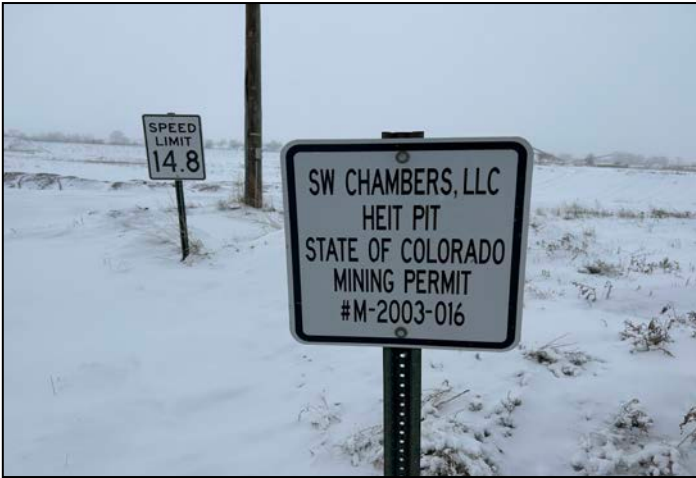
This was an inspection of the Heit Pit conducted by DRMS representative Eric Scott in accordance with the requirements of the succession of operators' revision (permit transfer) SO4 from Pioneer Sand and Gravel to the City and County of Broomfield. DRMS received the complete SO4 application package on February 8, 2023. DRMS met the Successor Operator Representative, Kyle Regan of Civil Resources at the site entrance and observed the current site conditions. The site identification sign was observed at the site entrance, but will need to be updated (photo 1), and the permit area is defined by established fencing.

Photo 1 - Site identification sign at site entrance will need to be updated.

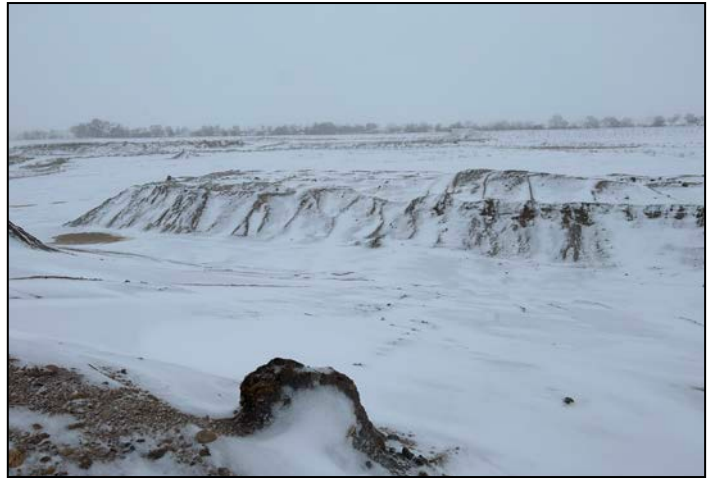
As shown in the included photos, a significant amount of material remains in the pit (photo 2). This material will be removed and utilized by Broomfield, or regraded prior to final release of the permit. Weed control measures will also need to be maintained until the permit is released.

Photo 2 - remaining material in pit will be removed or regraded by Broomfield prior to final release.
