MINERAL MATERIALS INSPECTION REPORT

Forest Service
United States
Department of
Agriculture

Pike and San Isabel National Forest
Pikes Peak Ranger District Forest
Phone: 719-636-1602

MINERAL MATERIAL OPERATING PLAN					
MINE NAME:		CLAIM NUMBER(S):		INSPECTOR(S):	
Pikeview Quarry		CMC256219		Amy Titterington	
TOWNSHIP:	RANGE:	SECTION(S):	COUNTY:	TYPE OF OPERATION:	
13 S	67 W	9	El Paso	Negotiated Sale Contract	
OPERATOR(S):		OPERATOR(S) PRESENT:		INSP. DATE:	INSP. TIME:
Riverbend Industries		Yes		January 11, 2023	10:00
REASON FOR INSPECTION:		DATE OF LAST INSPECTION:		JOINT INSP. AGENCY:	
New Operation		12/14/2022		DRMS	
STATUS:	PLAN EXPIRATION DATE:	MINERAL:		BOND AMOUNT:	
Authorized	12/31/2023	Placer		DRMS: \$13,389,784 (2020)	
USFS PLAN NUMBER:		COUNTY SUP (Y/N):		DRMS PERMIT NUMBER:	
2850-021209-RP-2022-001		Yes		M-1977-211	
VOLUME PERMITTED:	VOLUME DISTURBED:	NEPA DATE:		CONTACT:	
197,500 LCY	111,222 LCY	CE: 07/28/22		Jerry Schnabel	
FOLLOW UP REQUIRED:	INSPECTOR'S SIGNATURE:			SIGNATURE DATE:	
Yes

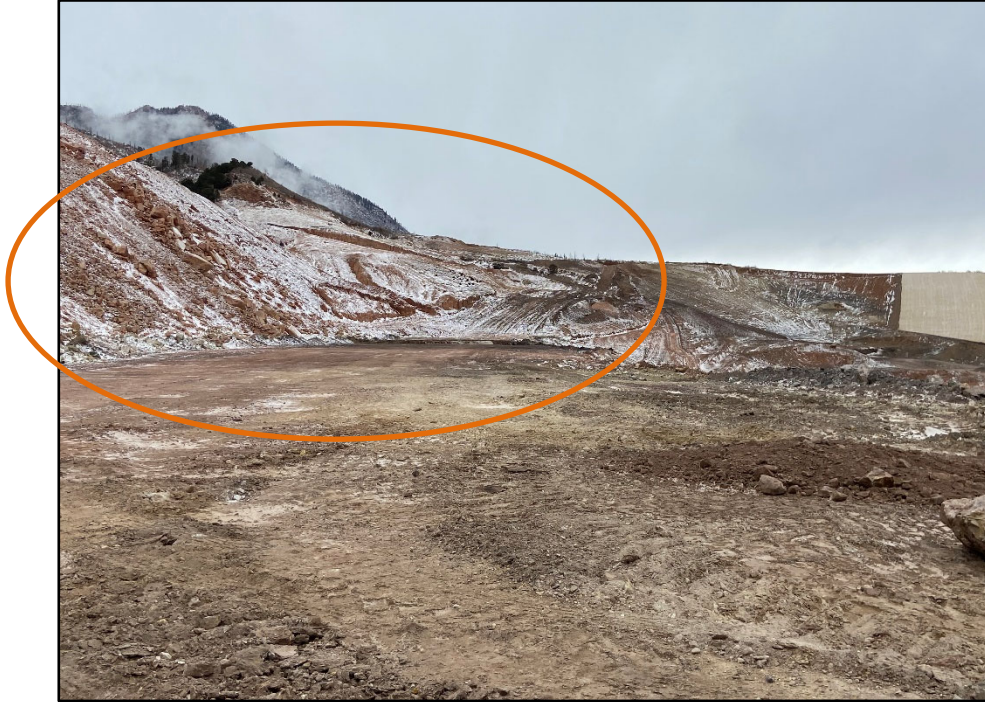
However, when the site is active backfill is still being excavated from the north (Photo 1) and south borrow area (Photos 4) and placed in lifts to build up the 2H:1V outslope portion of the backfill in the main pit.

Photo 1 – Material is being mined from North Borrow Area.

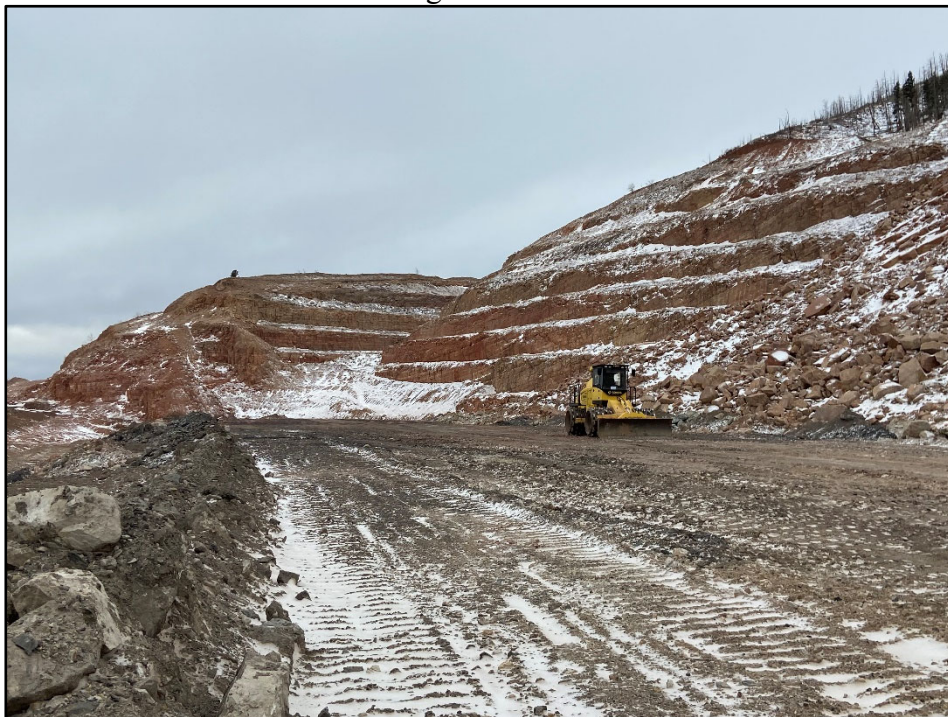
I visited the site in coordination with DRMS to conduct a monthly compliance inspection of the Pikeview Negotiated Sale contract. To date, Riverbend Industries has removed approximately 111,222 loose cubic yards of NFS fill material for use in the backfill of the main pit area (Photo 2).

Photo 2 – Fill material is being actively placed in main backfill area.

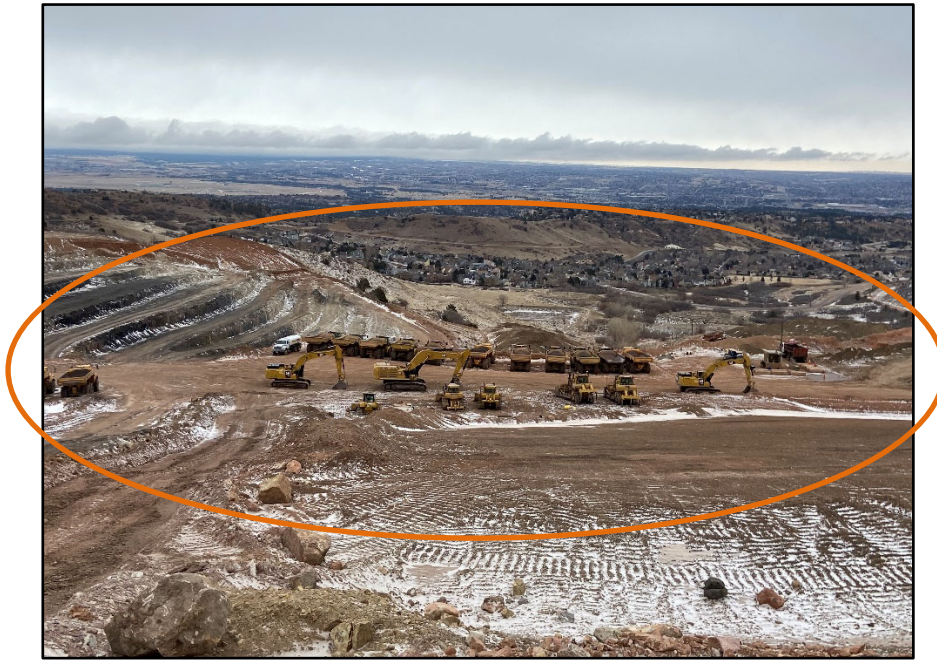
The site was not active today due to a safety standdown by the construction contractor (Photo 3).

Photo 3 – Staging area for contractor’s equipment. They were not working today due to a safety stand-down.

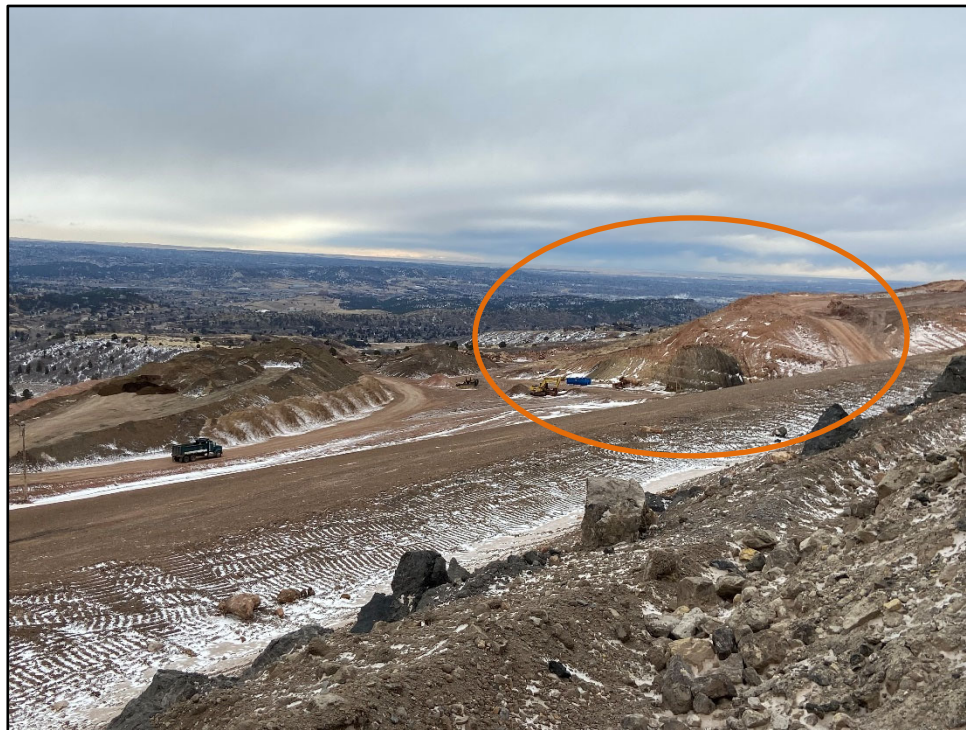
Photo 4 – Fill material being actively removed from USFS South Borrow Area.
