**MINERALS PROGRAM INSPECTION REPORT**  
**PHONE: (303) 866-3567**

<b>MINE NAME:</b> Derr Pit	<b>MINE/PROSPECTING ID#:</b> M-2008-017	<b>MINERAL:</b> Sand, gravel	<b>COUNTY:</b> Weld
<b>INSPECTION TYPE:</b> Monitoring	<b>WEATHER:</b> Clear	<b>INSP. DATE:</b> March 8, 2023	<b>INSP. TIME:</b> 11:00
<b>OPERATOR:</b> Broken Arrow Investments LLC	<b>OPERATOR REPRESENTATIVE:</b> Kelly Hodge	<b>TYPE OF OPERATION:</b> 112c - Construction Regular Operation	
<b>REASON FOR INSPECTION:</b> Normal I&E Program	<b>BOND CALCULATION TYPE:</b> None	<b>BOND AMOUNT:</b> \$753,487.00	
<b>DATE OF COMPLAINT:</b> NA	<b>POST INSP. CONTACTS:</b> None	<b>JOINT INSP. AGENCY:</b> None	
<b>INSPECTOR(S):</b> Eric Scott	<b>INSPECTOR'S SIGNATURE:</b>

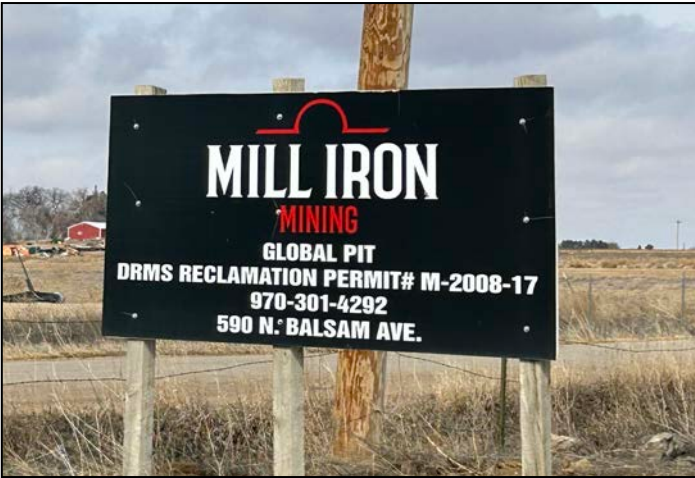
This was a monitoring inspection conducted by Eric Scott of DRMS of the Derr Pit (M2008-017). DRMS met on-site with permittee consultant JC York to tour the site. Permittee representative Kelly Hodge was also present for the inspection. The site identification sign was present at the site entrance (Photo 1), and the permit boundary was clearly marked with white PVC pipe.

**Photo 1 – Site identification sign at site entrance**

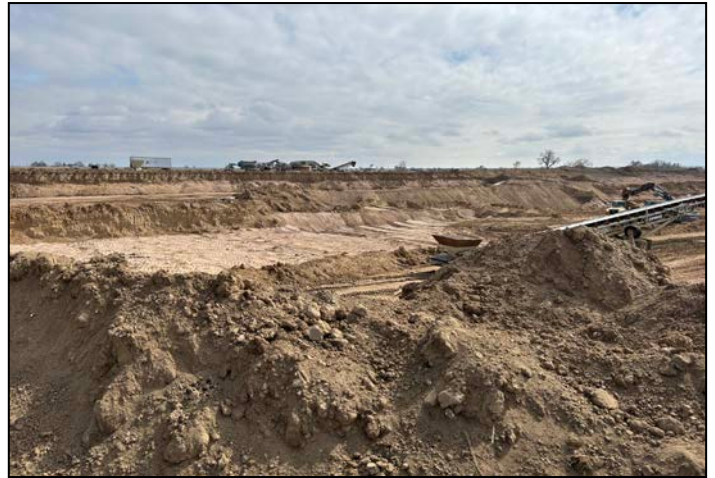
At the time of this inspection, mining, processing, and loading activity were taking place primarily in Phases 1 and 2 of the slurry wall lined area (Phases 1 through 4) on the southwest area of the permit (photo ). Mining activity has been extended to the north center, unlined, area of the permit within Phase 6 (photo ?), but not to a depth that will expose groundwater - as previously approved.

**Photo 2 – Recently excavated area in Phase 6 above GW level looking SE from west side of excavation.**

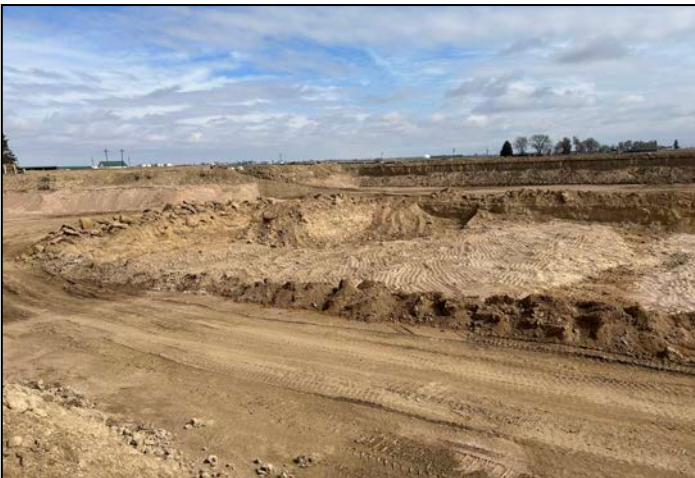
**Photo 3 – Recently excavated area in Phase 6 above GW level looking NE from west side of excavation.**

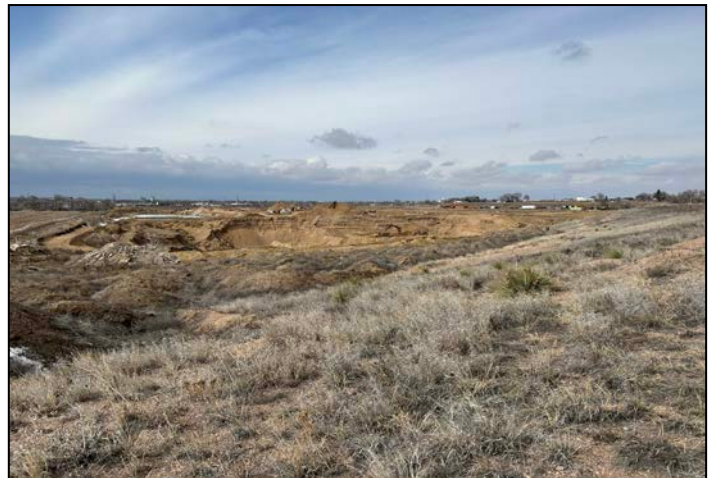
**Photo 4 – Looking west into Phases 1 and 2 in slurry wall lined area from east permit boundary.**
