**MINERALS PROGRAM INSPECTION REPORT**  
**PHONE: (303) 866-3567**

| <b>MINE NAME:</b><br>Big "G" Gravel Pit | <b>MINE/PROSPECTING ID#:</b><br>M-2006-081 | <b>MINERAL:</b><br>Sand and gravel | <b>COUNTY:</b><br>Pueblo |
| <b>INSPECTION TYPE:</b><br>Monitoring | <b>WEATHER:</b> Clear | <b>INSP. DATE:</b><br>February 28, 2023 | <b>INSP. TIME:</b><br>11:45 |

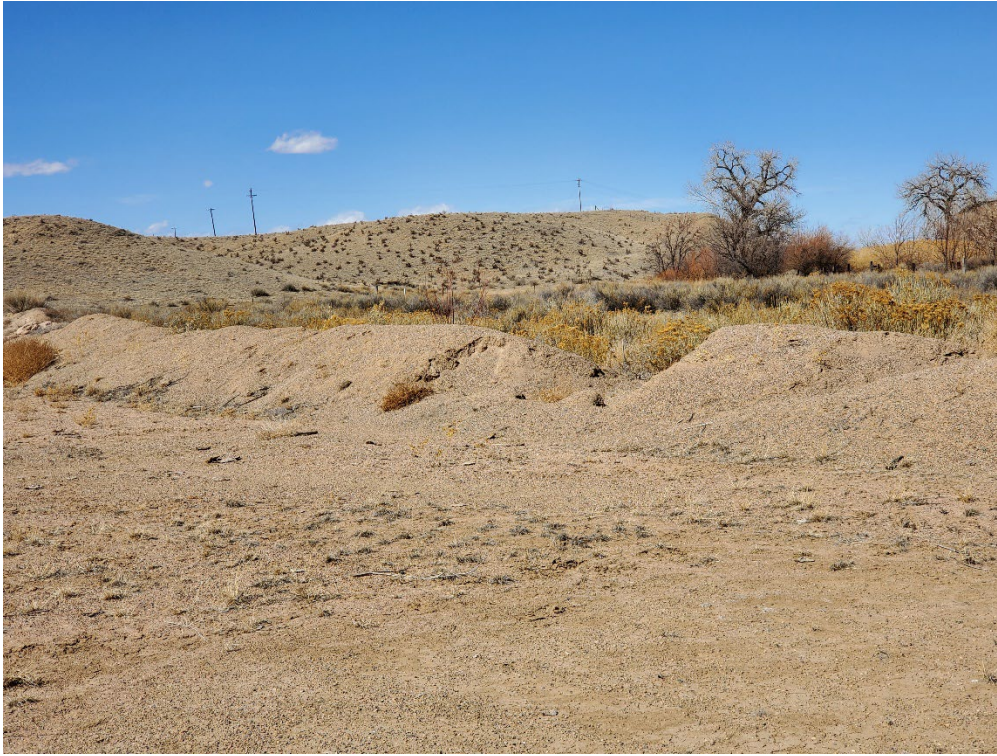
Along the northern boundary in the western Phase I area, earthen berms were created to protect the nearby Rocky Ford Highline Canal from sediment run-off created on site. There were a few areas along the berm that have been eroded on top that need to be re-stabilized (see photos).

**Photo 1: Looking north at northern border of western Phase 1 at eroded berm**

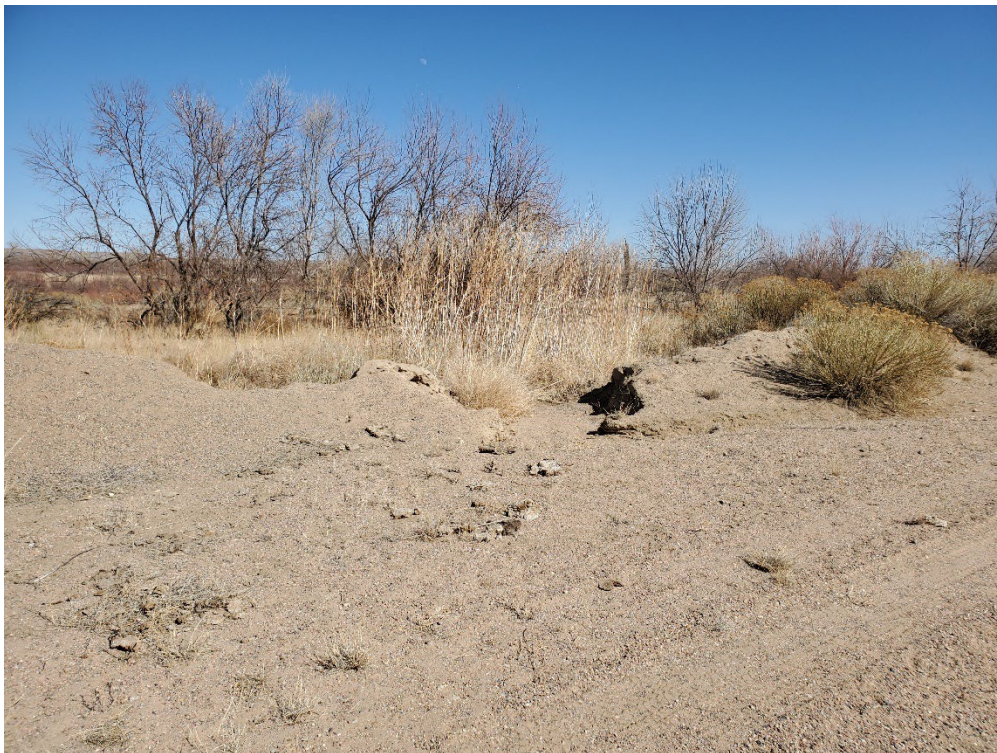
**Photo 2: Looking north-west at northern border of western Phase 1 at eroded berm**

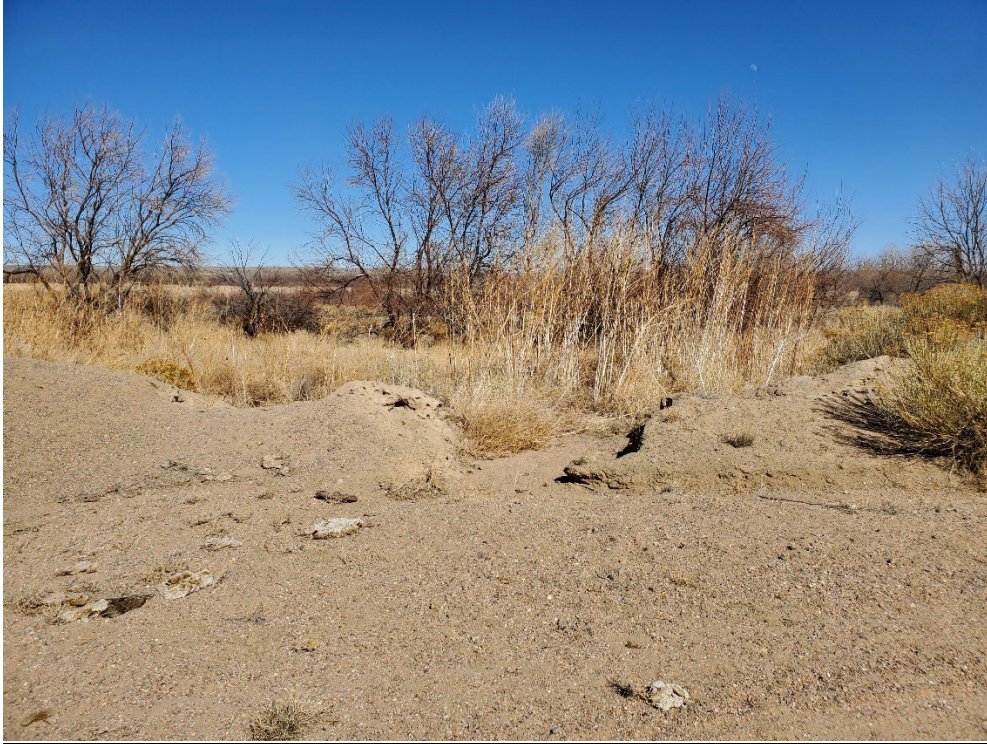
**Photo 3: Looking north at northern border of western Phase 1 at eroded berm**

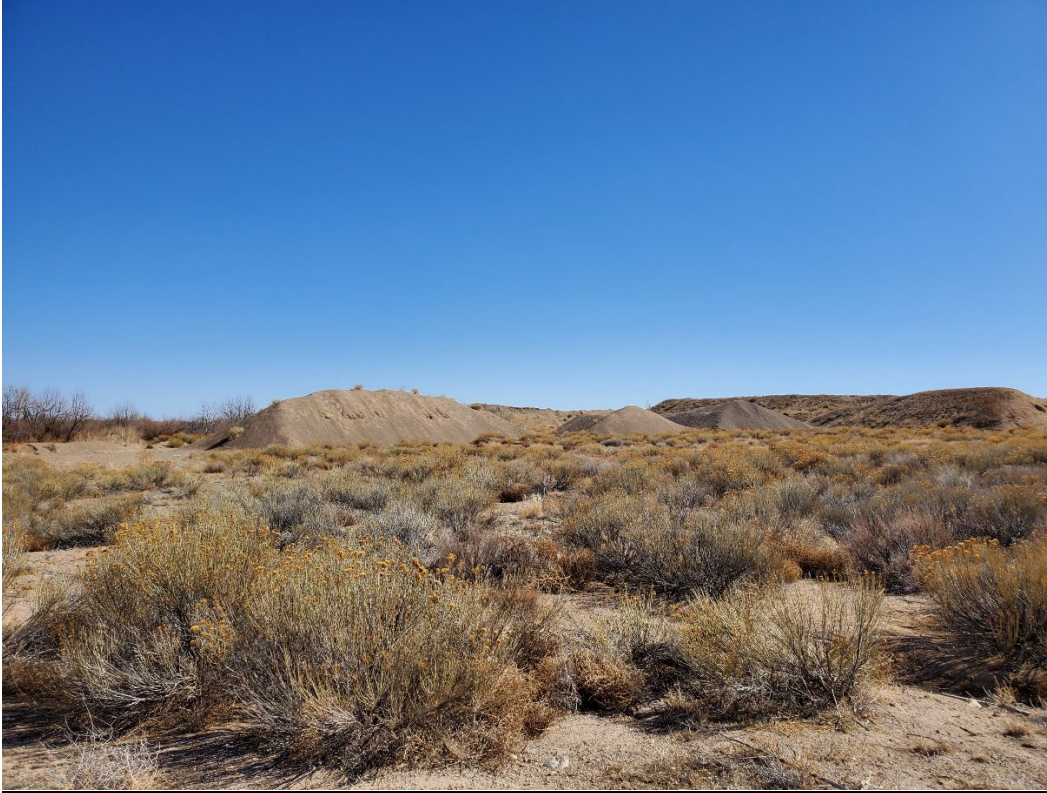
In the approved reclamation plan, the Operator(s) stated that unsold processed material and/or reject material may be used as backfill. During the inspection, asphalt was observed in product stockpiles. While asphalt is acceptable to be mixed in with product, the Division reminds the Operator(s) that this material is not approved for use as backfill at this site.

**Photo 5: Looking east at product stockpiles in western Phase 1 area**

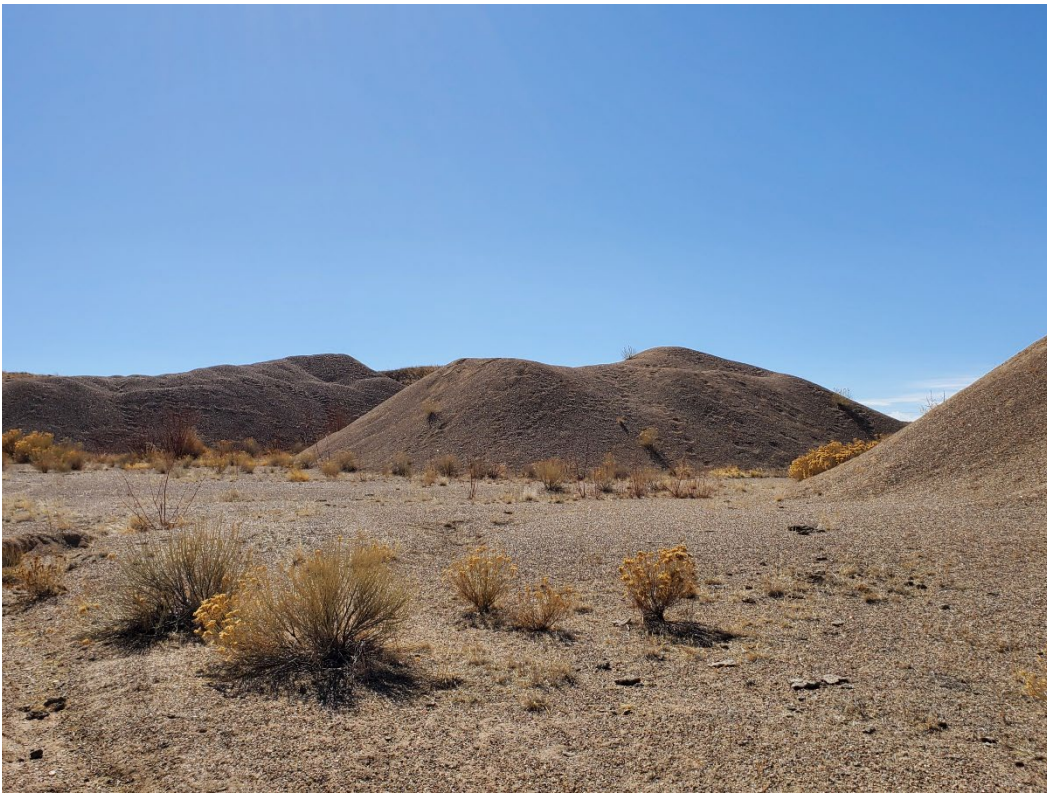
**Photo 6: Looking south at product stockpiles in western Phase 1 area**

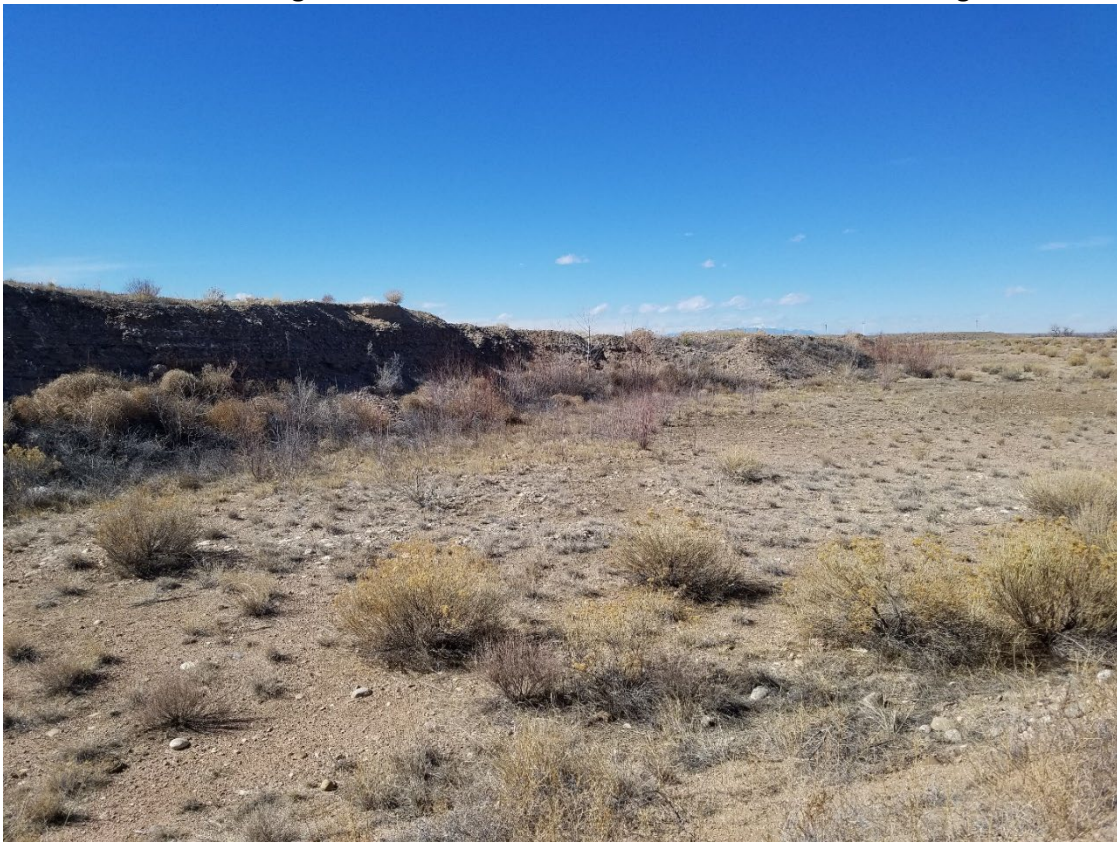
**PROBLEM:** Tamarisk (salt cedar) trees are present within the pit of the western Phase I area and are becoming established. This is a problem for failure to employ weed control methods for a state listed noxious weed species within the permitted area, and to reduce the spread of weeds to nearby areas as required by Section 3.1.10 (6) of the rule.

A problem has been cited for the establishment of the state listed noxious weed, tamarisk. On the north side of the western-most highwall, tamarisk was observed. Currently, the approved reclamation plan states that if noxious weeds were to invade the site, a weed control program will be implemented. Once the Operator(s) has implemented one of the options mentioned above in their weed control management plan, they will need to provide photo evidence to the Division that indicates the weed control plan has been implemented and the

**Photo 15: Looking south west in the western Phase I area at the establishing tamarisk along the west highwall**

**CORRECTIVE ACTIONS:** The operator has an approved weed control and management plan. Pursuant to this plan, tamarisk will either need to be treated chemically or by a combination of mechanical and chemical methods. According to the plan, to treat them mechanically, a bulldozer will be used to remove the tamarisk, followed by an herbicide treatment of the re-sprouts when they are one to two meters tall. To treat them chemically, the plan calls for the cut-stump method where the tamarisk will be cut to within two inches of the ground's surface and immediately (within one minute) treated with herbicide on the perimeters of the cut stumps. Alternatively, in areas that have little to no desirable shrubs and trees, the tamarisk can be treated with applications of Arsenal or Arsenal plus Roundup (the optimum treatment times being late summer/early fall). The chosen weed control plan shall be implemented and photo evidence showing the eradication of the noxious weeds from the infected area shall be submitted to the Division by the corrective action date.

**CORRECTIVE ACTION DUE DATE:** 9/30/23

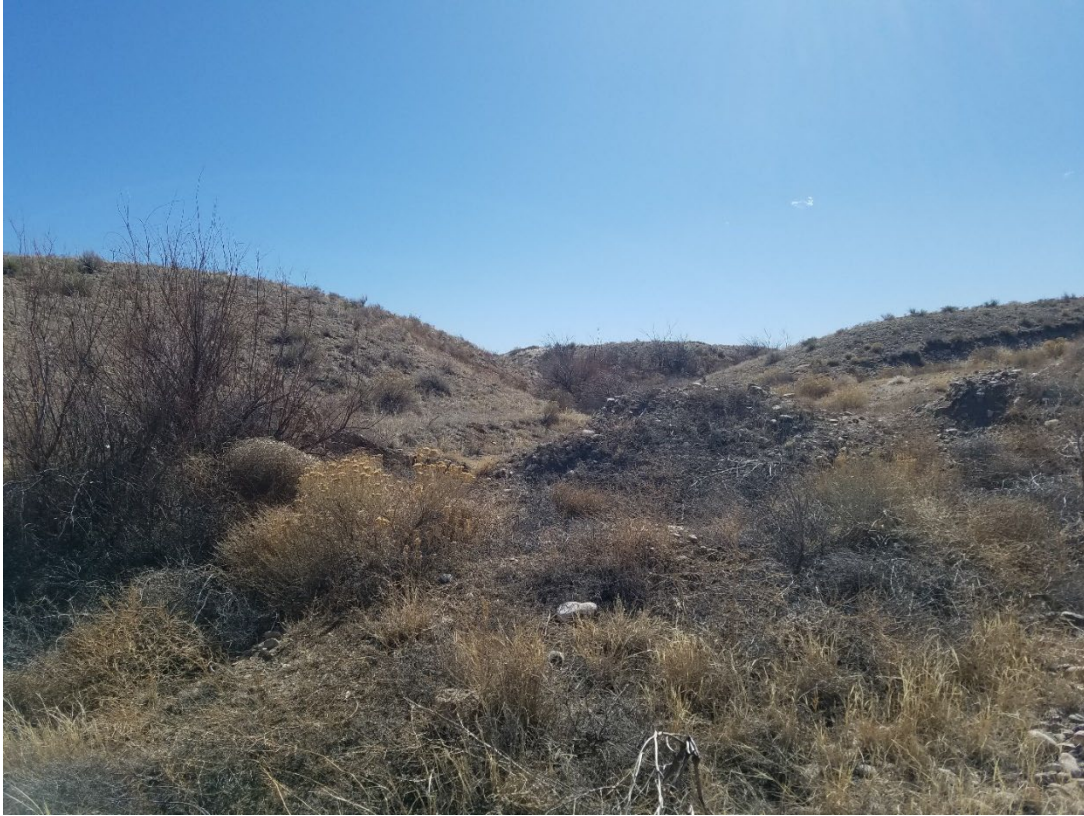
**Photo 16: Looking east in the western Phase I area at the establishing tamarisk along the west highwall**

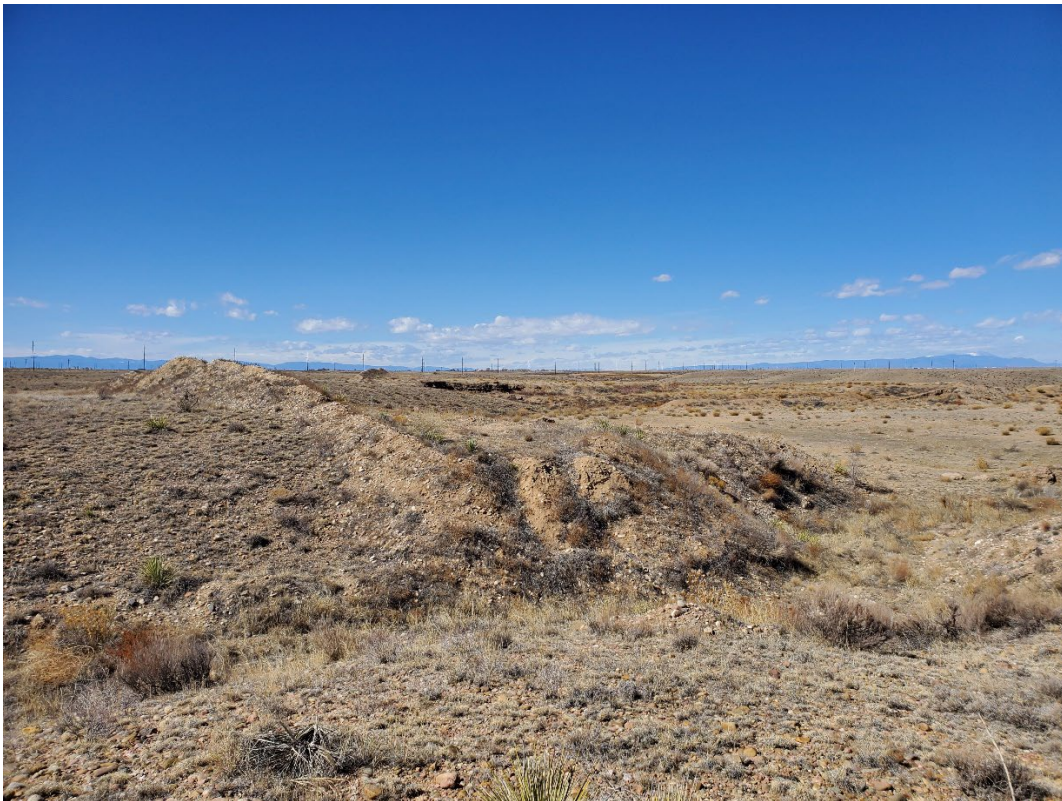
Topsoil piles were observed in the location indicated on the mining plan map. They appeared to be stabilized and separated from mining activities.

**Photo 17: Looking south-west near the eastern border of the western Phase 1 area at the stabilized and vegetated topsoil stockpiles**

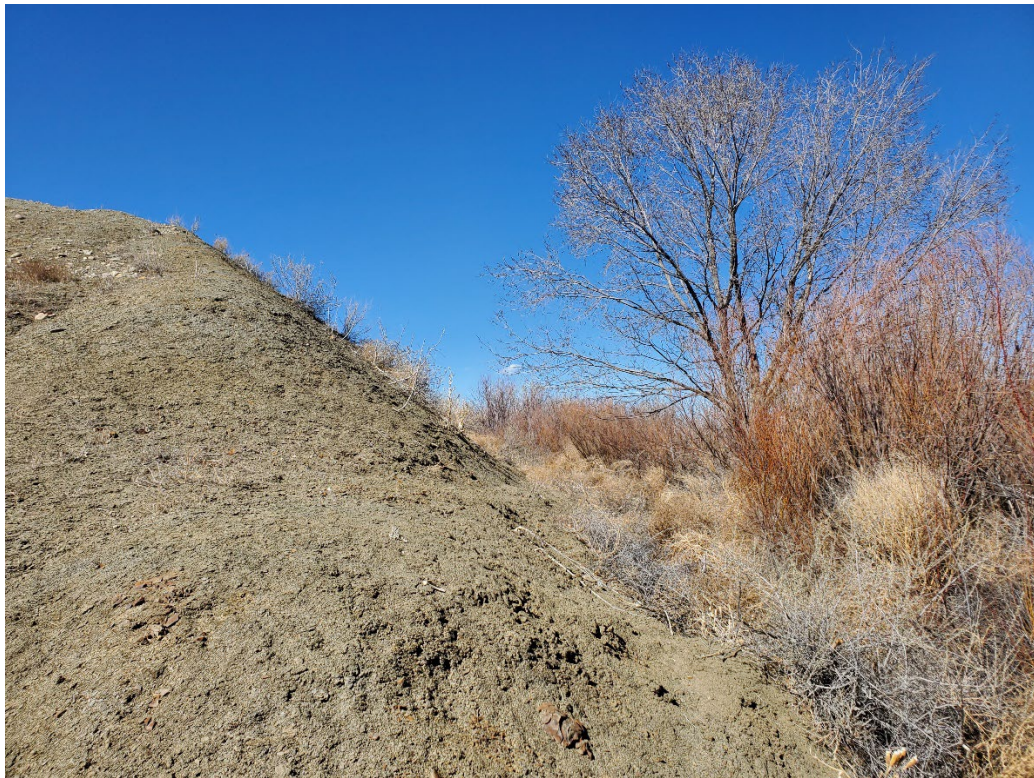
The Division noted the proximity of the north boundary of the eastern Phase I area as being very close to the Rocky Ford Highline Canal. The Operator(s) were advised to use caution upon reclamation of the eastern Phase I area to avoid causing offsite damage and to avoid upsetting the hydrologic balance.

**Photo 21: Looking west at the north edge of the eastern Phase 1 border that meets the Rocky Ford Highline Canal**

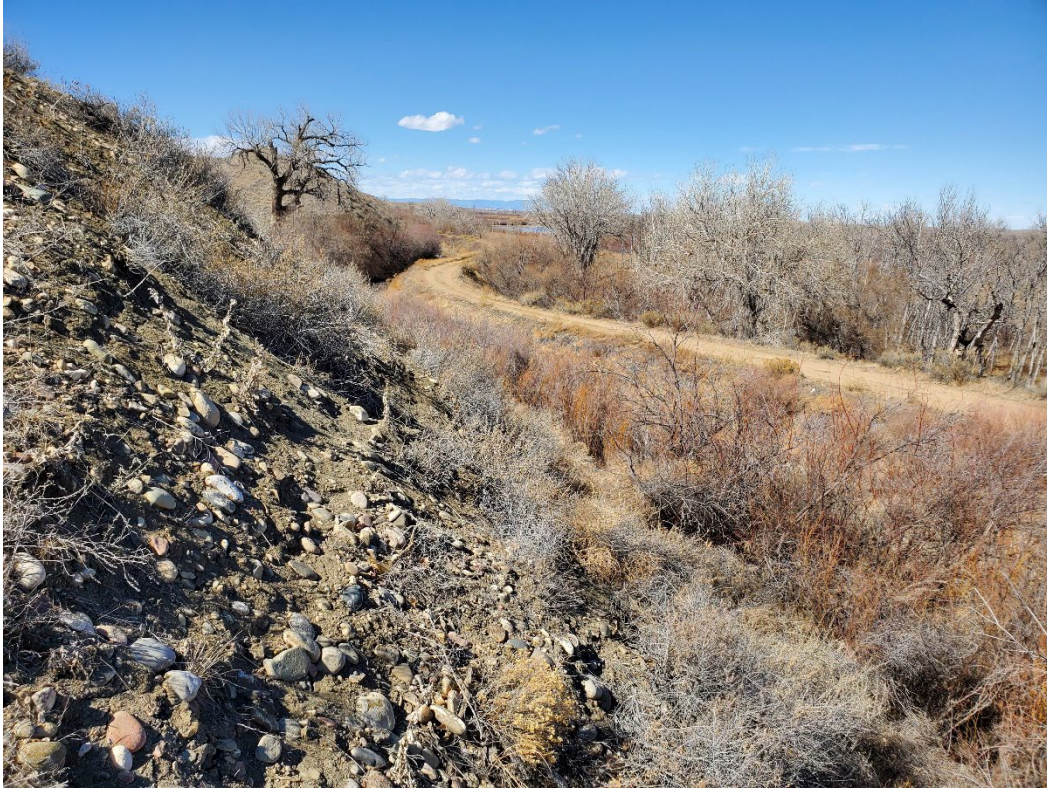
**Photo 22: Looking west at the north edge of the eastern Phase 1 border that meets the Rocky Ford Highline Canal**

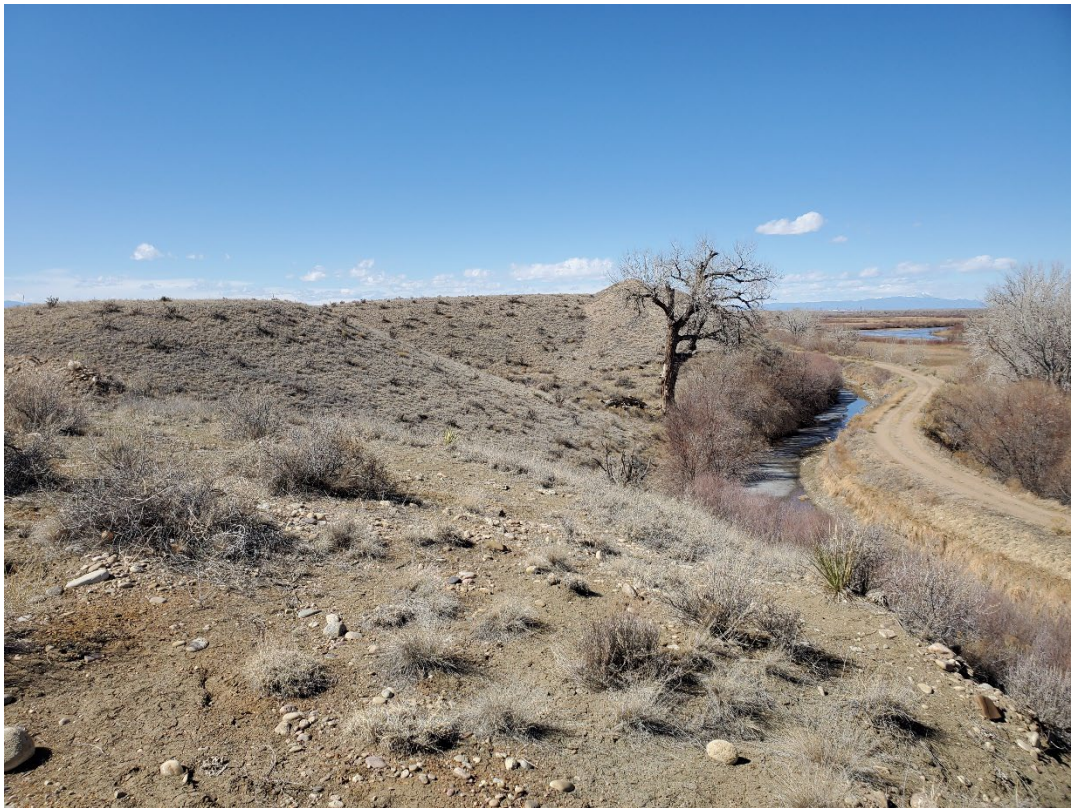
**Photo 23: Looking west at the north edge of the eastern Phase 1 border that meets the Rocky Ford Highline Canal from the top of the slope**

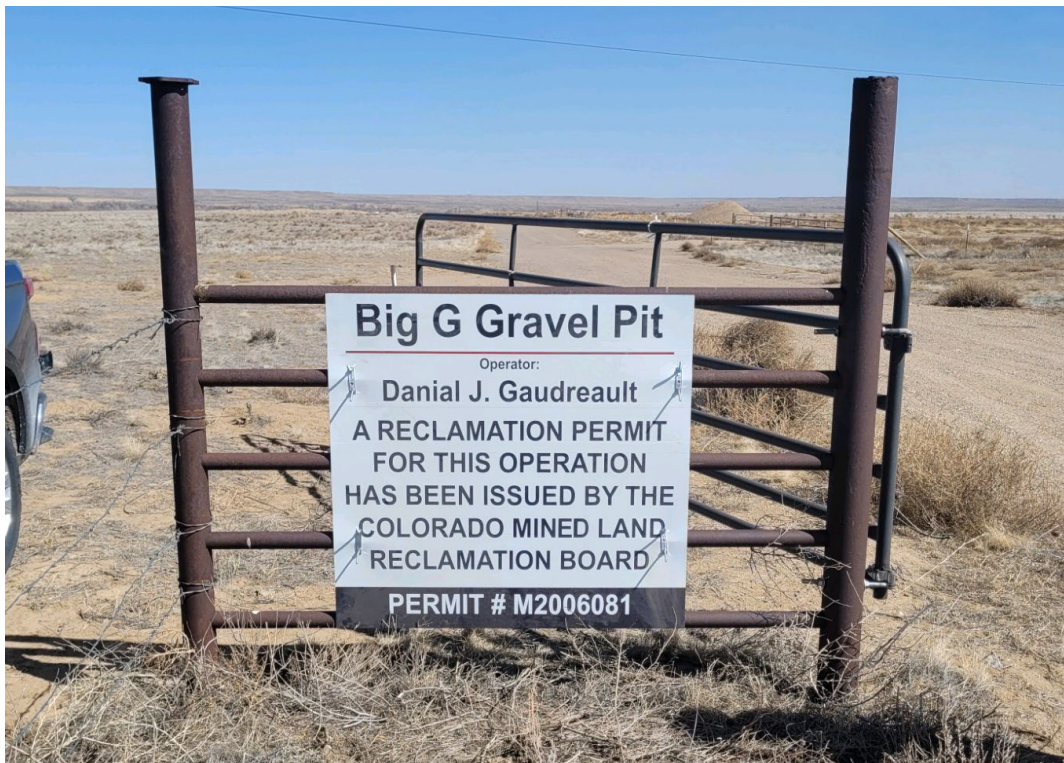
Prior to the inspection, Mr. Gaudreault called and informed the Division that the mine sign posted at the entrance of the access road had been stolen. Upon arrival at the site, Mr. Gaudreault stated that a new sign was almost done being made and that it would be posted as soon as possible. On March 5, 2023, Mr. Gaudreault provided the Division with photo evidence that this has been complied with (see photos).

**Photo 25: New entrance mine sign posted (photo from John Gaudreault)**
