MINERALS PROGRAM INSPECTION REPORT
PHONE: (303) 866-3567

MINE NAME: Henderson Mine	MINE/PROSPECTING ID#: M-1977-342	MINERAL: Molybdenum	COUNTY: Clear Creek, Grand
INSPECTION TYPE: Monitoring	WEATHER: Clear	INSP. DATE: March 14, 2023	INSP. TIME: 09:00
OPERATOR: Climax Molybdenum Company	OPERATOR REPRESENTATIVE: Kasey Martin	TYPE OF OPERATION: 112d-3 - Designated Mining Operation	
REASON FOR INSPECTION: Normal I&E Program	BOND CALCULATION TYPE: None	BOND AMOUNT: \$92,702,835.00	
DATE OF COMPLAINT: NA	POST INSP. CONTACTS: None	JOINT INSP. AGENCY: None	
INSPECTOR(S): Peter Hays Brock Bowles	INSPECTOR'S SIGNATURE:

Designated Chemical Storage:

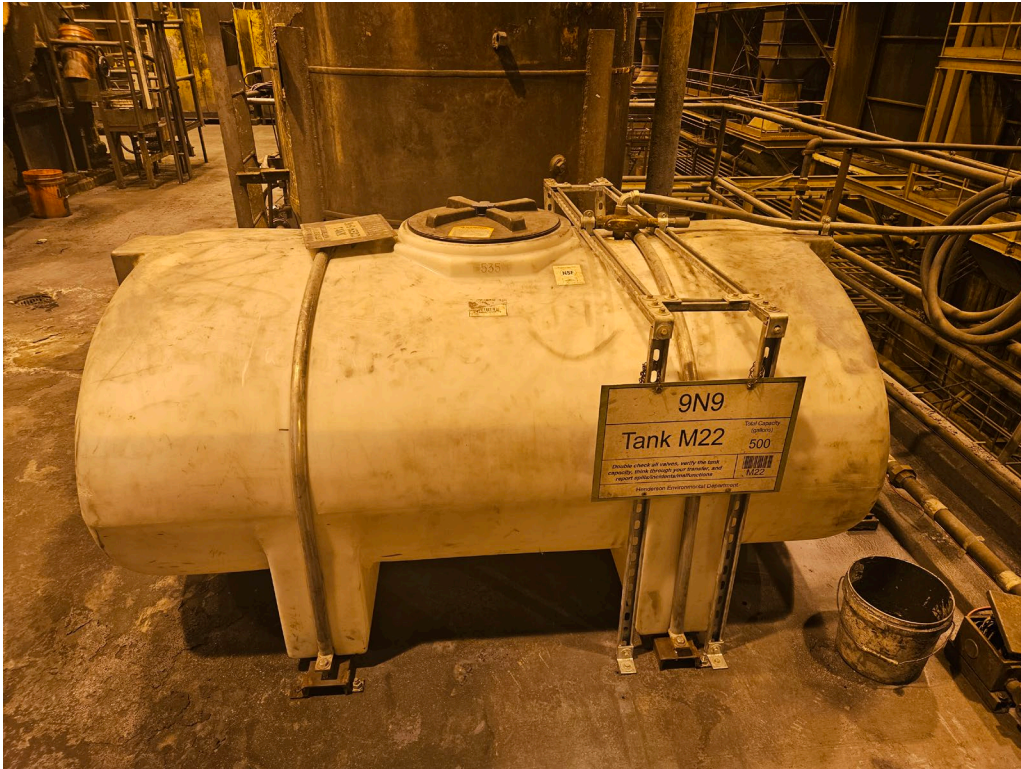
New plastic 500 gallon 9N9 head tank

The steel 500 gallon head tank for Tergitol NP- 9/9N9 Surfactant Storage was replaced by a plastic tank since the last designated chemical inspection. The plastic tank capacity is 500 gallons, so no revision to the EPP is required by the Division.

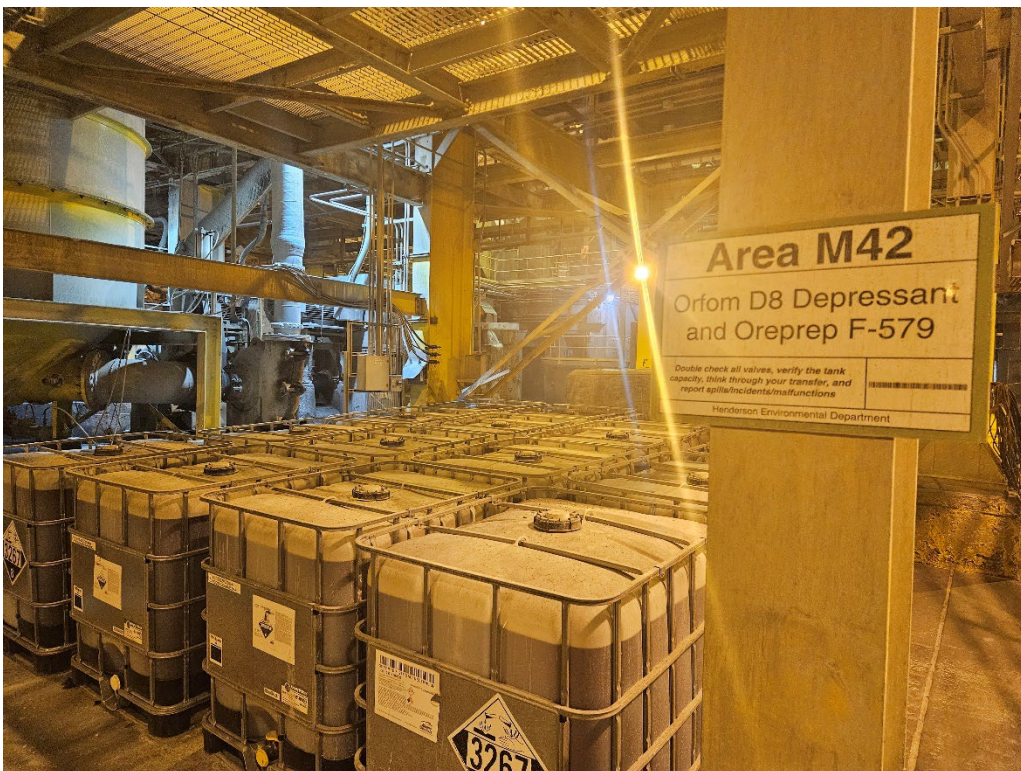
Current storage of D8 in totes

The Orform D8 Depressant is currently stored in 275 gallon totes in the Mill building with a maximum storage capacity of 5,400 gallons. The Operator is in the process of relocating the Orform D8 Depressant from tote to tank storage. The empty tank was observed during the inspection. The Division will require the Operator to update the EPP to accurately describe the storage of Orform D8 in the EPP.

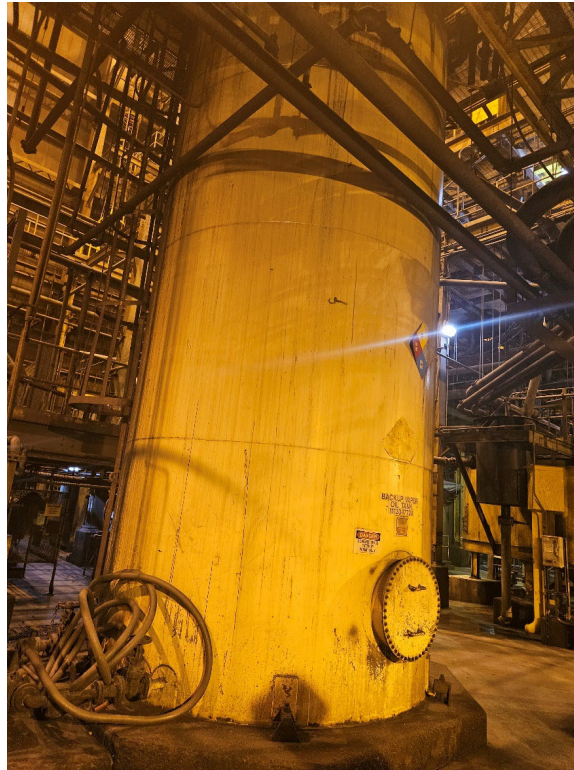
Future D8 storage tank
